HISTORIC STRUCTURE REPORT: 1428 WEST BALTIMORE STREET

EMILY CONNORS

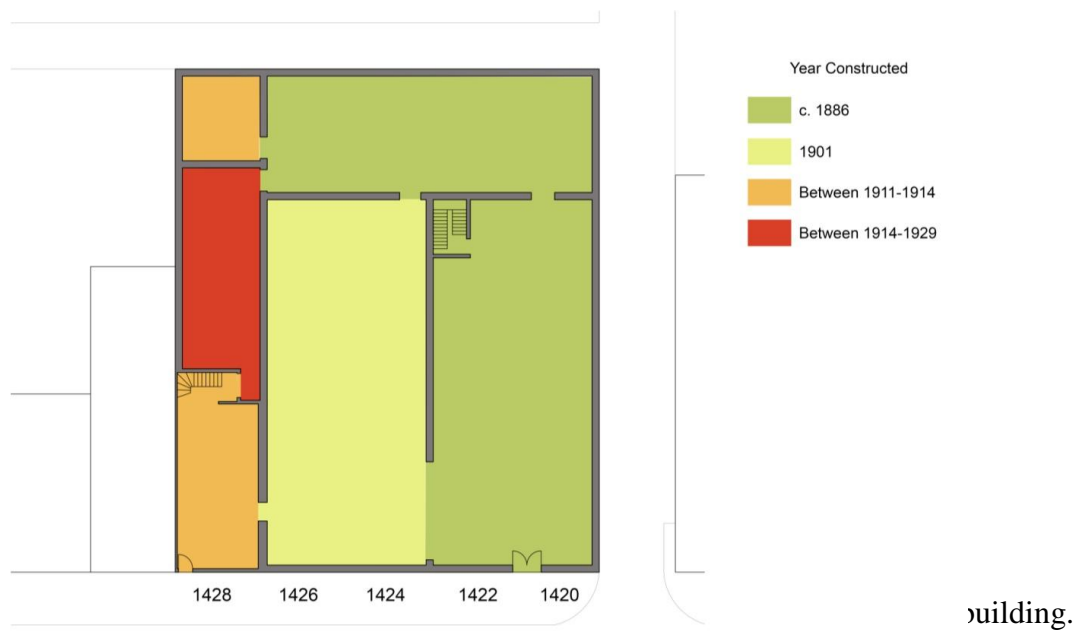
Figure 2. Diagram of Construction Sequence.

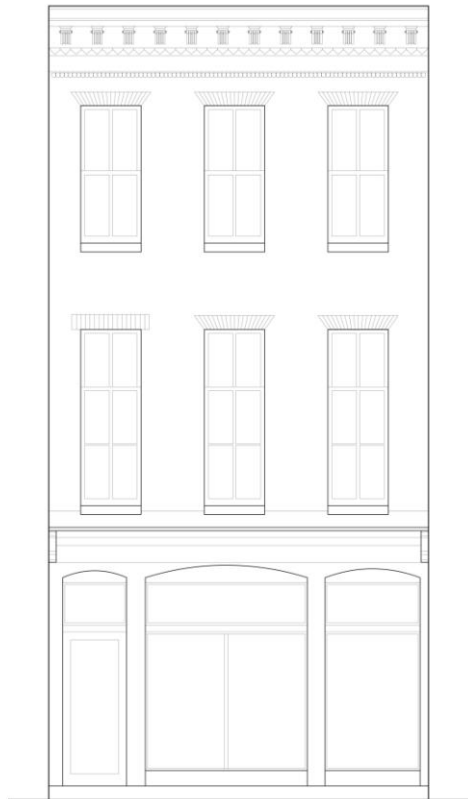
Figure 9. Exterior South Elevation.

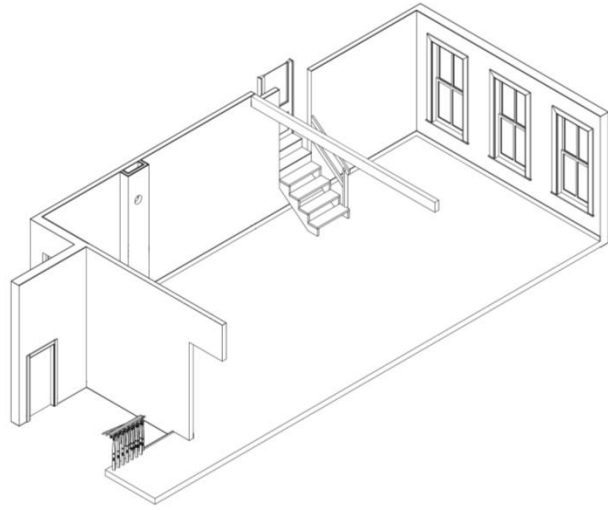
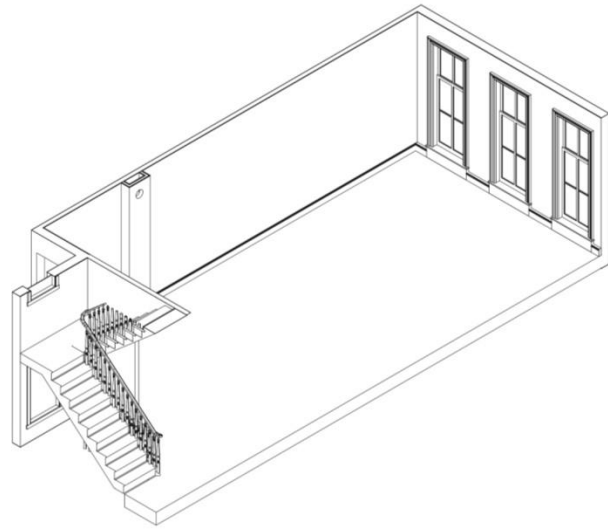
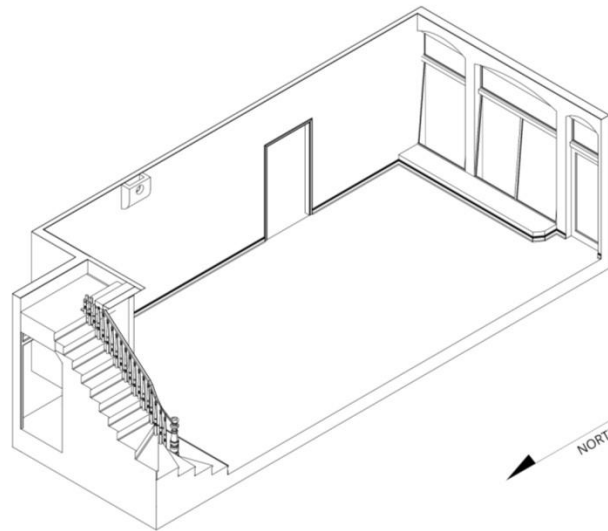
Figure 10. Axonometric Floor Plans.

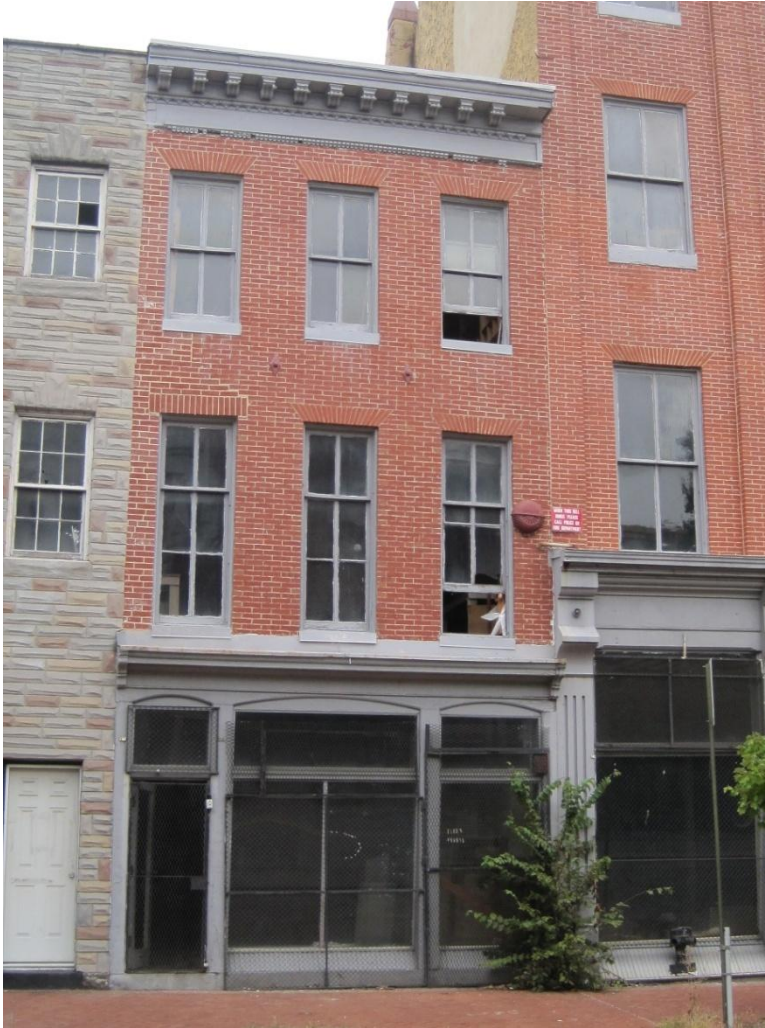
Figure 11. Exterior: south elevation.

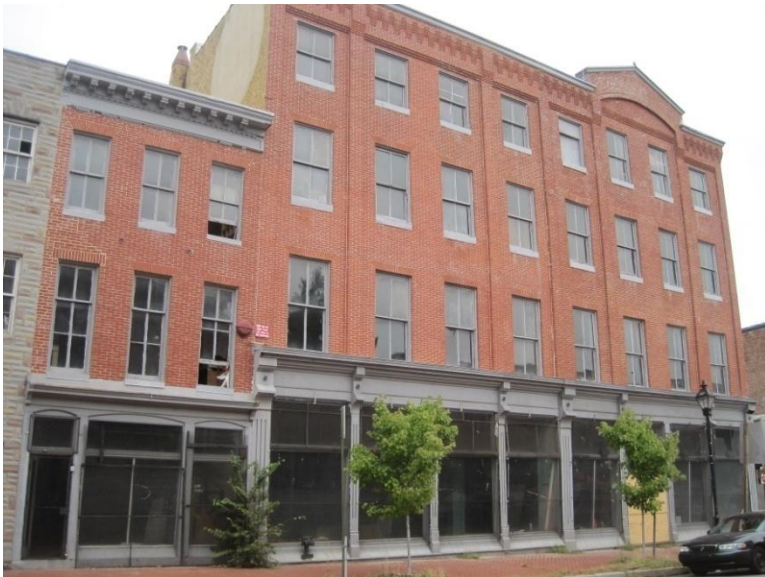
Figure 19. Exterior: 1420-1428 West Baltimore Street.

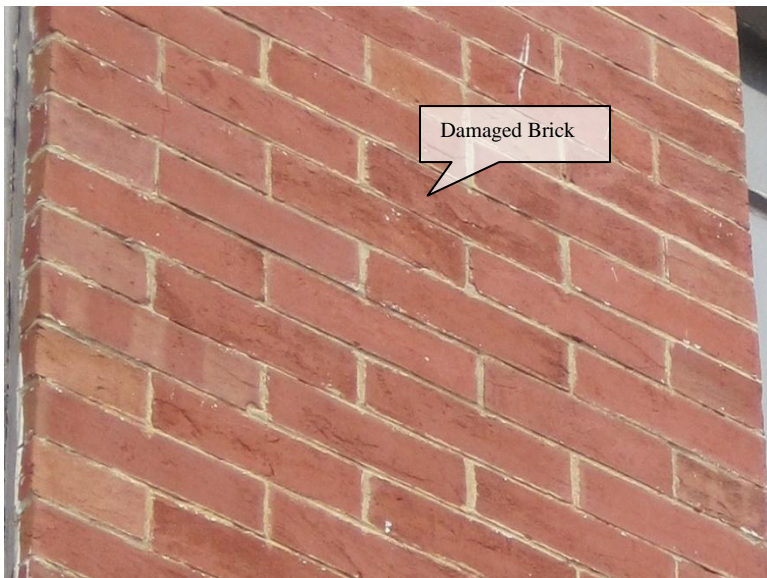
Figure 21. Exterior: damaged brick surface.

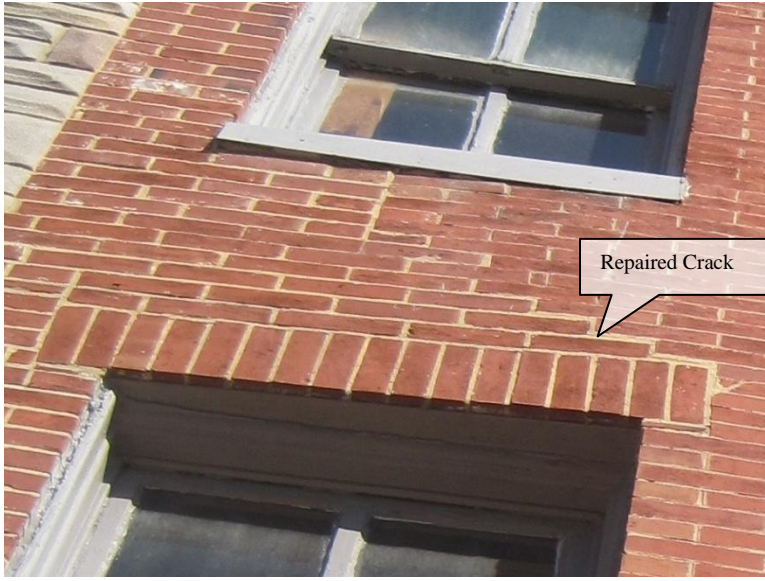
Figure 22. Exterior: second floor west lintel and repaired crack above.

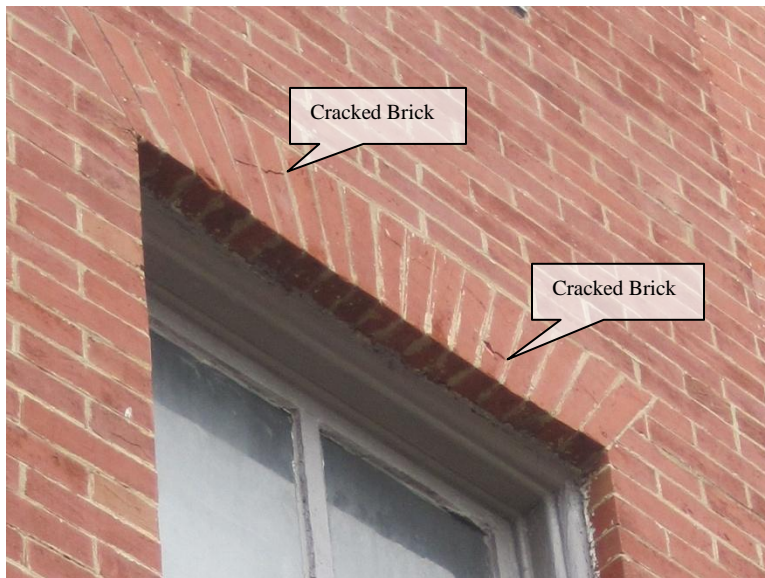
Figure 23. Exterior: second floor east lintel cracked brick.

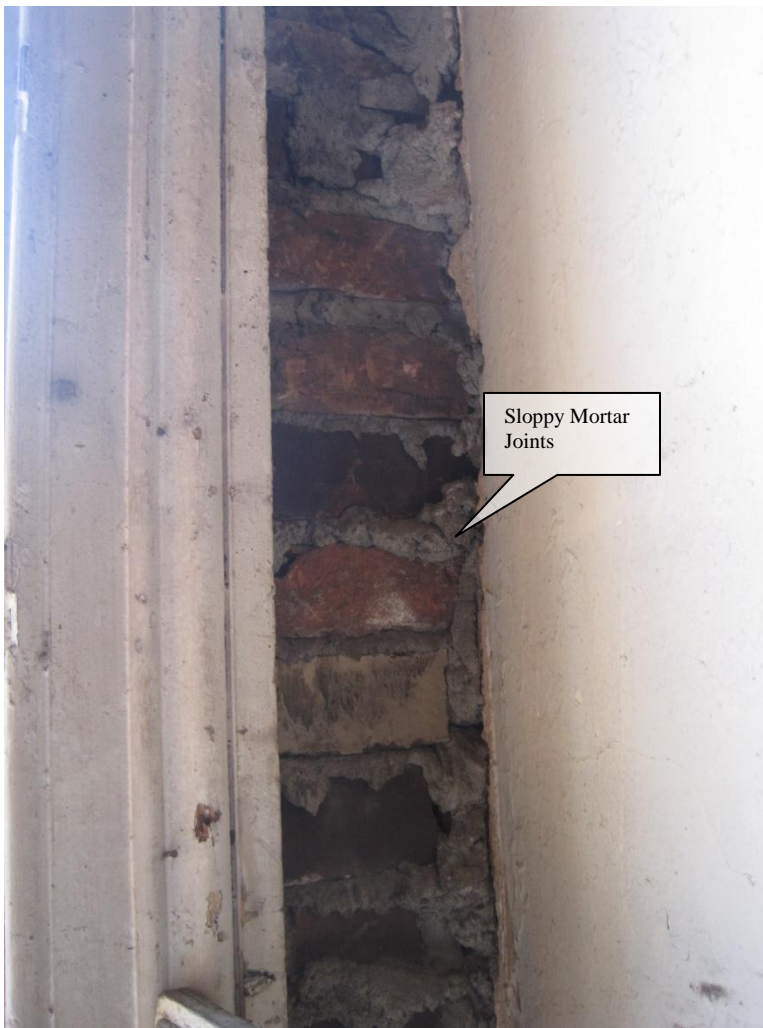
Figure 24. Second Floor: exposed masonry on south wall.

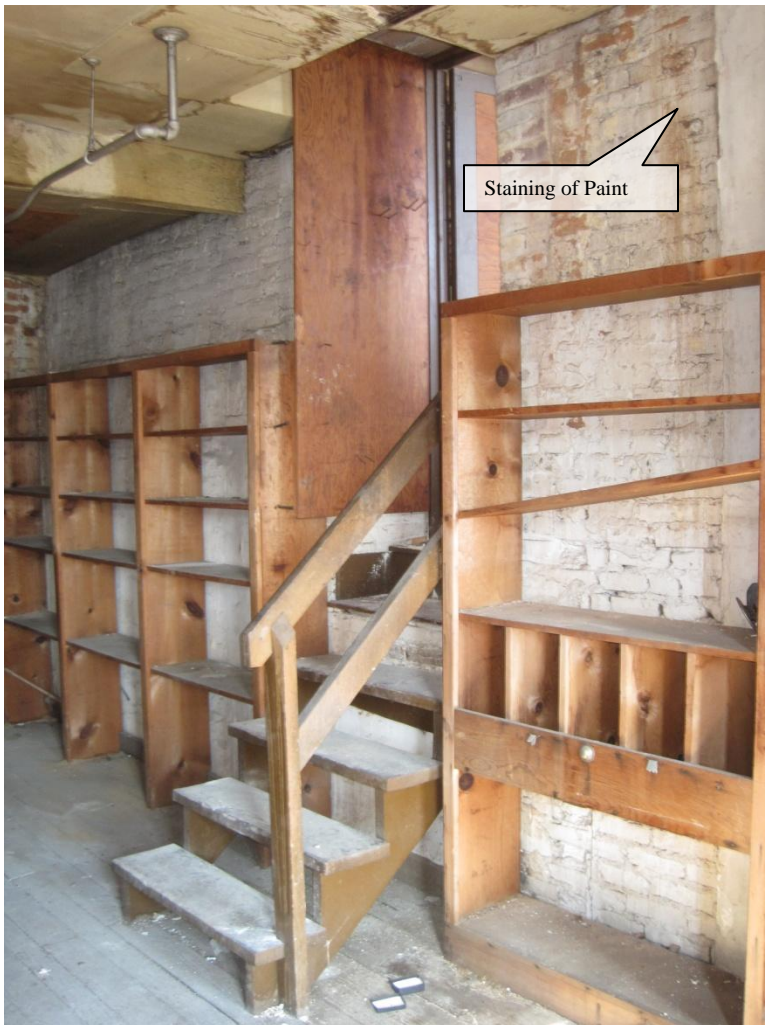
Figure 25. Third Floor: exposed and painted masonry on east wall.

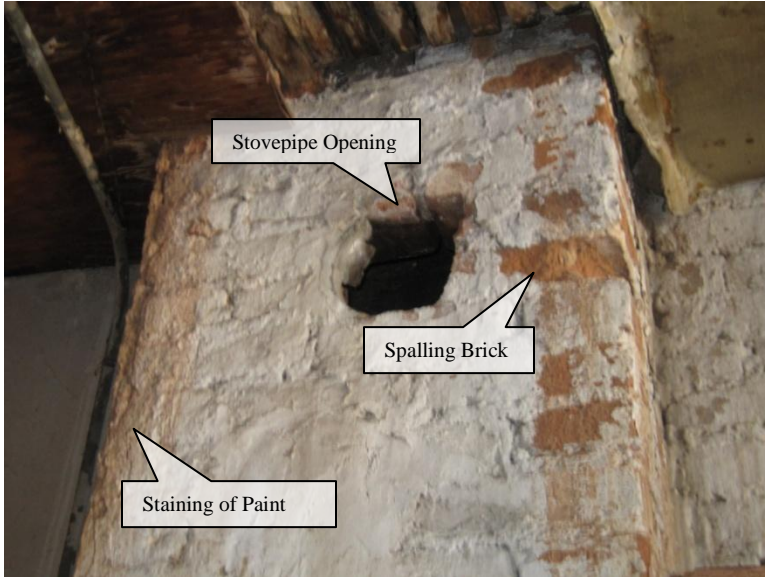
Figure 27. Third Floor: stained paint and spalled brick on east wall corresponding with water damage above.

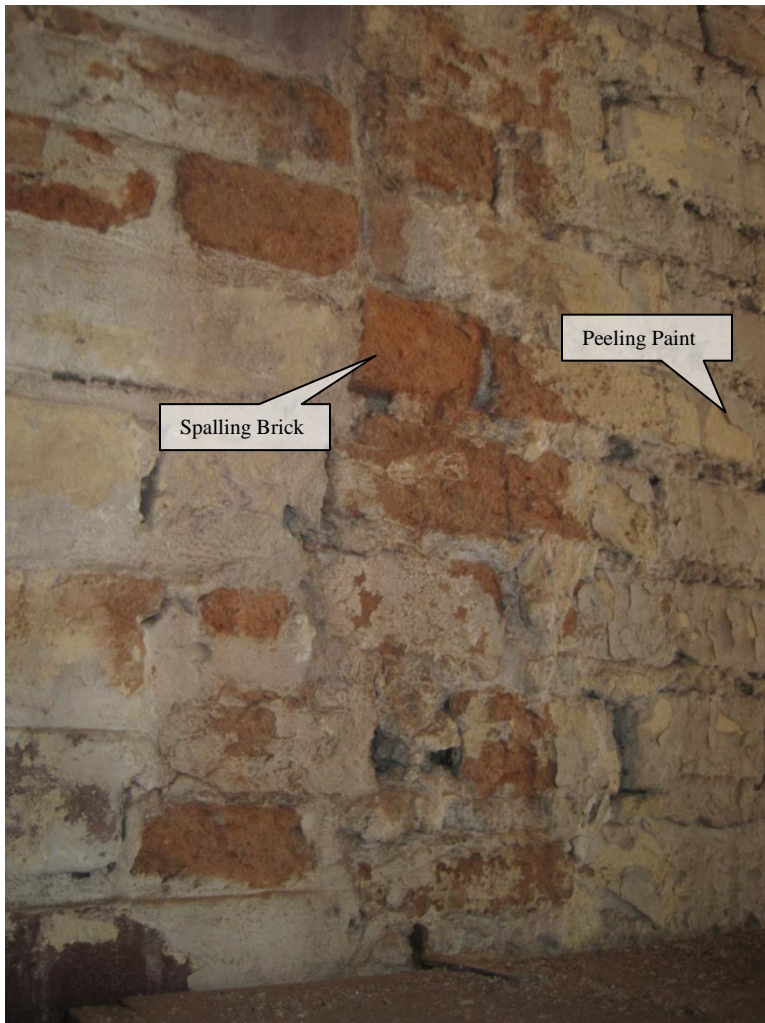
Figure 28. Third Floor: peeling paint and spalling brick on east wall.

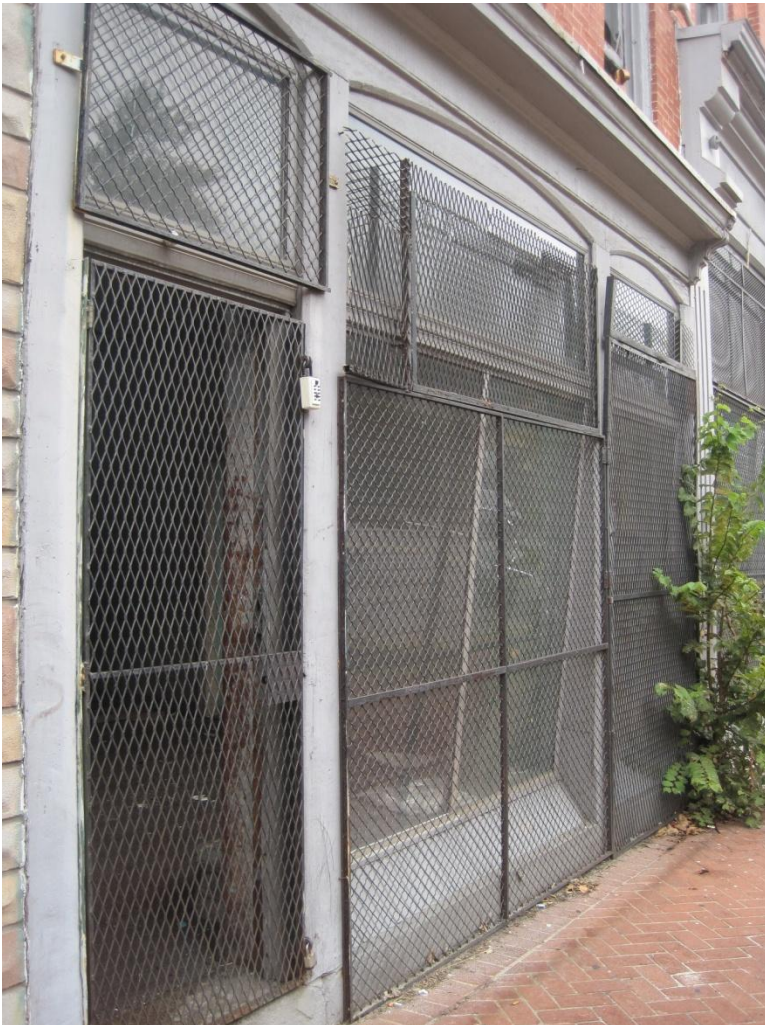
Figure 29. Exterior: storefront.

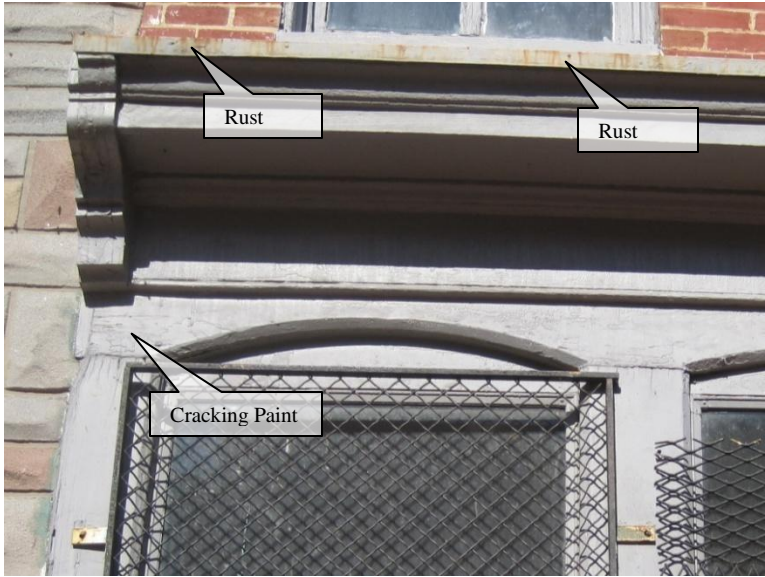
Figure 30. Exterior: cracking and peeling paint; rust on flashing.

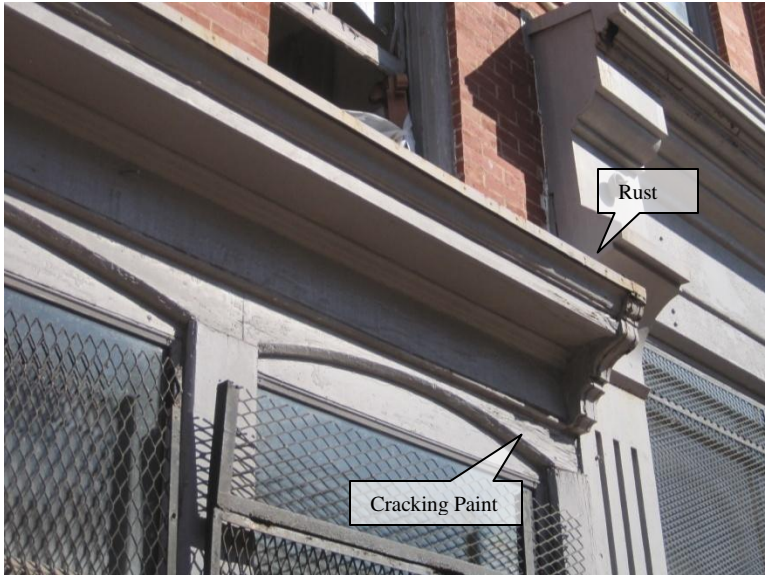
Figure 31. Exterior: cracking and peeling paint; rust on flashing.

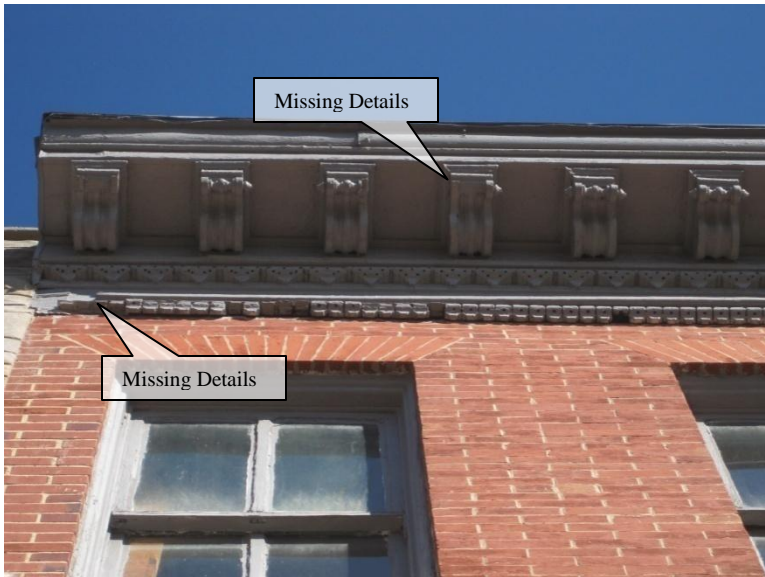
Figure 32. Exterior: missing details and cracking paint on cornice.

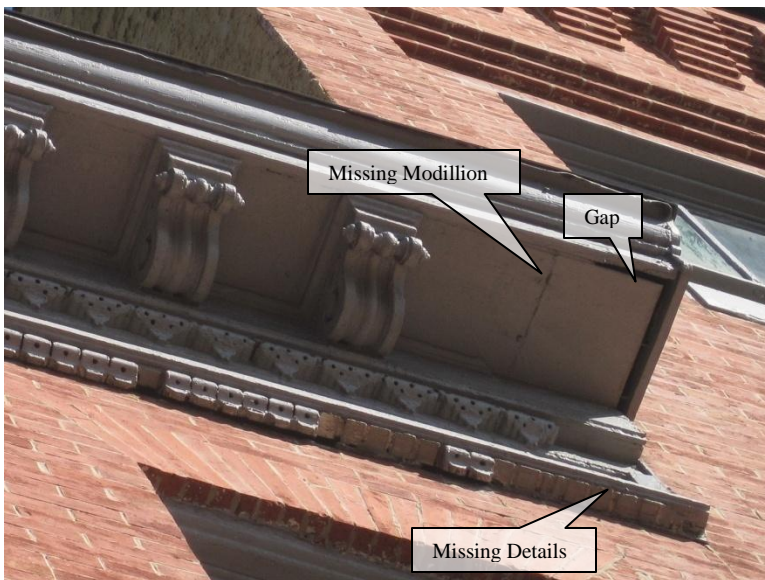
Figure 33. Exterior: missing details and gap in cornice overhang.

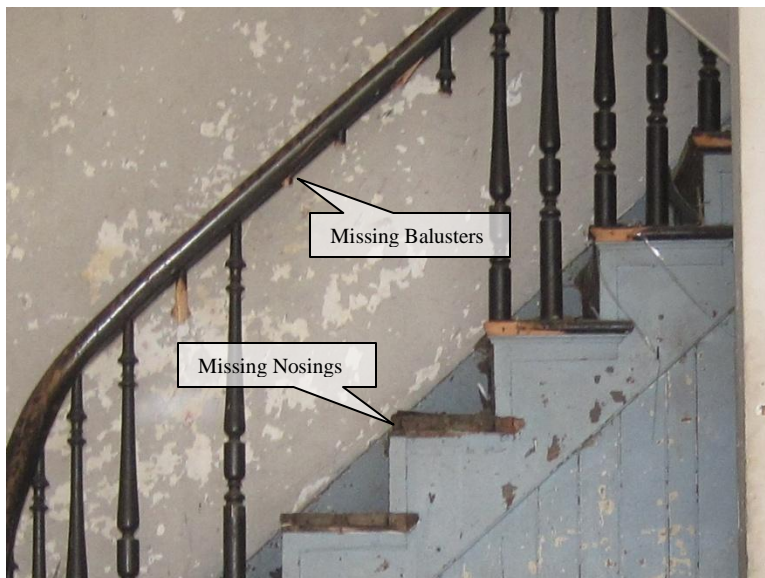
Figure 34. First Floor: missing balusters and nosings.

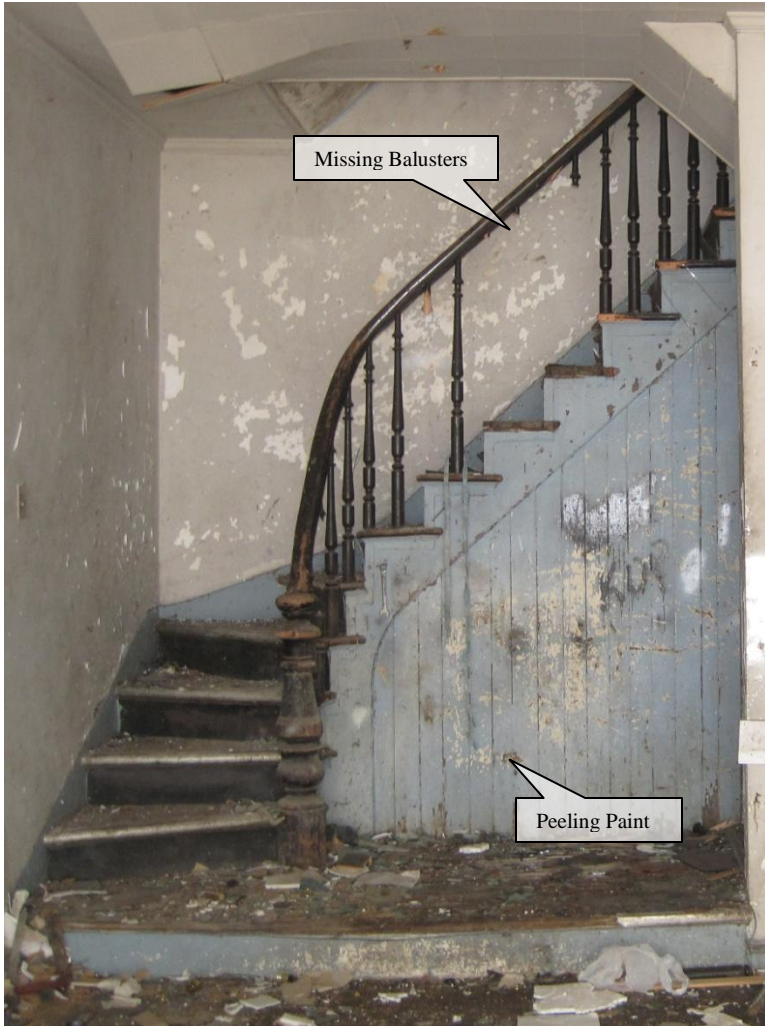
Figure 35. First Floor: peeling paint on wall below stairs and missing balusters.

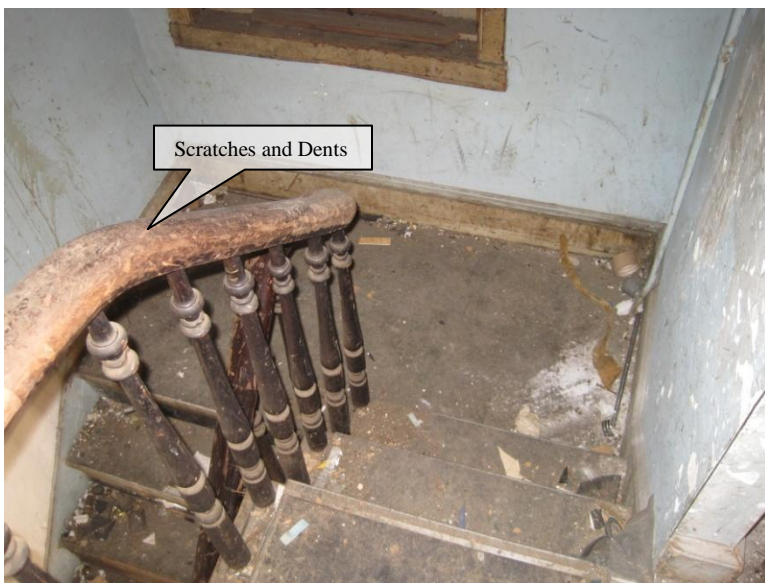
Figure 36. First Stair Landing: scratches and dents on handrail and balusters.

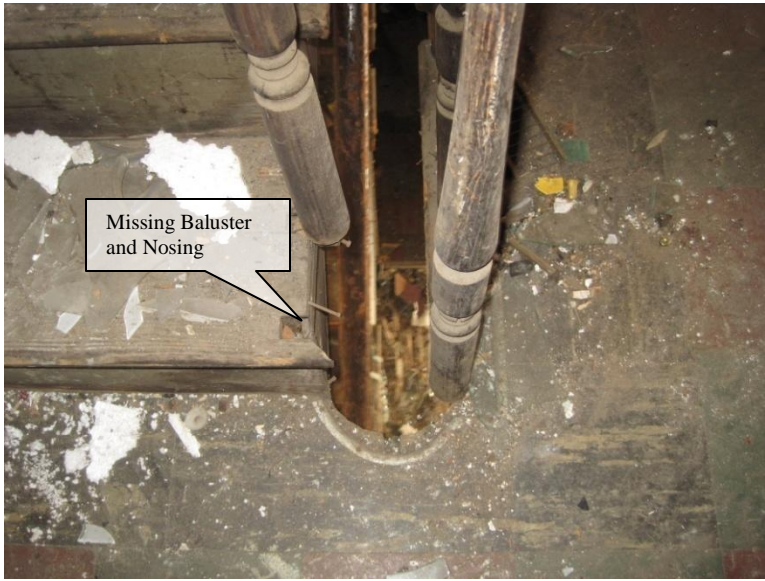
Figure 37. Second Floor: missing baluster and nosing.

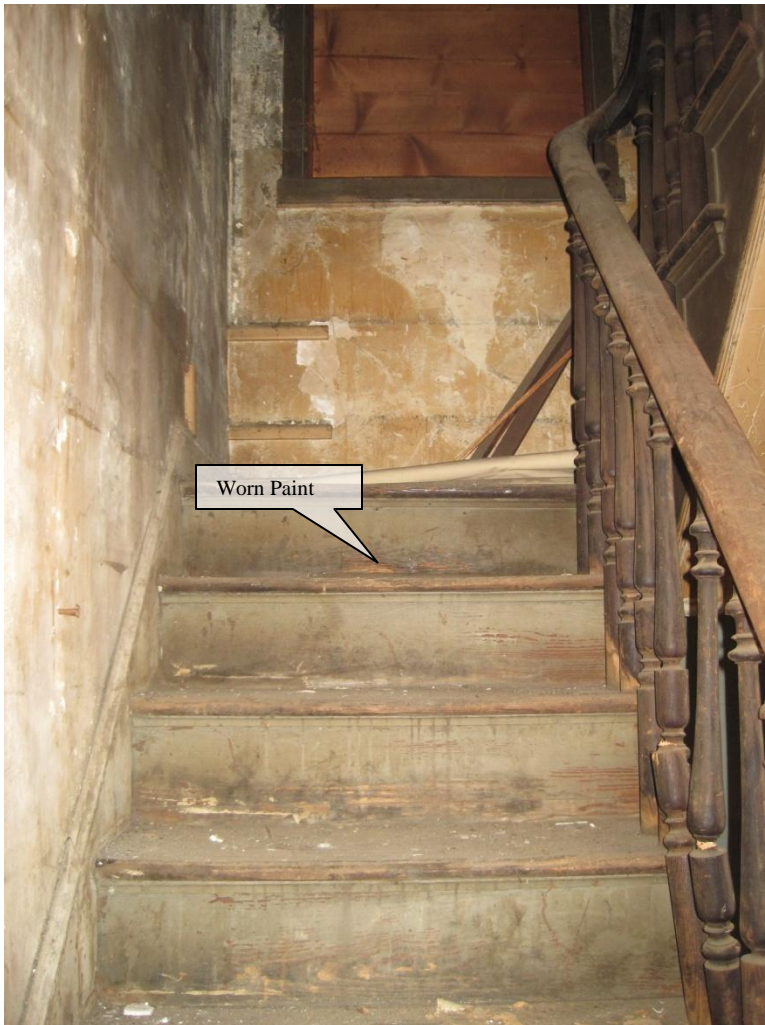
Figure 38. Second Floor: paint wearing away on both treads and risers.

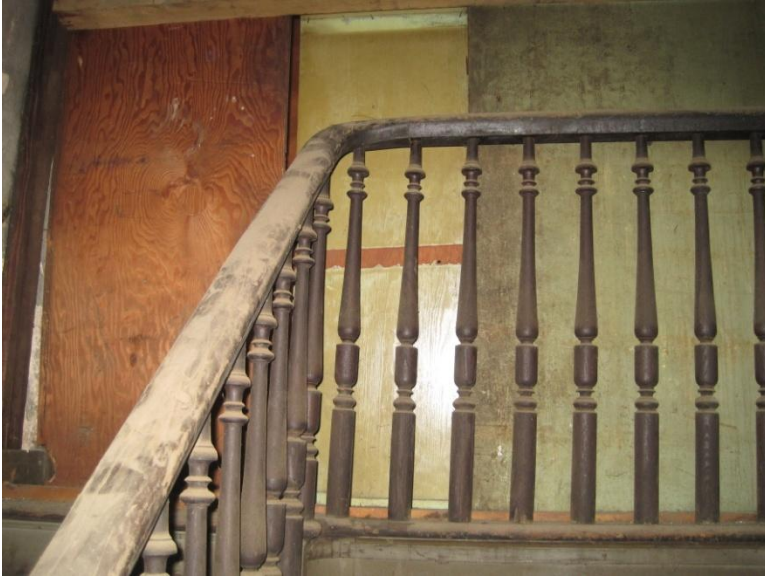
Figure 39. Third Floor: best preserved handrail and balusters.

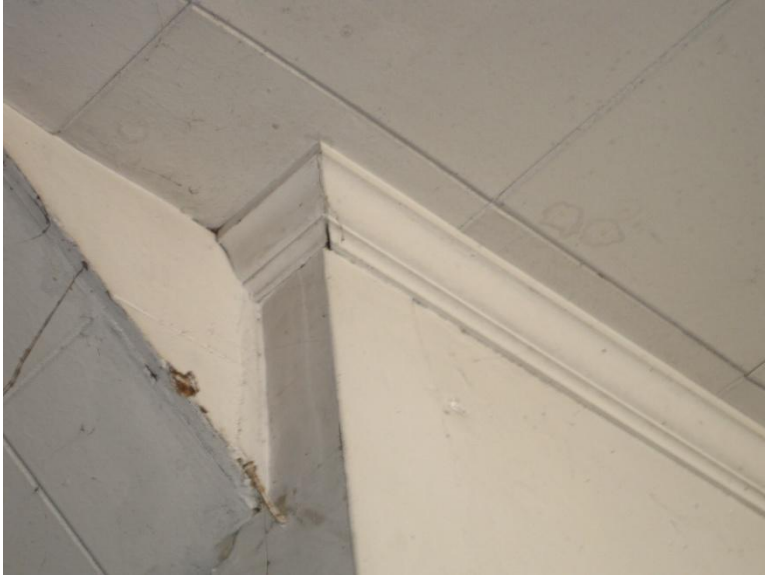
Figure 40. First Floor: crown molding.

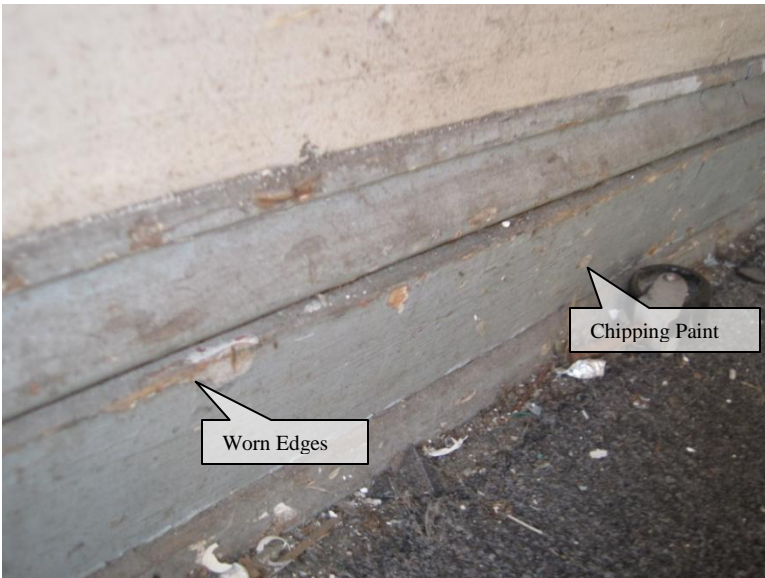
Figure 41. First Floor: dirt, wear along edges, and chipping paint on baseboard.

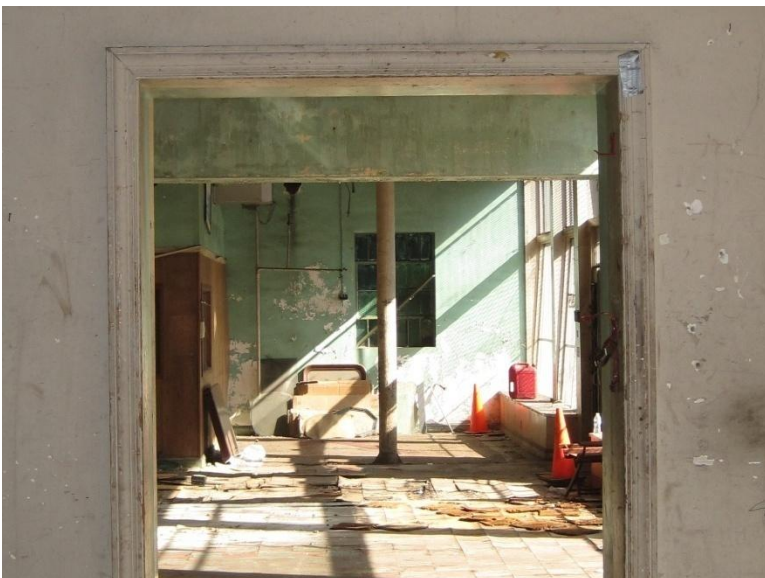
Figure 42. First Floor: east wall doorway trim.

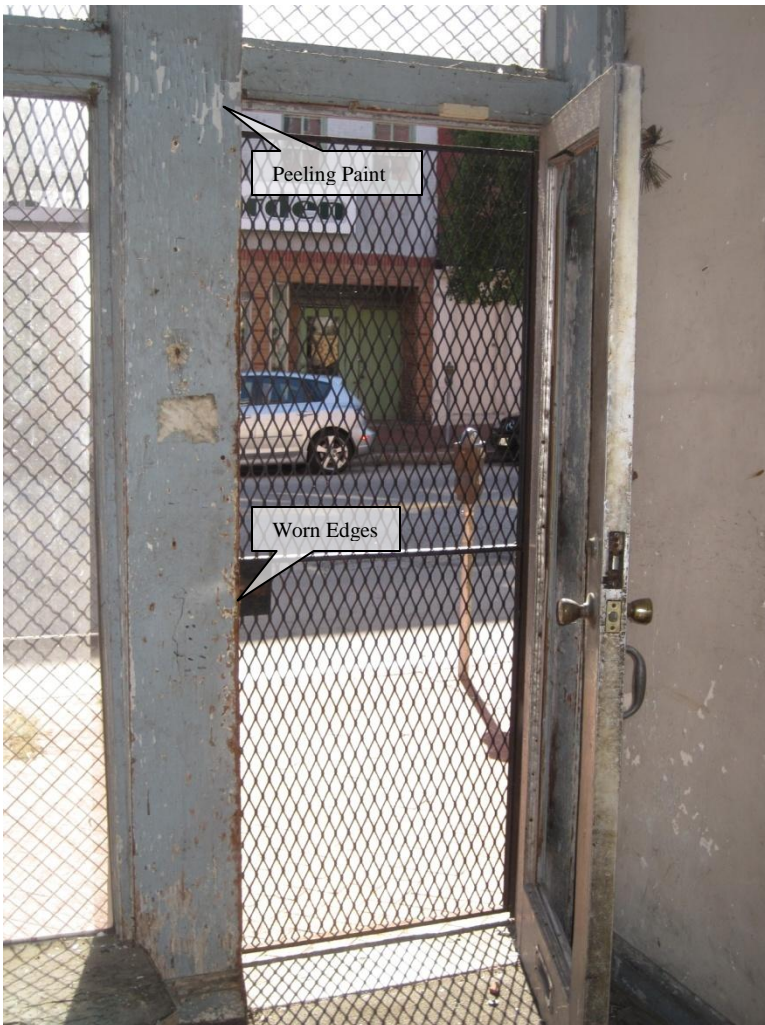
Figure 44. First Floor: peeling paint and wear at corner edges on south wall trim.

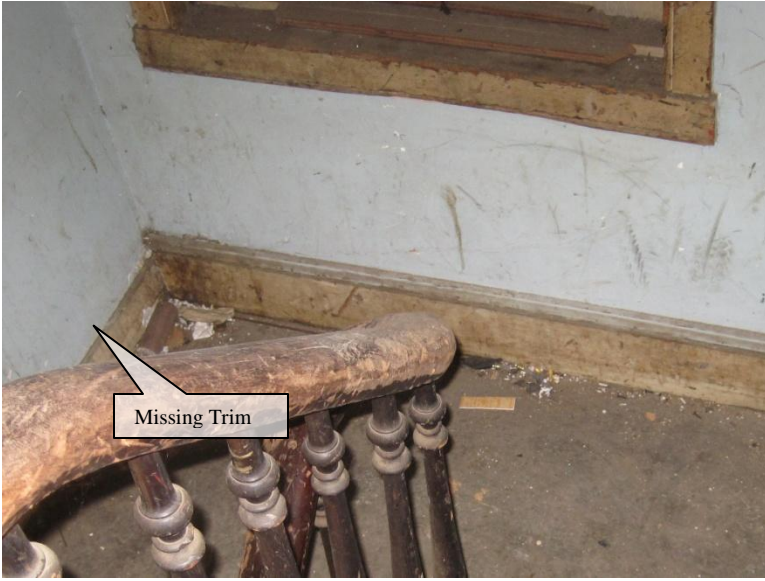
Figure 45. First Stair Landing: missing baseboard piece and damaged window trim.

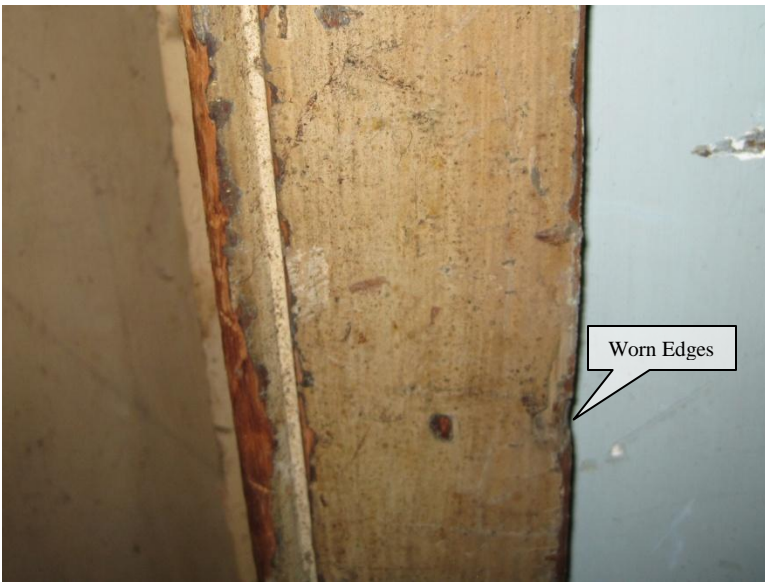
Figure 46. First Stair Landing: worn edges on window trim.

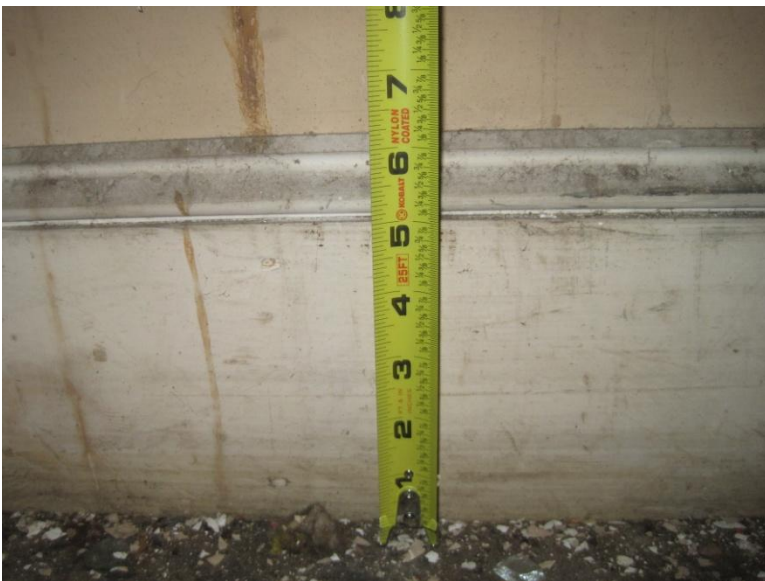
Figure 47. Second Floor: baseboard.

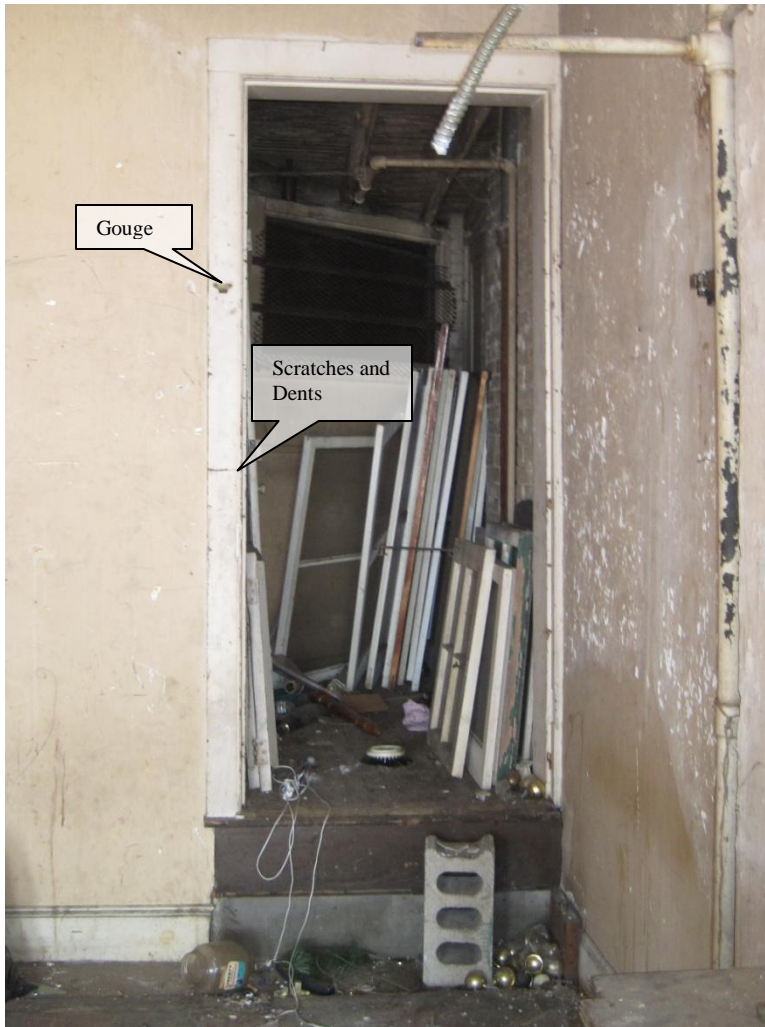
Figure 48. Second Floor: worn edges, scratches, and gouges in doorway trim.

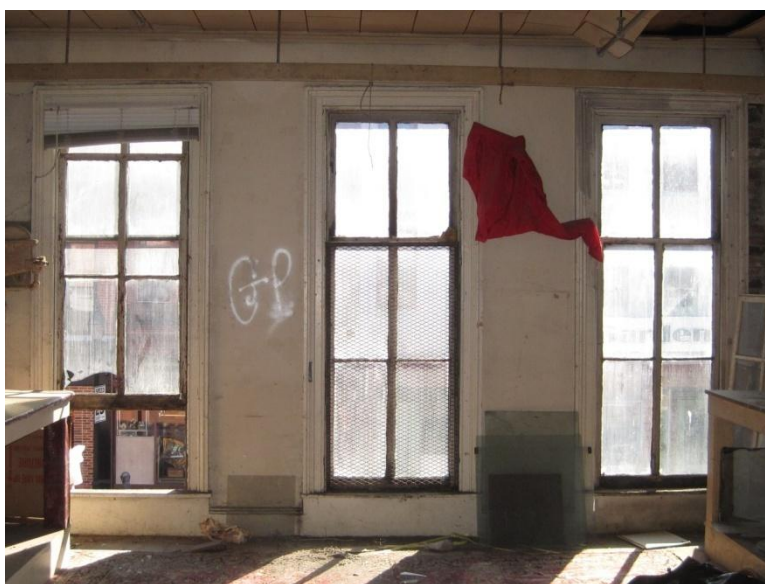
Figure 49. Second Floor: window trim on south wall.

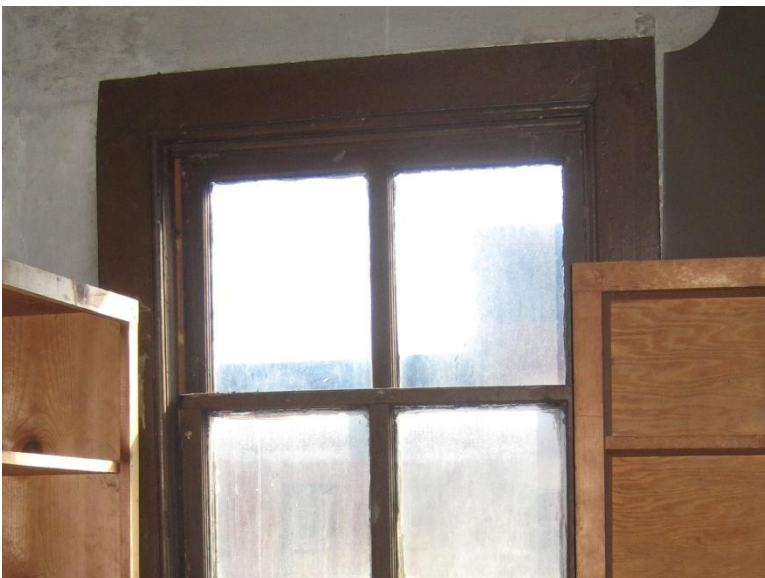
Figure 54. Third Floor: window trim with little wear.

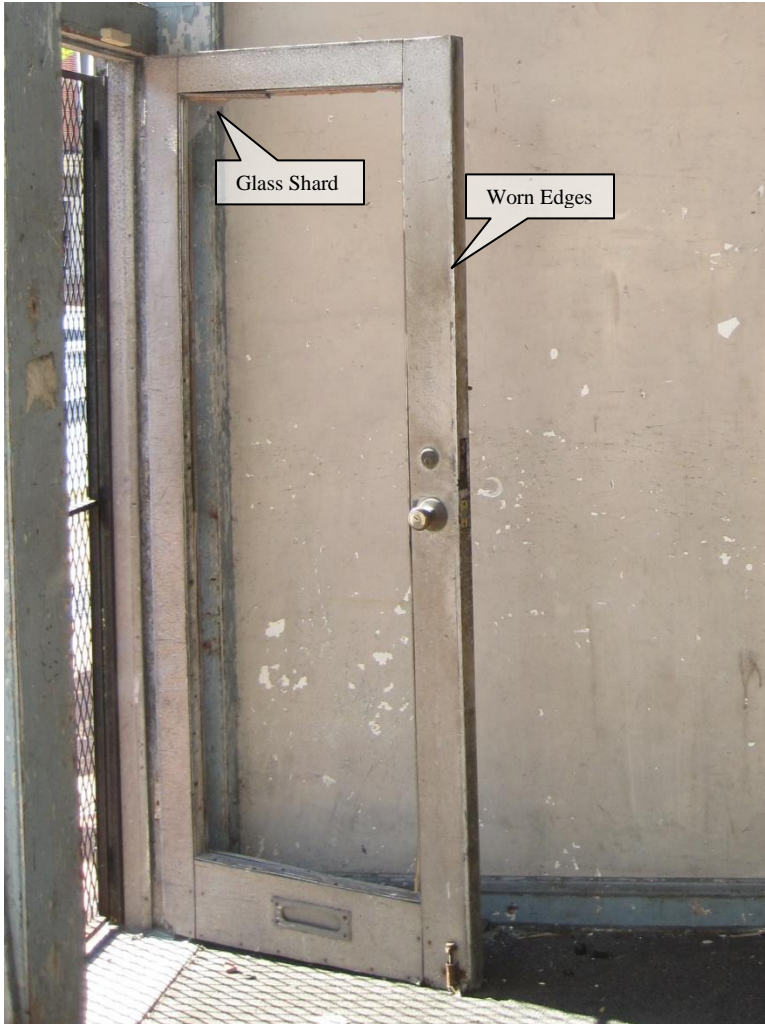
Figure 55. First Floor: missing glass on entry door.

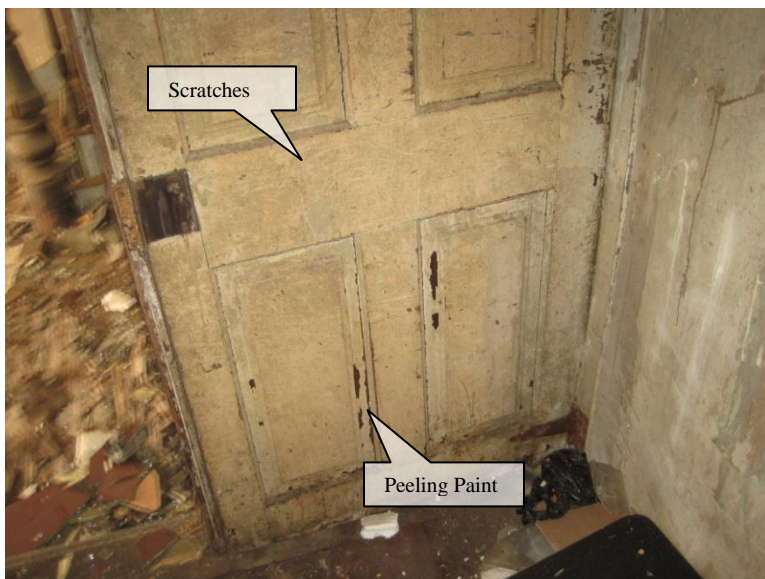
Figure 56. First Floor: scratches and peeling paint on basement door.

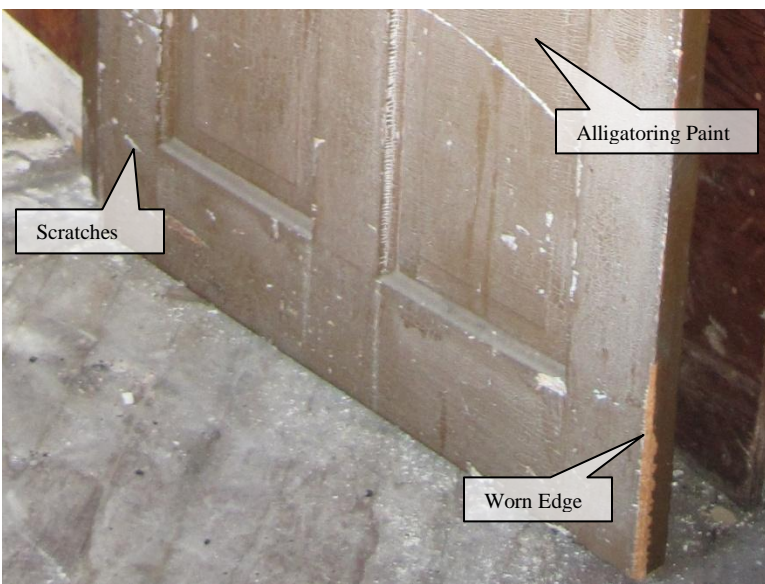
Figure 58. Third Floor: damage to stile edge, scratches in the surface, and alligatoring paint on connecting door.

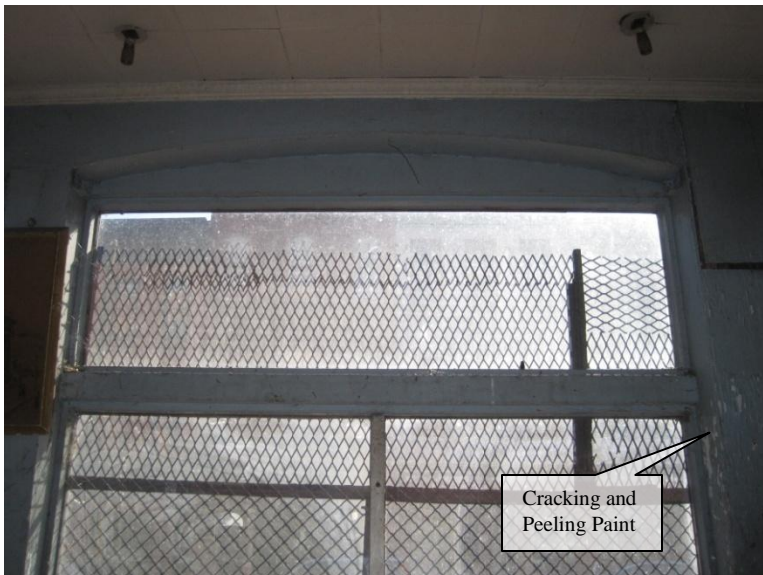
Figure 59. First Floor: storefront windows and transom.

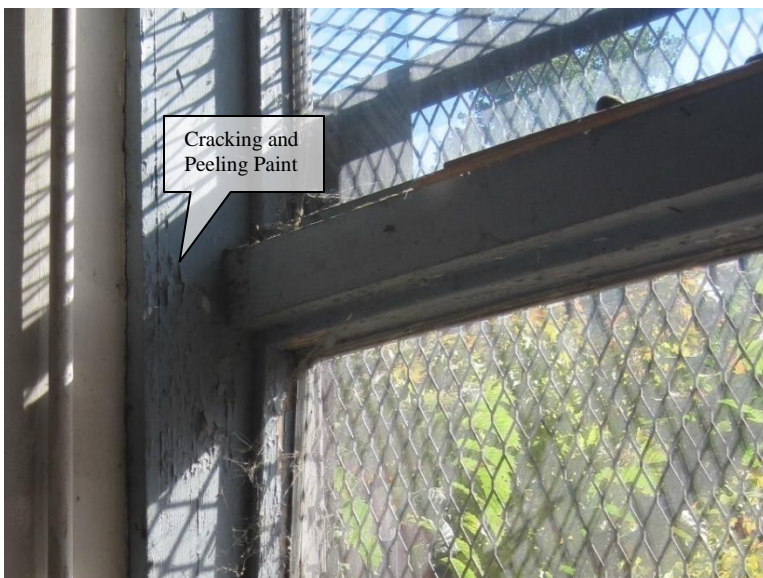
Figure 60. First Floor: cracking and peeling paint on storefront window frame.

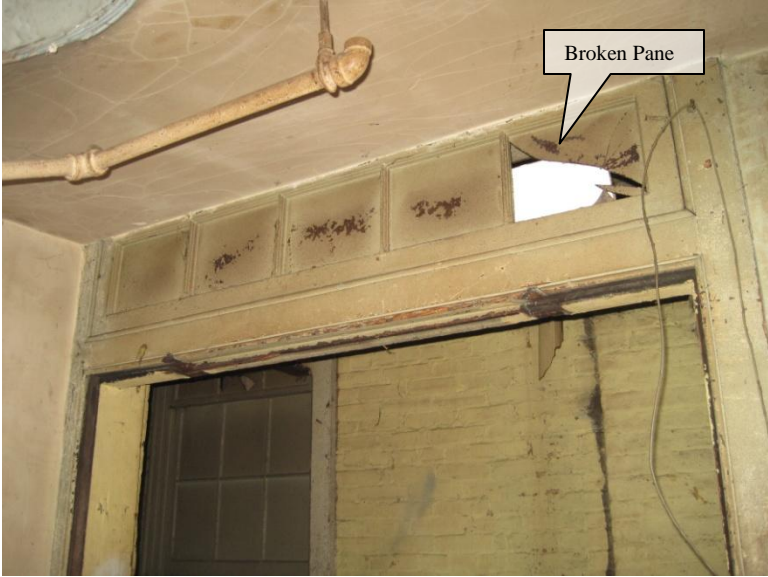
Figure 61. First Floor: painted glass and broken pane on doorway under stairs.

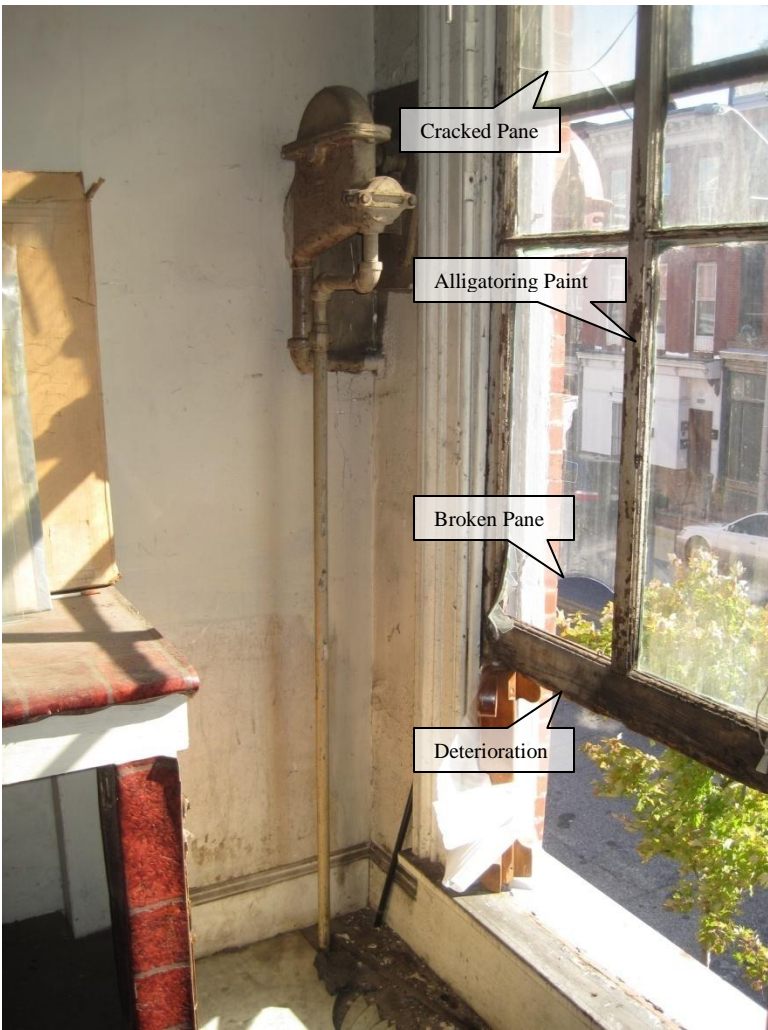
Figure 62. Second Floor: broken and cracked glass, deteriorated bottom rail, and alligatoring paint on east window.

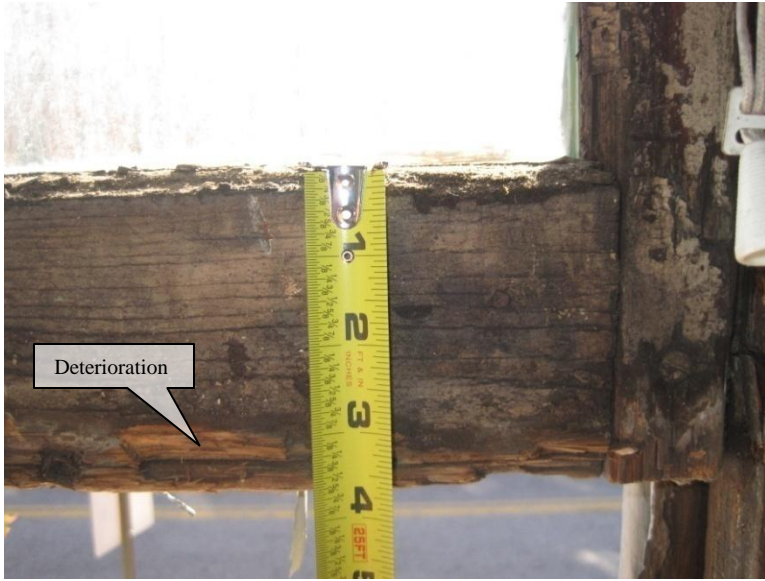
Figure 63. Second Floor: deteriorated bottom rail on east window sash.
