HISTORIC STRUCTURE REPORT: 1428 WEST BALTIMORE STREET

EMILY CONNORS

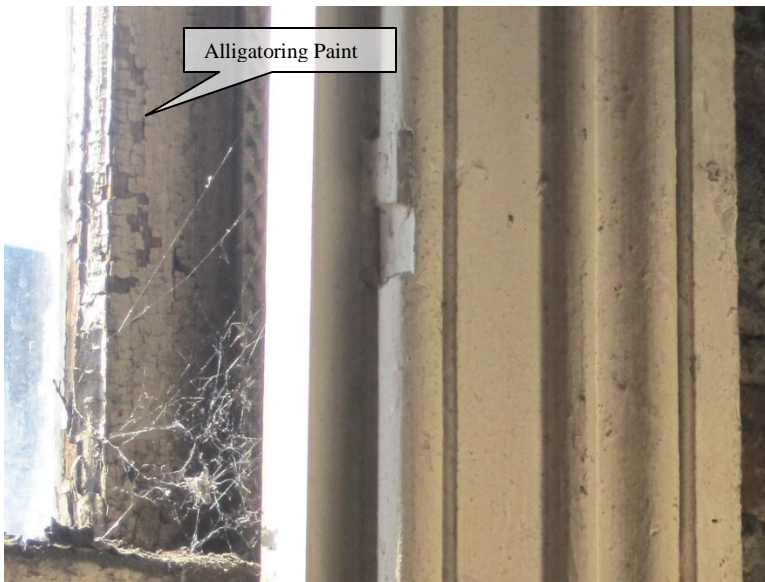
Figure 64. Second Floor: alligatoring paint on west window sash.

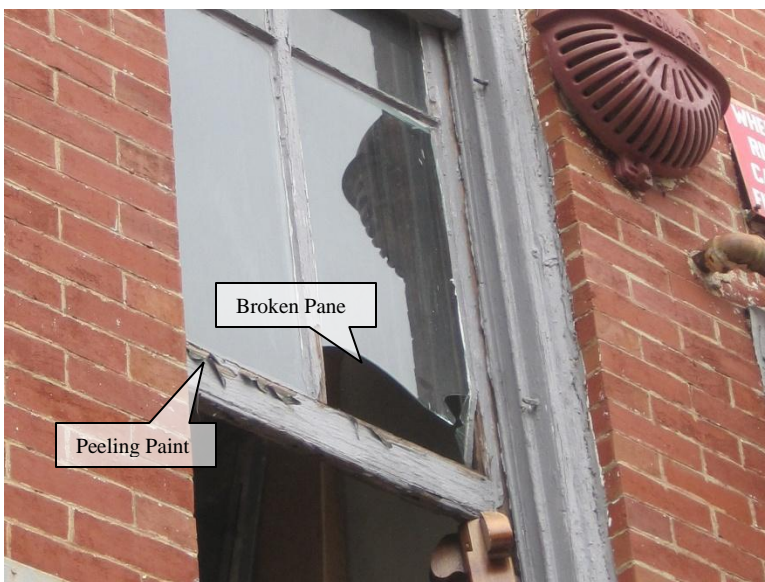
Figure 65. Exterior: peeling paint and broken pane on second floor east window.

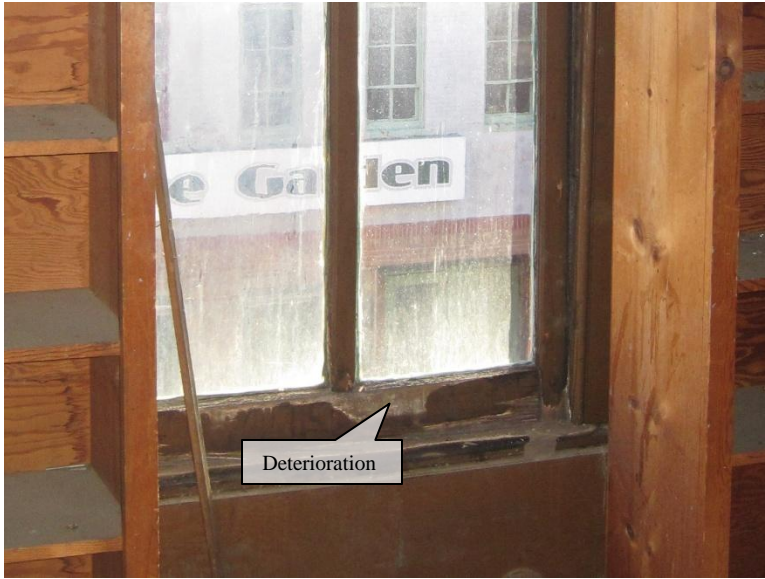
Figure 66. Third Floor: deteriorated bottom rail of sash on middle window.

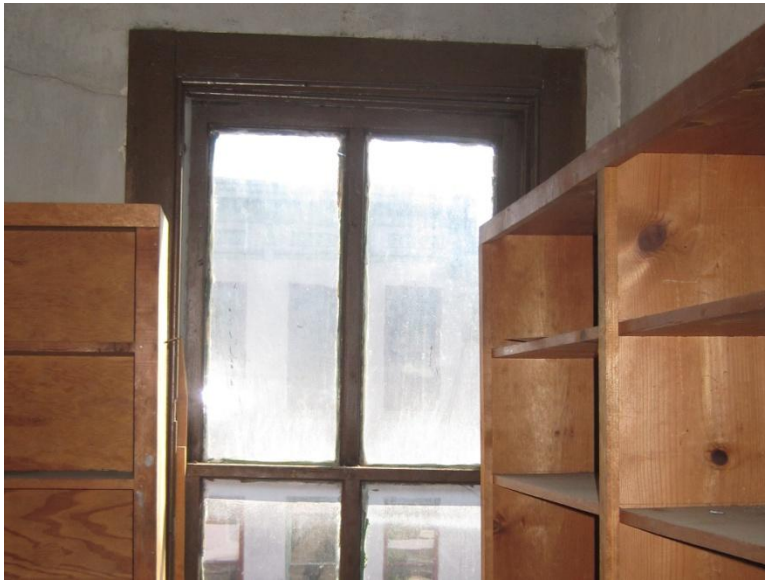
Figure 67. Third Floor: good condition of wood, paint, and glass on upper portions on west window.

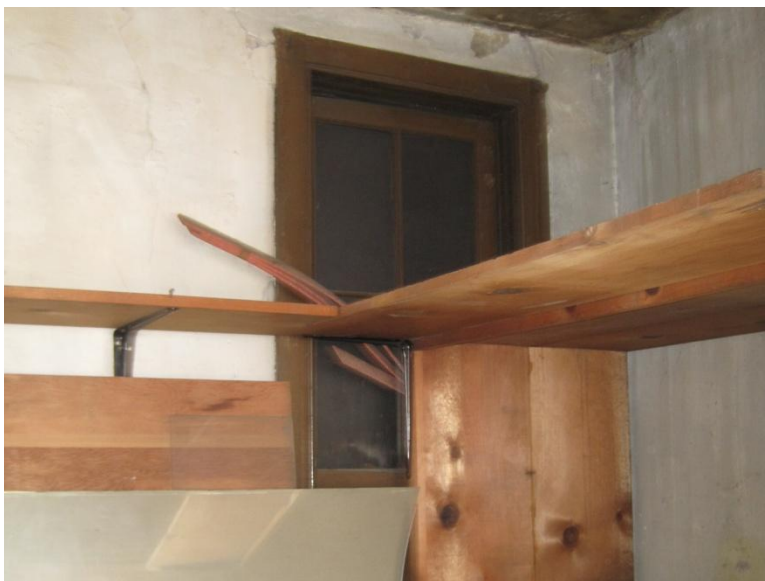
Figure 68. Third Floor: closed off north wall window.

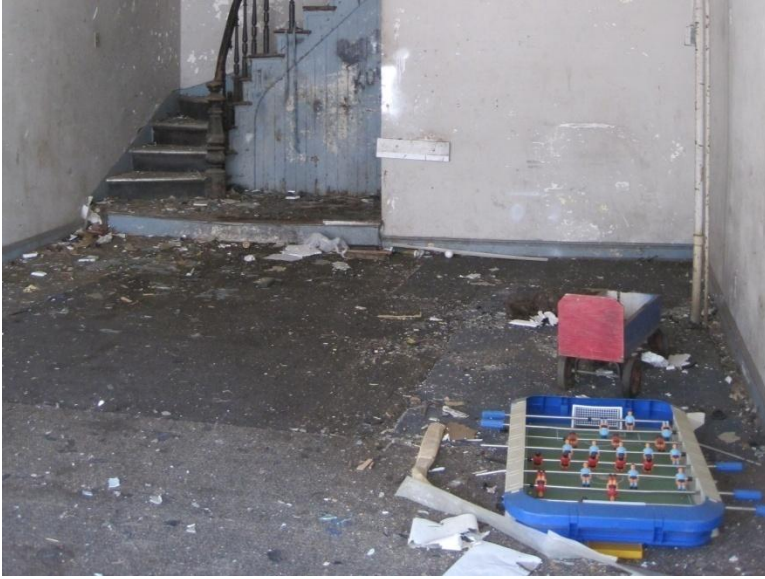
Figure 71. First Floor: worn carpeting.

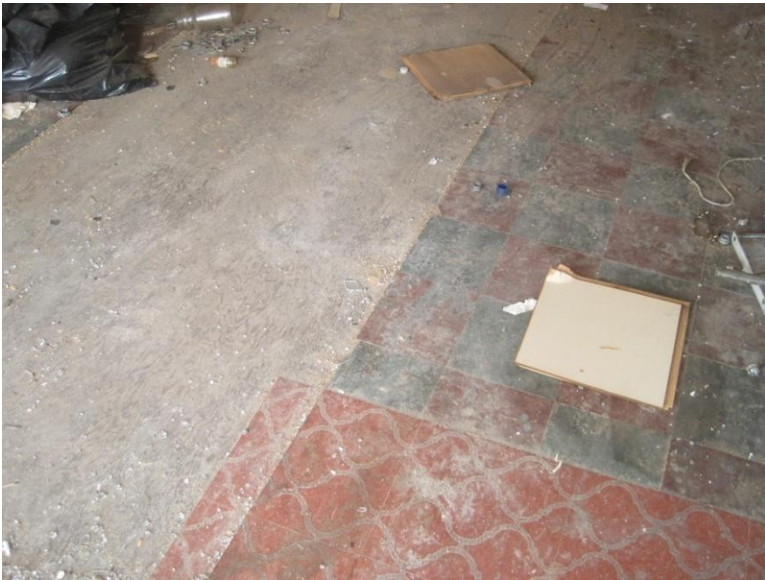
Figure 72. Second Floor: plywood subflooring and two layers of vinyl tile.

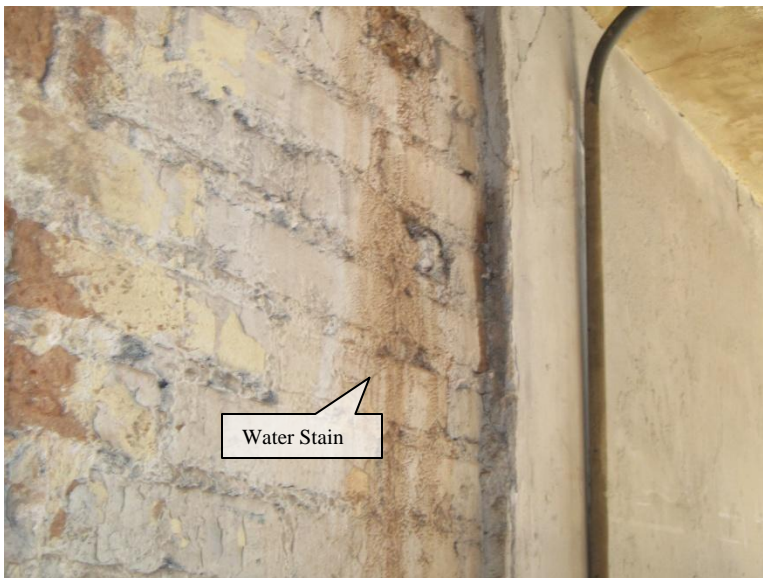
Figure 74. Third Floor: plaster laid over brick.

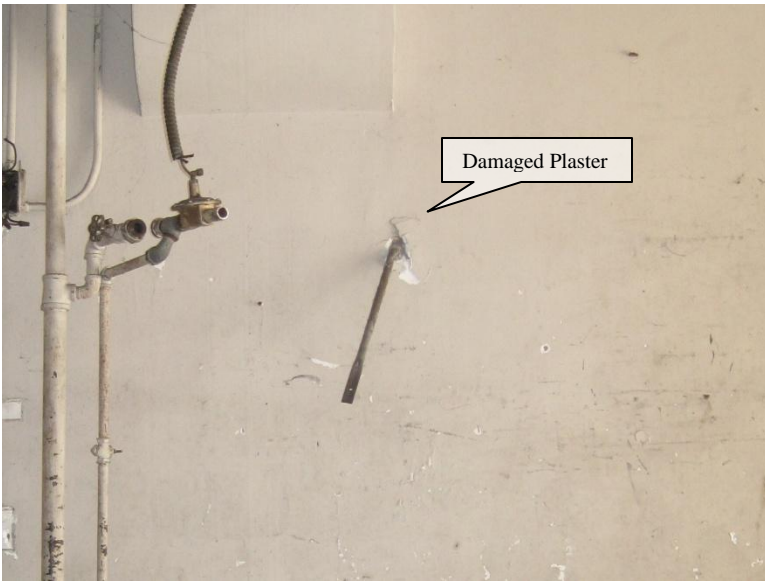
Figure 76. First Floor: damage to plaster on east wall.

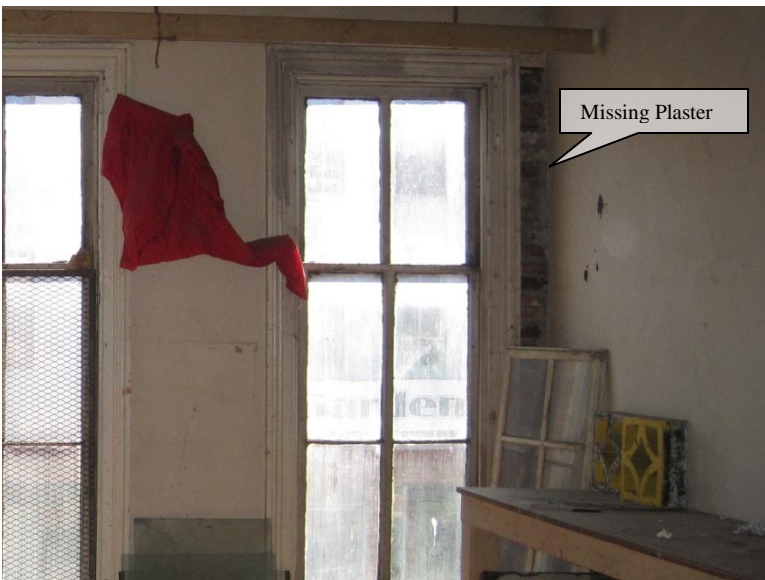
Figure 77. Second Floor: missing plaster on south wall.

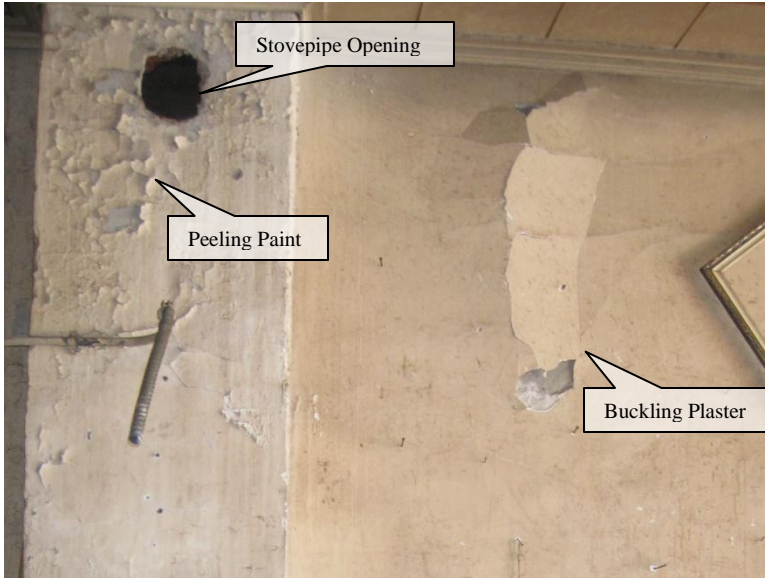
Figure 78. Second Floor: plaster pulling away and peeling paint on east wall.

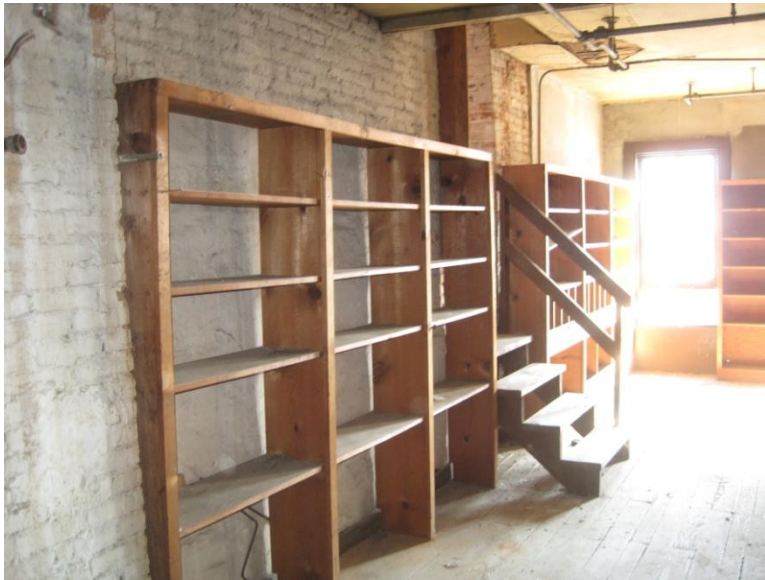
Figure 79. Third Floor: missing plaster on east wall.

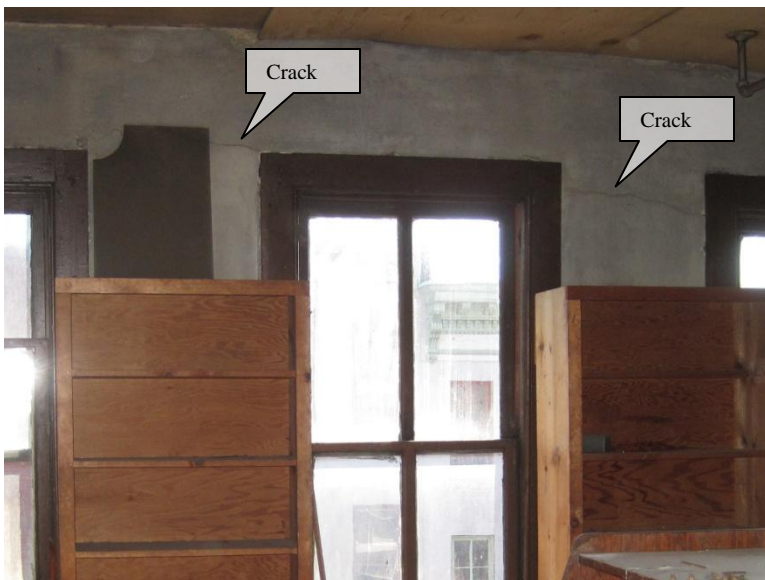
Figure 80. Third Floor: cracks in plaster on south wall.

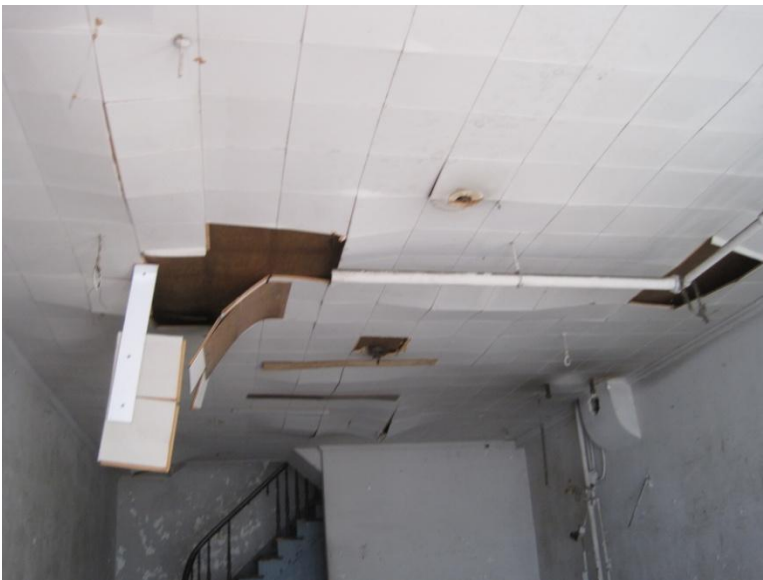
Figure 81. First Floor: ceiling tiles falling down.

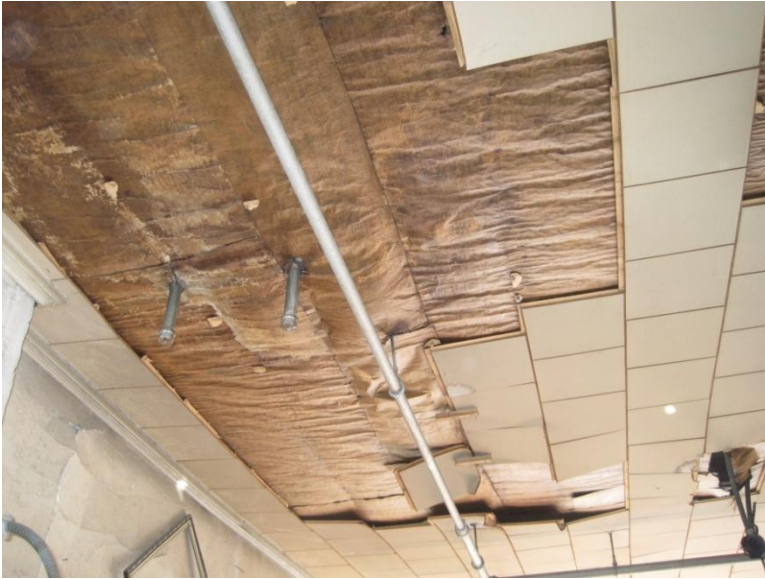
Figure 82. Second Floor: missing ceiling tiles.

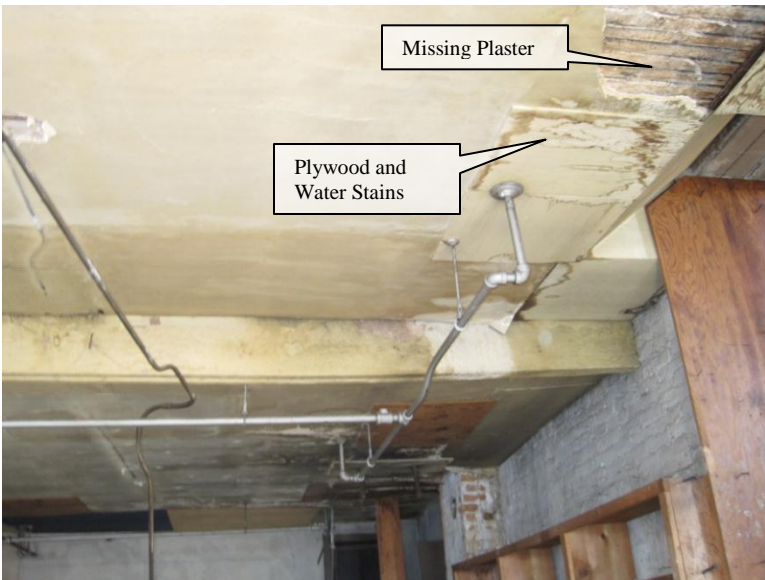
Figure 83. Third Floor: water damage and plywood patches on plaster ceiling.

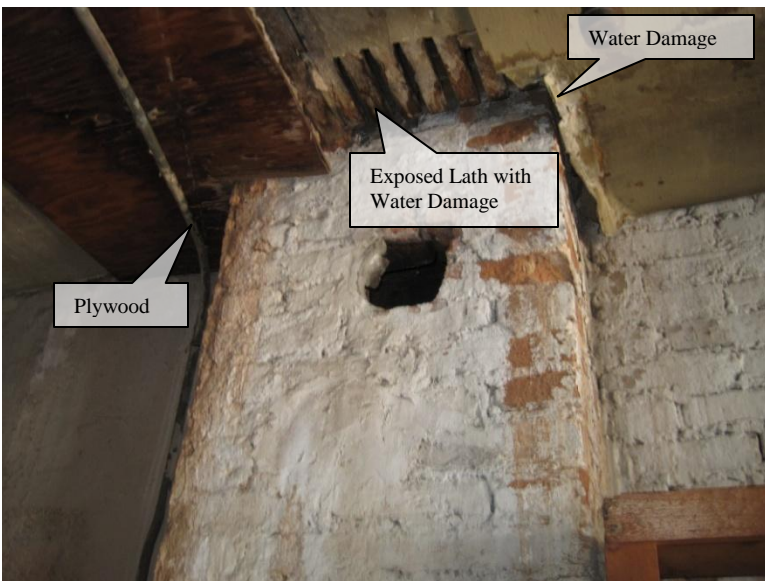
Figure 84. Third Floor: water damage to the plaster, lath, and plywood near east wall.

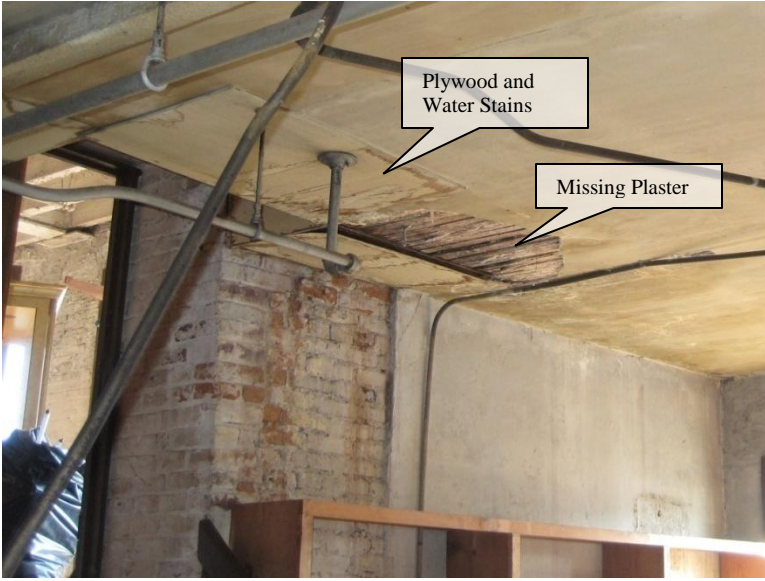
Figure 85. Third Floor: water damage and plywood patching.

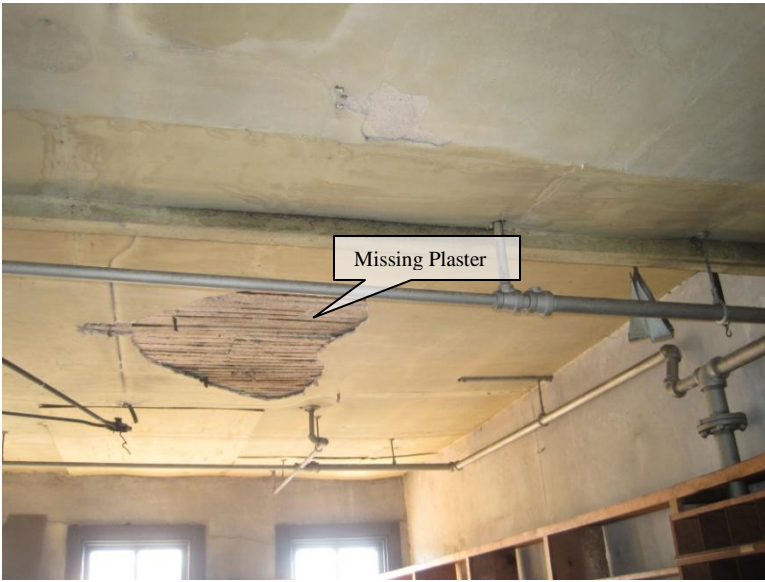
Figure 86. Third Floor: fallen plaster.

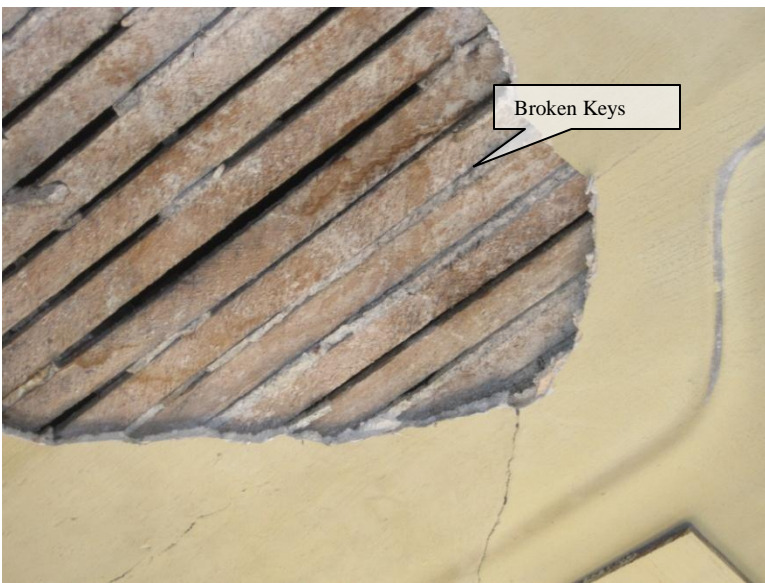
Figure 87. Third Floor: broken plaster keys.

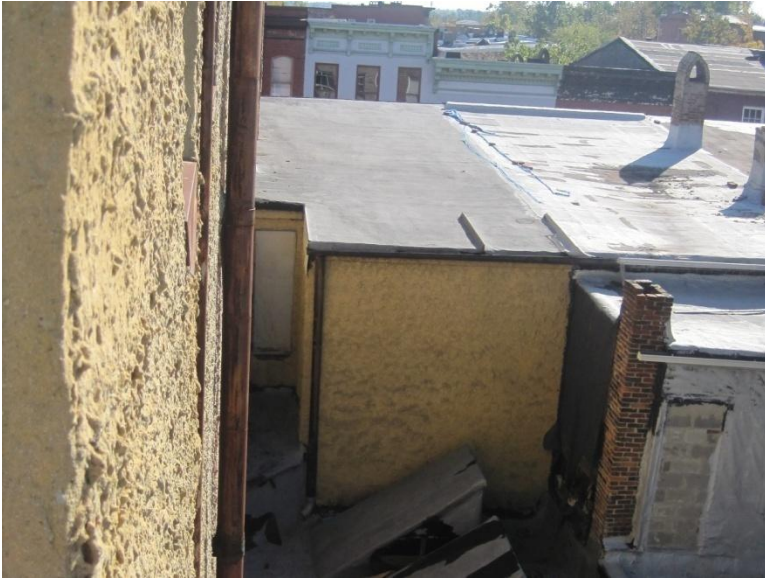
Figure 88. Exterior: flat roof.

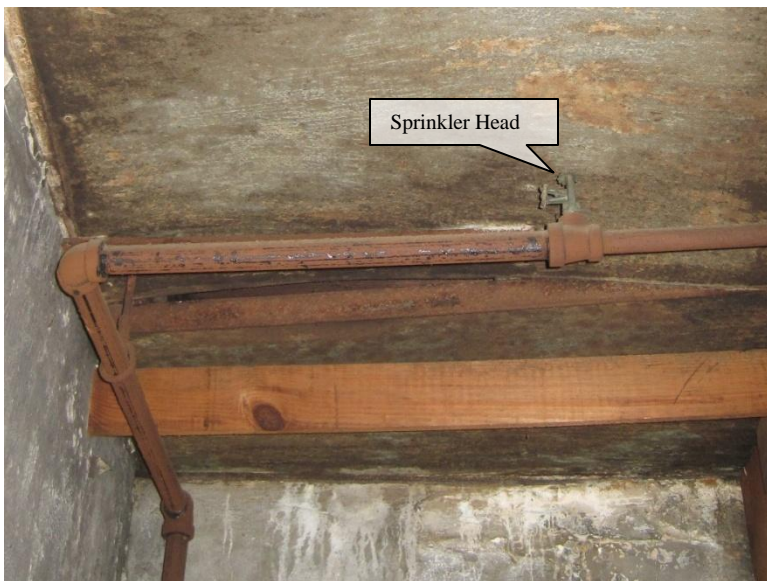
Figure 93. Third Floor: sprinkler head located in stairwell.

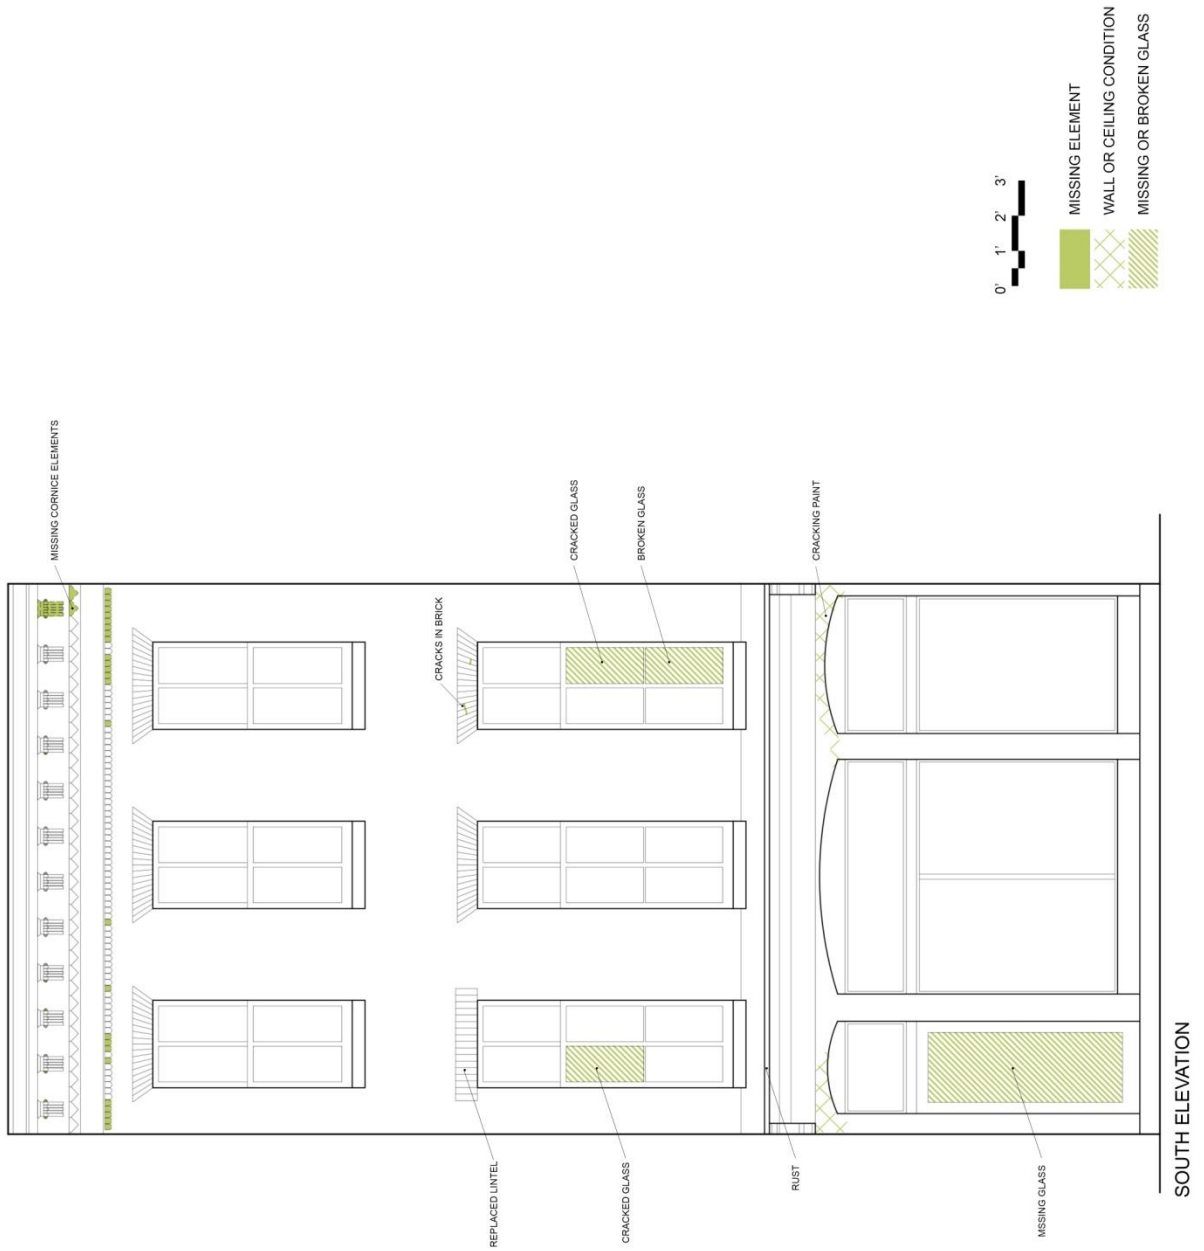
Figure 94. Annotated Conditions: South Exterior Elevation.

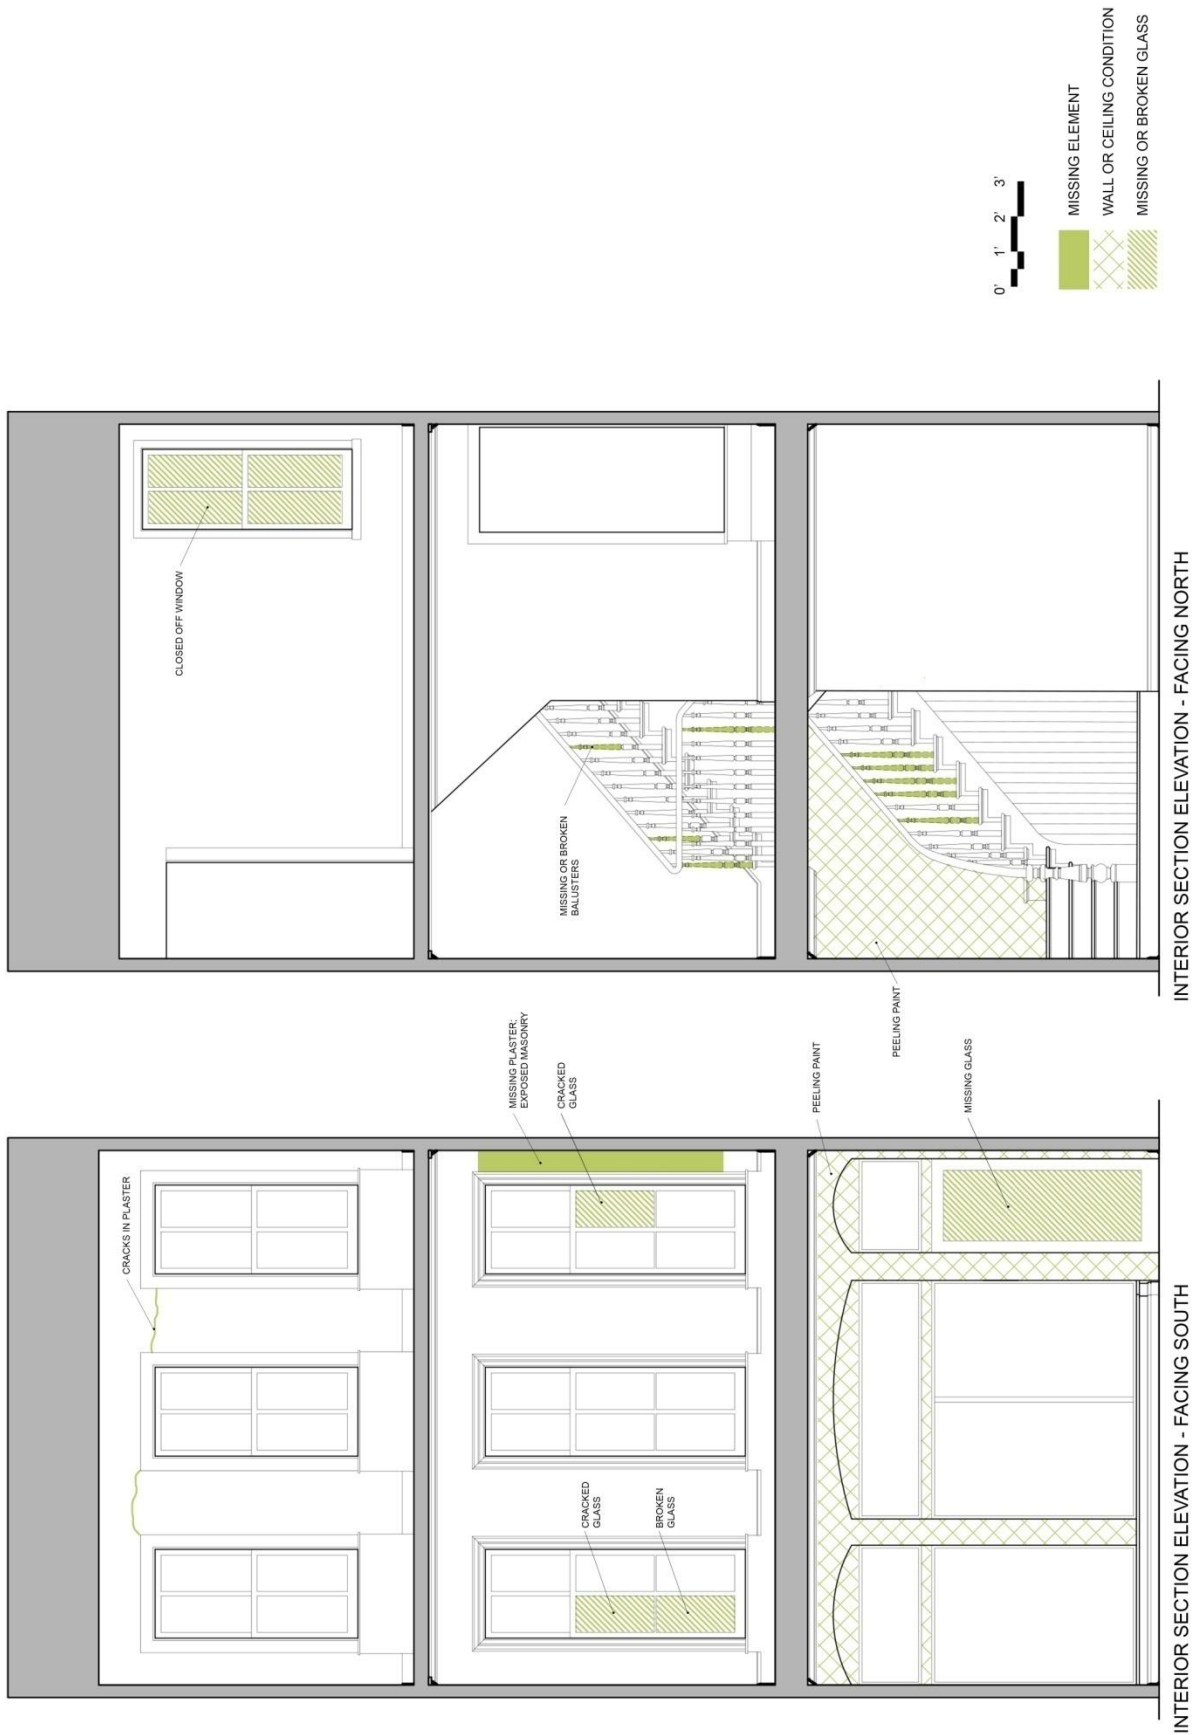
Figure 95. Annotated Conditions: South and North Interior Elevations.

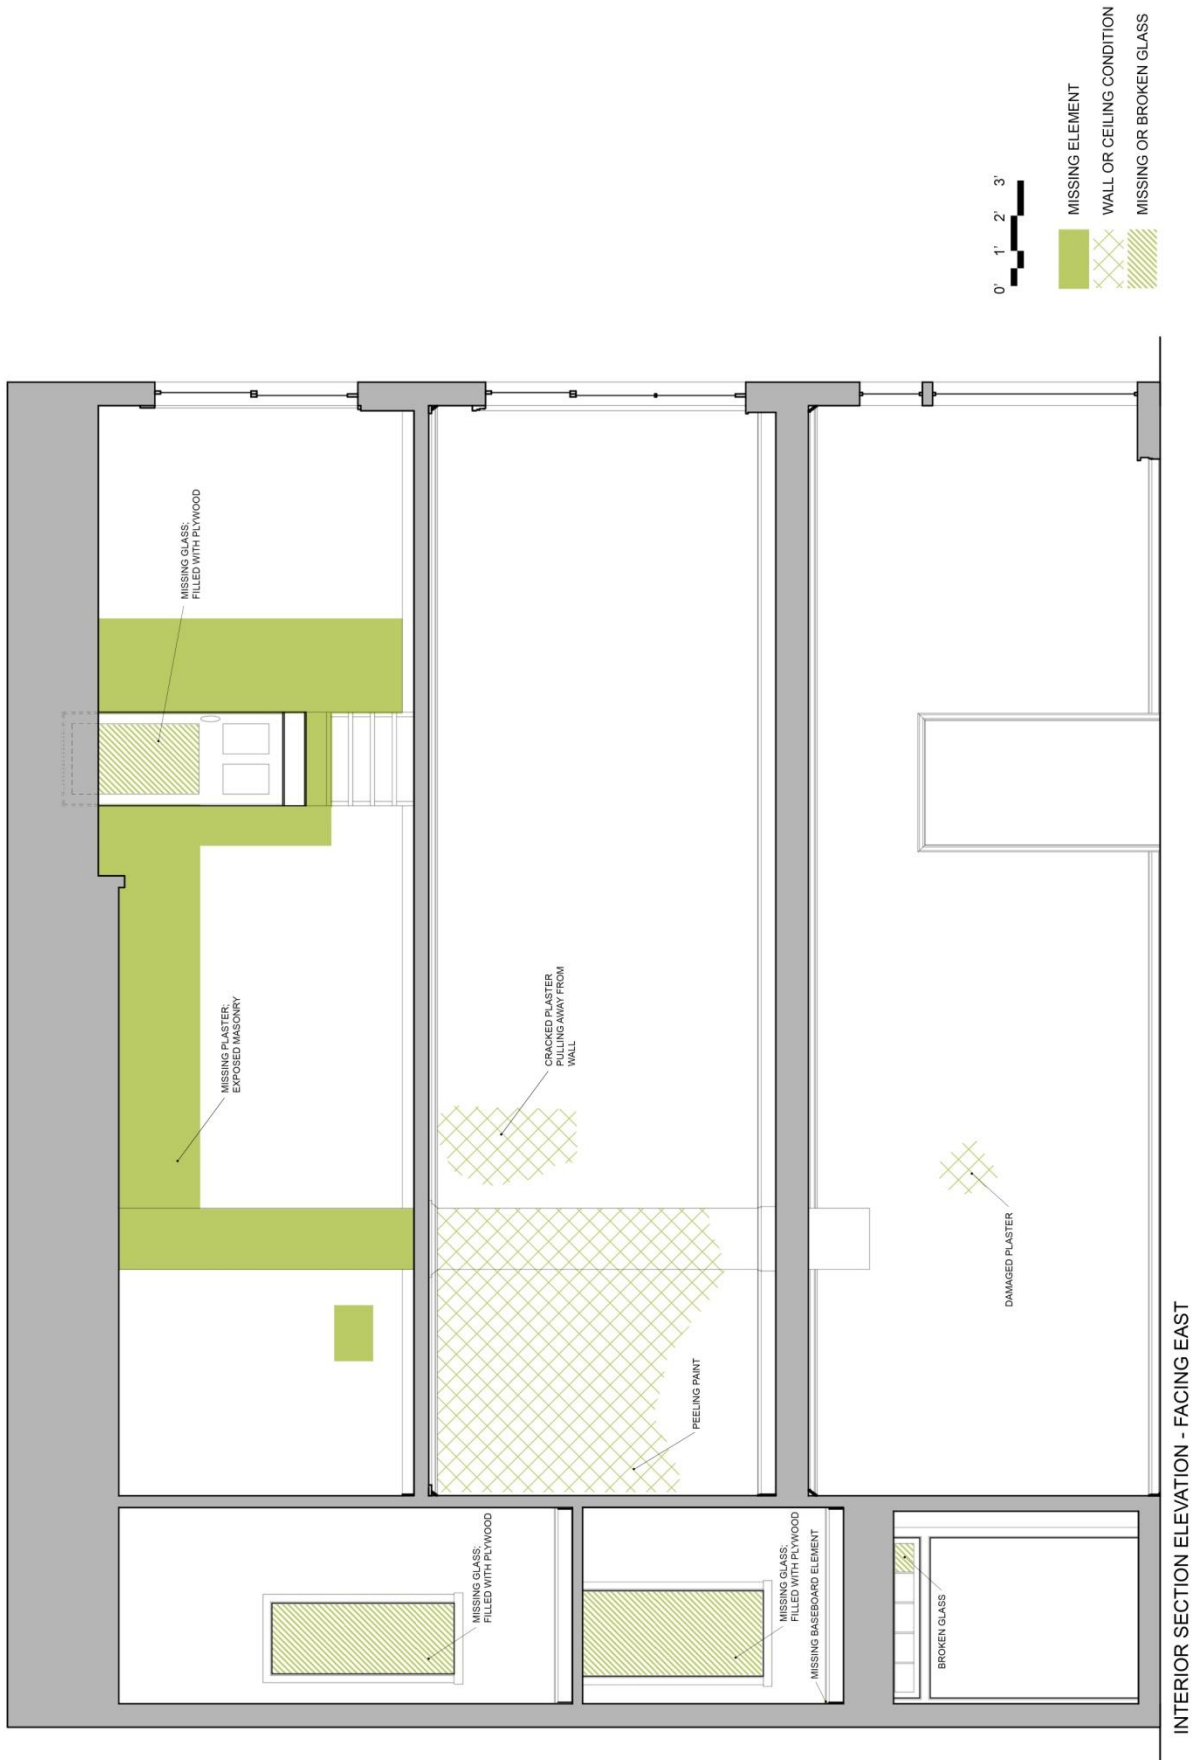
Figure 96. Annotated Conditions: East Interior Elevation.

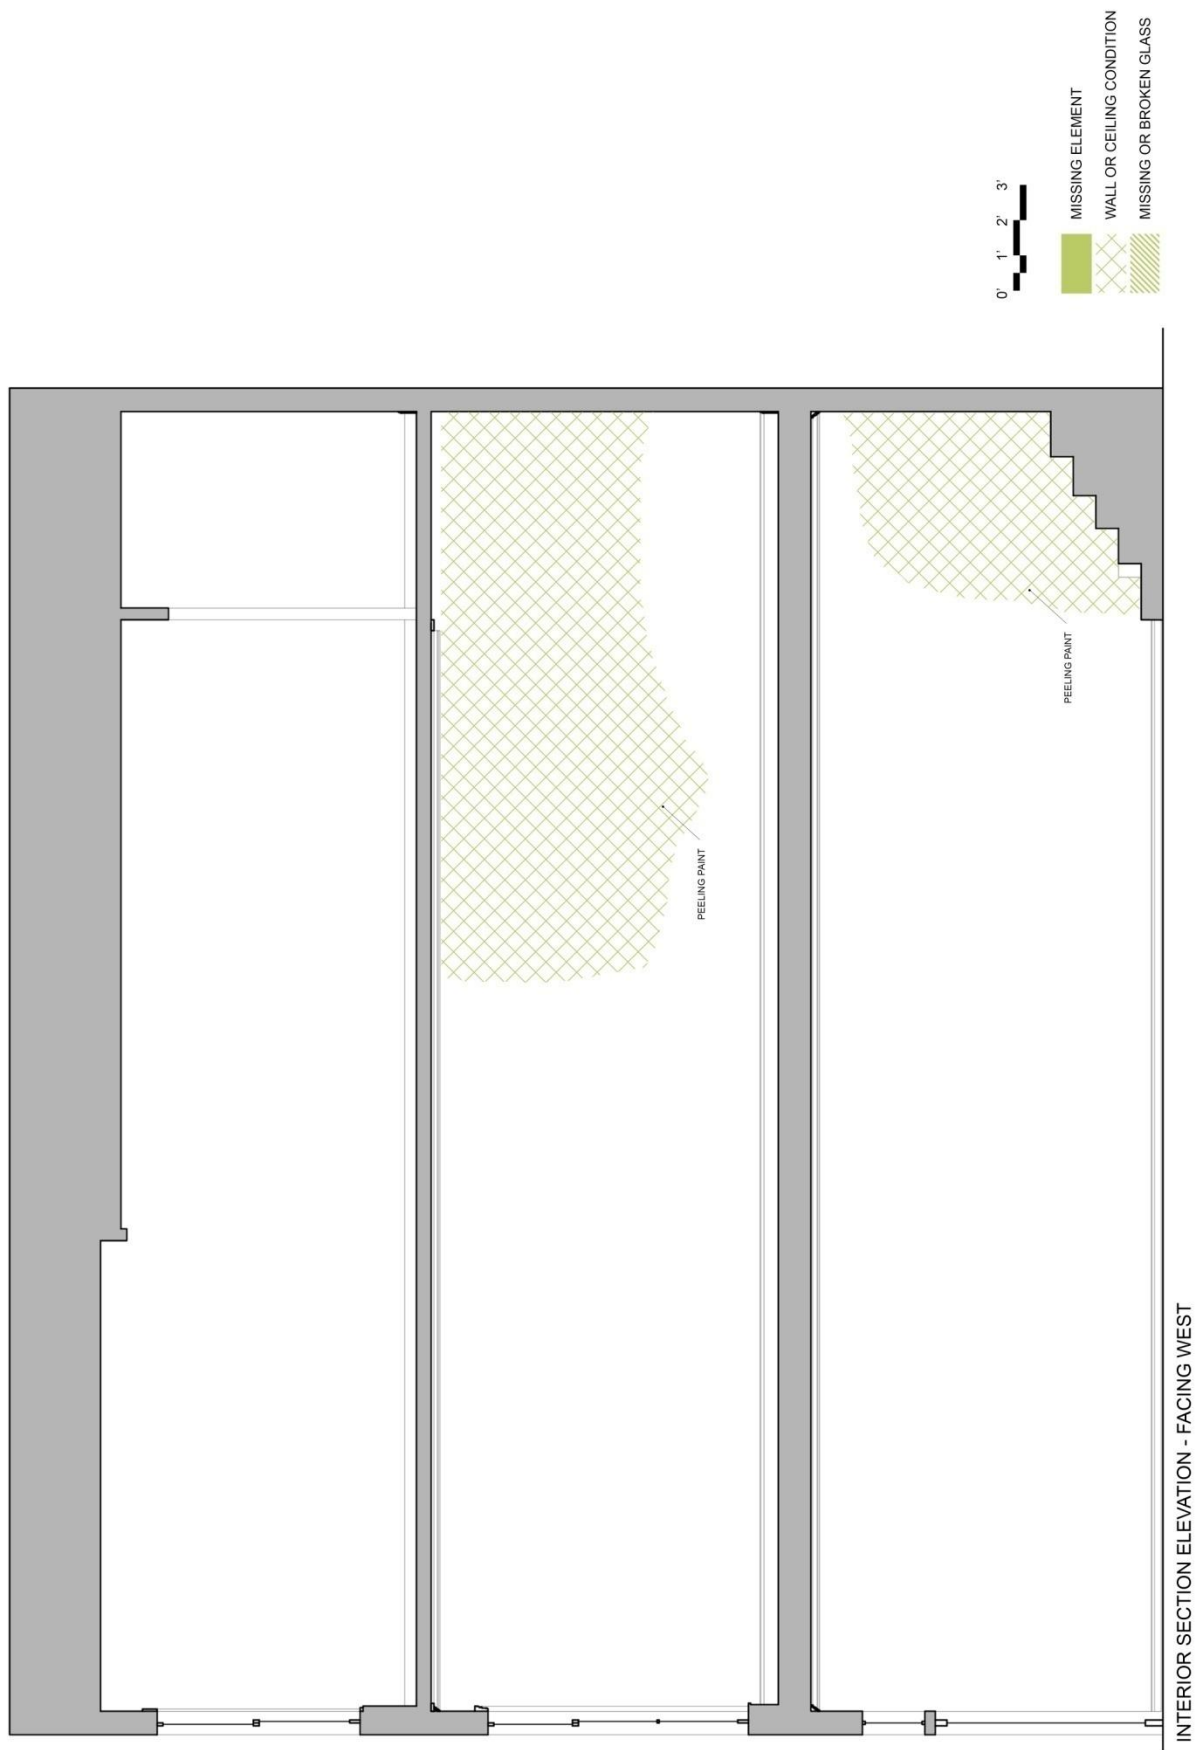
Figure 97. Annotated Conditions: West Interior Elevation.

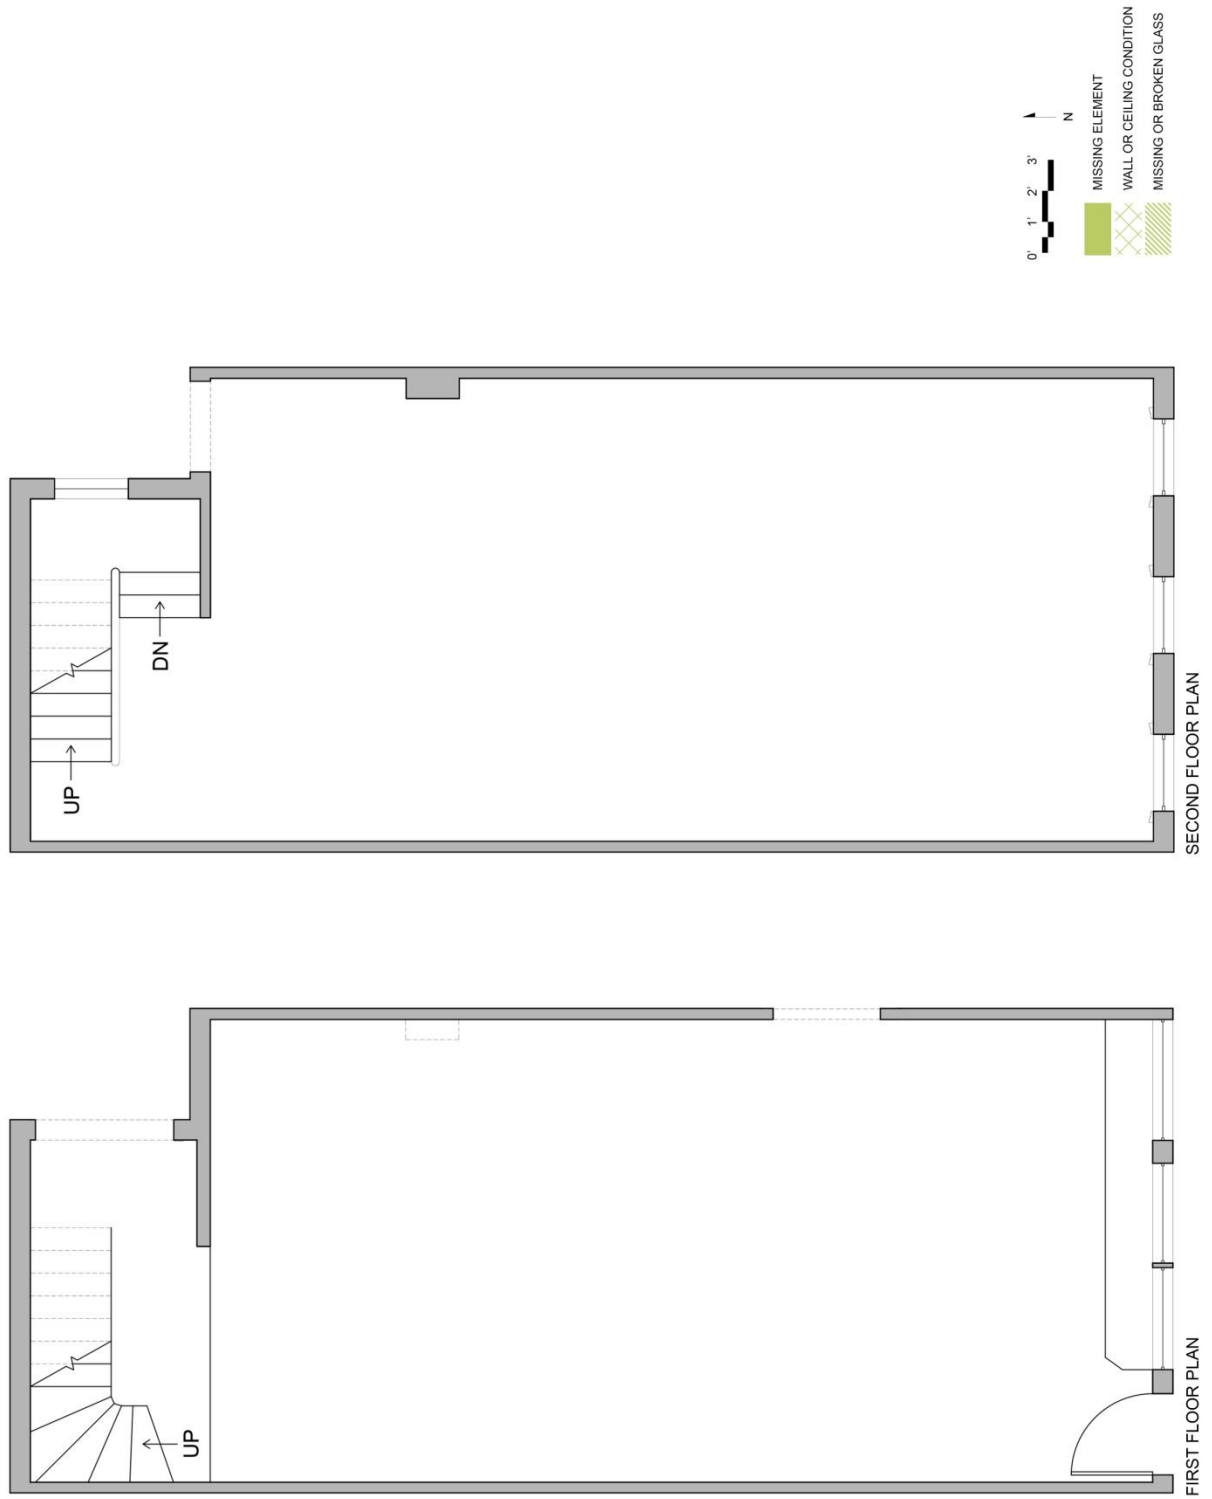
Figure 98. Annotated Conditions: First and Second Floor Plans.

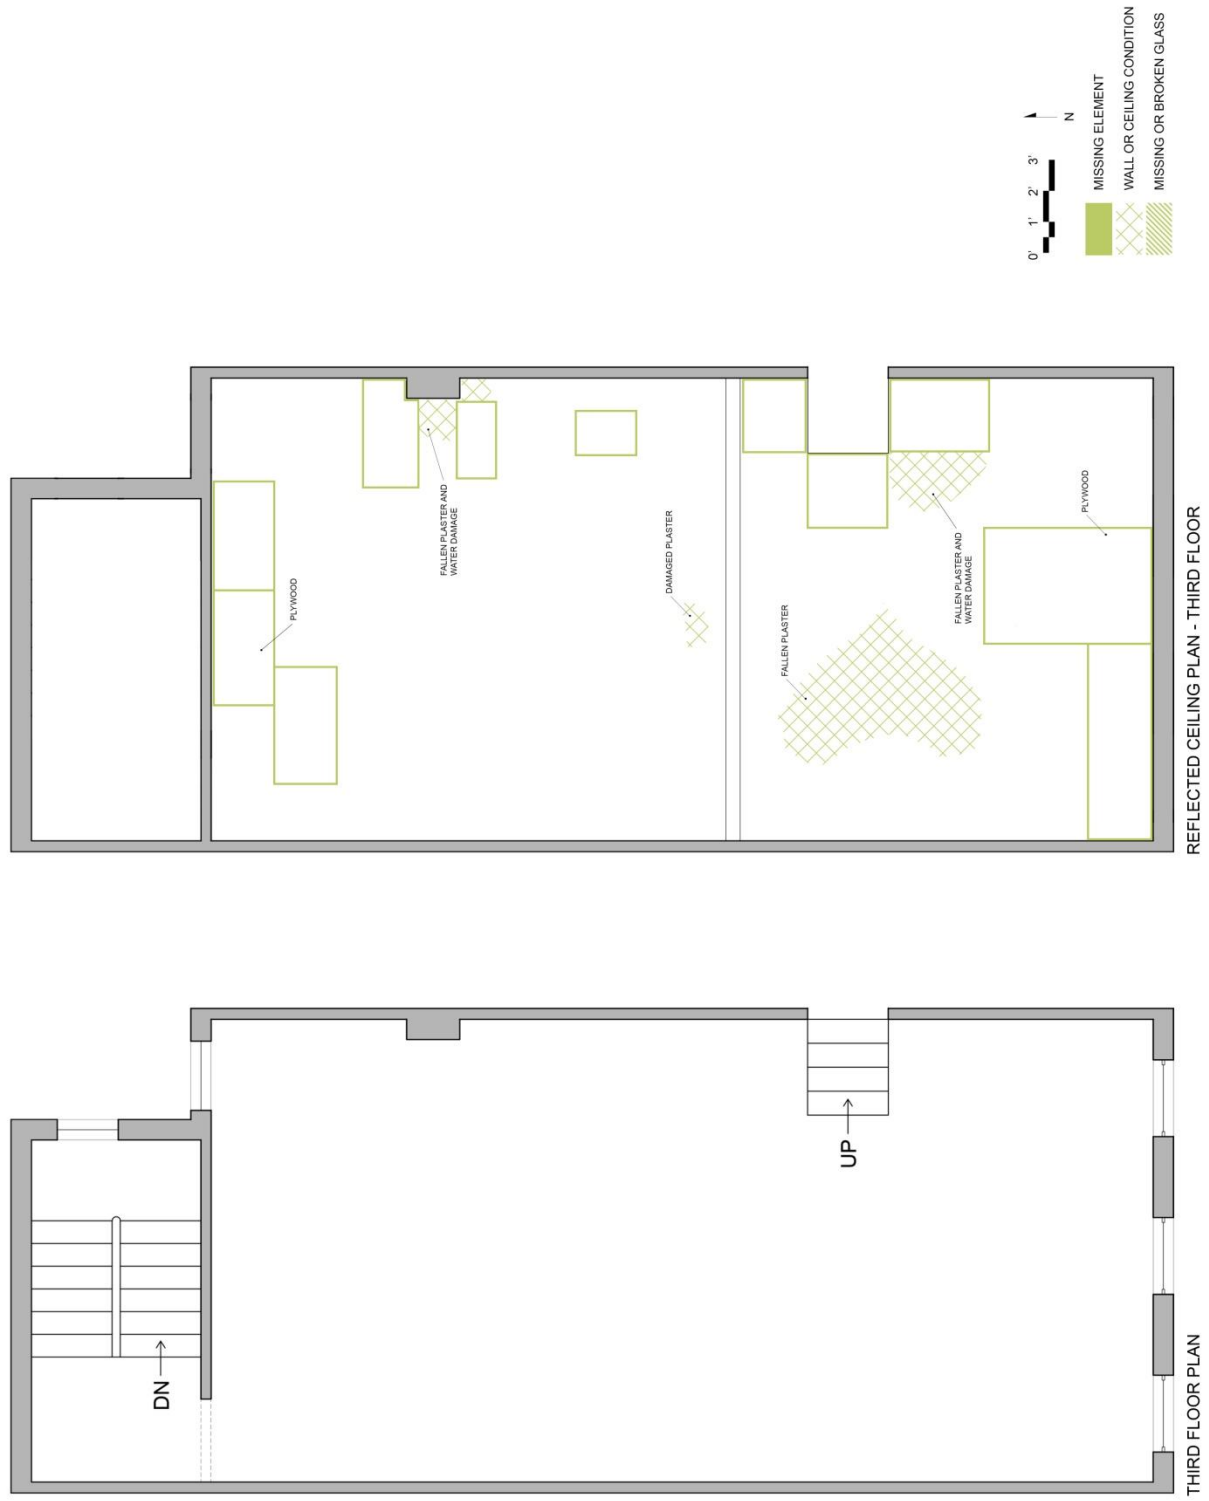
Figure 99. Annotated Conditions: Third Floor Plan and Reflected Ceiling Plan.

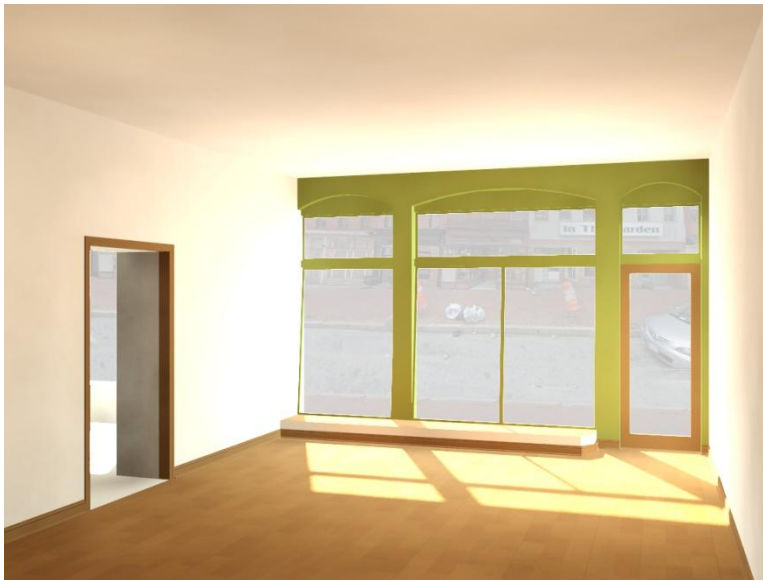
Figure 100. Before and After: first floor rendering.
