**Final Report on the
I-129 Missouri River Bridge
Deck Condition Assessment Using Non-Destructive
Testing Methods**

Bridge No. 9700.0S129, Sioux City, IA

**Final Report
I-129 Missouri River Bridge
Deck Condition Assessment Using Non-Destructive Testing Methods
Bridge No. 9700.0S129, Sioux City, IA**

November 5, 2012

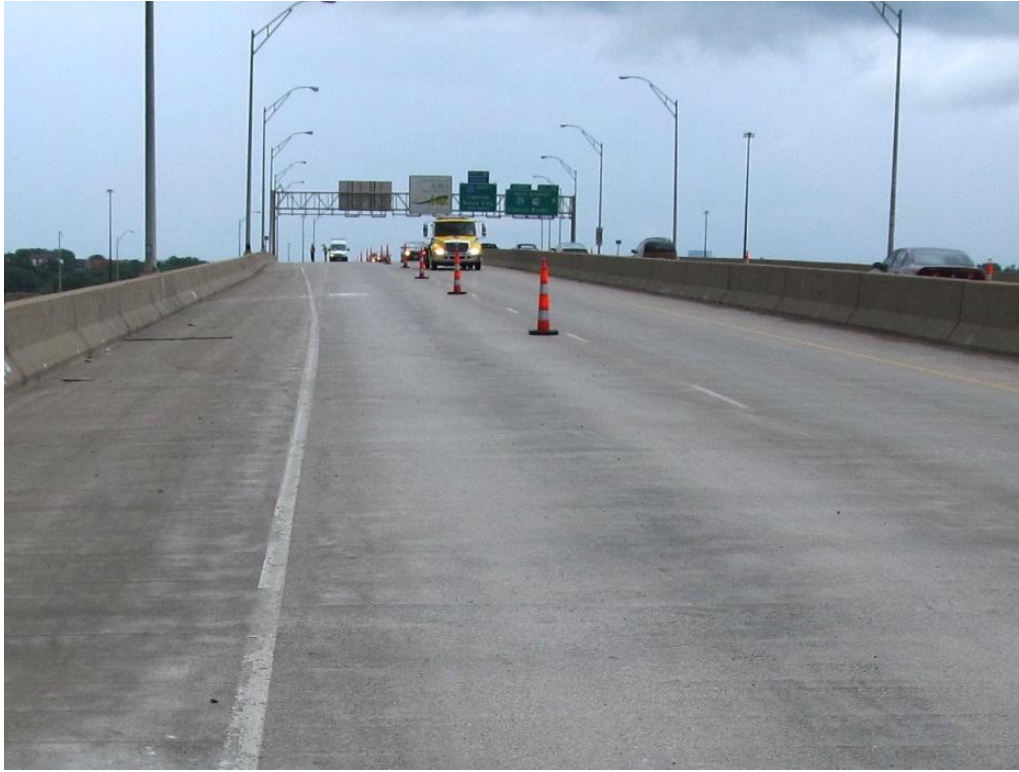
Figure 3.13. Deck surface showing surface texture and color variation between wheelpaths and surrounding deck.

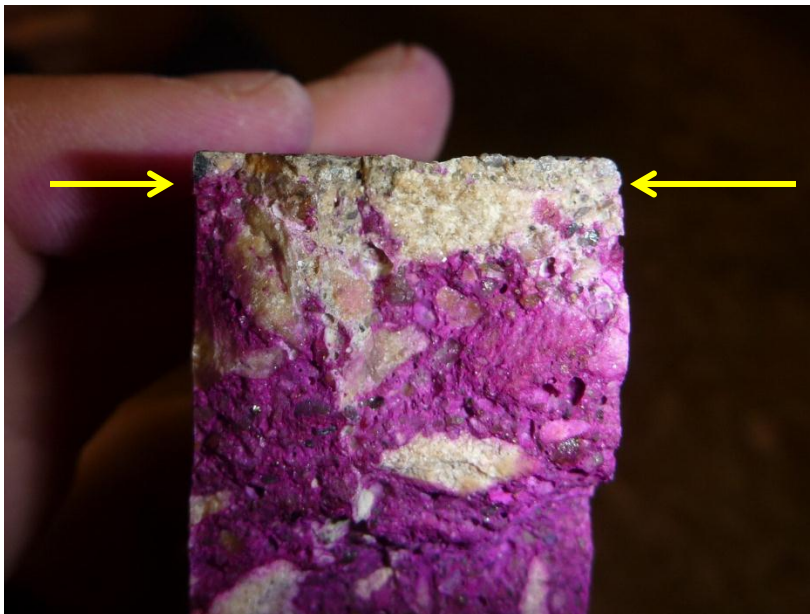
Figure 8.2. Phenolphthalein indicator on a freshly cracked surface of a core. The depth of carbonation is indicated by the arrow (pink color indicates $pH > 9$).

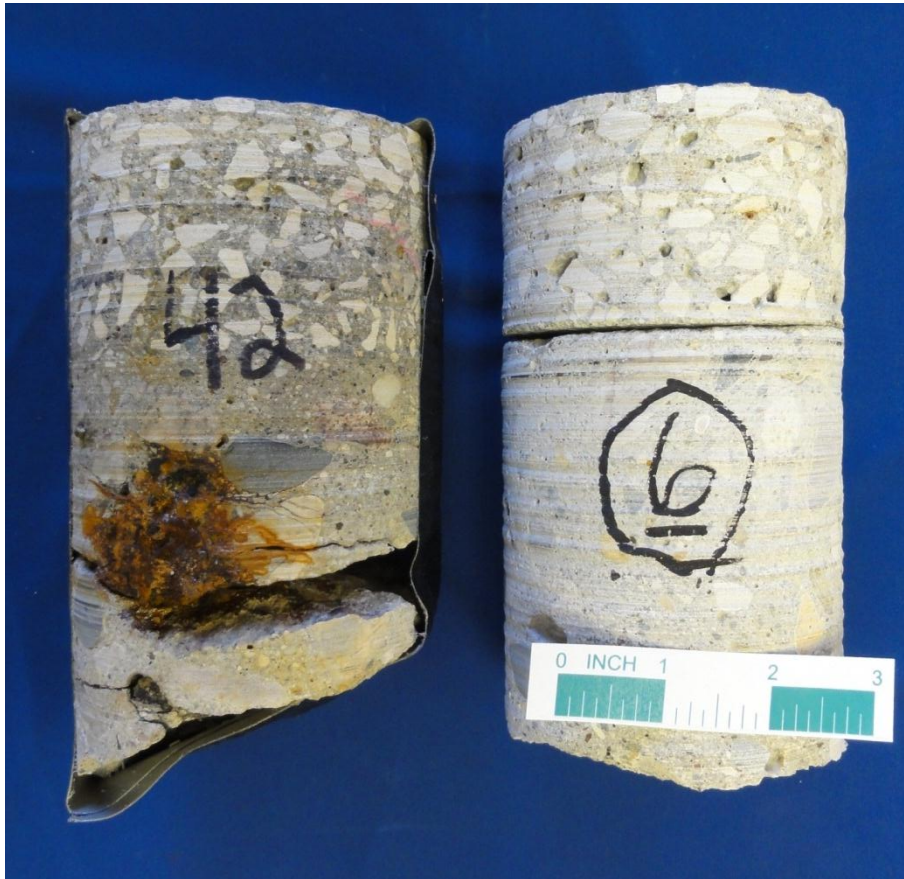
Figure 1. Core 6 and 42 as received for petrographic studies. Topping layer in Core 6 as received was delaminated from the base concrete.

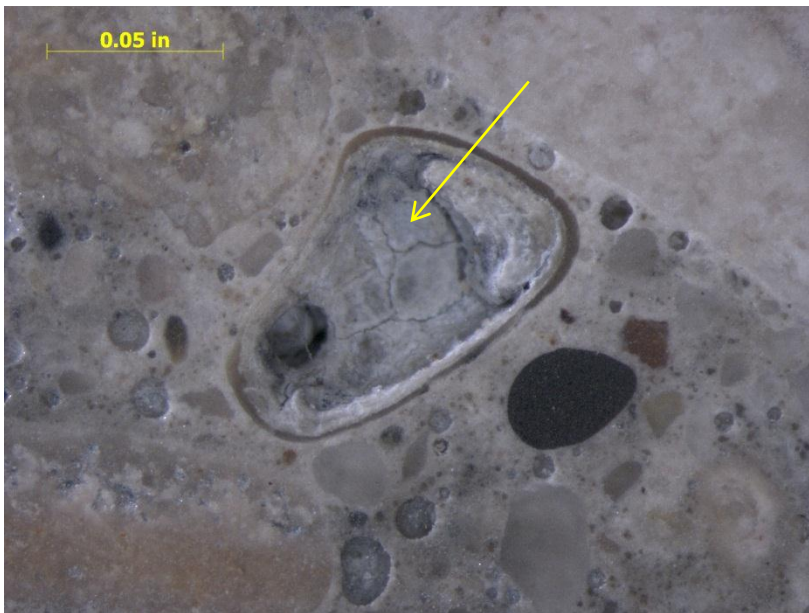
Figure 5. Core 6 topping; the largest reacted fine particle of shale (encircled in Figure 2) located in close proximity to the intercepting microcracks. Most of the interior of this particle has been consumed in the alkali-silica reaction; gel was found on the surfaces of the microcracks.

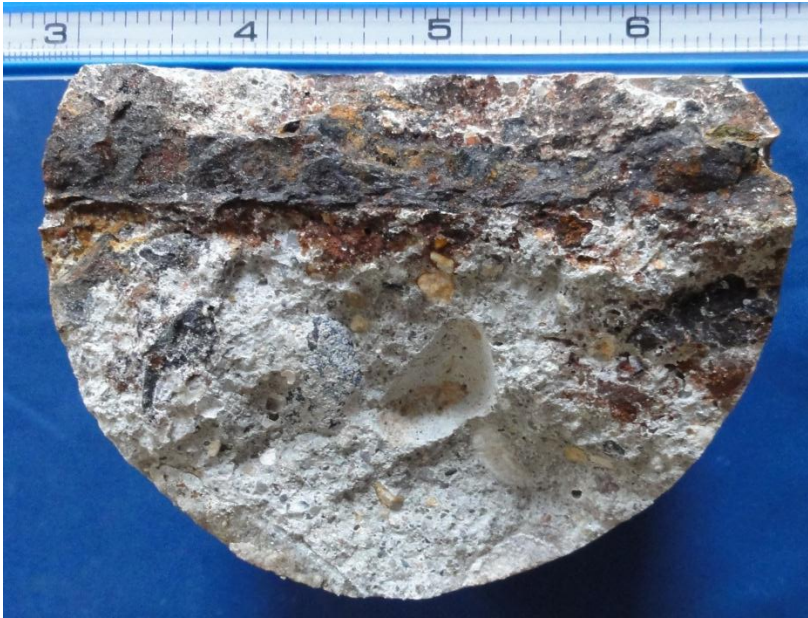
Figure 8. Core 42; corroded rebar in base concrete at one of the transverse cracks.

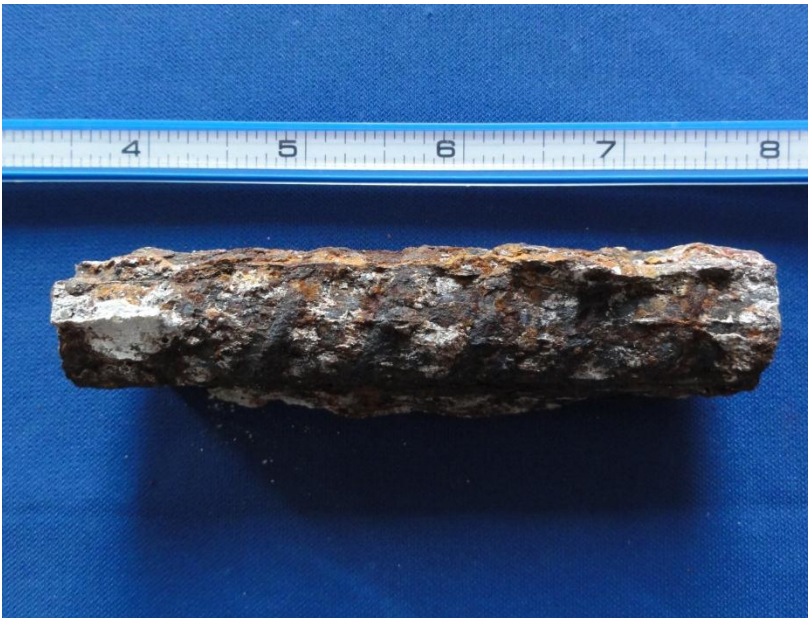
Figure 9. Core 42: corroded rebar taken out of base concrete at one of the cracks.
