# Hydrogen Assisted Fracture of 30MnB5 High Strength Steel: A Case Study

Garikoitz Artola <sup>1,\*</sup>

and Javier Aldazabal <sup>2</sup>

<sup>1</sup> Azterlan, Research and Development of Metallurgical Processes, Aliendalde Auzunea 6, 48200 Durango, Spain<sup>2</sup> Tecnun, University of Navarra, Manuel de Lardizábal 15, 20018 San Sebastian, Spain; jaldazabal@tecnun.es

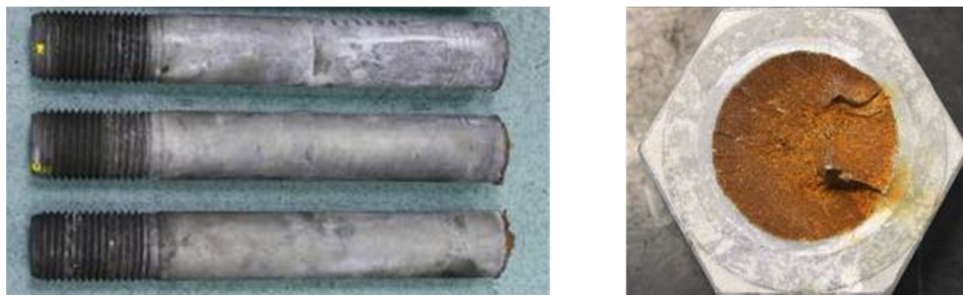
The bolt in Figure 4 shows the actual HE case that motivates this study. It is a hot dip galvanized M52 class 10.9 bolt that was installed in an outdoors structure in a coastal onshore location in Northern Spain. The structure consisted of 90 bolts from the same batch and the fractured bolt is part of a set of seven bolts that suffered delayed fracture after a week in service at the same site. All the bolts were tightened with a dynamometric wrench to the desired fastening torque. The torque was calculated to reach the design clamping force of the joint, employing the measured friction coefficient between the bolt and the nut greased threads. The bolt-nut batch had passed regular quality control checks and no deviation was found in the fractured products; they were free of forging defects, decarburization, liquid metal embrittlement or quench cracking.

**Figure 4.** M52 class 10.9 bolt that failed in service due to delayed fracture.

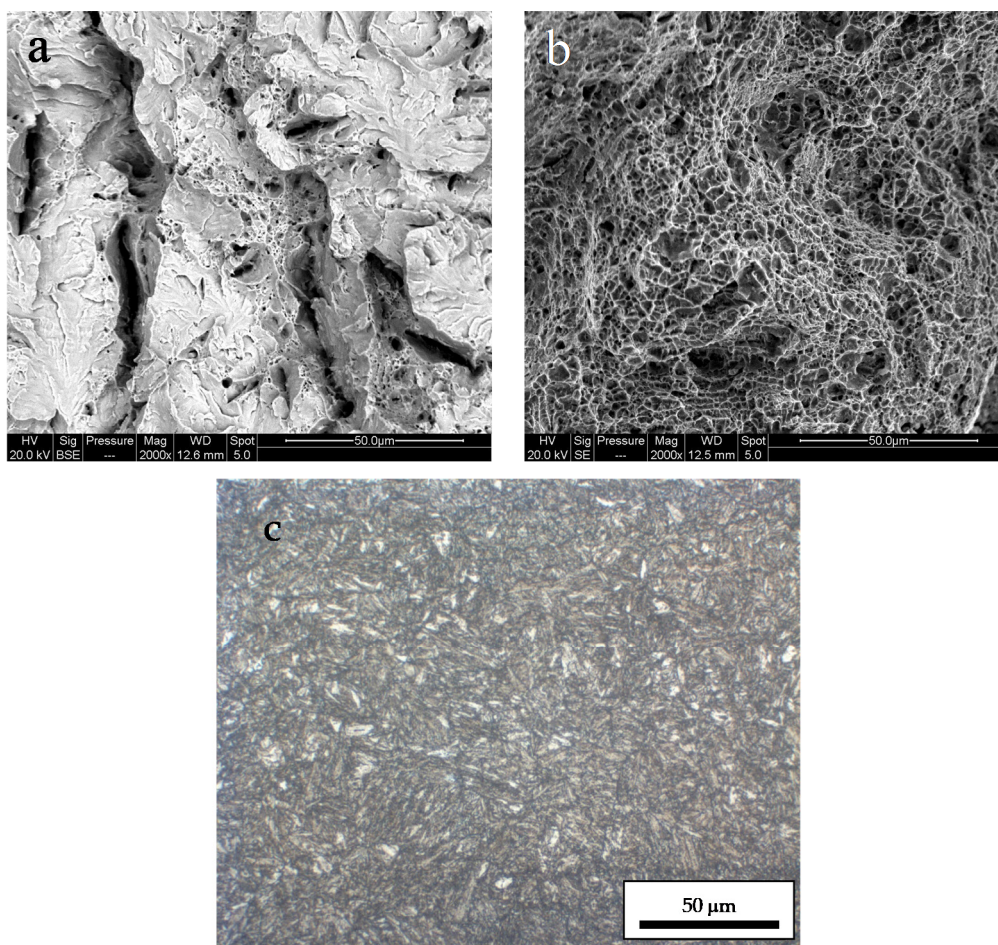
When the failure surface of the cracked bolts was inspected, a trans-granular brittle cleavage pattern was observed, which is shown in Figure 5a, while the expected fractographic texture for the bolt corresponds to a ductile failure pattern like that shown in Figure 5b.

**Figure 5.** (a) Brittle cleavage texture in the crack surface of the M50 class 10.9 bolt shown in Figure 1; (b) ductile collapse texture in the tensile specimens extracted from the shaft of the same bolt; (c) microstructure of the bolt in the center of the shaft diameter.

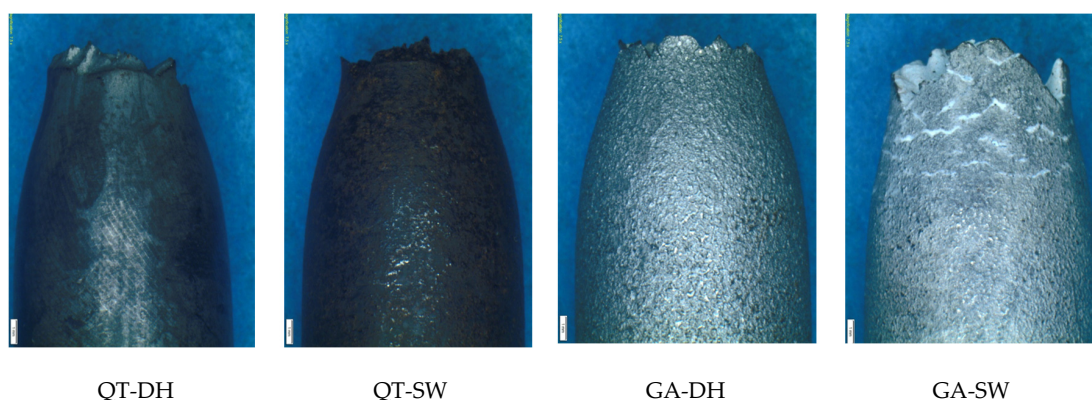
The EAC was also confirmed by visual inspection of the fractured SSRT specimens (Figure 14). Only GA-SW specimens showed a very severe cracking pattern all along the necking section. The cracks caused by EAC appear remarked in white, due to material deposition from the electrolyte in the areas of the substrate exposed by the appearance of the cracks themselves. Similar EAC cracking patterns had been observed in previous work [18] for steels with the same strength level as the GA-DH specimens, when a cathodic protection potential was applied to seawater immersed SSRT.

**Figure 14.** Pictures of the necking areas of representative SSRT specimens showing no EAC except for GA-SW.
