Numerical analysis of settlement-induced damage to a masonry church nave wall

Abstract. Differential soil settlements can induce structural damage to heritage buildings, causing not only economic but also cultural value losses. In 1963, the Saint Jacob's church in Leuven was permanently closed to the public because of severe settlement-induced damage caused by insufficient bearing capacity of the foundation. Currently, the church is stabilized using a temporary shoring system. This work aims at implementing a practical modelling approach to predict damage on church nave walls subjected to differential settlements. For that purpose, a finite element model of the Saint Jacob's church nave was generated and validated through on-site monitoring data including levelling, damage survey and laser scanning. The model takes into account the non-linear behavior of the masonry by means of continuum smeared cracking. The paper introduces two approaches to model the settlement on the structure. One of them consists in the direct application of vertical displacements underneath the structure according to the deformation profile measured on-site. In the second approach, interfaces with different

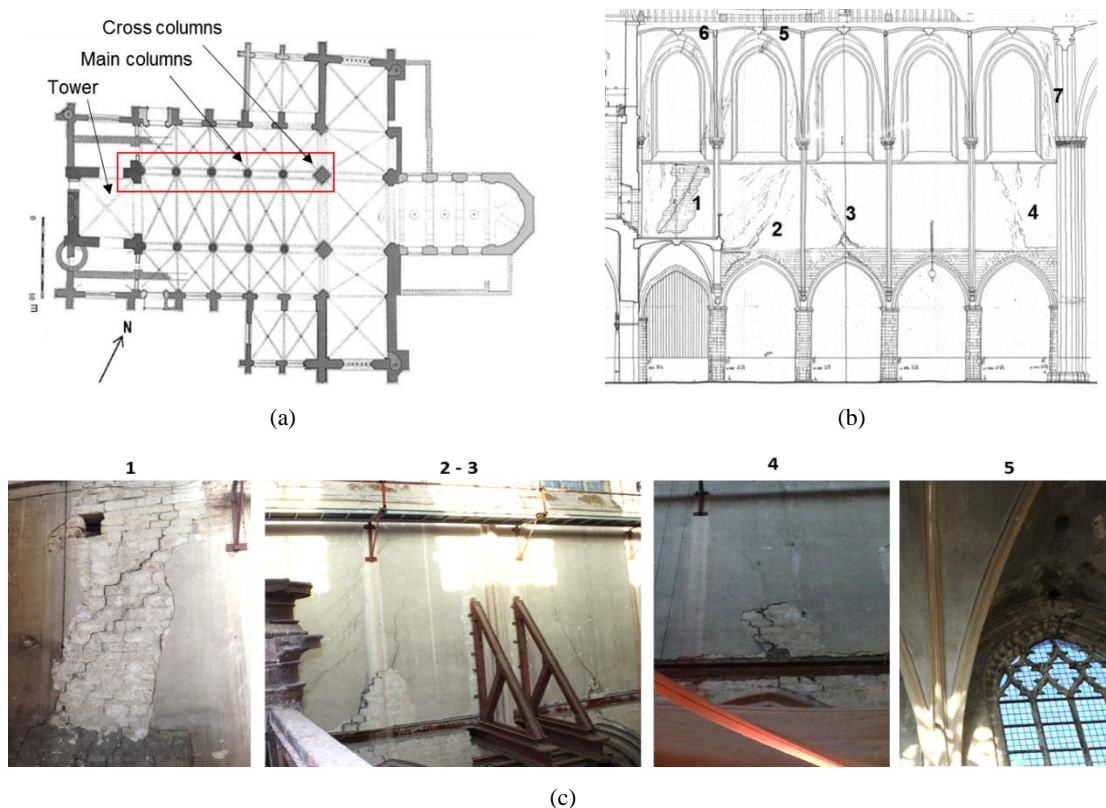
The main structural problems of Saint Jacob's church originated from a lack of load-bearing capacity of the foundation, which is built on compressible sandy clay soil. Investigations in pits, dug underneath different columns, allowed to identify the foundation system, which is composed of enlarged masonry pillars made of regular blocks of natural stone and lime mortar joints. The depth of the foundation pillars under the current floor level is about 2.9 and 3.7 m for the main and cross columns, respectively. In addition, decayed wooden elements were found underneath the pillars, placed 1.6 m below the water table. After a rigorous assessment, Schueremans et al. [1] concluded that the foundation system did not fulfill the required load-bearing capacity causing severe differential settlements. This system was not originally designed for the self-weight increase of the church over

time. In addition, these settlements intensified as a consequence of the decayed wooden elements underneath the foundation pillars, which might have caused the pillars to be punched into the subsoil.

The wall that is analyzed in this paper is the severely cracked northern wall of the main nave (**Fig. 2a**). The damage pattern is shown in **Fig. 2b-c**. This crack pattern is mainly caused by the settlement of the nave columns. The vertical displacements of the cross columns as well as the tower are significantly smaller than those of the columns in the nave. As a result, diagonal cracking appears in the masonry wall above the arcade similarly to shear cracking in a simply supported beam, with supports on the cross columns and tower.

Two levelling surveys have been performed on the building [1, 8]. Relative displacements measured in 1994 and 2005 at the base of the columns and walls indicate a maximum differential settlement of 9.3 mm across the structure during the measurement interval of 11 years. The corresponding relative displacement profile of the nave columns with respect to the cross column is shown in **Fig. 3** (1. Displacement profile). It presents a maximum settlement of 6 mm under the second column (counted from the left) in the period 1994-2005. However, it is important to notice that according to the crack pattern indicated in **Fig. 2.b**, it seems that the third column might have accumulated the largest vertical displacement during the lifetime of the masonry wall.

Figure 2. Analyzed nave wall, plan view (a), crack pattern (b) and photographic survey (c). The numbering of the cracks on the crack pattern (b) corresponds to the pictures presented in (c)

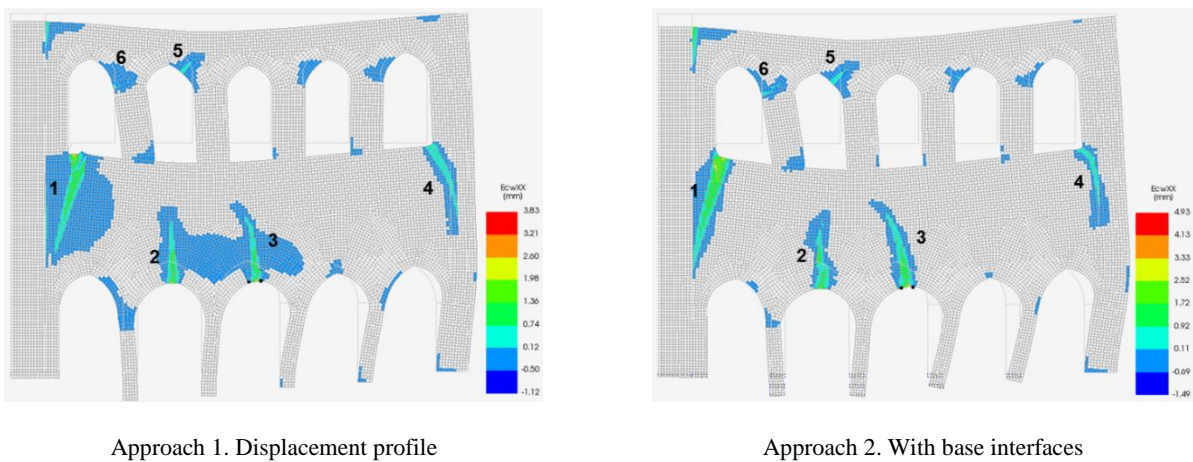
Fig. 4 shows the results of the models in terms of the crack pattern at the final step of the numerical analysis. Both approaches match well throughout the entire analysis, suggesting the ability of both to accurately simulate settlement-induced cracking. They both captured the main cracks observed in the damage survey (cracks 1 to 5 in **Fig. 2**). However, the location of some of them is slightly shifted, for instance cracks 1 and 4 appear from the external corner of the windows rather than from the internal corner as shown in the damage survey.

Approach 1 shows a lower maximum vertical displacement at the top of the wall than approach 2, with values of 3.9 mm and 5.8 mm respectively. This occurs because in approach 2, the loading (self-weight and extra load) acts uniformly on the entire structure, in contrast to approach 1 in which the applied vertical displacement is localized only at the base. This phenomenon might cause local stress concentrations and additional minor cracks when using approach 1.

Figure 4. Final deformed mesh and crack pattern indicating crack width

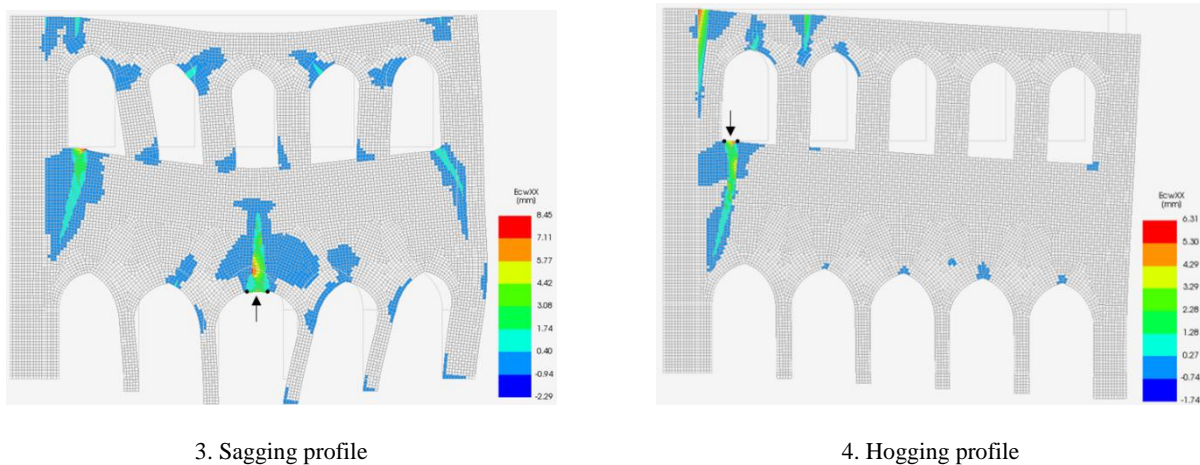
Fig. 6 shows the deformed mesh and crack pattern for the sagging and hogging profiles when reaching the maximum applied vertical displacement of 6.0 mm. The sagging settlement profile causes the middle arch to

open with a large crack in the middle top (4.1 mm wide) as a result. The hogging profile induces cracks on the left part of the nave wall, next to the stiffer masonry wall. It seems that the crack pattern acts as a hinge, where the right part rotates clockwise around the crack tip. The crack width obtained with this profile type is lower (the indicated crack is 2.3 mm wide).

Figure 6. Deformed mesh and crack pattern indicating crack width for sagging and hogging
