A Return to Manning the Post: the Adaptive Reuse of Publically Owned Fire Control Stations from the Second World War

Donald J. Seigny

May 2012

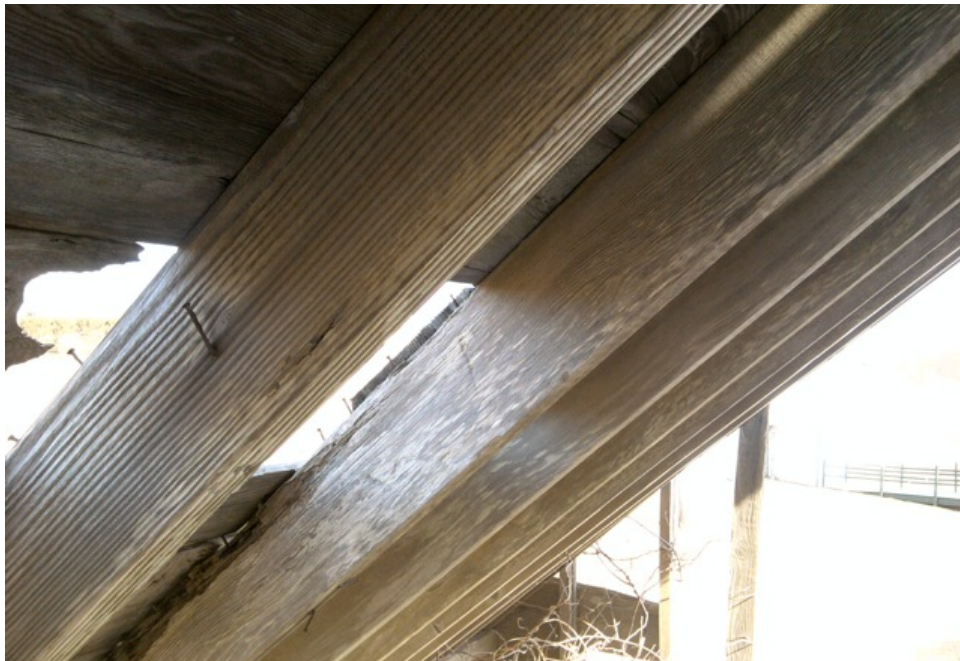
[Fig. 10] Detail of rafters, looking northeast. Note the occurrence of rot near holes in the roof.

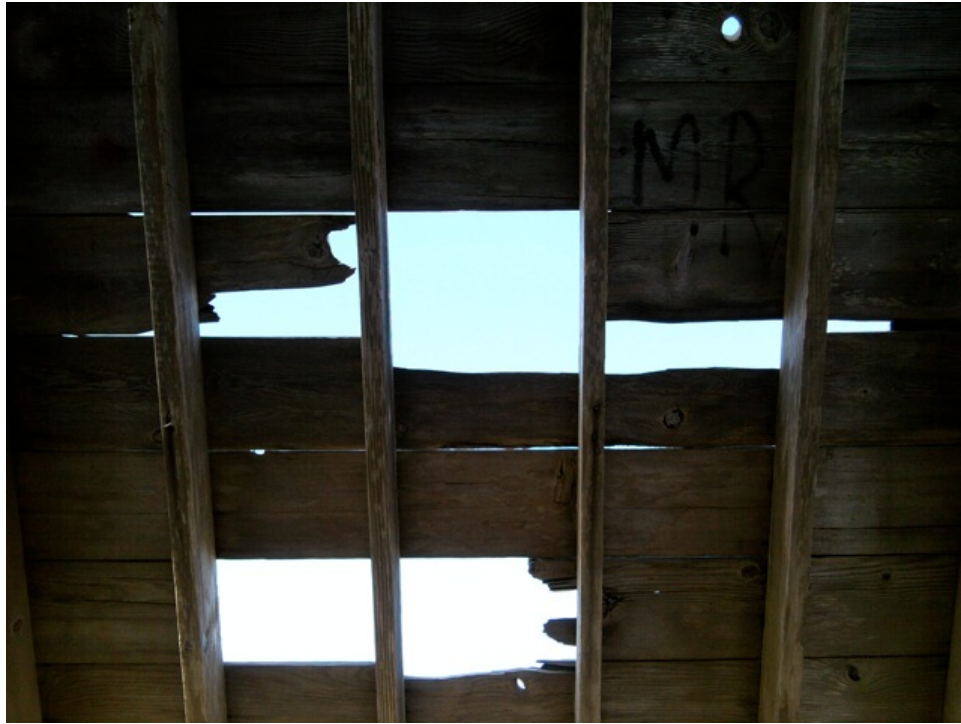
[Fig. 11] Detail of roof holes. The surrounding roof decking remains in good condition.

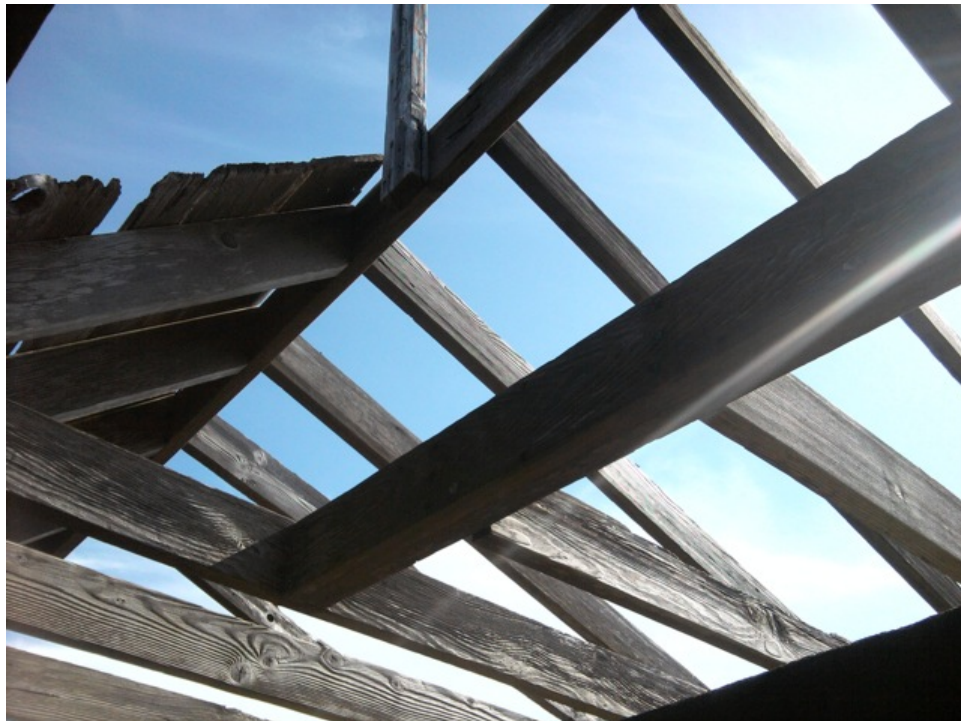
[Fig. 12] Detail of roof structure, facing southeast. Although weathered from exposure, the rafters have remained in good condition.

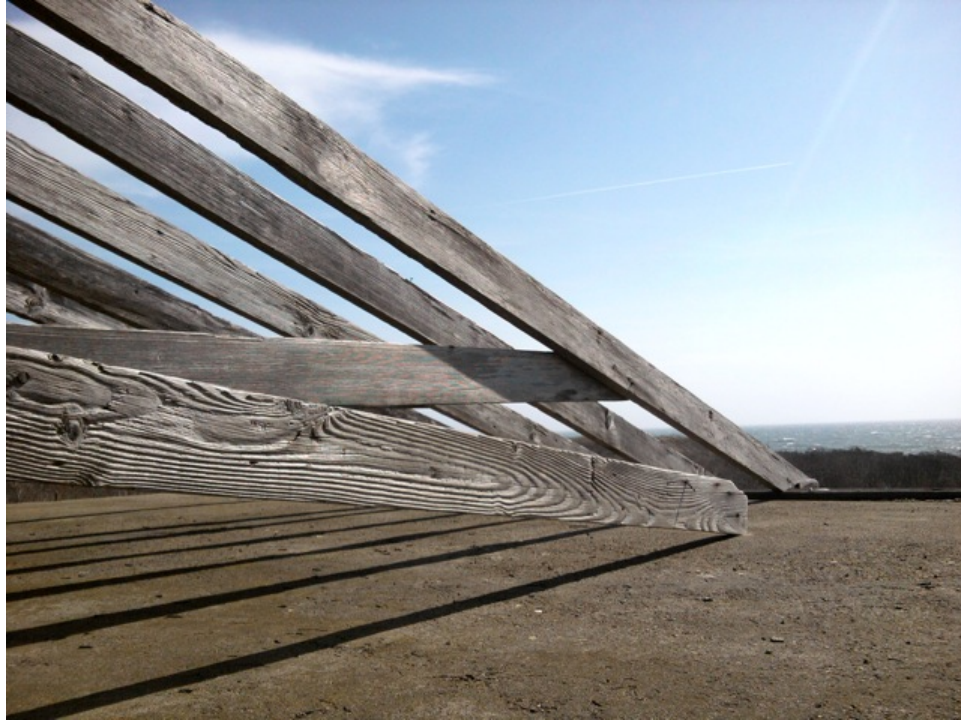
[Fig. 13] Detail of roof structure, facing southeast. Although weathered from exposure, the rafters have remained in good condition.

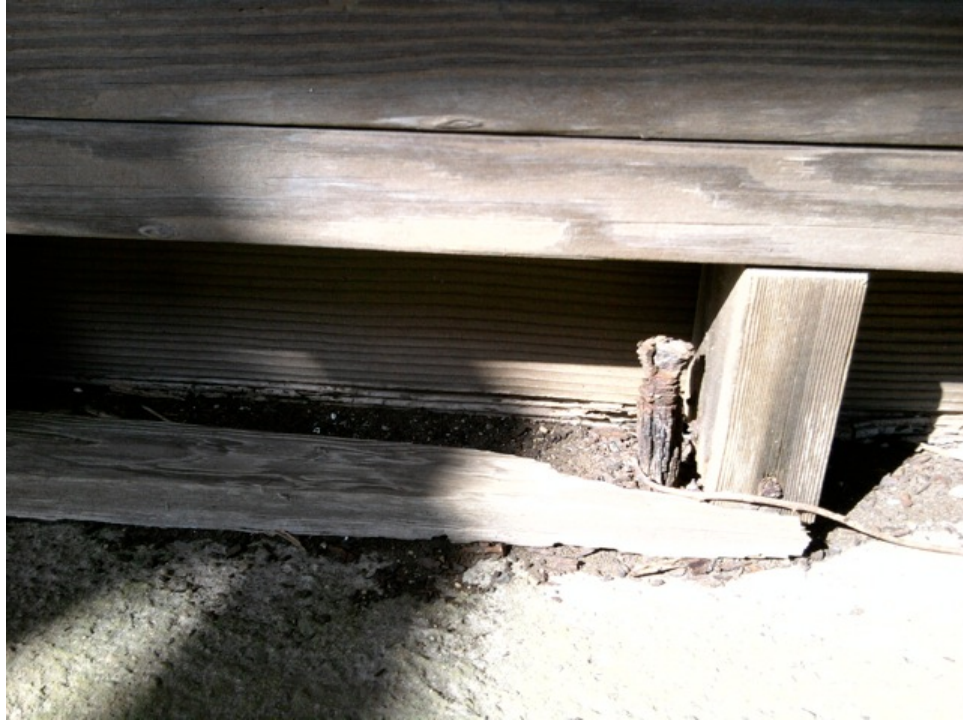
[Fig. 15] Detail of sill plate and roofing system, looking north. Note increased deterioration of wood and steel members.

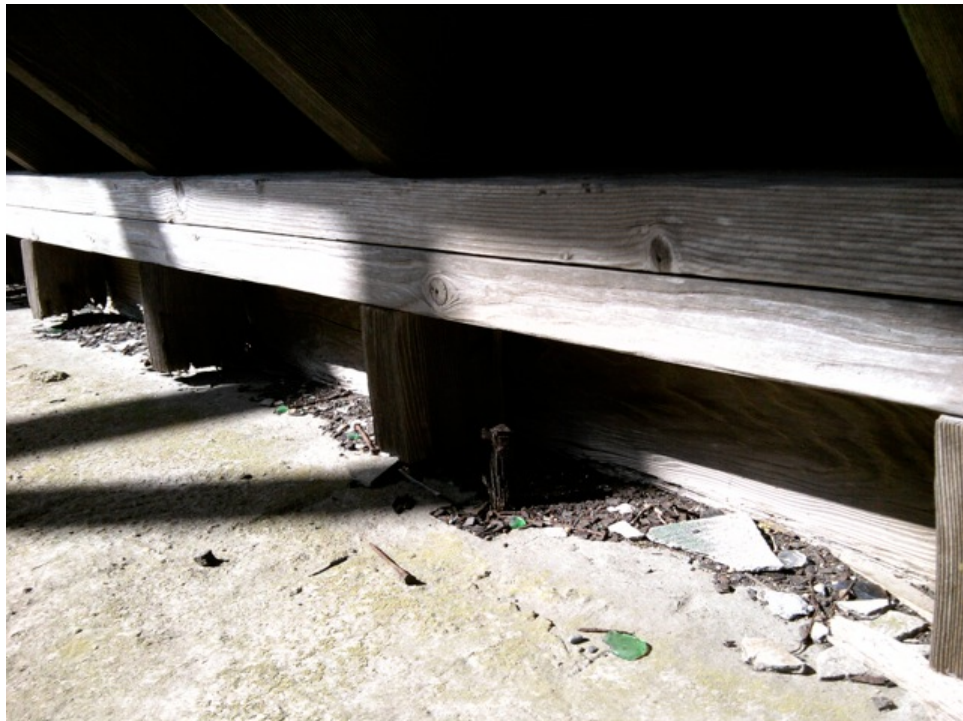
[Fig. 16] Detail of sill plate and roofing system, looking northwest. Note the missing sillplate.

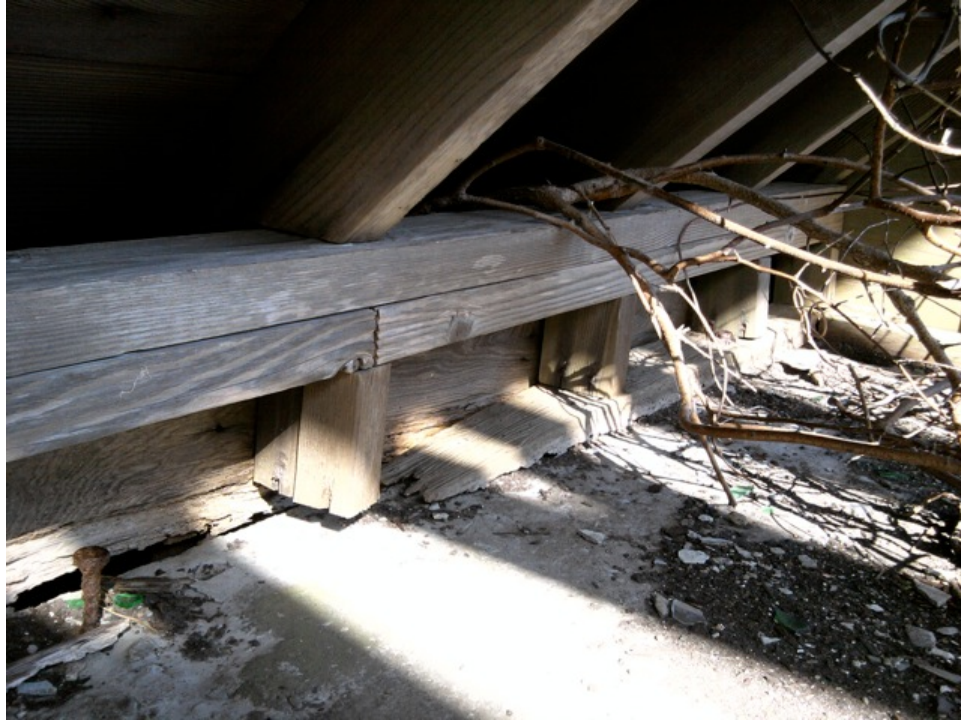
[Fig. 17] Detail of sill plate and roofing system, looking northeast. Note increased deterioration of wood and steel members.

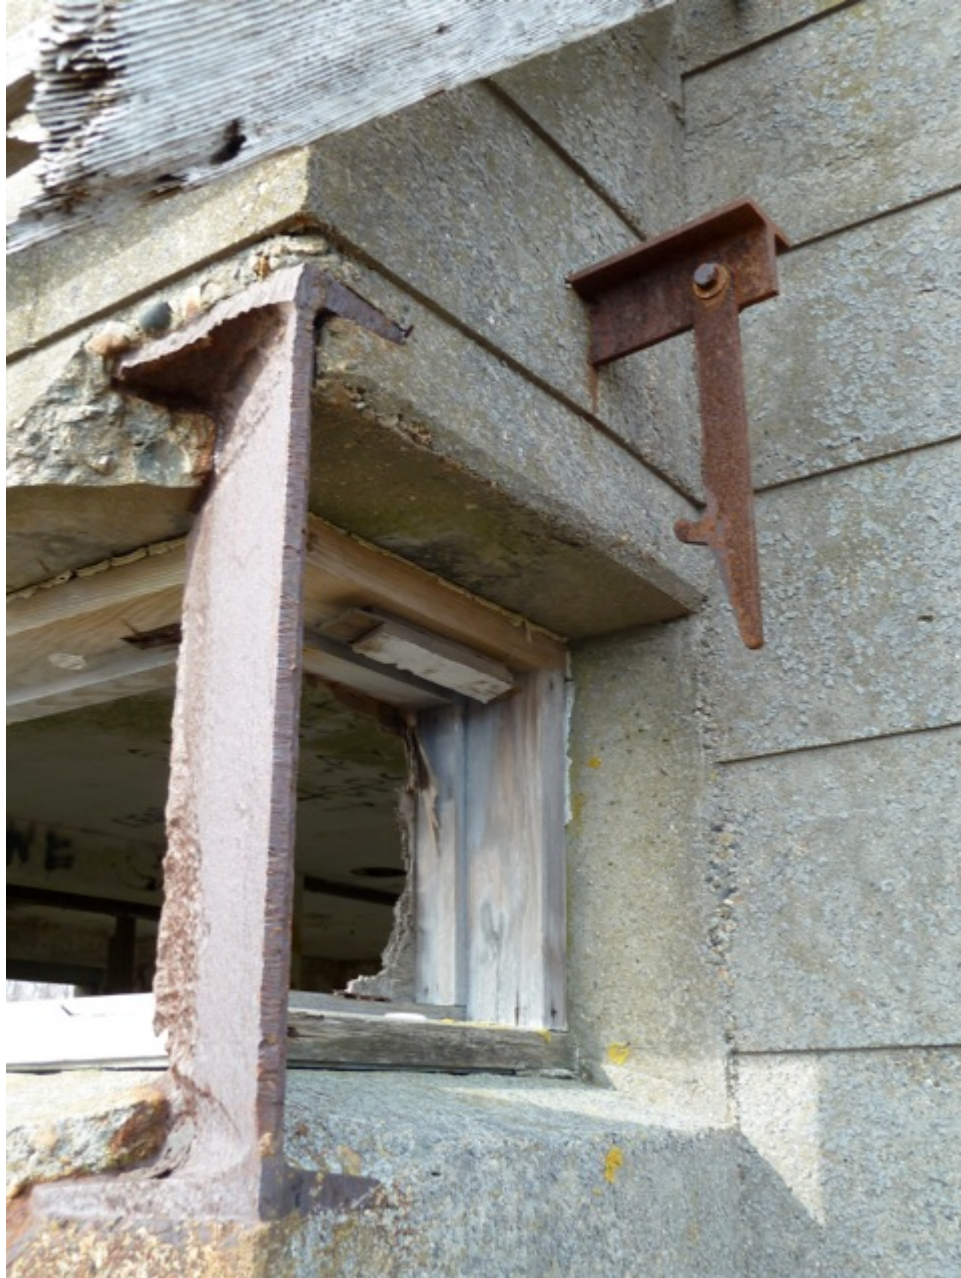
[Fig. 20] Detail of first floor ribbon window, looking northwest. Note the cracked concrete, wooden window frames, remnant of window sash, and intact window hook and mount.

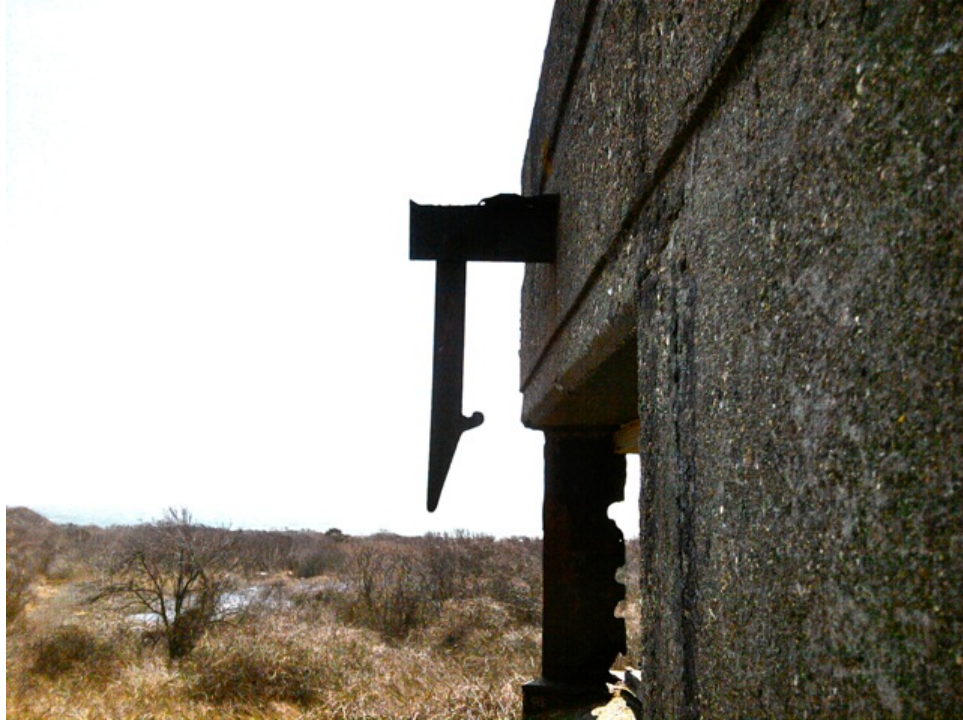
[Fig. 27] View of second story window hook and mount on west elevation, looking south. Note corroded steel corner support.

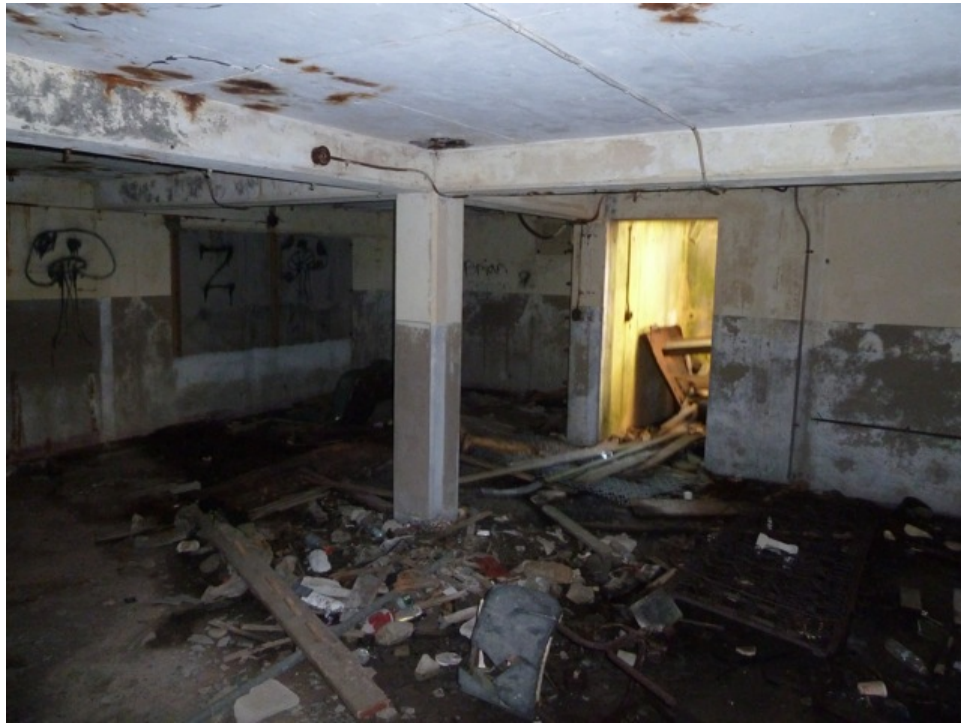
[Fig. 2] View of Room B-1, looking southwest. Note rust stains on the ceiling, debris, intact electrical conduits, and original paint treatment.

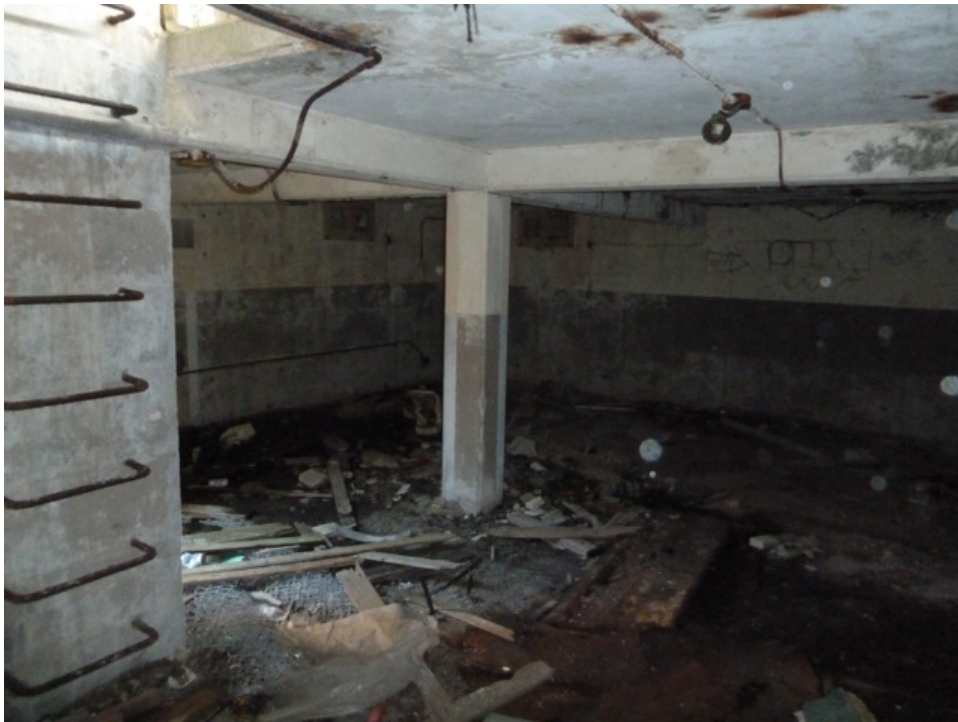
[Fig. 4] View of Room B-1, looking northeast. Note rust stains on the ceiling, debris, intact electrical conduits, ladder rungs, and original paint treatment.

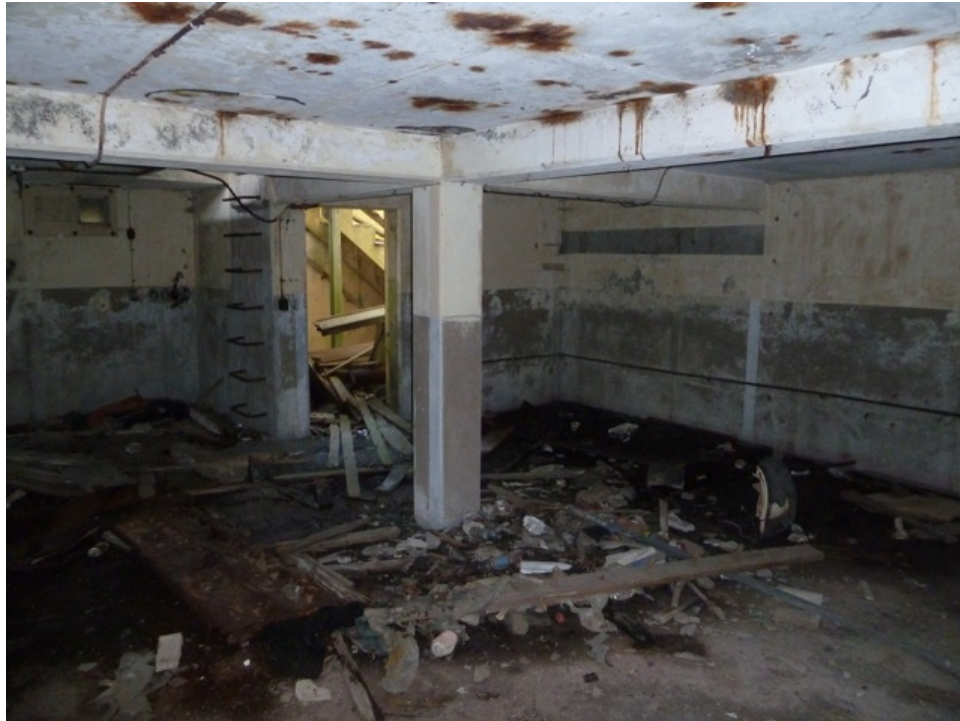
[Fig. 5] View of Room B-1, looking northwest. Note rust stains on the ceiling, debris, intact electrical conduits, ladder rungs, and original paint treatment.

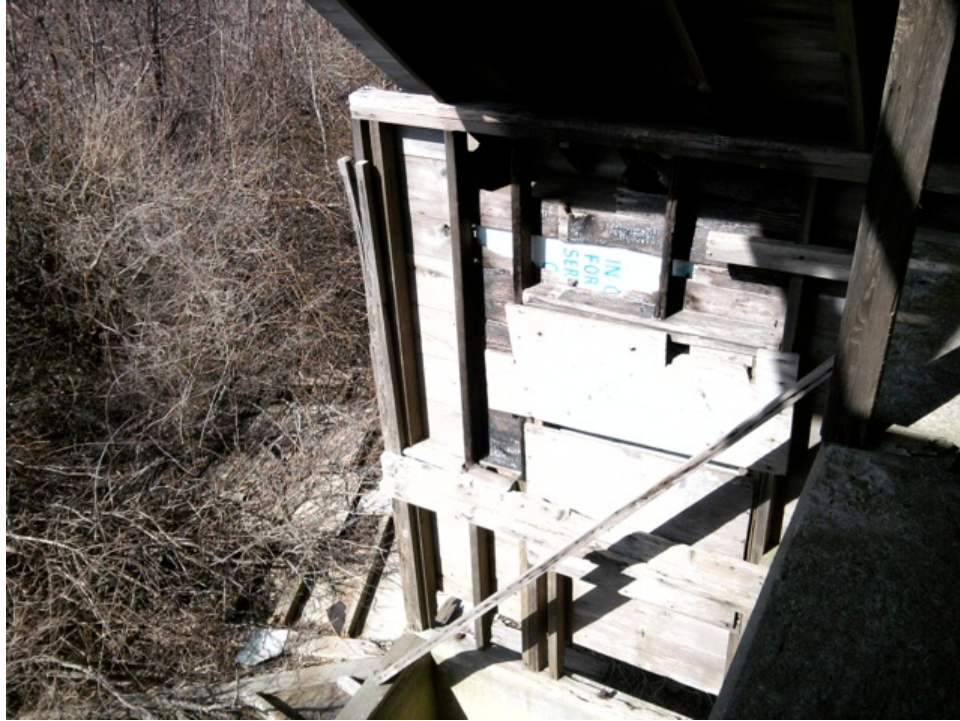
[Fig. 7] View of wooden portion of north elevation. Note the traces of a small fire to the left of the window.

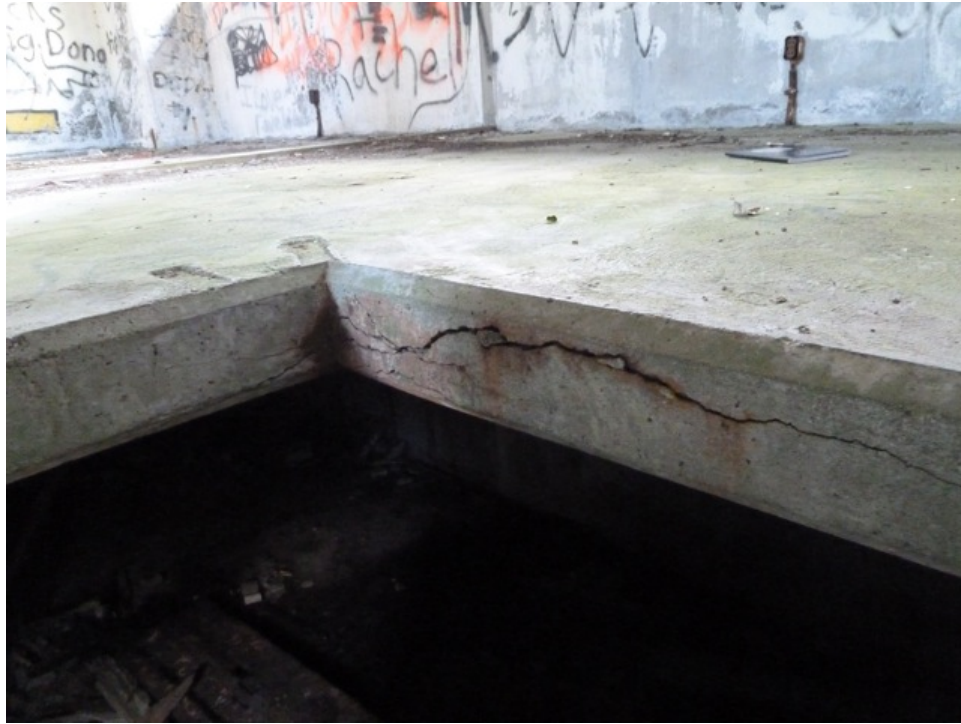
[Fig. 15] The cracking suggests delamination has occurred due to moisture infiltration. Note electrical outlet boxes on the south wall.

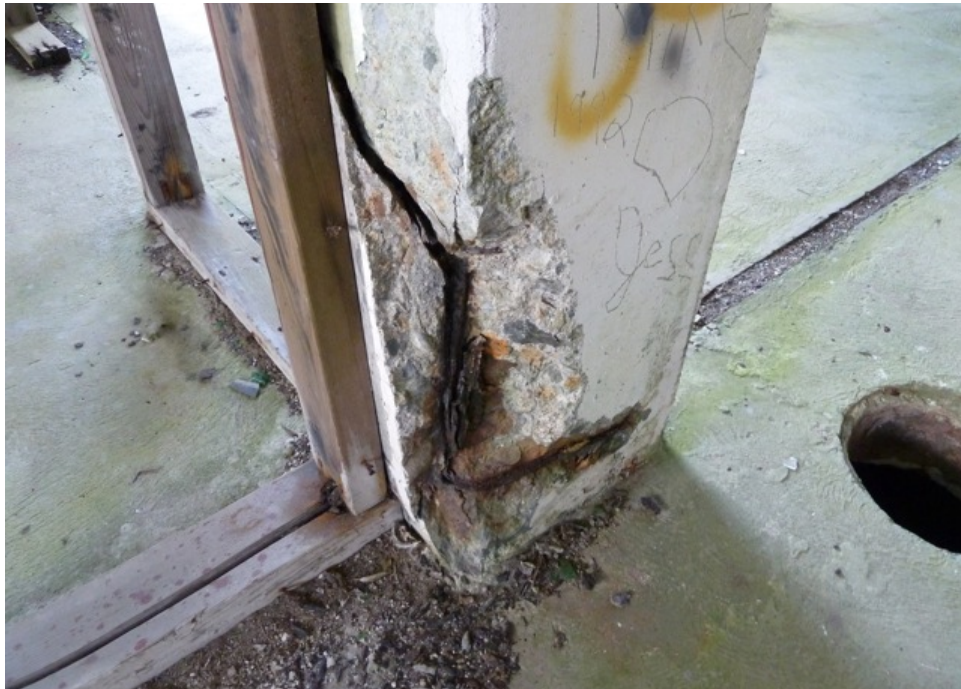
[Fig. 16] Detail of deterioration of central column in Room 1-1, looking northwest. Moisture exposure has led to reinforcement bar corrosion.

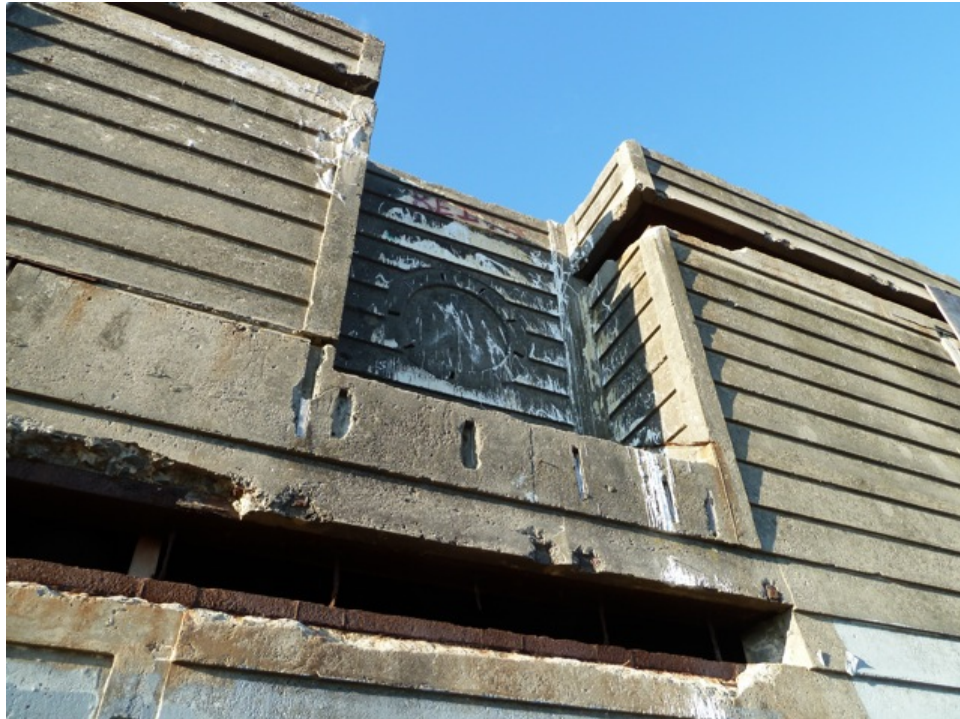
[Fig. 9] Detail of the south elevation, looking north. Note the paired concrete chipping above the ribbon windows, corroded steel within the ribbon windows, locations of wooden nailers, and formed concrete to mimic wooden clapboards.

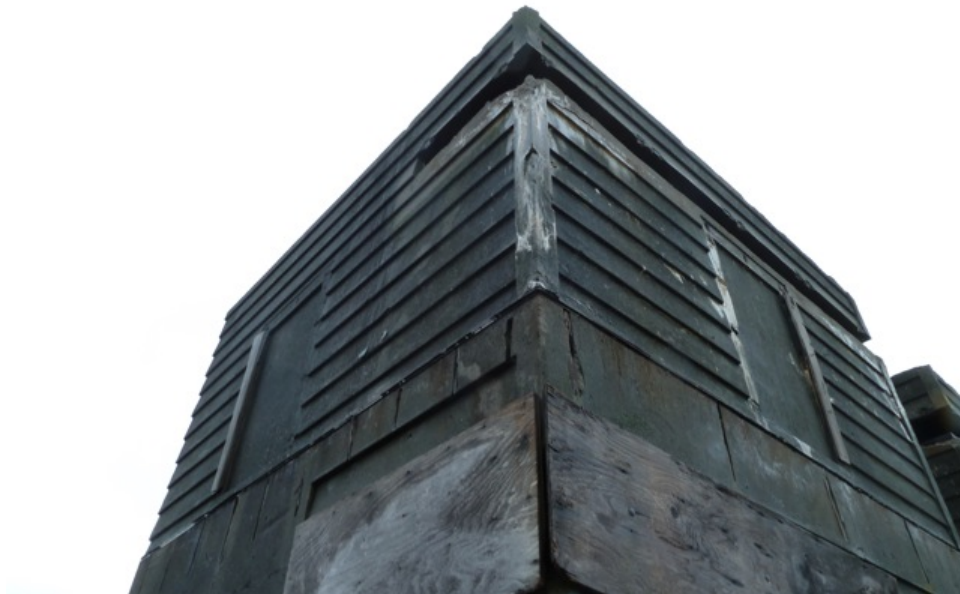
[Fig. 10] Detail of the southwest corner. Note the excessive efflorescence and locations of remaining window jambs bordering each of the two blind windows.

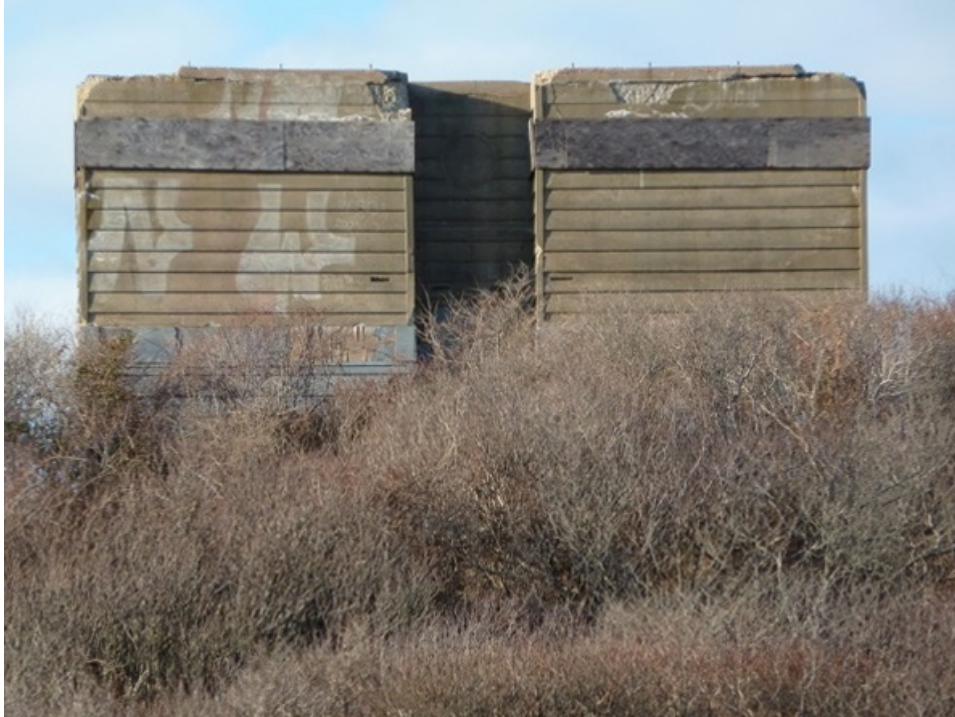
[Fig. 3] View of southeast elevation, looking northwest. Note the excessive erosion and cracking at the roofline.

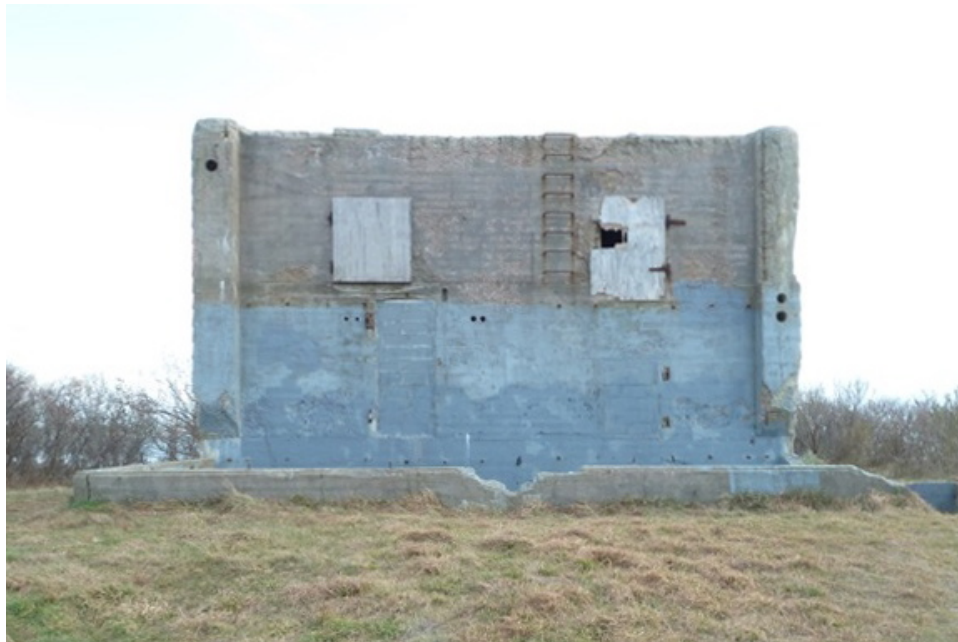
[Fig. 4] View of northwest elevation, looking southeast. Note the exposed ladder rungs and excessive erosion.

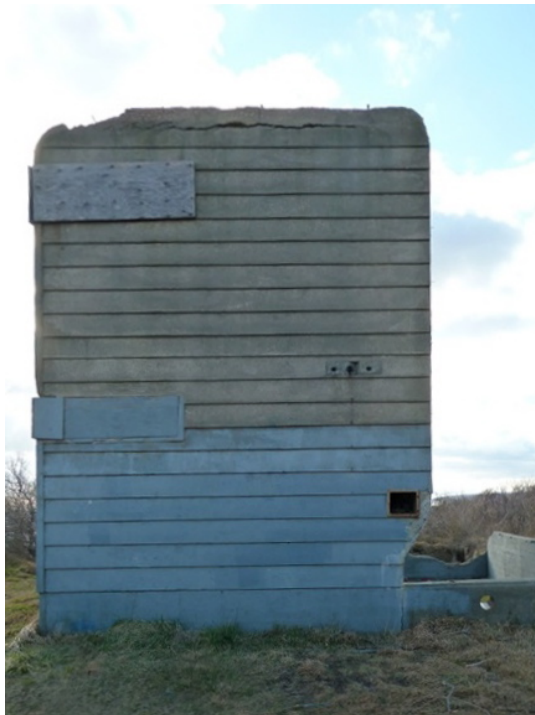
[Fig. 6] View of the northeast elevation, looking northwest. Note the excessive erosion and cracking at the roofline.

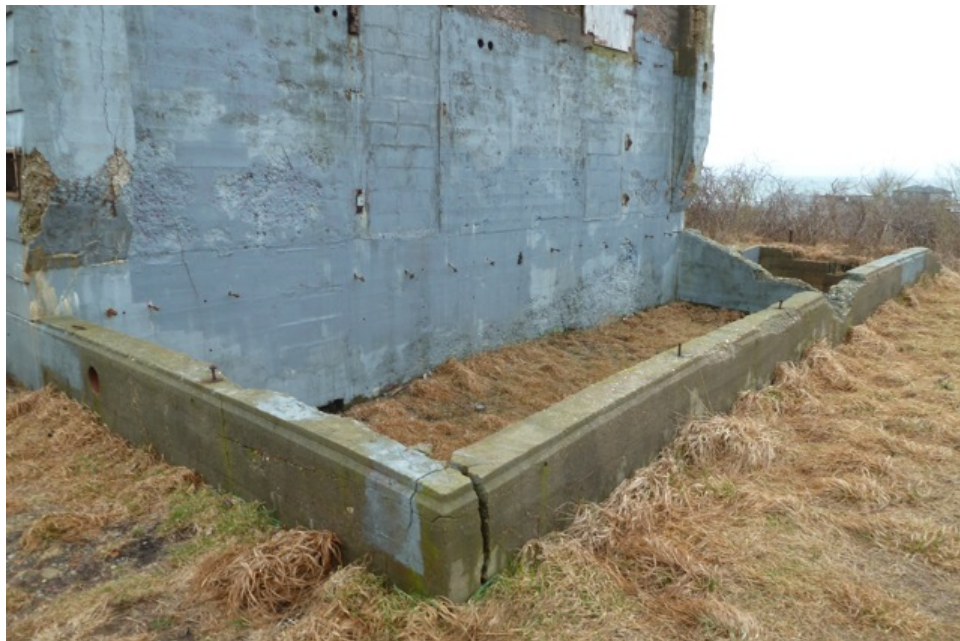
[Fig. 8] View of the foundation, looking south. Note the large crack where the southeast and northeast foundations walls meet.

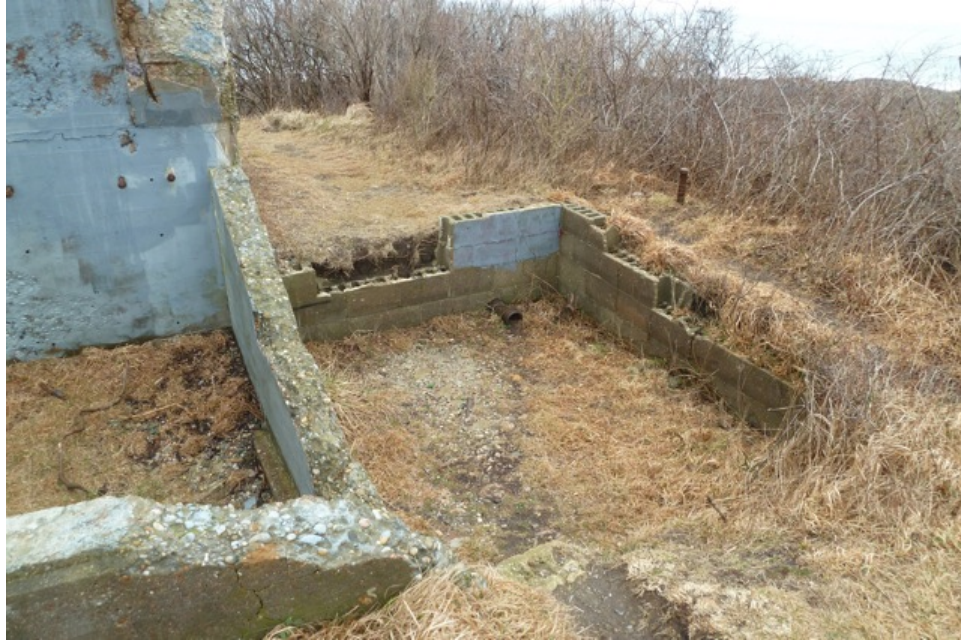
[Fig. 9] View of the latrine foundation walls, looking south. Note the missing CMU blocks.

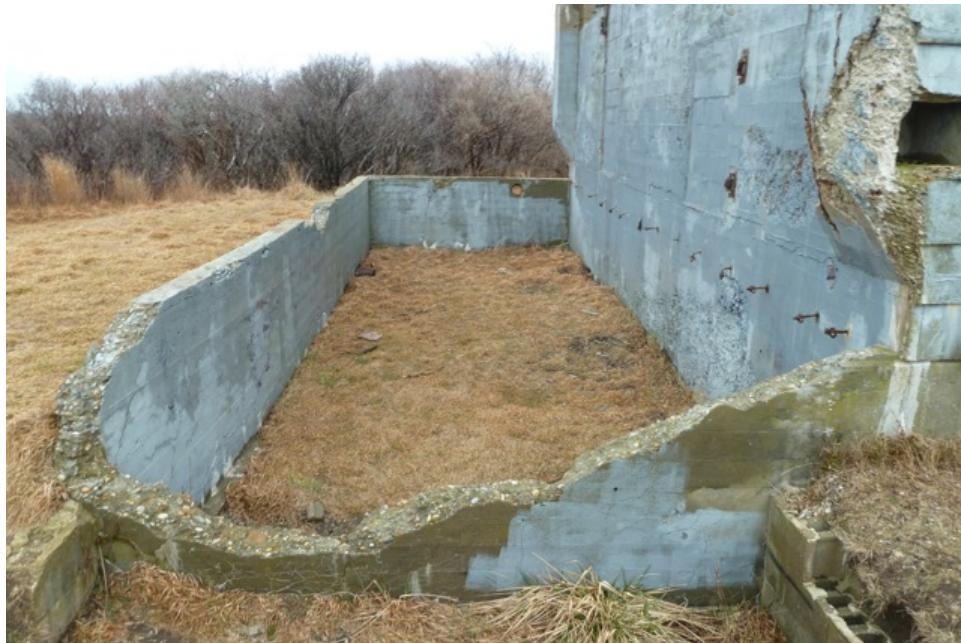
[Fig. 10] View of the southwest foundation wall, looking northeast. Note the excessive concrete erosion throughout.

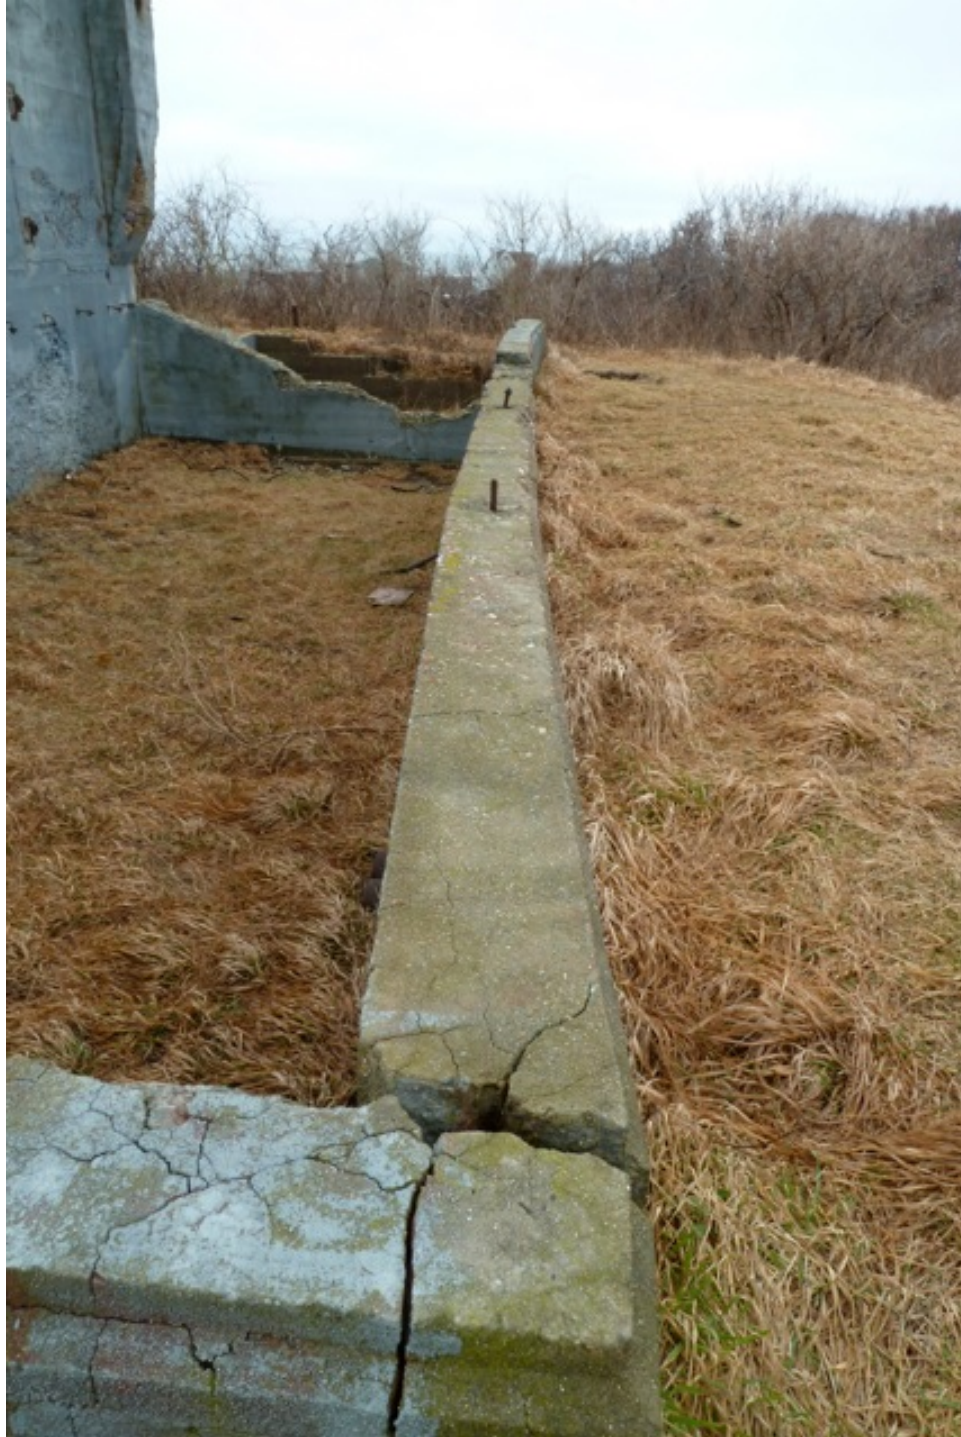
[Fig. 11] Detail of the northwest foundation wall, looking southwest. Note the bowing due to insufficiently retaining the change in ground level.

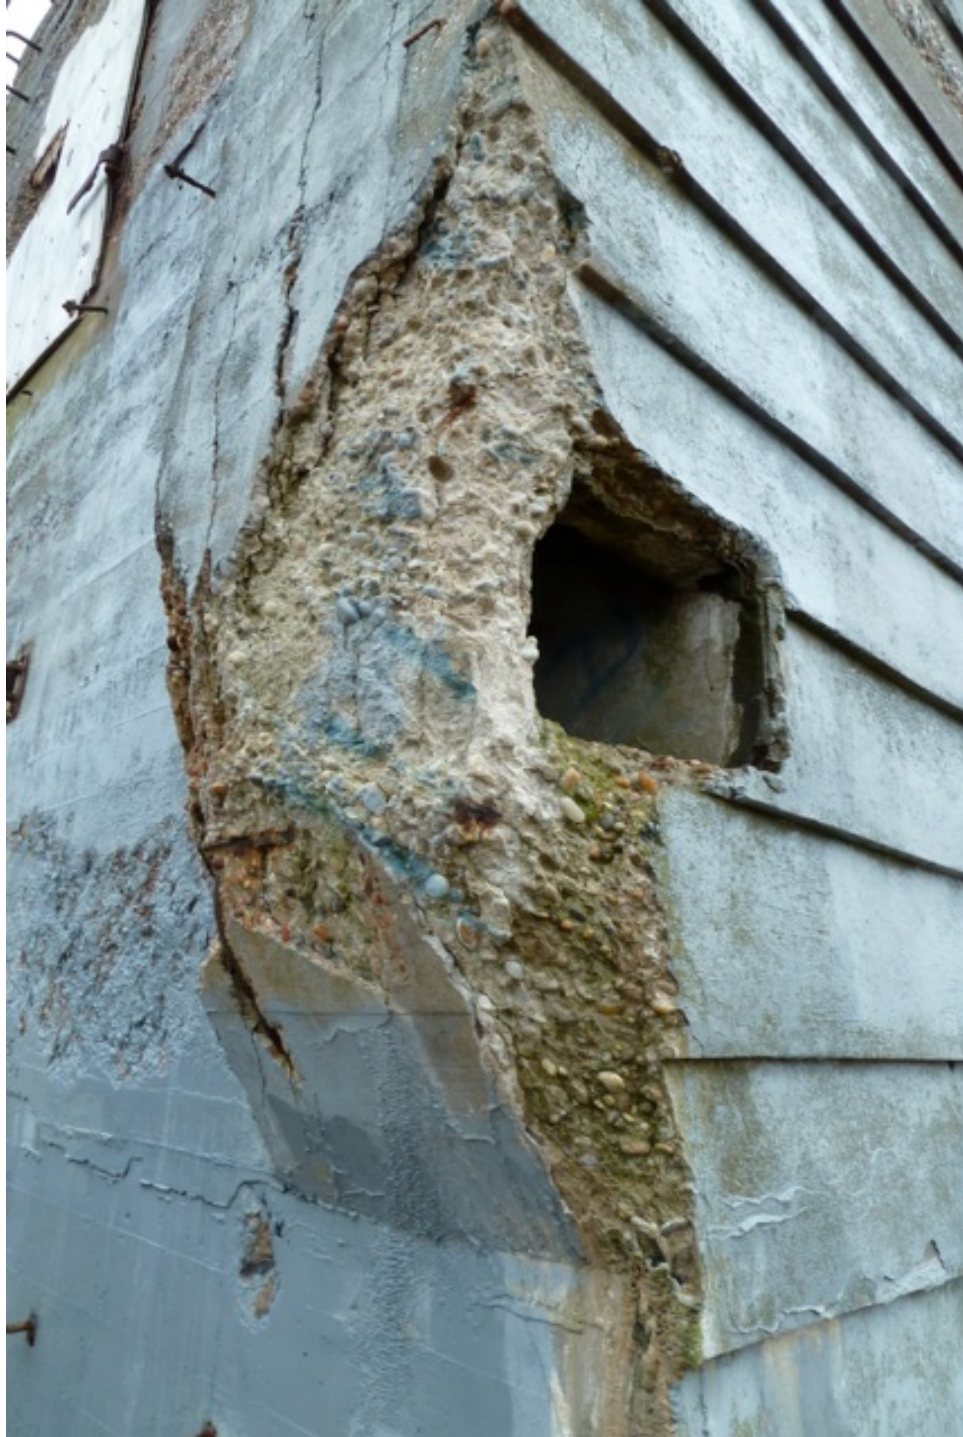
[Fig. 13] Detail of the southwest chimney base, looking east. Note the excessive erosion led to exposed reinforcement bars.

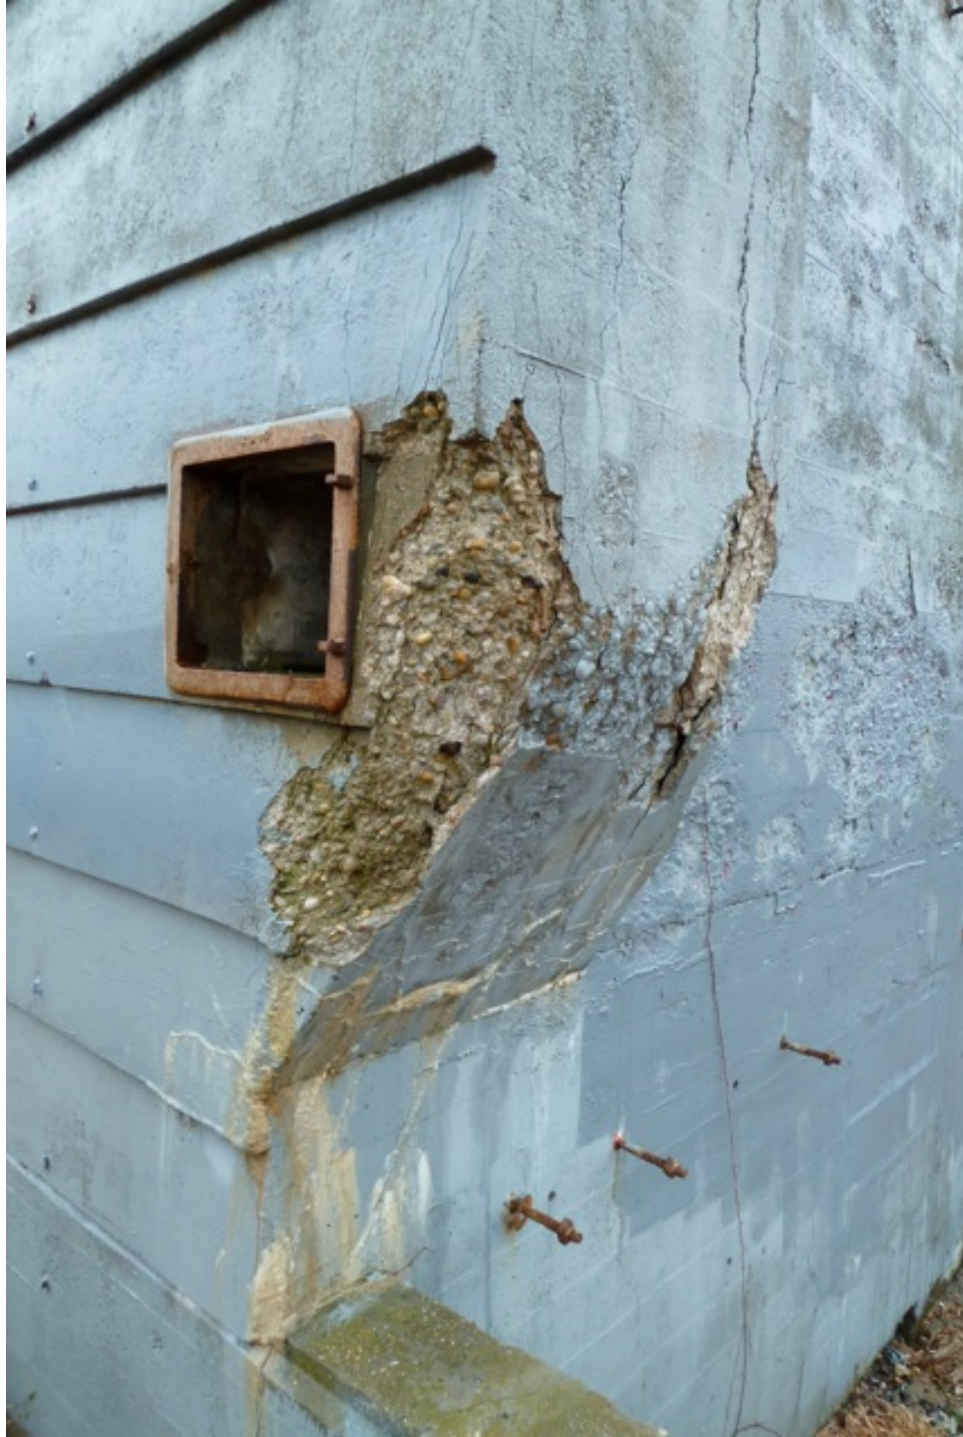
[Fig. 14] Detail of northeast chimney base, looking south. Note excessive erosion and efflorescence, as well as metal doorframe around the chimney access hatch.
