Pomham Rocks Lighthouse: Reuse and Rehabilitation Feasibility Report

Reuse and Rehabilitation
Feasibility Report

Community Partner:
The Friends of Pomham Rocks Lighthouse

Fall 2012

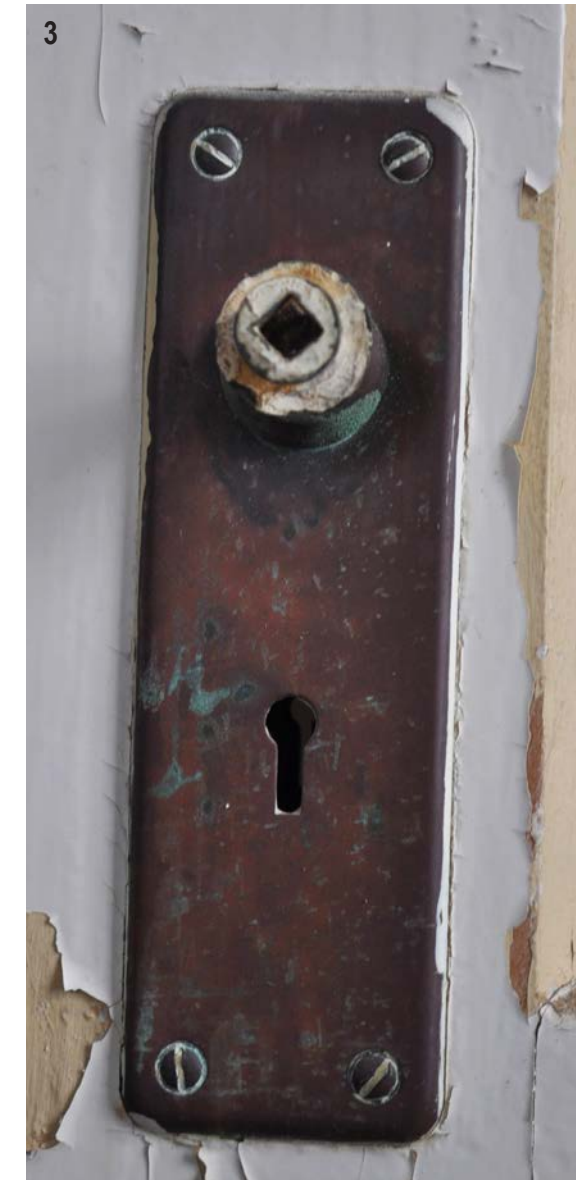
Exterior Granite: The mortar is deteriorating and failing at the mortar joints all along the granite foundation.

- **Chimney:** The brick chimney is exposed, and the mortar is deteriorating at the mortar joints.

- **Door Hardware:** Some of the original door hardware is missing. The remaining original door hardware is in fair condition but unoperable.
- **Cast Iron Radiators:** The original cast iron radiators exist and are in good condition.
- **Floor Vents:** Cast iron floor vents are original and in fair condition.

1. Granite foundation from north elevation shows missing mortar joints.
2. Lighthouse interior has exposed brick with deteriorating mortar.
3. Door hardware missing and inoperable.

The mortar joints will be repaired using a mortar that matches color and composition of the historic mortar. All work will be done in accordance with the guidance found in Preservation Briefs 2: “Repointing Mortar Joints in Historic Masonry Buildings.”

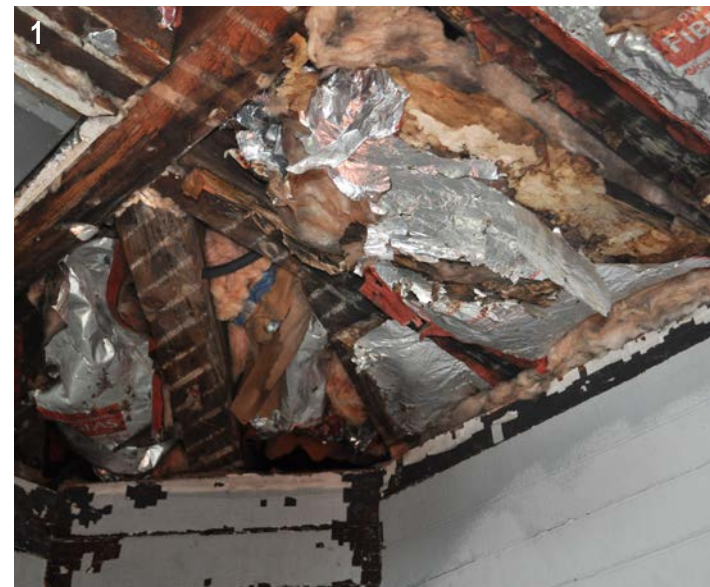
Insulation: Fiberglass insulation in the sub-floor of the lantern house has been exposed to moisture and is in poor condition.

1. Fiberglass insulation exposed to moisture and in poor condition.
2. Exposed lath and plaster deterioration in the first floor hallway. This section will be preserved.

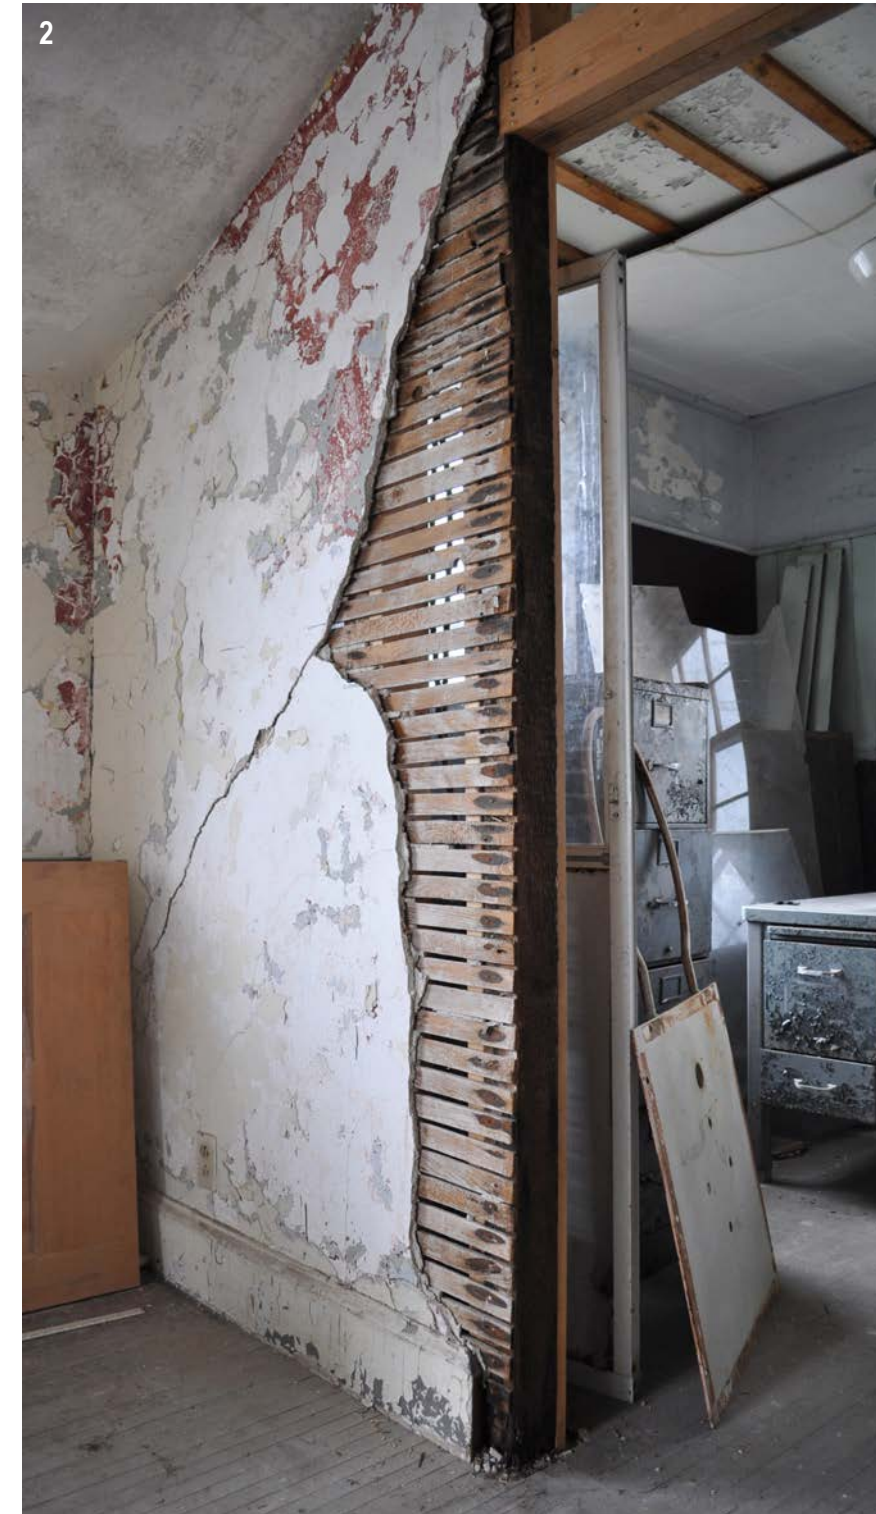
Plaster: The plaster ranges from fair to poor condition throughout the lighthouse with significant areas missing.

The plaster on the interior dividing walls and ceilings will be repaired and restored in accordance with the guidelines found in Preservation Briefs 21: "Repairing Historic Flat Plaster Walls and Ceilings."

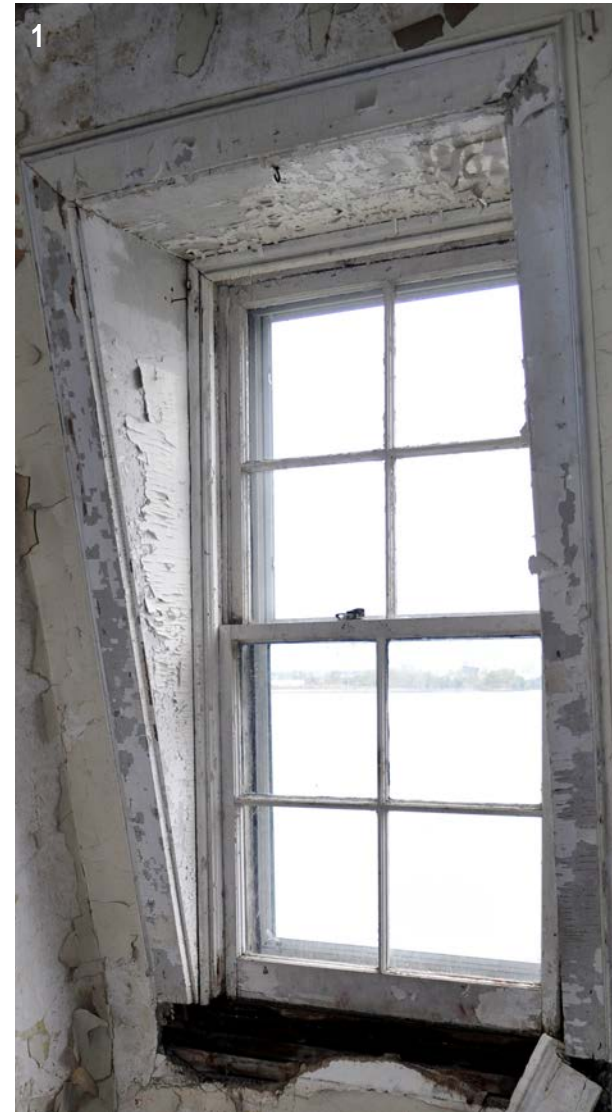
1. Plaster failure and missing sill in this second-story window.
2. Pomham Rocks Lighthouse boat dock, the only way to access the island.

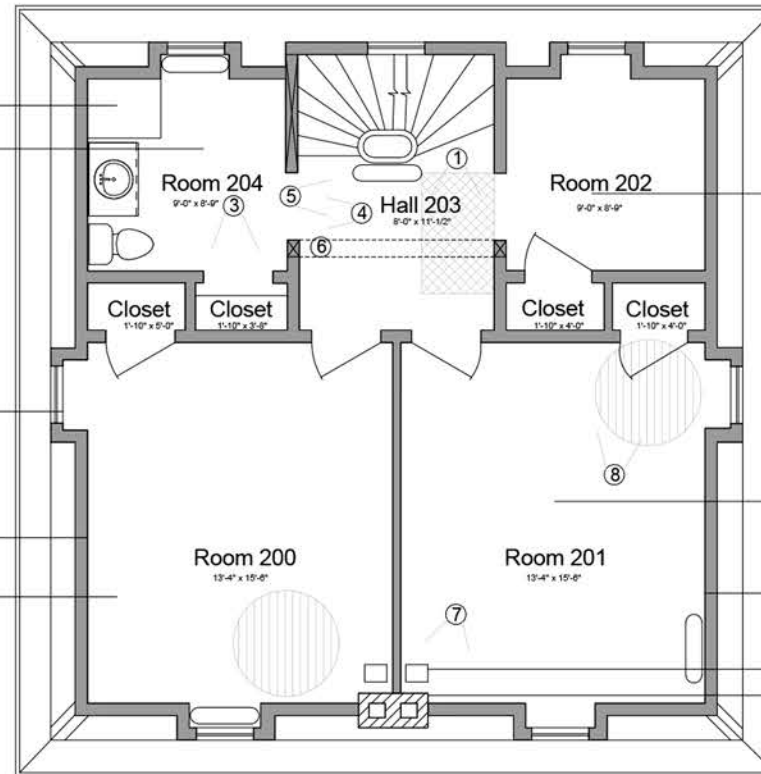
Shower
Plaster Failure on Whole Ceiling
(Lath Exposed)

2 Plaster Failure (Floor to Sill)

Plaster Failure on Whole Ceiling
(Lath Exposed)

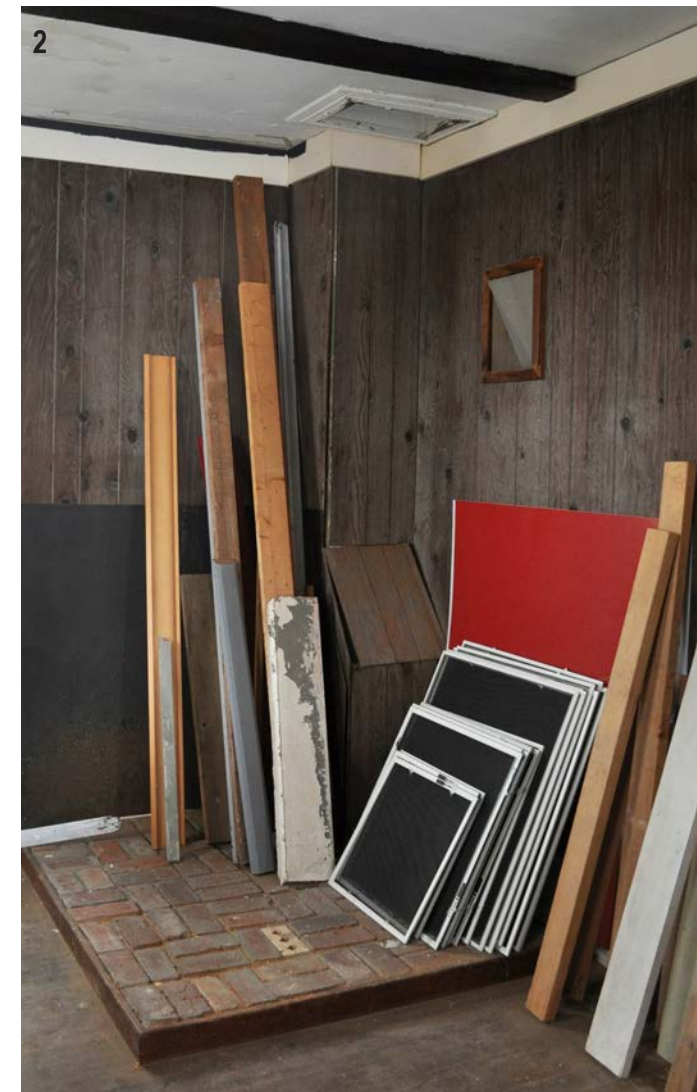
1. First-floor kitchen to be removed and converted to museum space. The cabinets are from the 1956 Coast Guard renovations.

2. The faux-wood ceiling beams, paneling and the raised brick hearth in the living room will be removed.

The cabinets in room 100 will be removed by the gentlest means in order to decrease any potential damage to the plaster and lath beneath.

The brick hearth will be removed, and any underlying wood flooring will be repaired with in-kind materials.

The faux-wood beams and ceiling tiles will be removed.

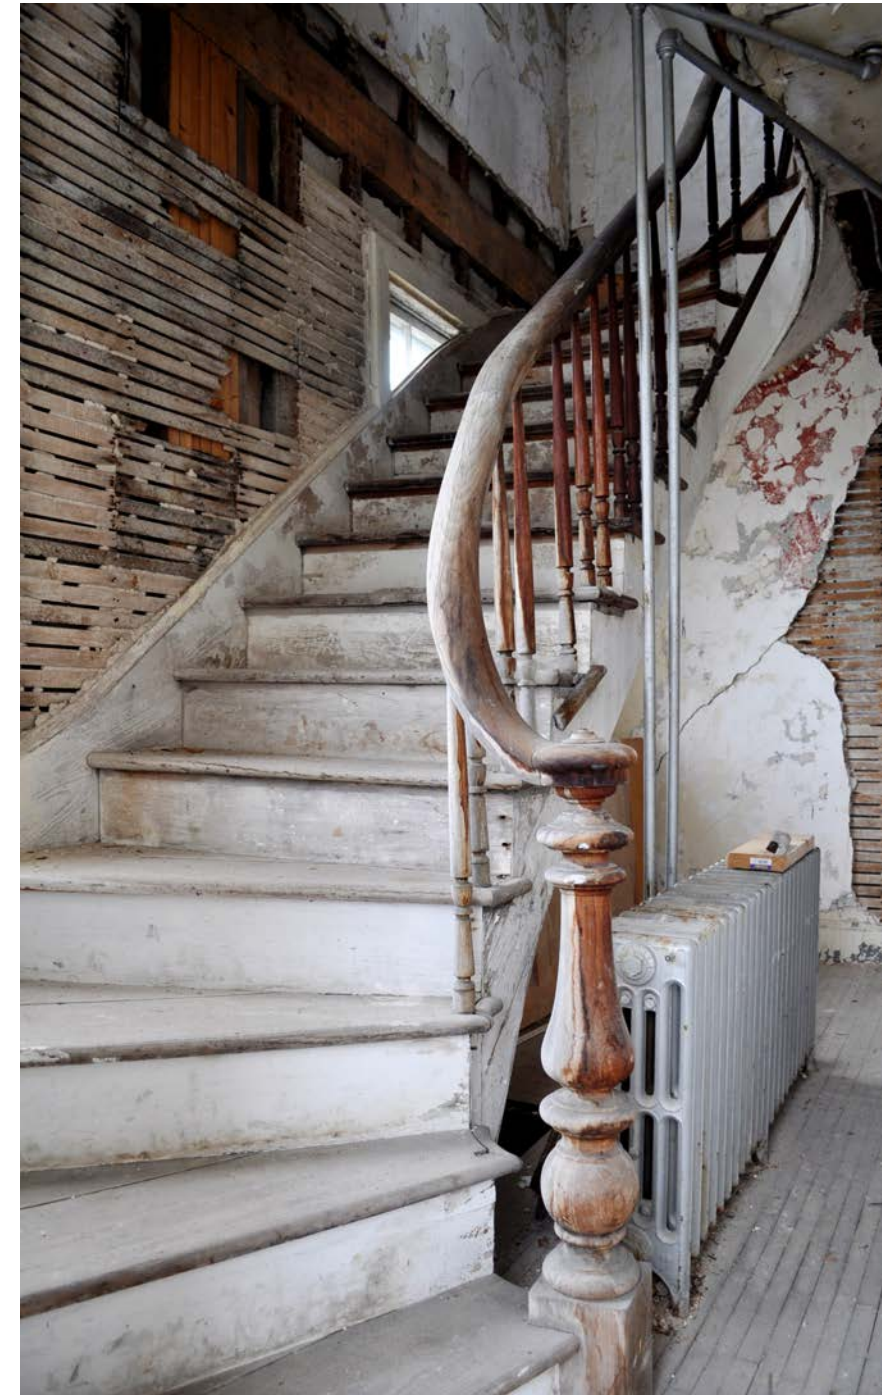
The interior staircase, a character-defining feature of the lighthouse, will be stripped and repaired.

The stairs will be stabilized and repaired. The missing balusters will be replaced with in-kind materials. The staircase will be stripped of any finish or paint by the gentlest means possible. The stairs will be sanded, and a coat of varnish or any safe protective coating will be applied. Any coating or varnish applied should be removable without causing damage to the wood surfaces underneath.

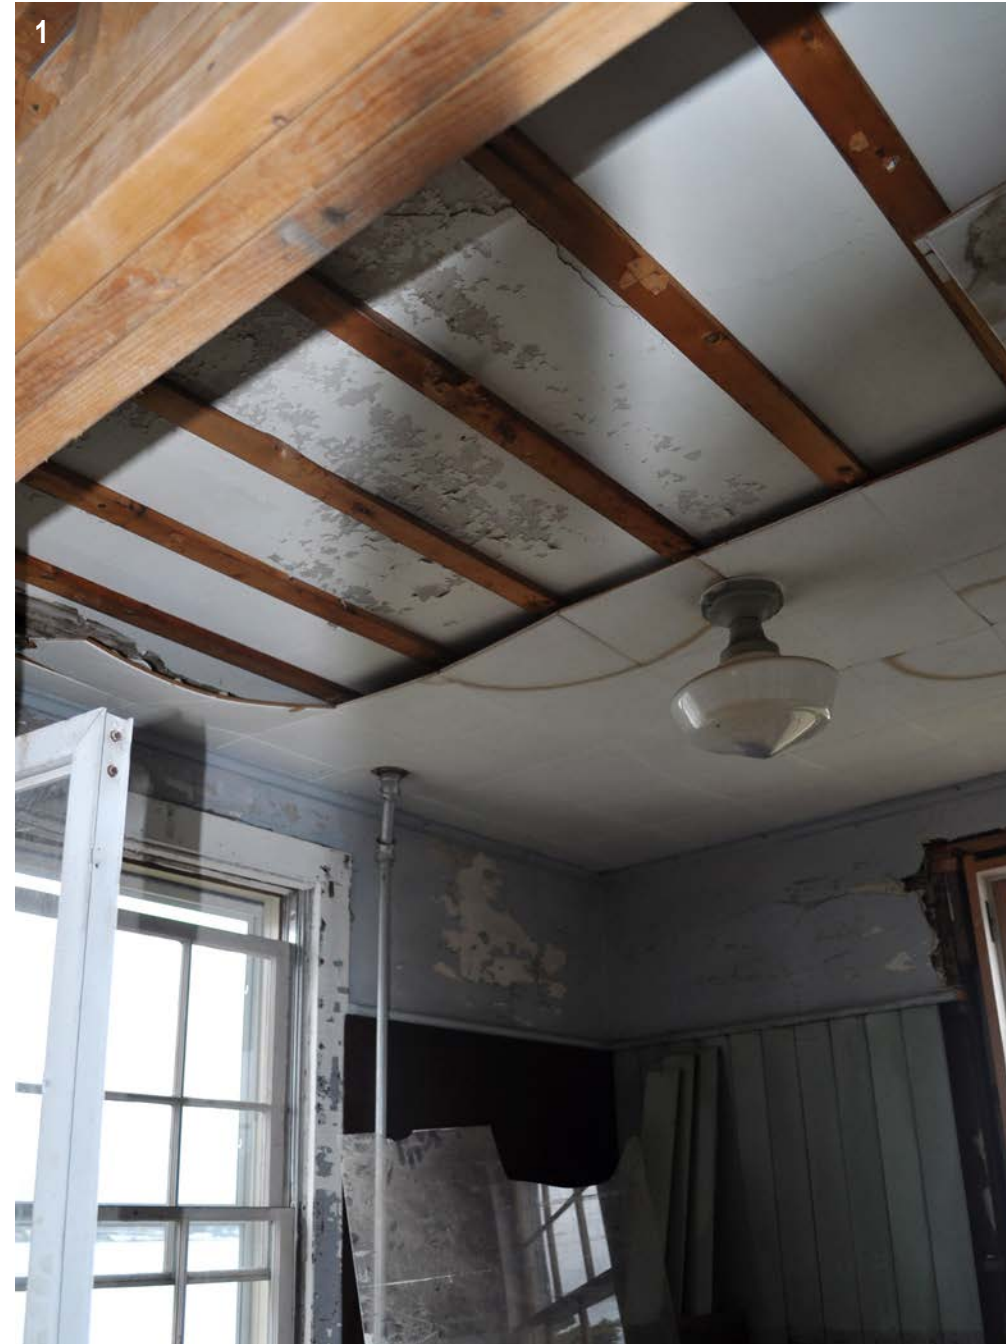
1. In the current first-floor office, ceiling tiles will be removed and plaster in-filled between the furring strips. This room will be converted to a bathroom.

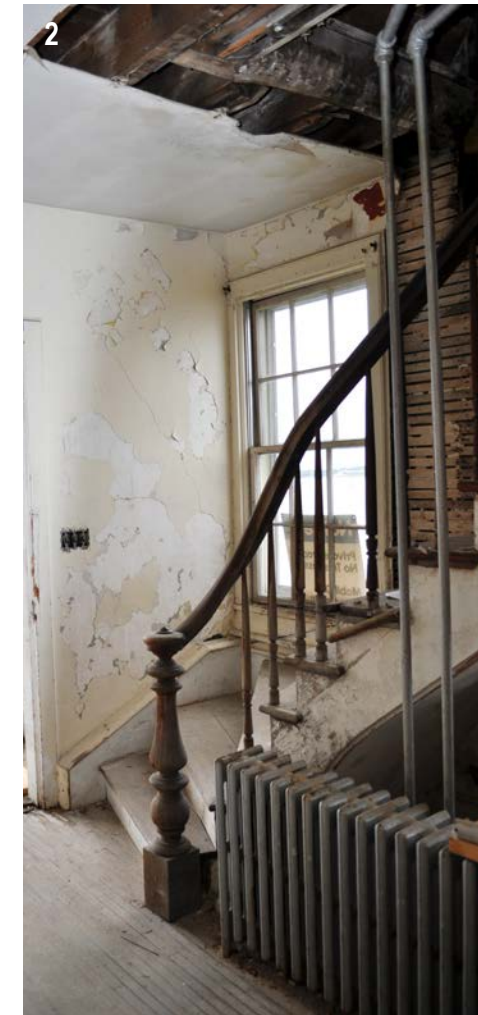
2. Piping for the cast iron radiators will be removed, and the radiators will be retrofitted to a radiant heating system.

The piping for the radiators will be removed and the radiators will remain. The radiators will be made operational by retrofitting them to a new radiant heating system. An electric element replaces the extensive water piping system, and each radiator will be connected to a programmable thermostat that allows the temperature of each room to be controlled. In the rooms where there are no radiators, new matching replacement radiators will be installed.
