Charles G. Calder House Rehabilitation Plan

22 Whitmarsh Street | Providence | RI

Existing Conditions

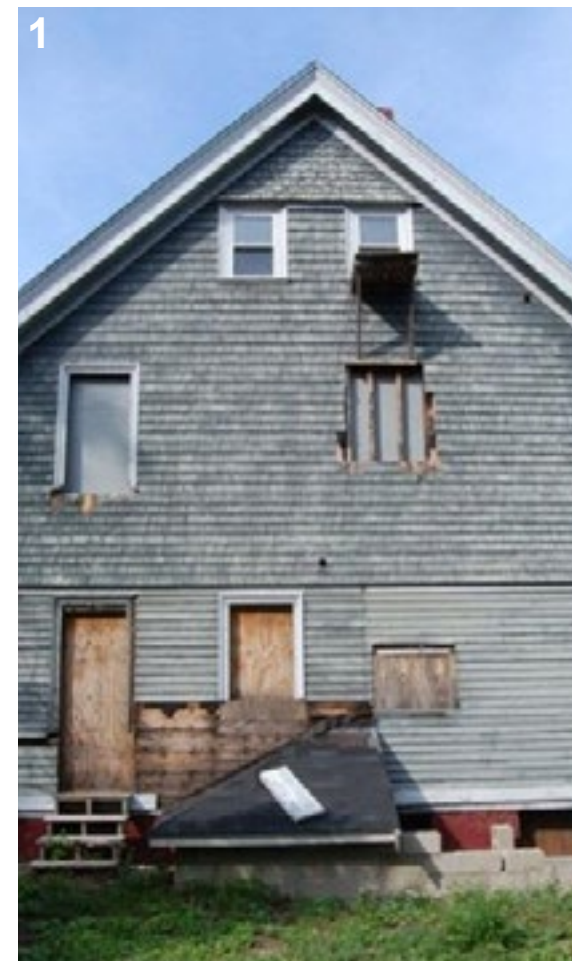
Building: The house is a two and one-half story, cross-gabled structure of wood construction. The building sits atop a brick foundation, clad in shingles and clapboard. The main entrance on the east elevation is accessed via a single-story porch. Many structural and decorative elements on both the interior and the exterior of the house have been altered or have suffered from lack of maintenance. Specific elements and their condition include:

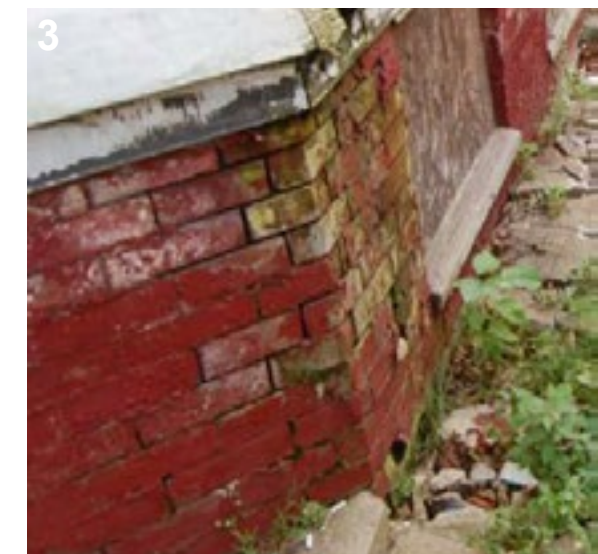
Foundation: The primary foundation for the house is constructed of brick, which has been painted in most areas. There is minor spalling on the brick throughout the foundation, but most of the brick has been protected by the paint and is in good condition.

The mortar in many areas of the foundation is either highly deteriorated or missing. Several basement windows are missing. There is significant damage to the foundation at the northwest corner due to the missing downspout and resulting water/freezing damage.

In recent years, a partially constructed concrete block bulkhead has been added to the foundation. This has resulted in a haphazard removal and reconstruction that appears to be structurally inadequate.

Unit Masonry Restoration: Bricks will be gently brushed and cleaned. Joints will be repaired to match existing mortar where mortar has eroded or cracked. Deteriorated bricks or bricks with cracks of greater than 1/2" will be replaced with bricks of similar size and color.

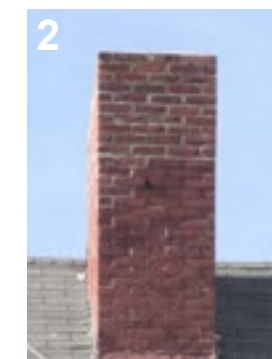
Chimneys: Two chimneys are located at the north and south ends of the roof ridge. The southern chimney has been painted red and improperly repointed. The mortar is deteriorated and is in need of being repointed. Many of the bricks are no longer in line with the coursing of the rest of the bricks, and associated flashing is warped and partially painted. The northern chimney exhibits two campaigns of inferior mortar repointing, the lead flashing is warped, and the entire chimney is coated in a layer of red paint.

Refractory Brick Masonry: Old mortar will be removed to a minimum depth of 2 to 2-1/2 times the width of the joint to ensure an adequate bond and to prevent mortar "pop outs." Any loose or disintegrated mortar beyond the minimum depth will also be removed. New mortar for repointing will be compatible to the existing mortar and condition of the bricks. New mortar will match color of existing. Chimneys will be re-lined.

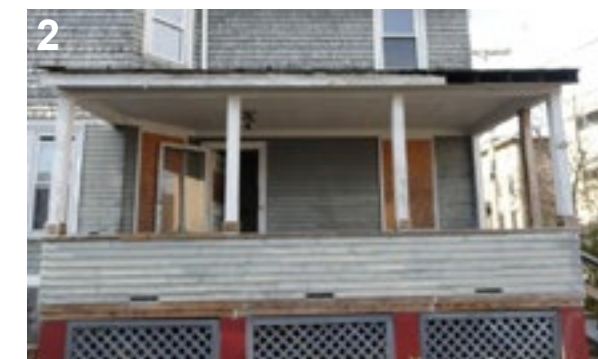
Porch: While the house originally had a large semi-circular porch located on the eastern side of the house, at some point this appears to have been removed and the existing porch added. The existing porch is of a smaller, square design with a clapboard skirt, square columns and a simple shed roof. The porch roof is in poor condition, with no functional gutters or downspouts. The deck is in fair condition and the lattice-work skirting below the porch at the foundation level is in good condition.

Wood Floor Decking: Replace wood floor decking and stairs on front porch with 3" wide hardwood spaces not more than 1/16" apart.

Exterior Finish Carpentry: Replace front stairs per architectural plans.

Asphalt Roof Shingles: Replace asphalt shingles on the porch roof to match the main roof in style and color.

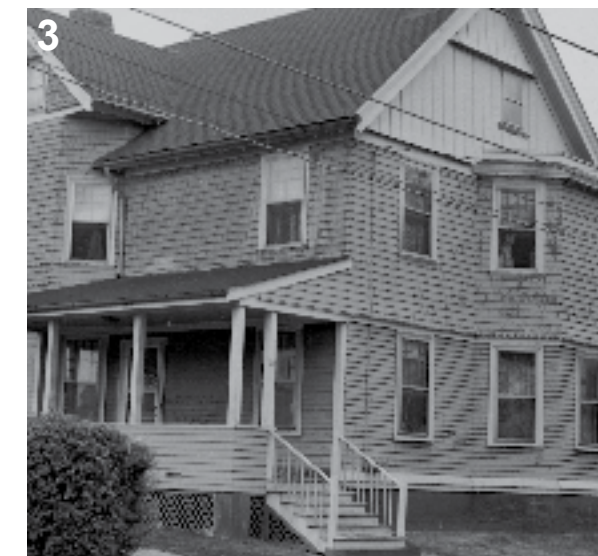
A photograph from the mid-1970s shows that the windows for the first, second and third floors were originally wood sash with multiple panes in the upper sash and single panes in the lower sash. This was a typical configuration for a house designed in the Queen Anne style.

Metal-Clad Wood Windows: All original patterns of the openings and their sizes (1886) will remain the same. All existing windows shall be removed and replaced with six-over-one sash metal-clad wood windows and will match selected and approved proportions of the frame and sash; configuration of window panes and muntin profiles. All replacement windows will be made as energy efficient as possible by the use of appropriate weather stripping to reduce air infiltration.

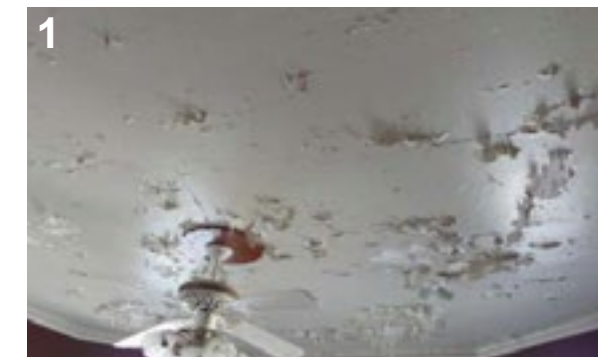
Ceilings: The ceilings of all three floors are in good condition. Ceiling plaster that was in poor condition has already been removed throughout or marked for removal, as is the case on the third floor. Certain ceilings do require patching and refinishing but not removal. The most prevalent damage has been caused by the removal of wall plaster and framing, which has resulted in cracking and deterioration at the wall-ceiling junctures. Due to moisture, exposure, and lack of climate control, the paint is failing on many ceilings.

Lime-Based Plastering: Thoroughly soak existing lath before applying new base coat of plaster, repair all holes to existing plaster. Complete with new finish-coat over existing plaster and new blueboard to create overall even uninterrupted surface. Com-

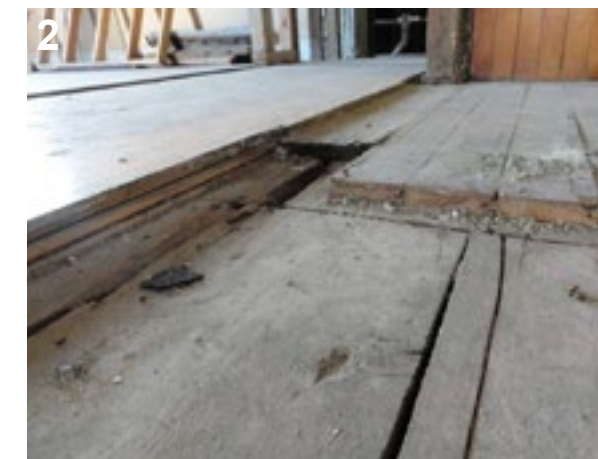
Floors: The conditions of the floors vary from moderately good to fair throughout the house. The floors are heavily scuffed and removal of the original heating system, including the radiators, has resulted in holes in both the floors and ceilings. The addition and removal of interior walls, as well as carpeting and floor tiles, has resulted in a confusing layering of floor boards and floor treatments. Most of the damage is cosmetic (not structural) and therefore most of the floors will only require patching, sanding, cleaning and refinishing. Some floors will require complete installation of new flooring layers over existing sub-flooring.

Flooring Restoration: Floors will be gently cleaned with an appropriate cleaner to remove wax build-up and dirt. Losses in the flooring will be patched with the same type of wood and stained to match existing floor color. Floors will be waxed and buffed.
