Fuller Farmstead: Reuse & Rehabilitation Feasibility Report

Reuse and Rehabilitation
Feasibility Report

Community Partner:
The Barnstable Land Trust,
Barnstable, MA

Fall 2013

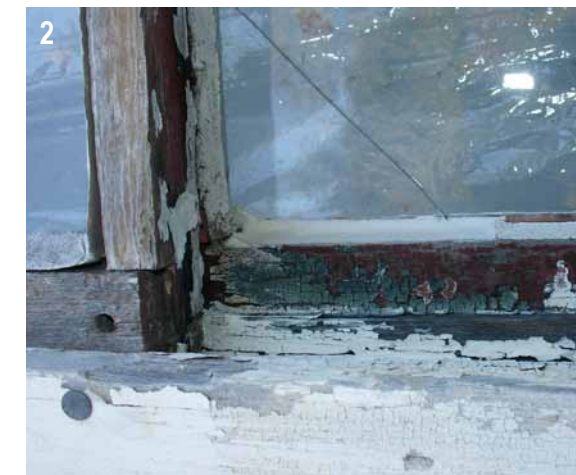
- East porch is missing trim boards.
- Porch indicates moisture and insect damage.
- Porch sills supported on concrete piers.
- Porch posts are missing ornamentation trim.

- Exterior wood sash storm windows are placed over windows.
- Storm windows show decay and failure, including: rotten sashes, broken glass and lack of glazing.
- Windows are not weather-tight or insulated.
- Two-over-two double-hung sash windows.
- Two-over-two double-hung sash windows have cylinder glass.
- All windows of this type on the structure show glazing failures, sash failures, broken panes and significant weathering.
- Sashes are in need of repair and rebuild.

- Chimneys consist of two brick and one stove pipe.
- Chimney in northern ell shows signs of cracking and moisture damage.
- Chimney on southern ell is missing above the roof line.
- Flashing around all chimneys is in poor condition.
- Both brick chimneys show signs of being rebuilt within the last ten years; however, the mortar used looks to be Portland cement, which will cause brick deterioration and cracking.
- The profiles of the rebuilt chimneys are not true to the profiles indicated in the historic 1890 photo.

1. East porch sills are supported by concrete piers.
2. Storm windows show decay and failure.
3. Chimney in northern ell shows signs of cracking and moisture damage.

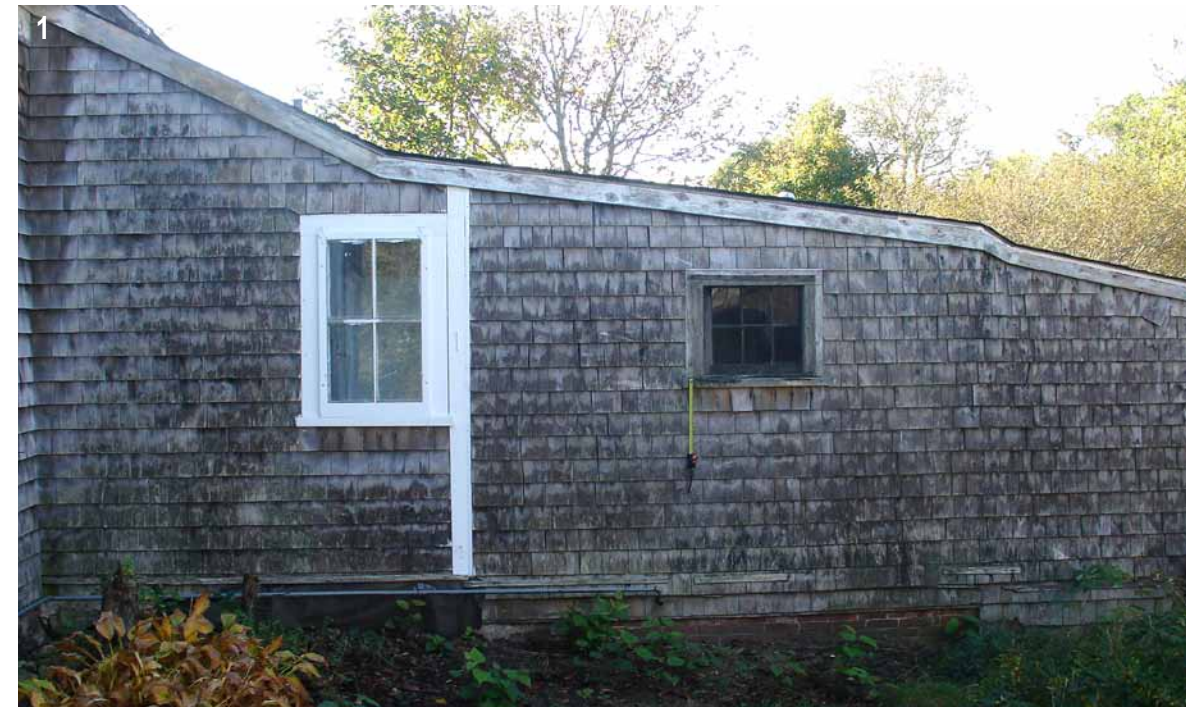
- Southwestern ell constructed at three different times.
- Moisture and weather have damaged the third part of the ell.
- Separation of second section of ell reveals horizontal planning.
- Southwest corner indicates structural failure.
- Window missing and replaced with plywood.
- Foundation consists of fieldstone, brick and cinder blocks.
- Second and third ells are in poor condition.

1. The exterior ell on the western elevation was constructed at three different times.

- Second and third section of ell will be demolished.
- Retain first section of the ell, which has the fieldstone foundation.
- Install windows in remaining ell with matching windows from the rest of the structure.
- First section of the ell should be replanked and reshingled in line with the existing exterior structure.

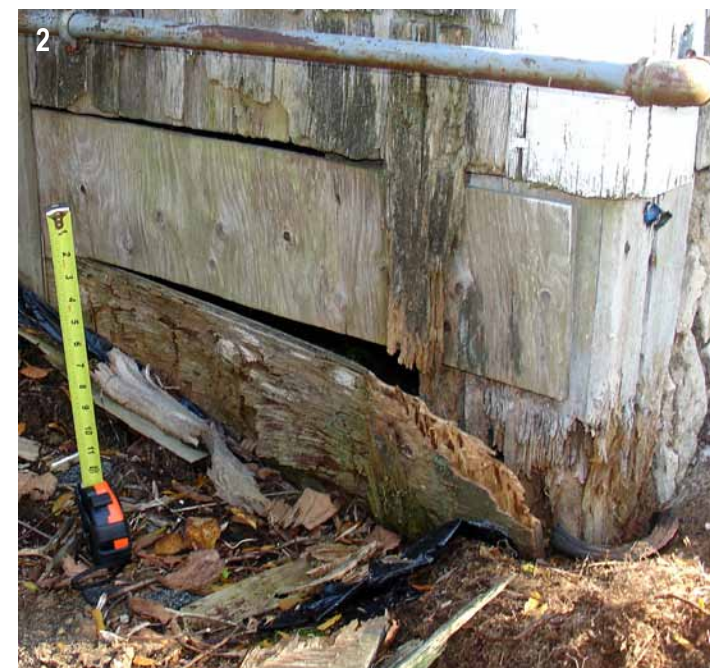
- The foundation includes round poles, roughly 10" tall and 8" in diameter, which are embedded within the walls. It is unknown how deep the poles run.
- Poles are located midway across the foundations walls and at the corners, but it is not apparent if the poles actually help support the structure.
- Currently, the sills rest unattached upon the poles.
- Foundation poles are extremely decayed.
- There is a hole approximately 10" wide from ground level to sill, located immediately below the double-hung windows in the central part of the western wall. This appears to have been made as an access path.
- The foundation has a point of failure in the southwest corner. Signs indicate that part of the foundation was removed to allow access under the new wing of the house. This hole is currently covered with rotting plywood.

2. Portions of the south west corner foundation were removed, and the hole is covered with rotting plywood.

- Program calls for a new foundation to be installed under the main structure to create a basement.
- Rubble façade should be added to replicate the original appearance.
- Replace wooden poles at corners/midpoints with concrete piers.
- Restack and recement stones.
- Fill access holes with stone/concrete that match the exterior of the structure.
- Recement and restack foundation at southeast corner.
- Construct angle iron frame with metal doors on southwest corner.

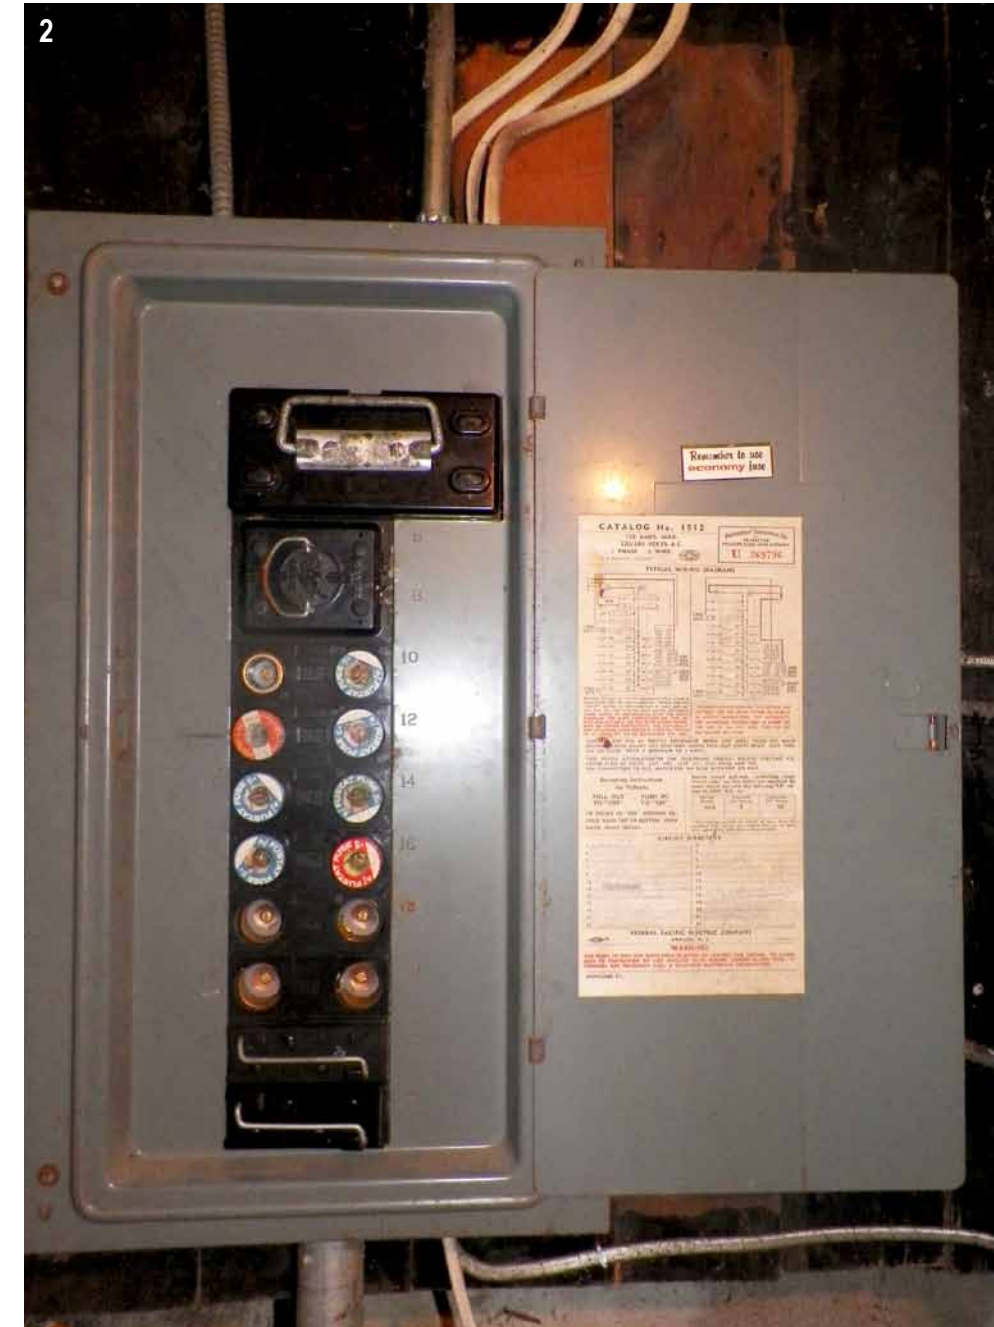
- The electrical system reflects different generations of wiring.
- The panel is a 150 amp maximum panel.
- The circuit panel is of the round glass fuse type, with large block main fuses.
- There are broken fuses in some circuit areas and fuses missing in others.
- The branch wiring is of three different vintages: cloth (possible), metal sheathed and Romex style.
- It's not possible to determine if any of the wire consists of aluminum rather than copper.

2. Electrical panel is 150 amp maximum.

- Existing fuse box should be replaced to code with a 250 amp circuit breaker pane.
- All non-code compliant wiring should be updated to meet current building codes.
- Wires should be snaked along existing channels to locations where power is to feed interior walls.

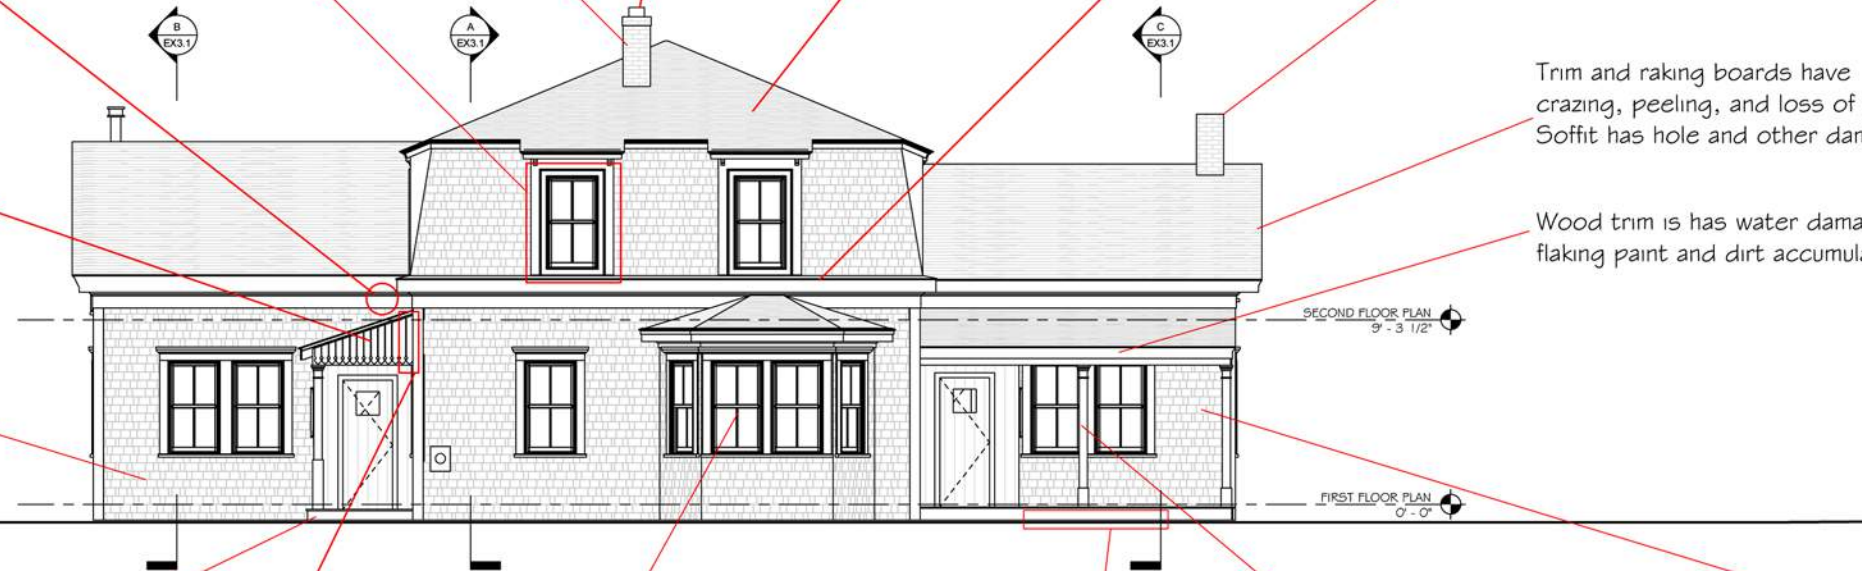
Sheet Title: EXISTING CONDITIONS EAST ELEVATION

Storm Windows have rotting frames. Many also have crack panes of glass. Not weather tight - some barely attached. Typical.

Wood band board and decking has water damage, bio. growth and is significantly decayed. Typical.

Wooden porch posts are weathered, damaged, have failing paint and separating joints. Typical.

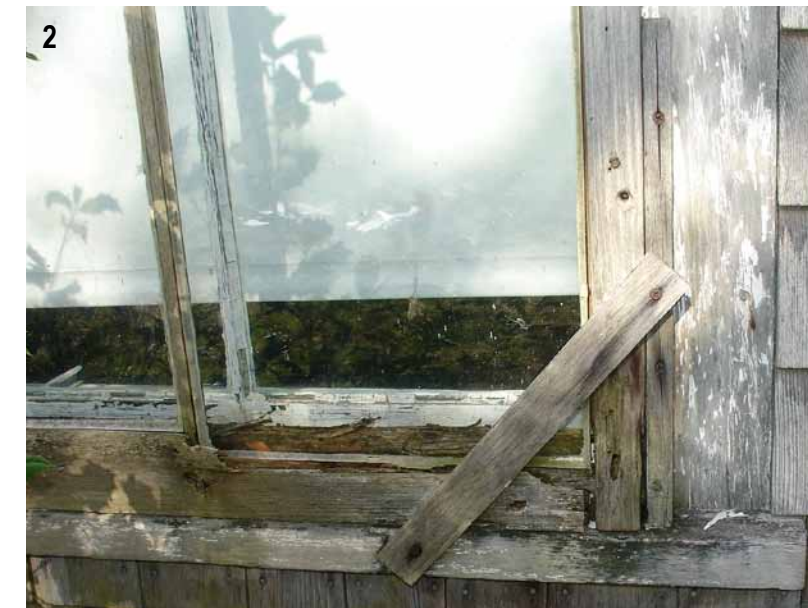
1. South porch roof needs to be reattached to main structure.

2. Wood window sashes need to be repaired.

- Reattach south porch to main structure.
- Replace porch sills with dimension lumber.
- Remove “chicken coop” entrance on east and south porch.
- Rehabilitate porch columns.
- Reattach/fabricate original porch ornamentation.
- Replace floors with similar wood planks.
- Stain/paint trim same as exterior.

- Remove and repair sashes from windows.
- Repair sashes by repining loose cross rails, meeting rails, muntins and top rails.
- Scrape and repair wood deterioration on casings.

- Reconstruct missing wood portions with epoxy filler.
- Re-glaze panes and replace glass with period glass.
- Conform to correct putty bevel.
- Reassemble sashes in jams.
- Use unobstructed wood lugs at corners of sash and jam.
- Prime and paint window sashes to match exterior trim

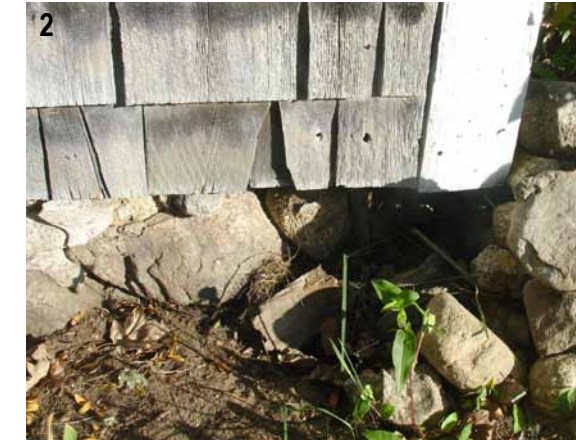
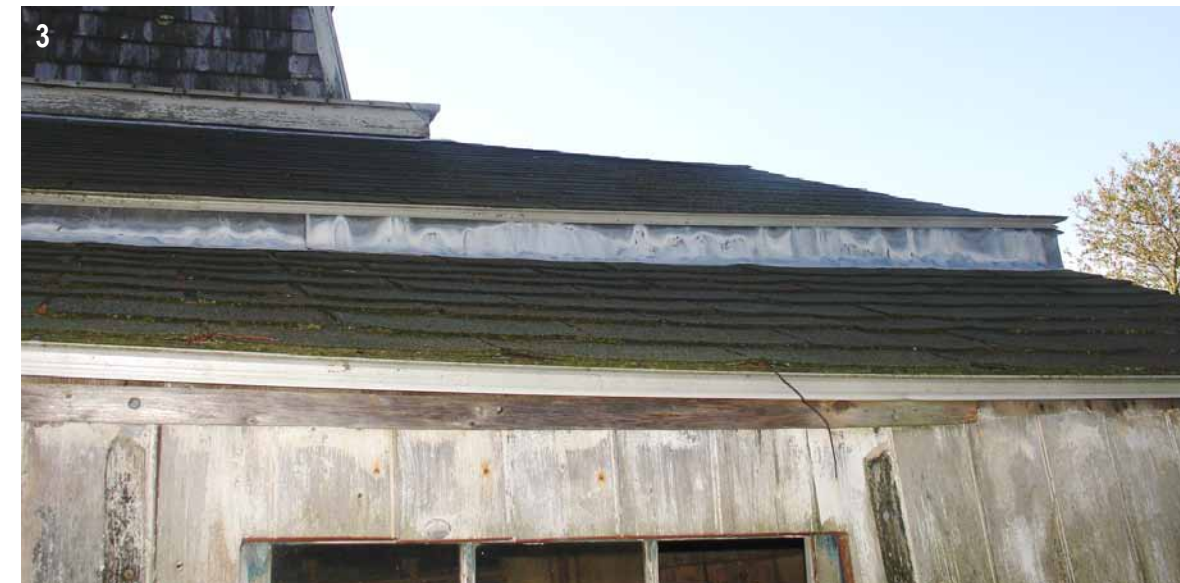
1. North chimney should be dismantled and restacked with new mortar.

2. Restack and recement foundation stones.

3. Replace some roof shingles and check the integrity of the flashing.

- Rebuild chimneys to current building code.
- New chimneys should match the 1887 profile of the property.
- Install new lead flashing.
- Dismantle north chimney to first floor, restack the bricks and installing new mortar.
- Rebuild south chimney to roofline.

- Replace cupped or curled shingles with like shingle material.
- Check security and integrity of valley flashing.
- Replace and repair damaged or loose shingle pieces.

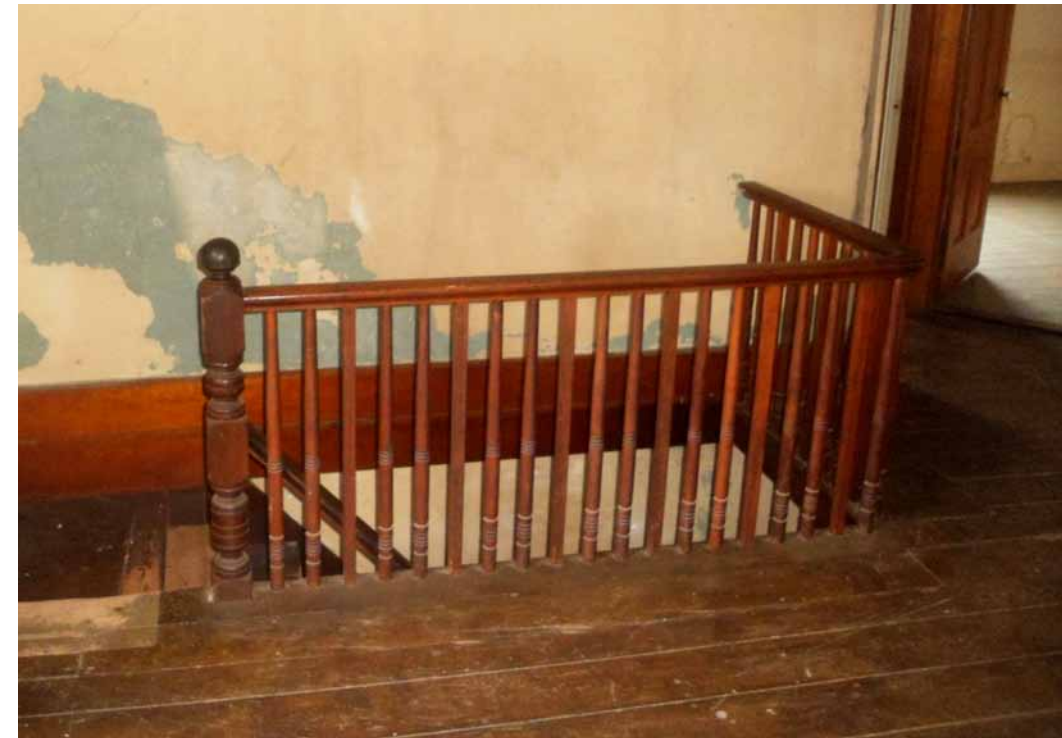
Wood floors and banisters need to be cleaned and refinished.
