St. Mary's Parish House: Reuse and Rehabilitation Feasibility Report

Reuse and Rehabilitation
Feasibility Report

Academic Partner:
School of Architecture, Art
and Historic Preservation

Community Partner:
Island Commons

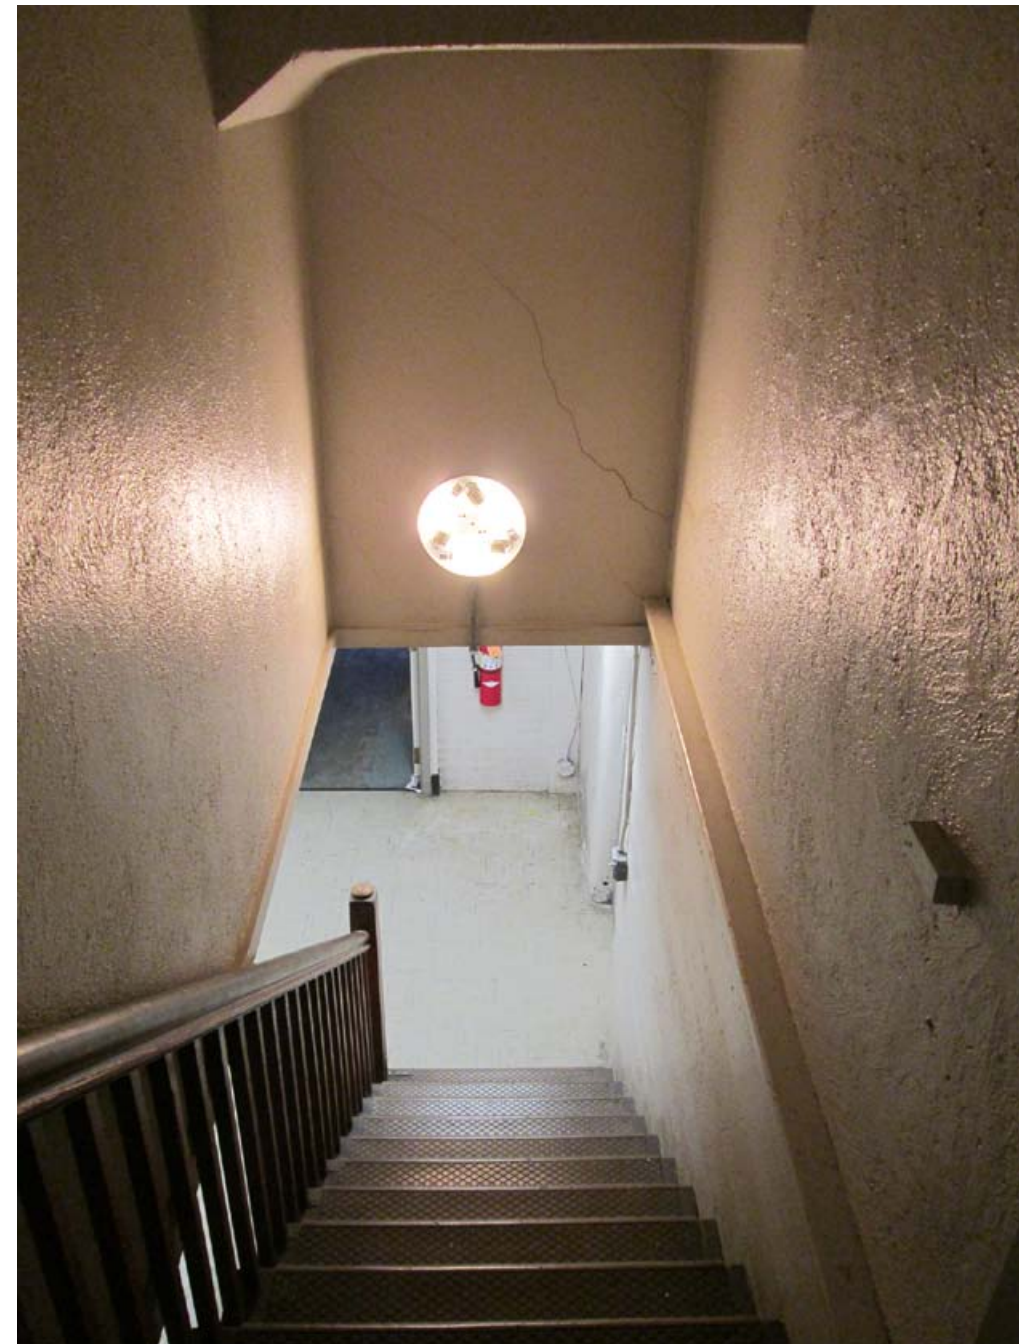
Stairs leading to the basement. Plaster walls exhibit cracking. Light fixtures will be replaced with ones that respect the building's historic character.

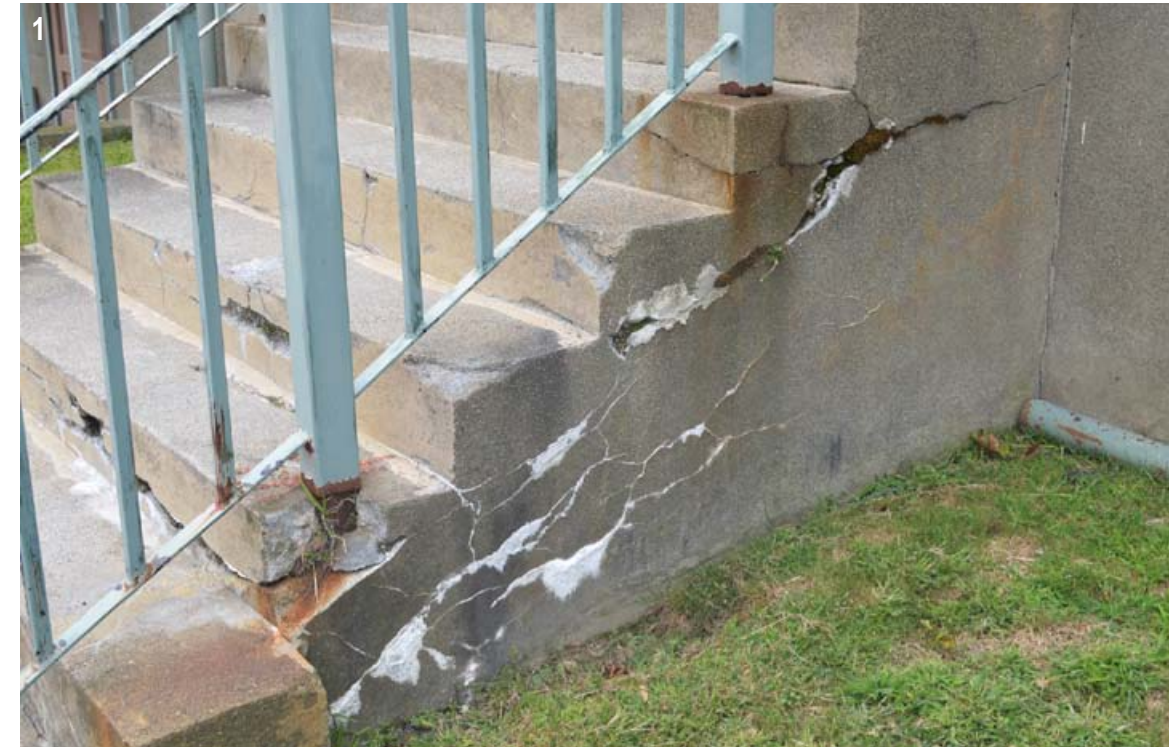
The concrete front porch stairs are in poor condition with significant cracking throughout, rust and loss of large chunks of concrete.

The painted cast iron railings on the steps to the front porch are in poor condition with a significant amount of rust and paint loss. They appear to have been added c. 1980.

1. The front stairs exhibit significant cracking and loss of concrete. The railings show rust and paint loss.

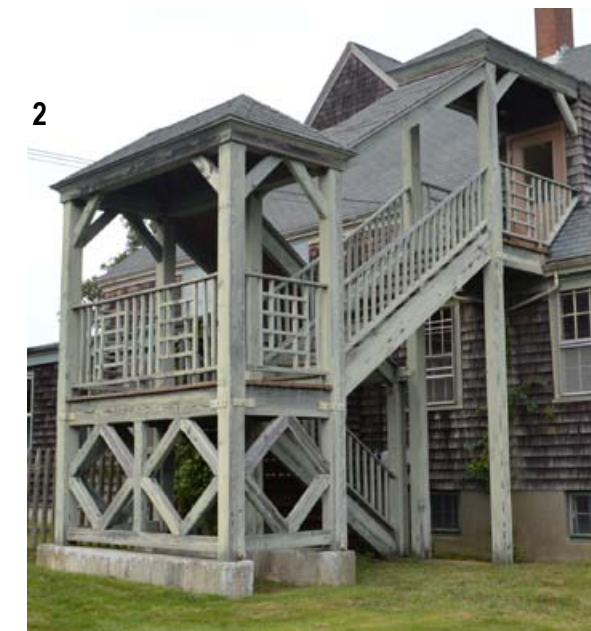
The south fire escape is in fair to poor condition. There is significant weathering of the wood, including some rot. Risers are detached from stringers, and treads are detached from risers. There is also significant paint loss.

2. The south fire escape shows wood rot, paint loss and detached risers.

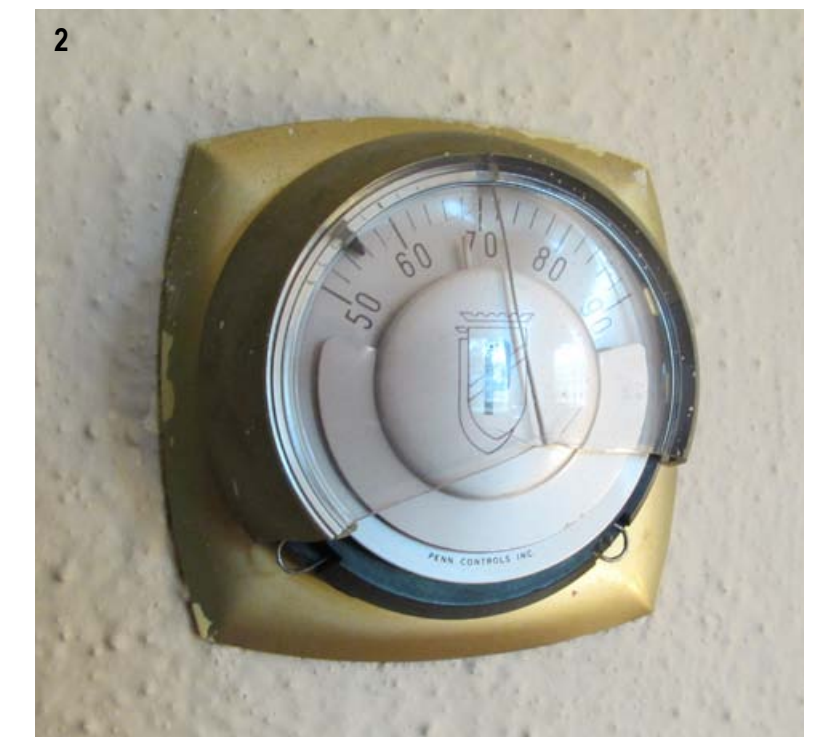
2. Broken thermostat in the upstairs northern classroom.

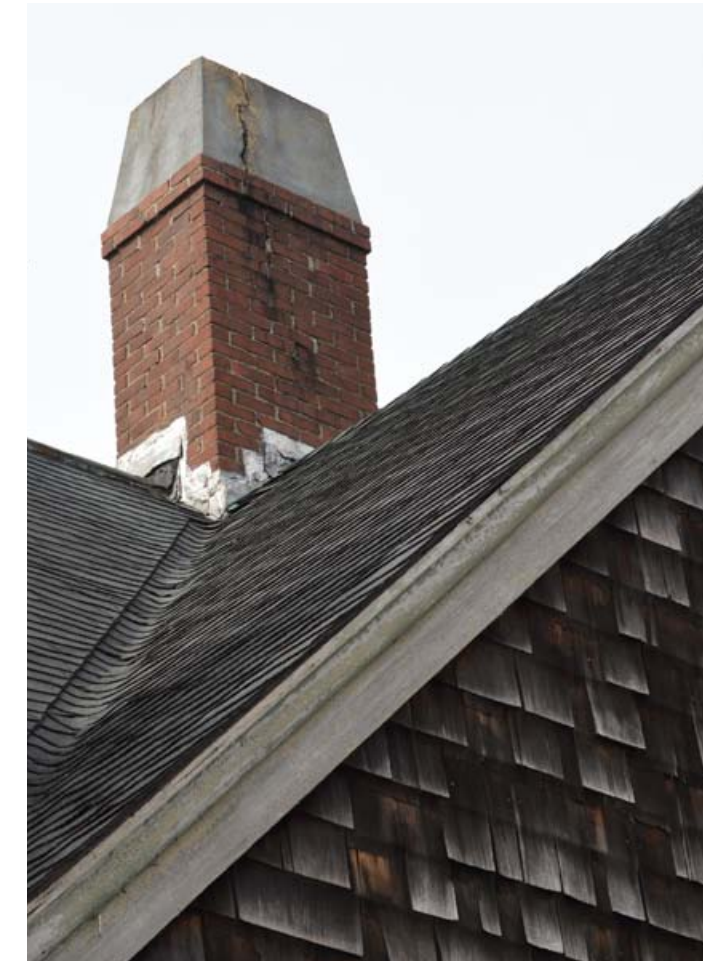
- **Problem:** The chimneys are in fair condition, showing signs of deterioration. There are loose mortar joints in both chimneys and visible cracks running down the exterior of the north chimney up into the concrete chimney cap.
- **Solution:** On the south chimney, all exterior masonry joints will be tapped with a masonry hammer to determine failing joints. Where loose, mortar will be removed down to a sound layer and repointed in kind with matching mortar and joint profiles. This should be done in accordance with NPS

To repair cracks and loose mortar joints, the north chimney will be removed and rebuilt with salvaged bricks.

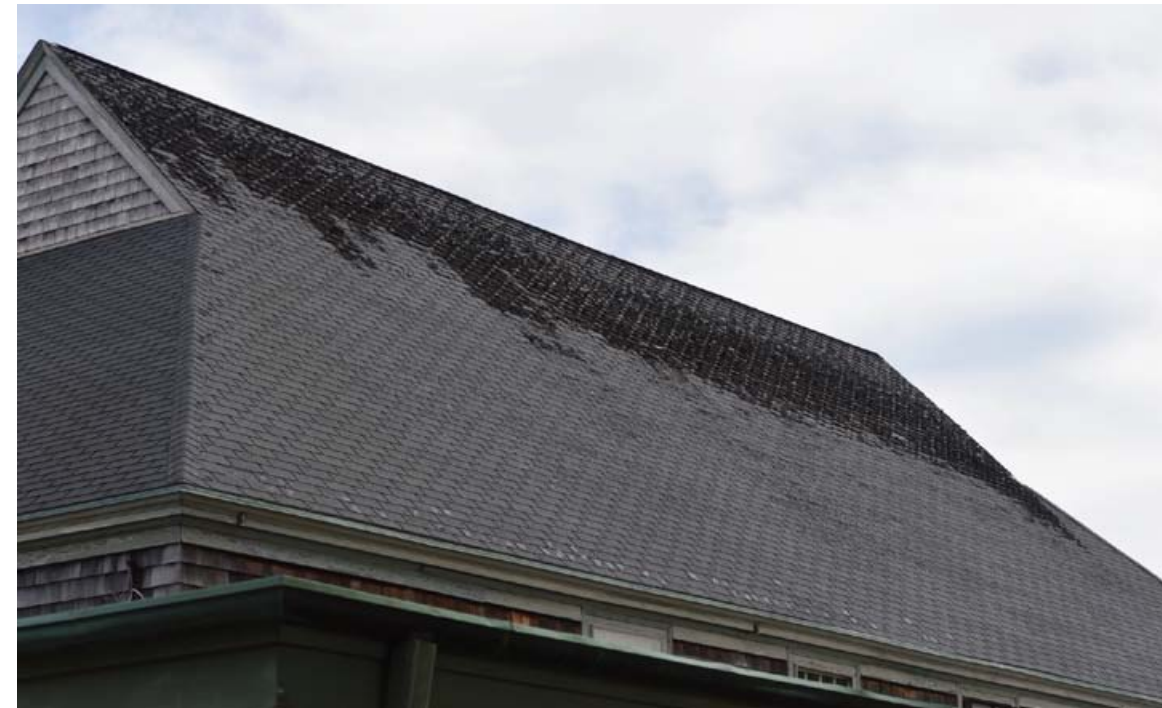
The asphalt roof on the original structure has reached the end of its useful life and exhibits critical deterioration, particularly on the west façade. The part of this roof on the east façade that is flat has limited access, but it appears to be either EPDM or tar. From aerial views on Bing Maps, it appears to be in poor condition.

The deteriorating asphalt roof needs to be replaced, potentially with red cedar shingles to achieve historic appearance.

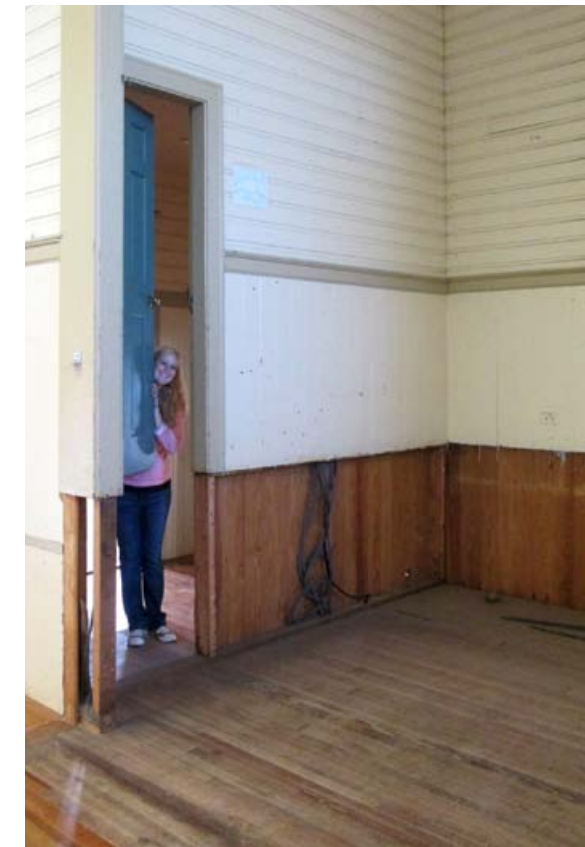
A team member peeks through one of the floating doors of the removed stage area.
