The Baptist Church in Warren: Rehabilitation and Preservation Report

Rehabilitation and Preservation Report

Community Partner:
The Baptist Church in Warren

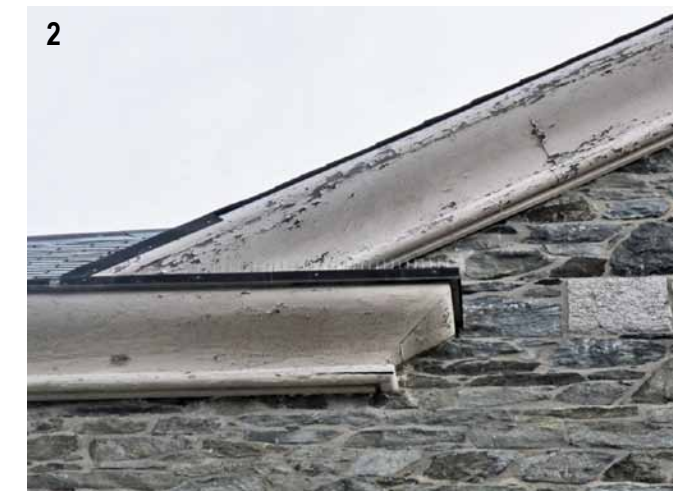
1. Drainage holes along the base of the north facade show mildew growth from water damage.

2. Paint failure on cornice.

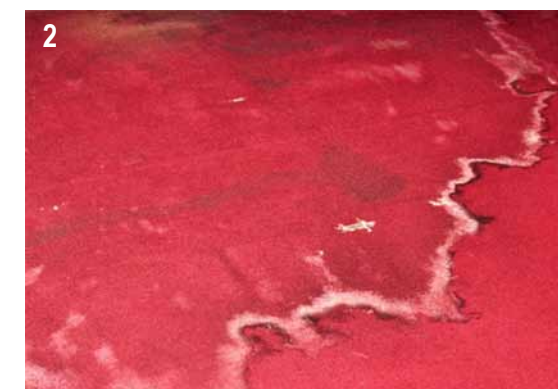
1. A pronounced view of the stained glass bowing of the doors leading into the sanctuary.
2. The carpet shows signs of water damage.

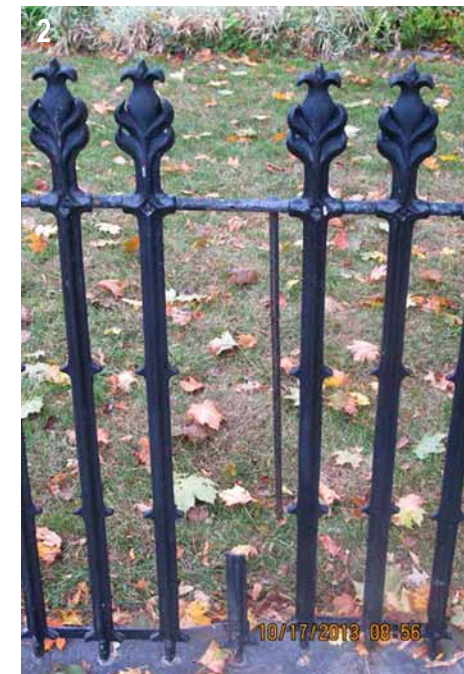
Skirting the perimeter of the church property on Main Street and Miller Street is a decorative cast iron fence. Overall the fence is in fair condition. There are broken cast iron posts and some issues with the protective finish. The granite base has shifted because of freeze/thaw cycles, which have upset the balance of the fencing.

2. Cast iron fence exhibits missing and broken posts.

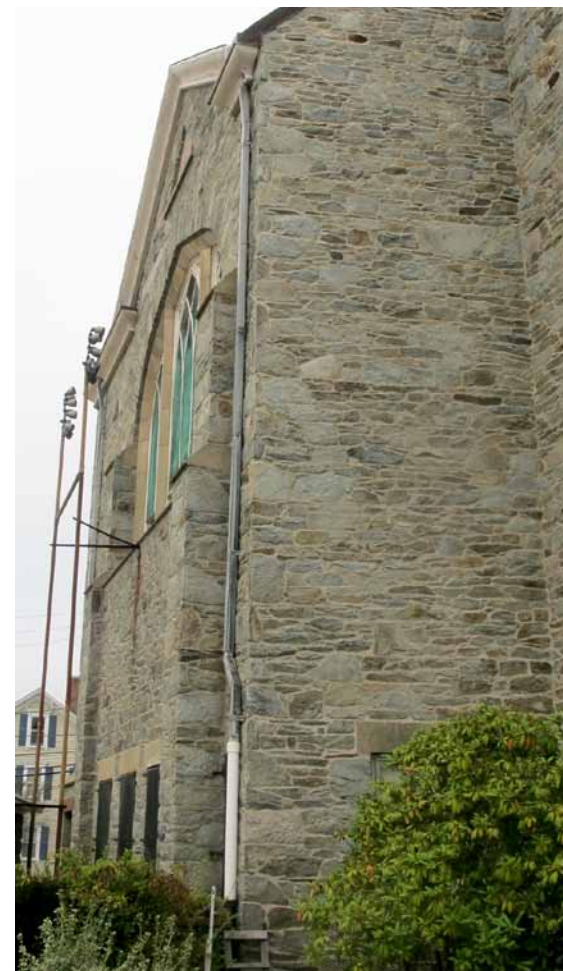
Downspout on the southeast corner of the west facade.

- 1.2.1 Mimic construction detail of current gutter system on south elevation. This may include but is not limited to the following:
- 1.2.2 Remove first five courses of slate above cornice. Remove sheathing as needed to accommodate new gutter system and repair or reinforce rafter tails.
- 1.2.3 Construct and fabricate a gutter system behind cornice detail. The structure of the gutter shall be made of wood and lined with copper.
- 1.2.4 Downspouts shall be made of copper. Drainage from downspouts shall be properly diverted into the ground and away from the building.
- 1.2.5 Acceptable installation of copper gutter system or equal: <http://www.copper.org/>

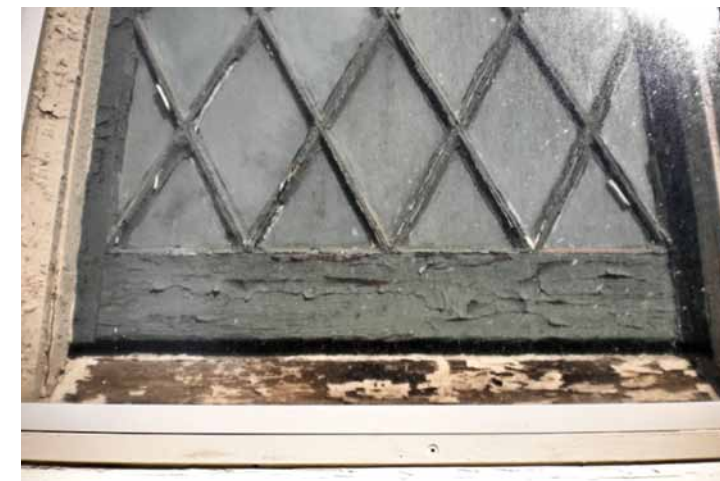
Paint failure around the windows due to moisture exposure.
