IR THERMOGRAPHY IN MOISTURE AND EARTHQUAKE DAMAGE DETECTION PERFORMED IN THE ŽIČA MONASTERY, SERBIA

Slavica RISTIĆ^{1*}, Suzana POLIĆ-RADOVANOVIĆ²

This paper presents the results of the IR thermographic diagnostics of the seismic damage inflicted upon the Žiča Monastery after the earthquake on 3rd November 2010. The Žiča Monastery founded in 13th century is located in central Serbia. The moisture content in the structure was detected too. The obtained results document the current state of the buildings and, at the same time, confirm the advantages of IR thermography as a method in the diagnosis of earthquake cracks, useful for the seismic retrofit study. The obtained results enable the identification of the structure parts where more in-depth investigations need to be concentrated. The procedures and activities for curative conservation and protection of the Žiča Monastery should include the thermographic test results. The results and the conclusions obtained in this case study could be used as example for further extensive studies of historical and cultural heritage buildings.

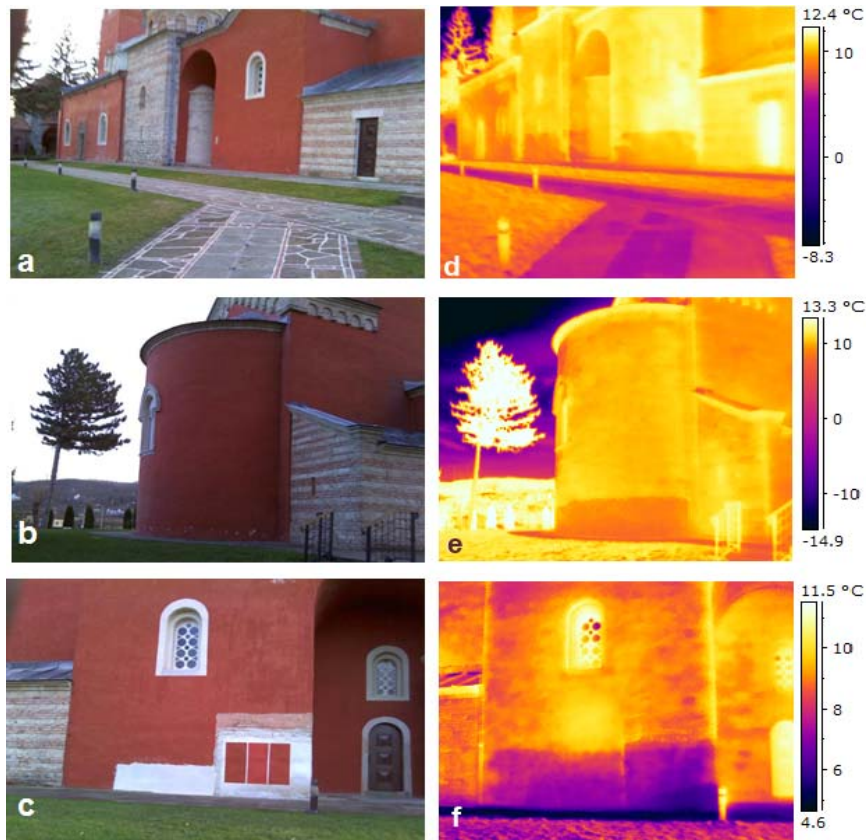
Figures 5a to 5f show some results of the church façade moisture investigation. In general, the temperature of the damp areas can be colder than the dry ones due to surface evaporation, or it can be warmer because of the higher thermal inertia of water content versus building materials. The apparent discrepancies between the two results are a consequence of different micro climatic conditions of the scanning.

The south façade of the Church of St. Savior has a visible cold zone in the lower part due to the presence of rising damp. There is no moisture in the part of the building where the red plaster is missing because of drainage (Figs. 5a and 5d). The round eastern end of the church (where the altar is) is presented by a digital photo and a thermogram (Figs. 5b and 5e). Moisture is detected up to the height of 1.5m. The north side of the monastery façade (Fig. 5c) has moisture content up to the height of 2m. The thermogram (Fig. 5f) shows the complex structure of the wall as well.

Fig. 5. Façade of the Church of St. Savior
