HISTORIC AMERICAN BUILDINGS SURVEY: INVESTIGATION AND DOCUMENTATION OF THE HALFWAY SCHOOLHOUSE IN EASTPOINTE, MICHIGAN

Whitney D. Gravelle
Final Project, GHPR 690
Eastern Michigan University
Geography & Geology Department
Historic Preservation Program
Winter Term 2015

ERIN-WARREN FRACTIONAL DISTRICT No. 2 SCHOOLHOUSE HABS No. MI-449
(Halfway Schoolhouse)

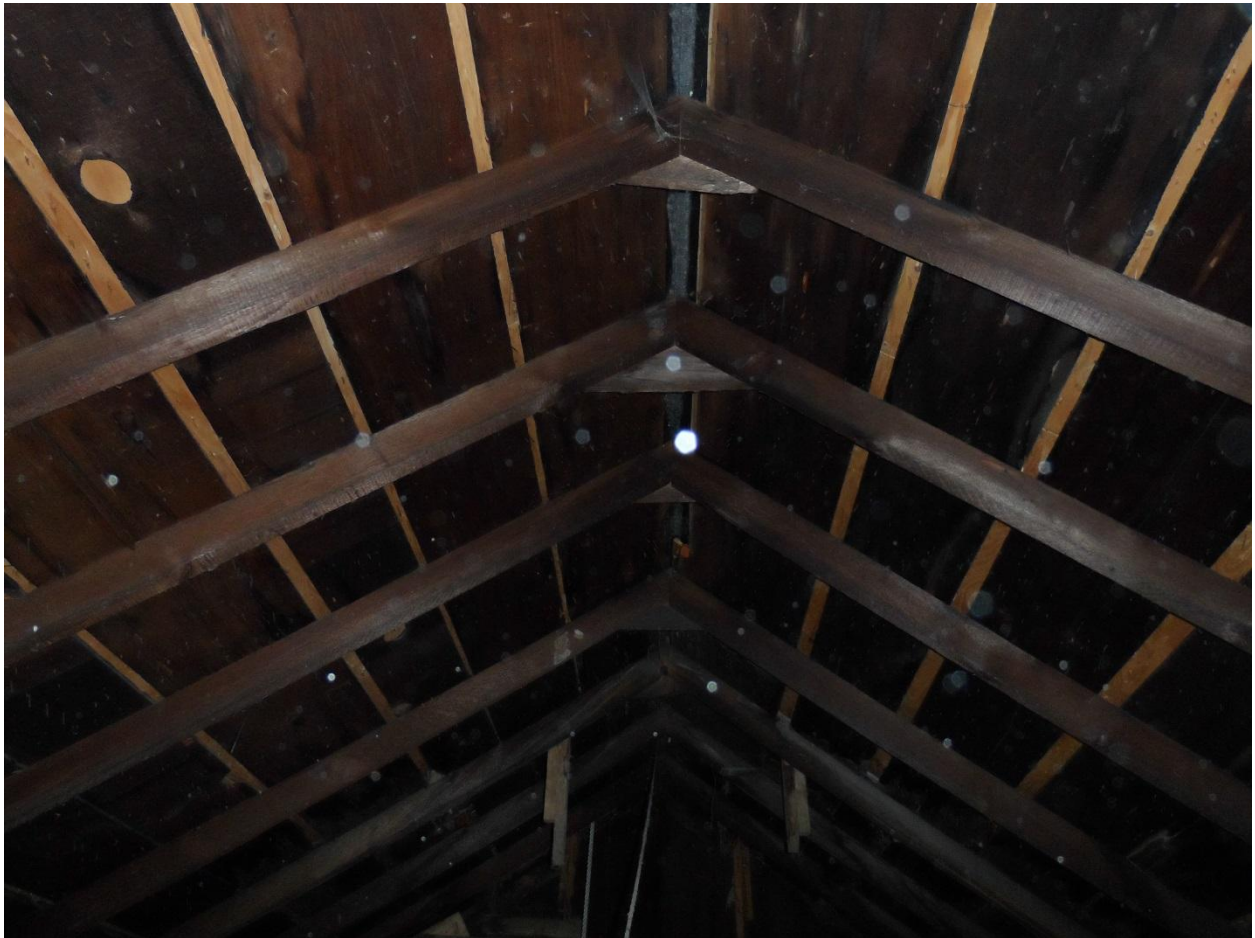
Figure 21. Roof sheathing and rafters. Wood gusset plates contribute additional support at the connection between the rafters. *Chris Gravelle, photographer, 2015.*

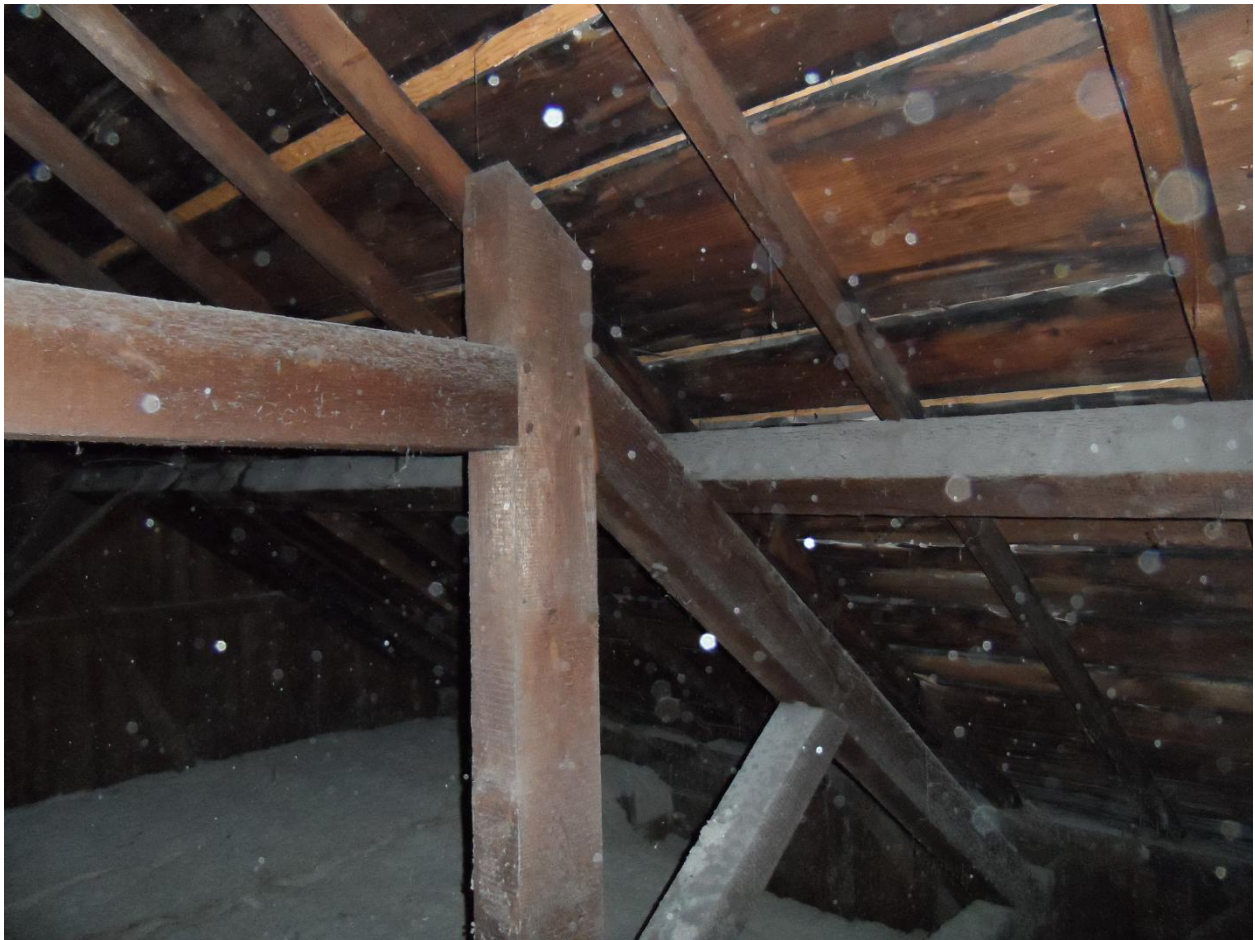
Figure 22. Detail of Queen Post truss. The trusses are designed using mortise and tenon joinery in which wood pegs are driven into the tenon to secure the connection (as seen on the top of the post).
Chris Gravelle, photographer, 2015.

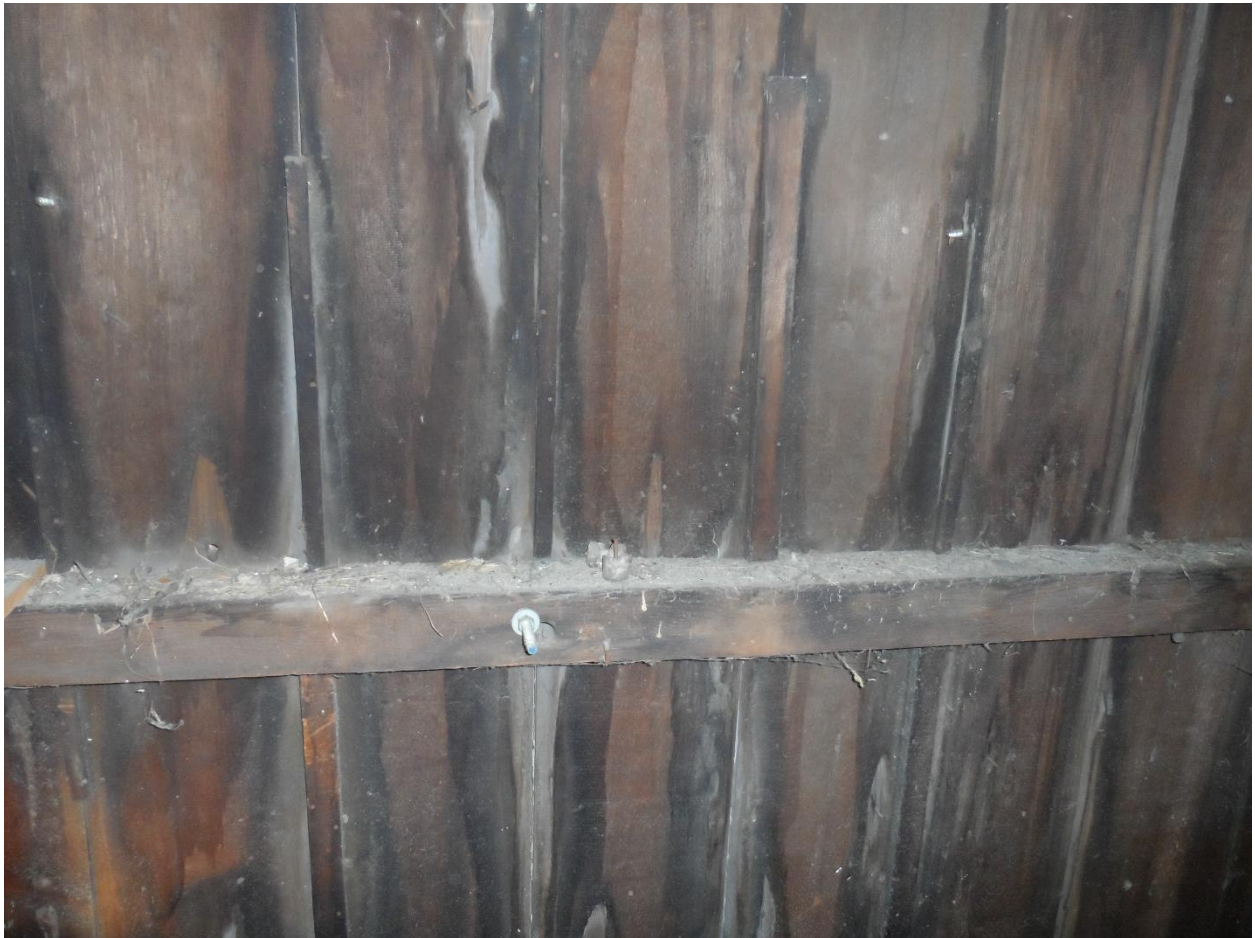
Figure 23. Original board and batten siding, as seen from the interior of the attic. *Chris Gravelle, photographer, 2015.*

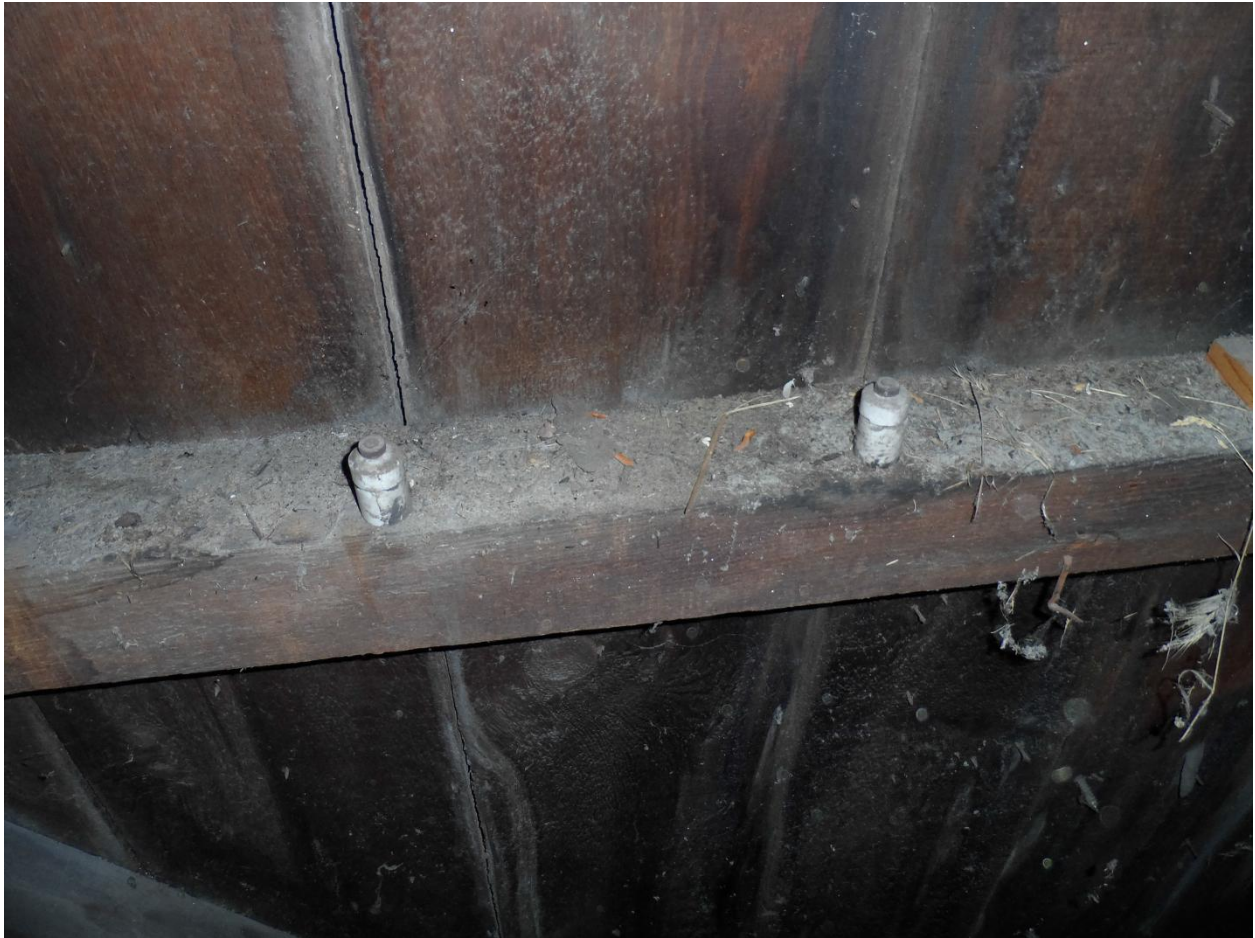
Figure 24. Remnants of the original knob and tube wiring in the attic. Electrification of the schoolhouse was completed in 1915. *Chris Gravelle, photographer, 2015.*
