# Tunnelling and Underground Space Technology

## Repairing a shield tunnel damaged by secondary grouting

This paper reports on a repair work which has recently been conducted for a metro tunnel in Hefei city, China. The tunnel has been originally constructed using shield method where synchronous grouting was used to fill the gaps between the tunnel segments and soil. Following a regular maintenance inspection of the tunnel, several leakage issues were identified between three stations. Secondary grouting was adopted as a solution to block the tunnel leakage, however, shortly after the start of grouting work, the track and track bed were found to be unevenly uplifted with significant cracks in the tunnel's segments. The paper describes and discusses key aspects of this case study including ground conditions, leakages patterns of the tunnel, recorded volumes and injection pressure of the secondary grouting, as well as survey data of track displacement and segment cracks. The investigation confirmed that the situation was caused by an inappropriate implementation of the secondary grouting, particularly by high grouting pressure (significantly higher than the geostatic pressure), lar

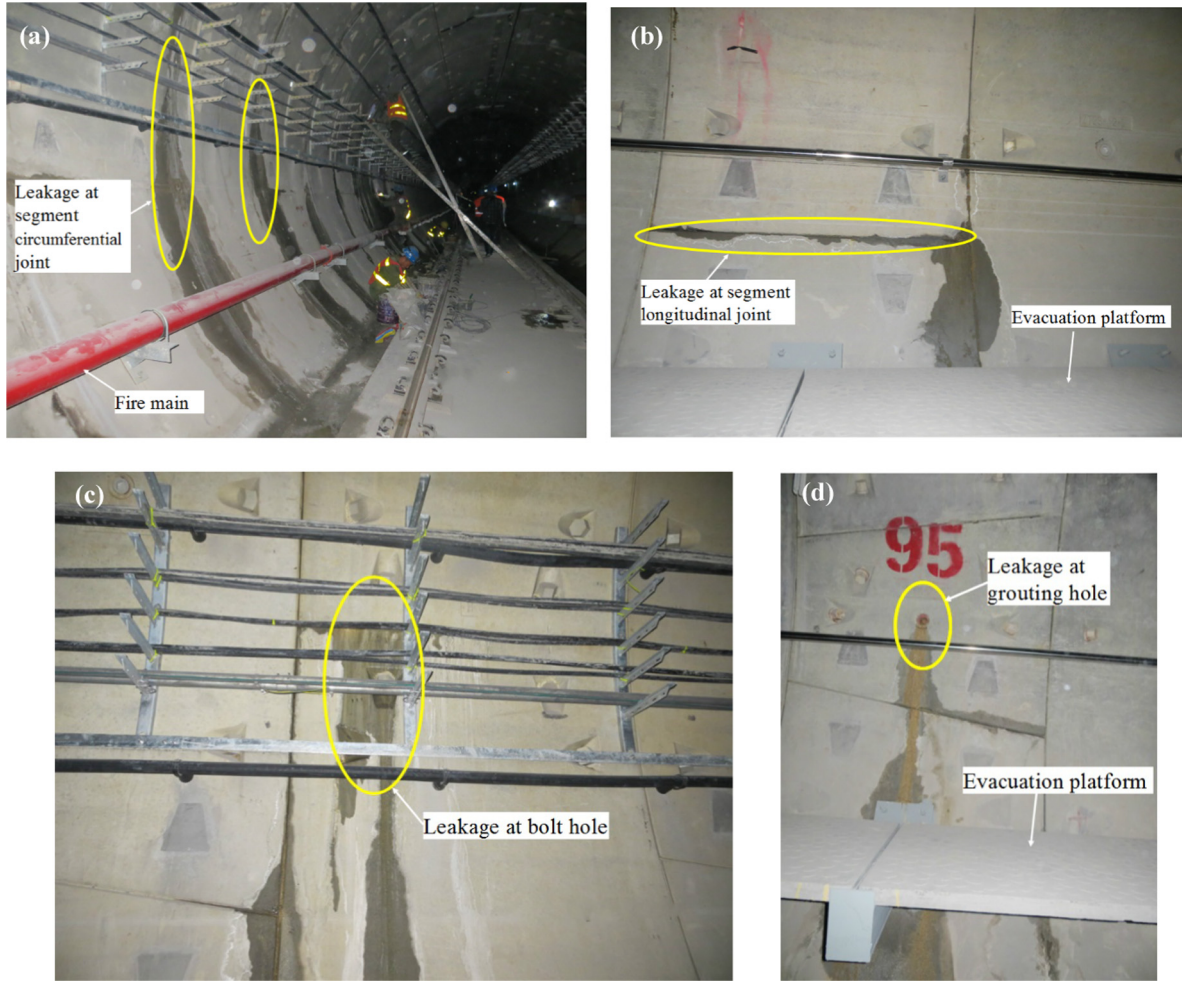
**Fig. 5.** Typical leakages found in the tunnel: (a) Leakage at circumferential joints of segments, (b) Leakage at a longitudinal joint of segments, (c) Leakage at a bolt hole, (d) Leakage at a grouting hole.

Although it has been reported that the contractor carried out the works according to best practice, there were obvious leakages at segments' joints and bolt holes (Fig. 5), which do not meet the design requirements mentioned above. The initial assessment indicated that perched groundwater had leaked through weak points created by several factors, including (i) dislocation between segments, which reduces the effective area of rubber seal between segments; (ii) fragmentation of segments caused by collision during transporting or assembling, resulting in poor installation of waterstop; (iii) sediment or slurry trapped between segment and waterstop, (iv) bolts between segments not installed tightly, (v) loose plugging of the grouting hole.

The treatment of leaking segments (see Fig. 5) used different strategies depending on the location of the leakage:

- (1) Leakage at segments' joints

Although leakage emerged at segments' joints, the post-failure investigation revealed that the rubber waterstops within them were only partially damaged and capable of providing an adequate water sealing. Therefore, the rubber waterstops were not disturbed any further during the leakage treatment. This was achieved by installing injection needles at the leakage sites and carefully injecting polyurethane material. The method was implemented in five steps:

- a. Removing and cleaning the mud or dirt from the segment joints with a wire brush.
  - b. Installing injection needles at leakage sites in the segments' joints, with a depth of 20 cm and a spacing of 30 cm.
  - c. Pointing the joints at the leakage sites with quick-setting cement slurry.
  - d. Injecting polyurethane into the leakage sites through injection needles with an injection pressure of 1.0–0.2 MPa. If there was still leakage at the joints after two hours of the injection, polyurethane was injected again until seepage stopped.
  - e. Removing the injection needles and cleaning any slurry covering the segment surface. A decoration treatment was also conducted at the joints for an improved finish if necessary.
- (2) Leakage at grouting holes

When the amount of leakage at a grouting hole was minimal, the hole was cleaned first and then filled with fast hardening micro expansive cement, and then plugged tightly. If there was still leakage after the treatment, a hole was drilled on the plug, and an injection needle was installed in the drilling hole, and polyurethane was injected through the needle until the leakage stopped. For grouting holes with significant leakage, binary slurry mixed with cement and soluble silicate was injected through the valve installed in the grouting hole.
- (3) Leakage at bolt holes

The leakage at a bolt hole is usually caused by leakage from the neighbouring segment joints thus treatment should also consider the neighbouring joints. Therefore, both ends of any bolt hole identified with leakage problem were filled with fast hardening micro expansive cement firstly, and then polyurethane was injected into the segment joints at the middle of the two corresponding bolt holes. The leakage stopped when the bolt holes were filled with polyurethane.
- (4) Leakage at cracked edges of segments

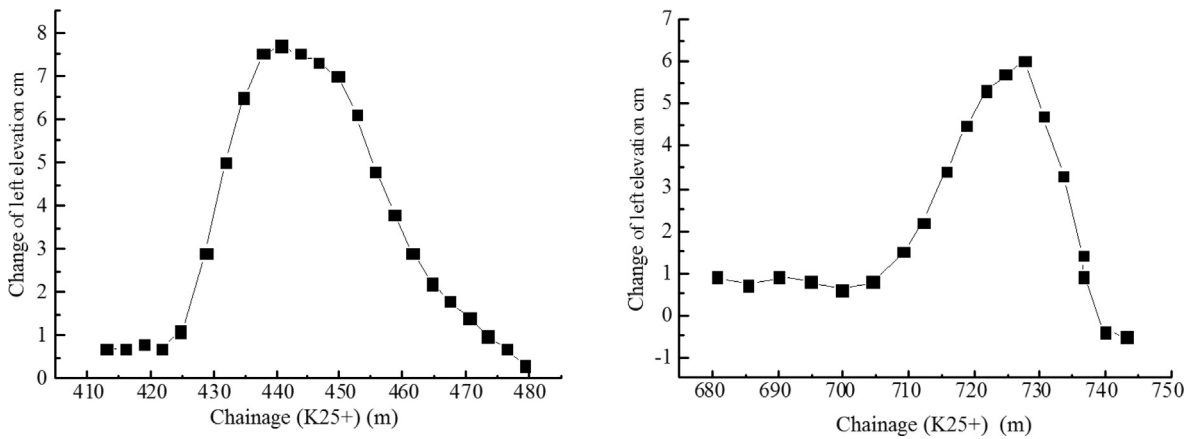
The change of track’s elevation at two positions is shown in Fig. 6. There is obviously uplift of the track following the implementation of the secondary grouting, with a maximum value of 7.7 cm. The uplift elevation is different at different positions of the track, for examples at

Fig. 6. Typical elevation change of track.

the position K25 + 440 m (i.e. distance to reference point is 25 km and 440 m) and K25 + 725 m the elevation uplift reaches its local peak value, but the corresponding value adjacent to these positions is small (about 1.3 cm). This indicates that differential uplift of segments happened during the secondary grouting.

As mentioned above, different degrees of uplift of track and track bed occurred due to the application of secondary grouting, causing changes in the slope of the track such that it did not meet the design requirements. Repairing of the track in the affected areas was thus required. The elevation of track could be adjusted through changing the thickness of track backing plate within an adjustment range of between 4 and 20 mm. The adjustment approach was adopted for most of the affected areas. However, the uplift of the track reached a maximum value of 88 mm, which is outside the range of adjustment that can be possibly achieved. When the elevation of track goes beyond the possible adjustment range, the original track bed can not be used anymore. For these areas, the track bed was rebuilt to accommodate the required track elevation and to ensure a firm connection between track and track bed.

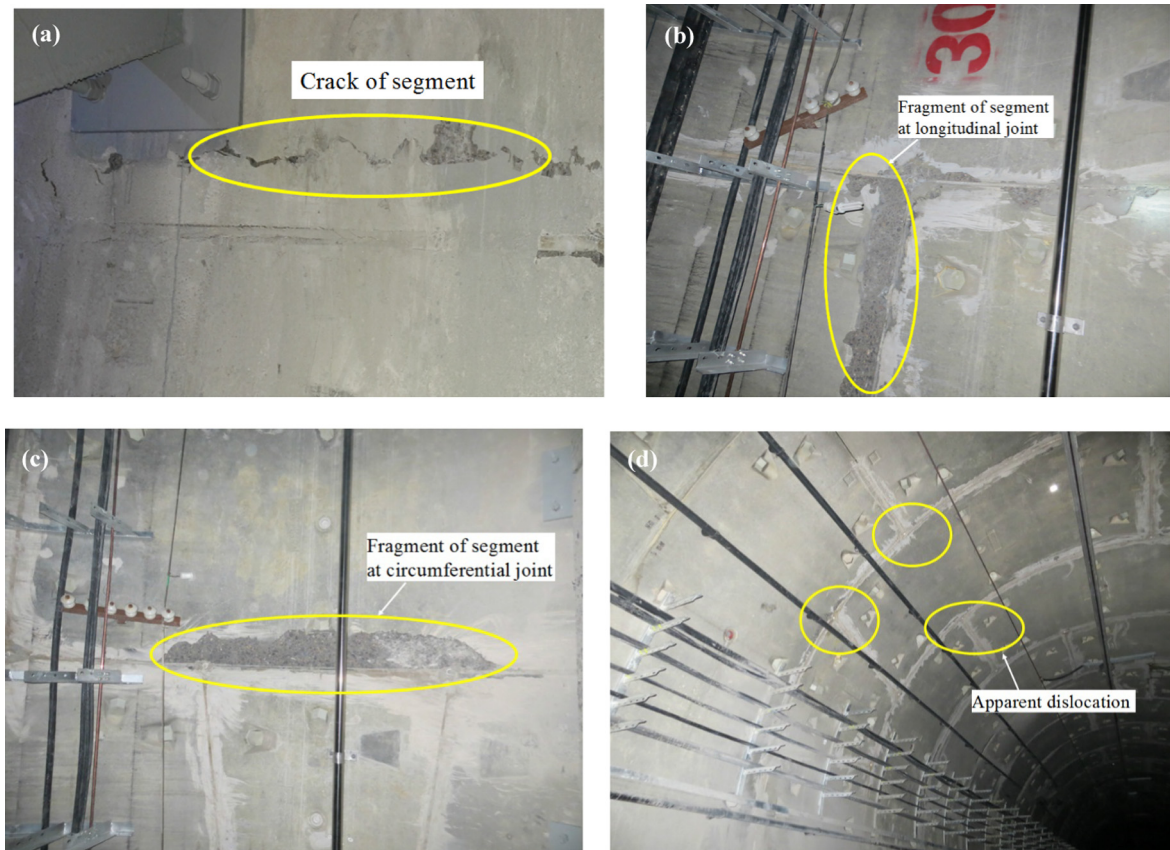
The differential uplift with the segments produced different modes of structural problem, such as cracks, fragments and dislocation, as shown in Fig. 7.

Fig. 7. Typical structural problems observed within the tunnel segments following the application of secondary grouting: (a) Crack within a segment, (b) Fragment of segment at a longitudinal joint, (c) Fragment of segment at a circumferential joint, (d) Apparent dislocation between segments.

In summary, the observed damages in the tunnel are most likely due to improper application of the secondary grouting, which is mainly caused by poor selection of the injection pressure, volume and locations. Following this investigation, the next challenge was to assess the state of segments to inform the planning of the repair work.

Repair strategies of cracks generated in the segments (see Fig. 7)

- (1) Defective segments above the centre line of the tunnel were not repaired, based on the experience of high-speed railway tunnels in China. Instead, the rupture surface of segments was cleaned and protected with concrete anticorrosive paint and, if exposed, the reinforcing bars were sprayed with anti-rust paint.

- (2) Segments below the centre line of the tunnel, with crack depths greater than 5 cm or crack areas larger than 20 cm<sup>2</sup>, were repaired as follow:

- b. A reinforcement bar (with a planted depth no less than 100 mm and the same specifications as the original bar in the segment) was planted at the crack area before repairing. A hole for reinforcing the bar was installed with an electric drill, and the reinforcing bar was fixed with chemical adhesive. The spacing of this chemical rebar-planting was about 80–100 mm. Transverse reinforcement was added and welded securely with a planting reinforcing bar when the cracked concrete area of the segment was found very big. No expansion bolts were used because these bolts might open up the subsequent repaired concrete and crack it.

- c. The concrete that had broken loose from the segment was removed completely with a steel chisel and hammer, after planting the reinforcing bar. Following the removal, a concrete interface treatment agent with a suitable viscosity was painted on the broken concrete surface. Before the solidification of the interfacial treatment agent, the broken concrete surface was repaired with layers of high strength concrete, each layer with a thickness of no more than 20 mm and a time interval of 5–6 h.

- (3) Those segments below the centre line of the tunnel, with crack depths of less than 5 cm and crack areas of less than 20 cm<sup>2</sup>, were repaired as follows:

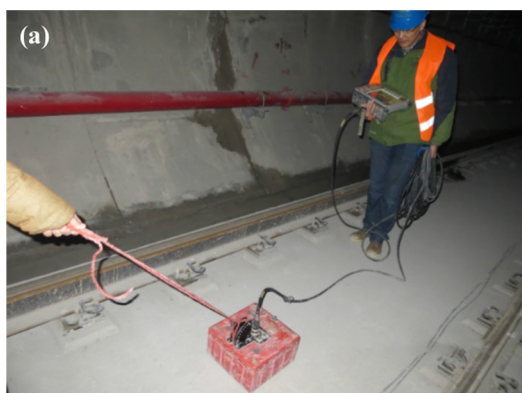
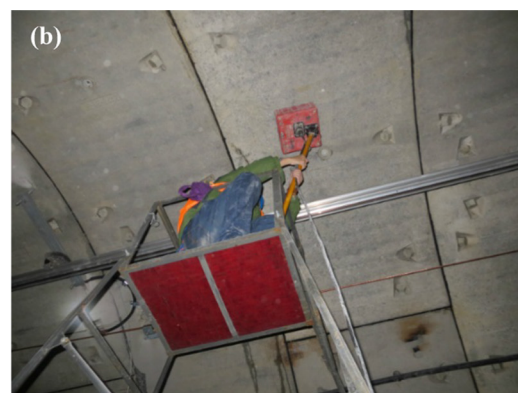
An SIR-3000 GPR, produced by Rauray Ltd with 400 MHz antenna, was used (Fig. 8) to scan both the floor (track bed) and the roof in the following zones: (i) The secondary grouting zones where uplift or uplift slope reached its maximal value, (ii) The transition zones between areas with and without secondary grouting as these zones were the most likely to experience disturbance due to secondary grouting.

Fig. 8. Photos showing the GPR scanning of the tunnel: (a) Scanning of tunnel floor, (b) Scanning of tunnel roof.

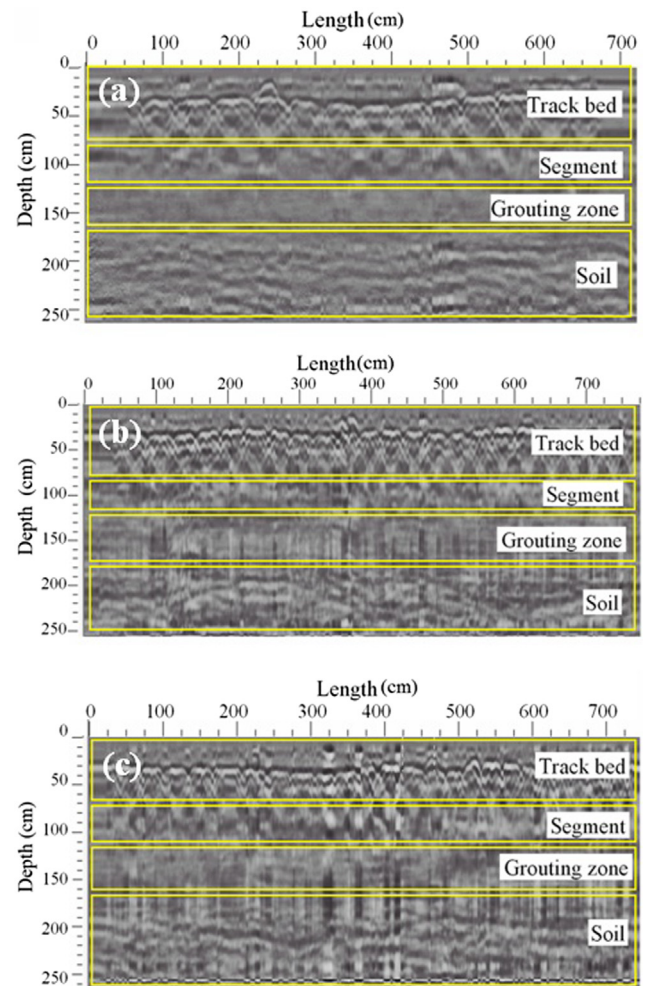
The interpretation of GPR results is shown in Fig. 9. The maximal thickness of the track bed is about 80 cm, and the thickness of a segment is 30 cm. The figure also shows the grouting zones around the segments, including previous synchronous grouting and later secondary grouting, with a thickness of 20–40 cm. The fold wave shown in the track bed is the reflected wave of the reinforcing bar. Analysis of the GPR detection signal identified no voids under the track bed or above the roof within the scanned zones.

Fig. 9. Interpretation of GPR scanning: (a) Typical section at the maximal uplift are, (b) Typical section at the maximal uplift slope area, (c) Typical section at the area without secondary grouting.

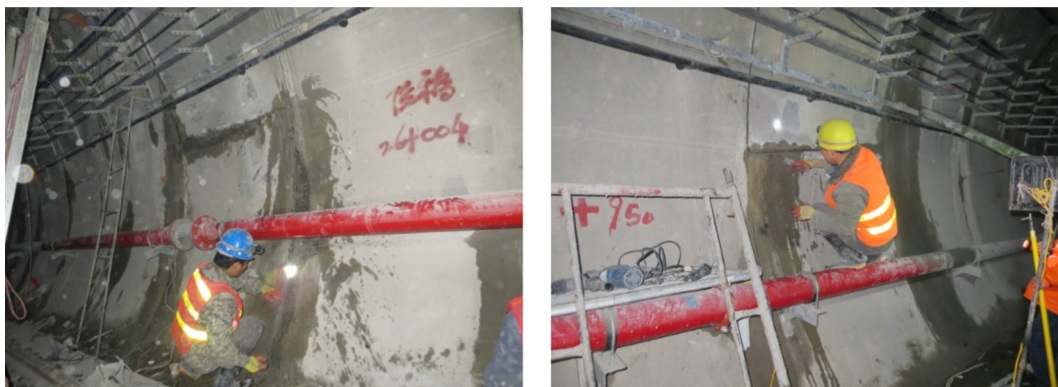
Fig. 10. Photos showing some the works of leakage treatment.

Fig. 10 shows photos taken during the leakage treatment carried out for the tunnel. It was very important during this work to avoid damaging the rubber waterstops in the segments' joints by drilling or other intrusive operations. It was also important to monitor the injected volume of polyurethane and check for any sign of spillage so that appropriate action could be taken. For instance, during the work on one of the treated segments, work had to be stopped after about 5 min of polyurethane injection as the volume of the injected slurry was insignificant but spilled out of the joints. In this situation, the work was not restarted until the situation had been adequately inspected. It was also important to monitor the value of the pressure gauge carefully and ensure it was within the selected range during the polyurethane's injection. All the connections of machine, equipment, pipe and connector were firmly fixed to prevent blasting during operations. In addition, because polyurethane is a solvent and combustible, good ventilation and avoidance of exposure to fire sources during its application were maintained.
