# The Reveal: A Technical Study and Conservation Treatment of an Overpaint Portrait

**The Reveal: A Technical Study and Conservation Treatment of an  
Overpainted Portrait**

*CNS 695 Master's Project*

Camille Ferrer

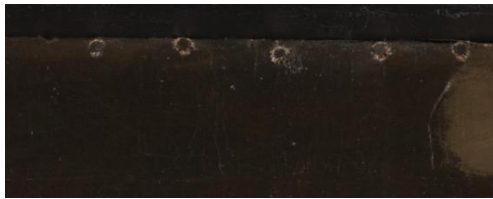
Figure 4: Close-up of tacks on painting surface. Before Treatment.

The artwork is on a white primed, unlined canvas tacked to a wooden stretcher. The tacks were placed on top of the canvas instead

of the tacking edges (Figure 4). Holes on the canvas edges suggest that the tacks were previously on the sides (Figure 7), but then later tacked on top. Additionally, the tacks present were not the original due to having a different size than the holes on the tacking edges. Overpaint was present overtop of the tacks, coinciding with the copious amounts of overpaint on the painting.

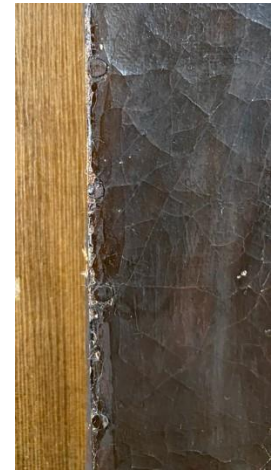
Figure 5: Close-up of tacks on painting surface. Before Treatment.

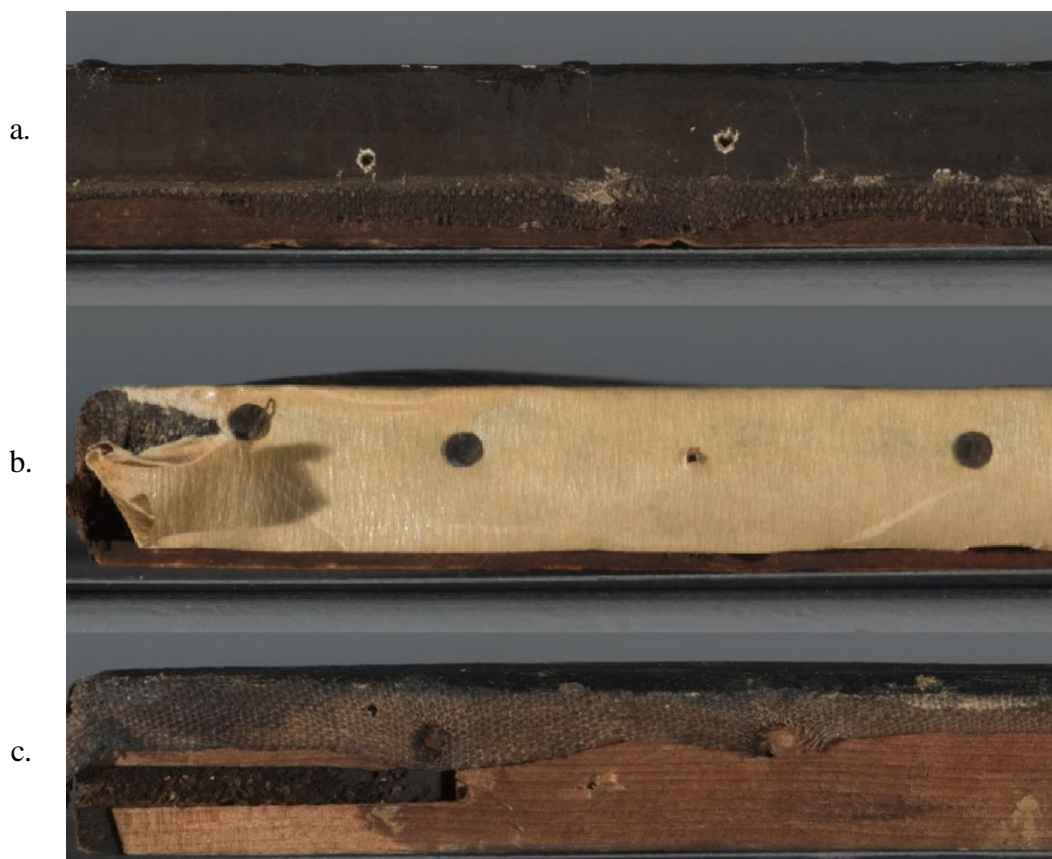
The stretcher consists of four wooden members with a Mortise with double miter and keys joints as depicted in Figure 6. (Katlan, 1992). There are 5 out of 8 keys present. The stretcher appears to be in structurally sound condition with scratches and abrasions throughout. “Woman X \*checkmark\*” is written in graphite on the bottom member. The stretcher was not believed to be the original due to multiple factors. Among them was the tacking edges being too thin on two sides (top and bottom) to properly be tacked (Figure 7c). Also, the paint seemed to extend

on the thicker tacking edges (Figure 7a). Lastly, there were some holes on the stretcher that don’t match where the original tacking should have been located. It appeared that the painting was moved to a different stretcher and tacked on top since it did not have enough of a tacking margin to tack on the other two edges.

Figure 7: Before Treatment. a. Left tacking margin with extended paint. b. Right tacking margin with masking tape. c. Bottom tacking margin with selvedge edge and original tacking holes. Upper tacking margin not included due to similarity to bottom tacking edge.

The tape on the tacking edge was mechanically removed with a spatula and scalpel. The tacks and stretcher were removed. The tacking edges were humidified with a dampen blotter and left under weights overnight to gently flatten them and allow the attachment of a temporary working stretcher. The previous tear repair patches were mechanically removed. The adhesive used for the previous tear repair resulted to be water soluble. To reduce the exposure of moisture to the painting, Gellan gum gel was used to soften the adhesive to then be removed using a scalpel. A temporary edge lining was attached to the canvas using Hollytex and Beva film. Afterwards, the artwork was attached to a temporary stretcher.

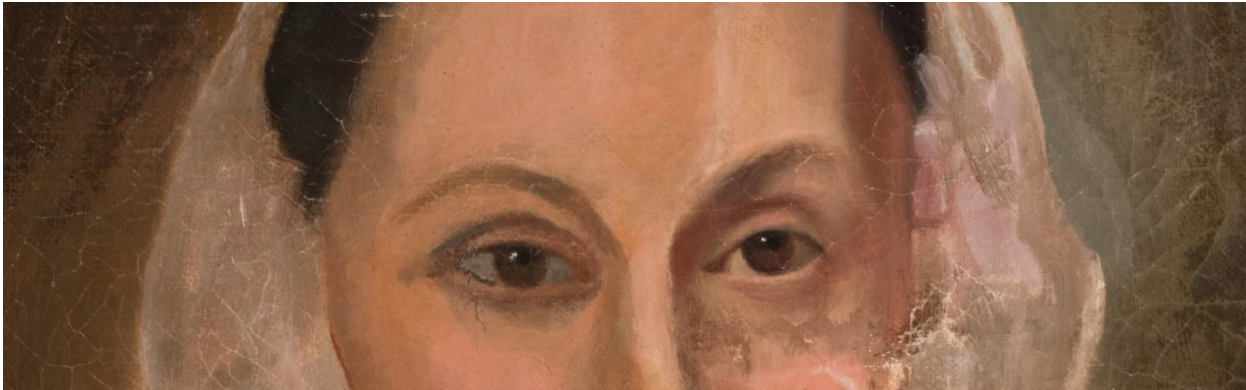
Figure 8: Before Treatment. Detail of figure's eyes and previous cleaning test on the sitter's proper left eye.

The paint layers were thinly applied oil paint with little to no impasto. Drying cracks, common to aging, were spread throughout. There was loss of pigment on the thumb and index finger (bottom-center of the painting) and on the edge of her right eye (observer's left) where the two tears were present. A diagonal crease was found on the upper right corner and a curved crease was seen on her left shoulder. Insect secretions were found on her hand. There were areas with slight lifted/flaking paint, especially on the upper right corner. There were evidence of overpaint almost all over the original paint layer. Large amounts can be found on her face (as seen on left side of Figure 8), and most of the dark background. The uneven sheen and layer of dirt and grime throughout the artwork, make it hard to distinguish other potential areas of overpaint. There is a possibility of multiple paint loss underneath the overpaint.

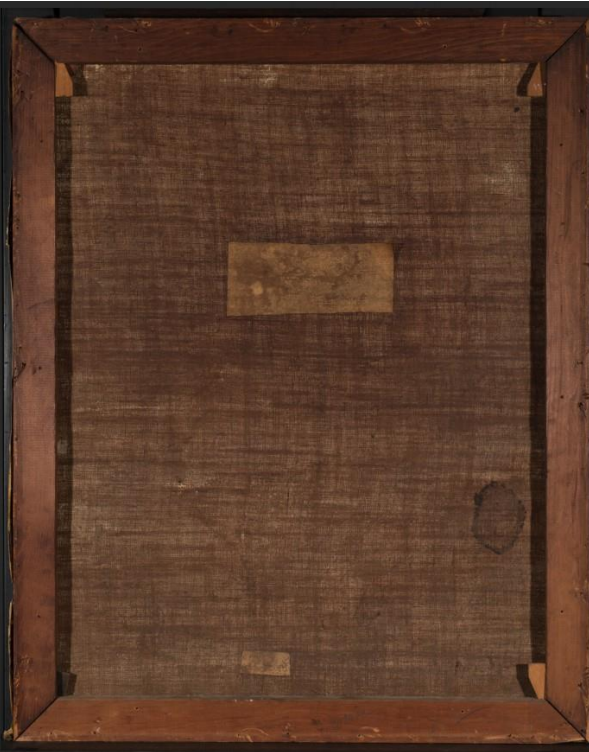
Figure 12: Before Treatment. Reverse. Two tear-repair patches from previous treatment.

In normal illumination, the painting condition was captured as we see it (Figure 9-12). The four tested areas done by previous conservators were identified. Without the frame, the masking tape on the right and partial top tacking edges could be seen slightly extending into the paint layer. Also, the tacks on the surface were visible. On the reverse, evidence of previous tear-repair treatment was found. An oval composed of an unknown substance was also seen on the bottom right (Figure 12).

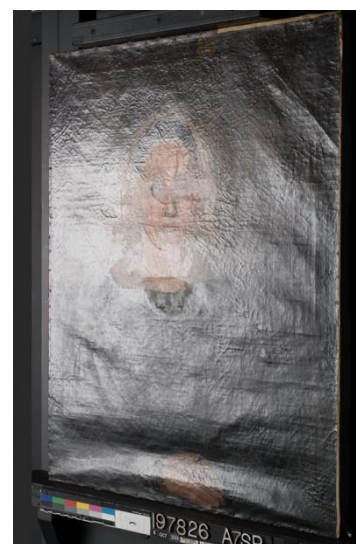
The raking light image revealed the surface topography, including the texture of the cracks. The canvas distortion was emphasized in the oblique specular image (Figure 13). This image also highlights the uneven sheen of the varnish including previous varnish removal test spots. The axial specular image exhibited similar results as the oblique specular.

Figure 13: Before Treatment. Oblique specular illumination

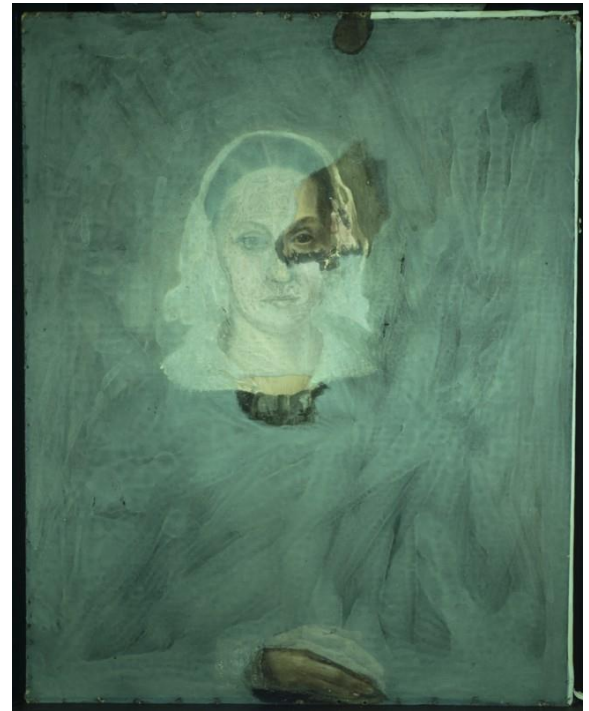
The artwork had an unevenly shiny varnish layer. There were multiple areas with varying degrees of gloss. The varnish was likely a natural resin due to green fluorescence under ultraviolet illumination (Figure 14). Ultraviolet illumination also revealed the varnish being very loosely applied before framing. There were sections where the brushwork can be seen. However, it seemed like the varnish was loosely poured/applied and spread around with a brush or cloth to cover the whole surface. The varnish layer had significantly discolored over time. As mentioned above, the previous conservator removed the discolored varnish on the bottom half of her hand revealing the “original” paint color. The other areas where overpaint was potentially removed, still had some gloss. Except for the test on the bow where the surface was completely matte (Figure 13).

Figure 14: Before Treatment. Front. UVA induced visible fluorescence image.

Under UVA the varnish fluoresces greenish indicating the varnish was a natural resin. There were clear brush marks throughout. The previously four tested areas were emphasized in this image since the final varnish layer has been removed, revealing the underneath painting which has different fluorescence. Under UVA, the application of the varnish could be seen. The top varnish seemed to be very loosely applied. It looked like the varnish was loosely poured/applied and spread around with a brush or cloth to cover the whole surface and then smoothed around the edges.

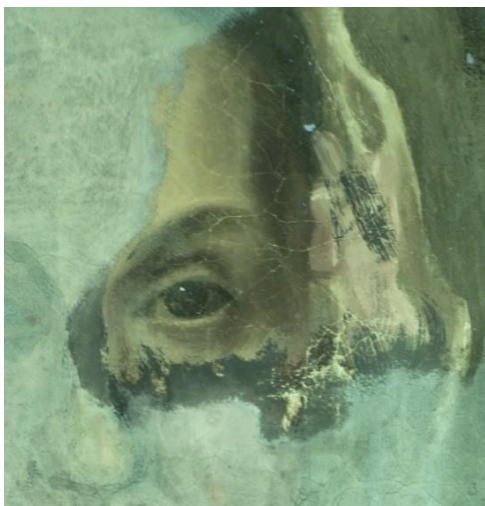
Figure 15: Before Treatment. Close-up of UVA induced visible fluorescence image. Dark grey border above greenish fluorescence identified as overpaint.

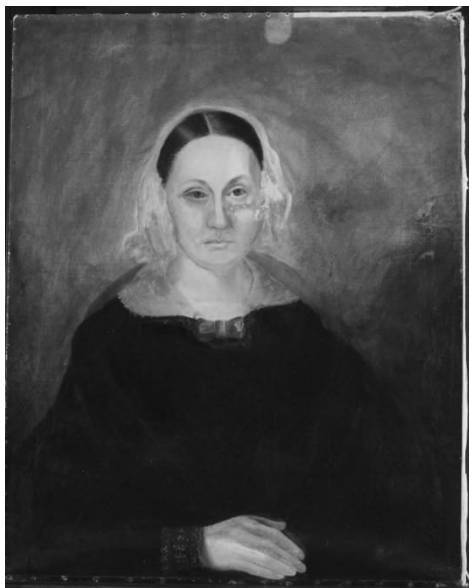
Figure 17: Before Treatment. Front. Reflected Infrared Radiation.

The RIR image (Figure 17) revealed minor adjustments, either done by previous restorer or the artist. Especially seen above the shoulders where there is a dark grey curvature, possibly an adjustment of the shoulder placement. The areas of overpaint also seem to appear a slightly darker grey compared to the “original” paint. Also, a thrilling discovery was made when the reflective infrared radiation image of the reverse was taken. A signature was found alongside a date on the bottom right of the verso of the canvas (Figure 2). It is unknown if the signature

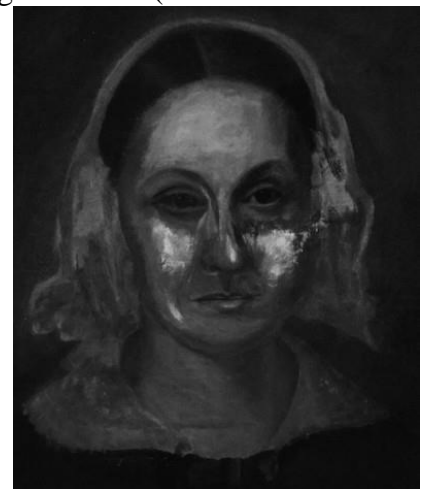
In the IRLUM image (Figure 16), the pigment used to overpaint the cheeks and some areas in the veil luminesce. Cadmium pigments are known to luminesce under induced infrared luminescence. However, it cannot yet be confirmed if the restorer used this pigment for the overpaint.

Figure 16: Before Treatment. Close-up. visible induced infrared luminescence.

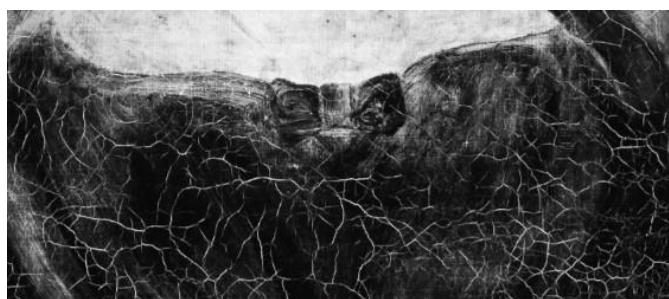
The transmitted infrared radiation image reveals cracking throughout, emphasized by the contrast with the dark garment (Figure 19). The outline of the tear-repair patches on the reverse can be seen in the middle of her face (Figure 20) and slightly on her thumb. The thicker areas will appear darker in the image. The thick layer of overpaint on her nose and cheeks were dramatically emphasized by the dark area on her face. In Figure 20, an underdrawing can possibly be seen.

Figure 19: Before Treatment. Close-up. Transmitted reflected infrared radiation.

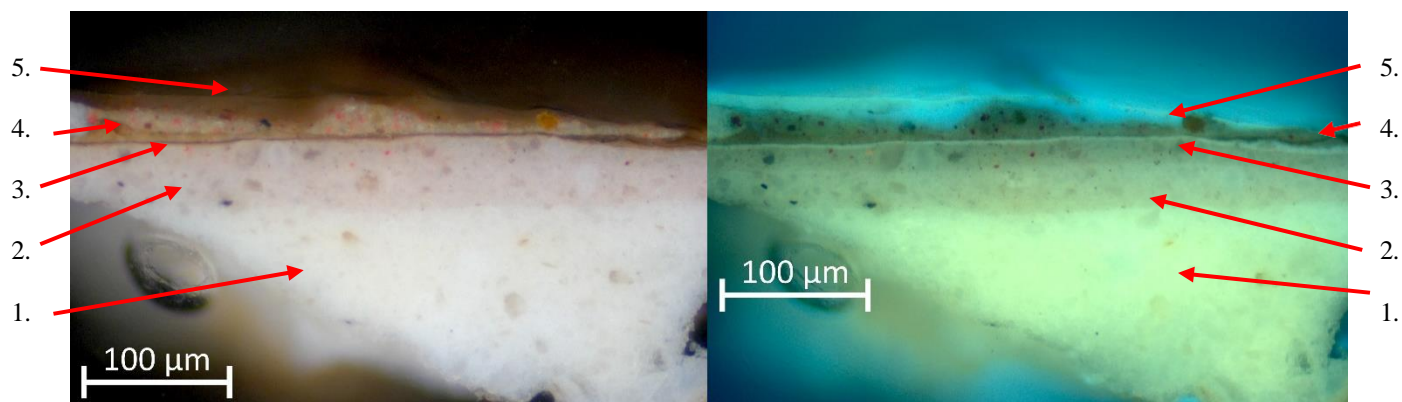
Figures 21 (left) and 22 (right): Cross-sections of sample #1 under microscope with 100  $\mu\text{m}$  magnification. Figure 22 under fluorescent microscopy. Painting layering structure marked and numbered: 1. white ground layer 2. Original paint layer 3. Thin dark line 4. Another paint layer (overpaint), and 5. Thick top varnish coating.

The first two cross-sections had a clear image of the layering structure of the painting. From bottom to top it showed a 1. white ground layer, 2. Original paint layer (flesh tones), 3. Thin dark line, 4. Another paint layer (overpaint), and 5. Thick top varnish coating. The thin dark line (3. in Figure 22) in-between the paint layers fluoresce under UV illumination, suggesting a secondary natural resin varnish layer between the original paint and the overpaint. The bright red dots indicate red pigment was used on the flesh tones. Since the red didn't fluoresce under ultra-violet illumination, it was not a lake pigment. The presence of mercury found on the flesh-painted areas using XRF suggests the red pigment could be vermillion. There are blues, ochre yellows, and other earth tones also seen in the paint layers, but the exact pigment cannot be currently confirmed. On sample #2, seen in Figures 23 and 24, the top paint layer seems to dip on the right over the original paint and ground. Knowing the location of the sample (tear loss on hand), it is probable that the top layer/s were brushed over the damaged area and into the paint layers resulting in this unusual dip on the side.

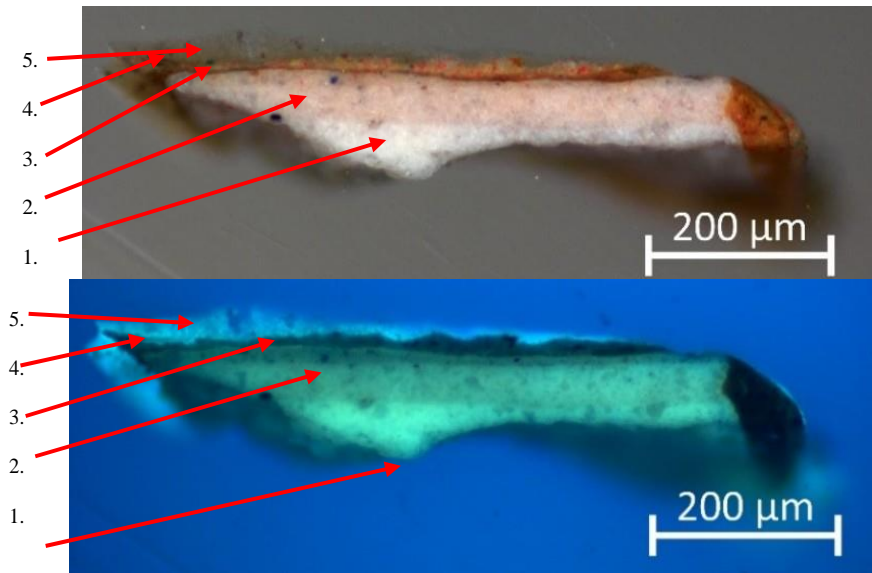
Figures 23 (top) and 24 (bottom): Cross-sections of sample #2 under microscope with 200  $\mu\text{m}$  magnification. Figure 24 under fluorescent microscopy. Painting layering structure marked and numbered: 1. white ground layer 2. Original paint layer 3. Thin dark line 4. Another paint layer (overpaint), and 5. Thick top varnish coating.

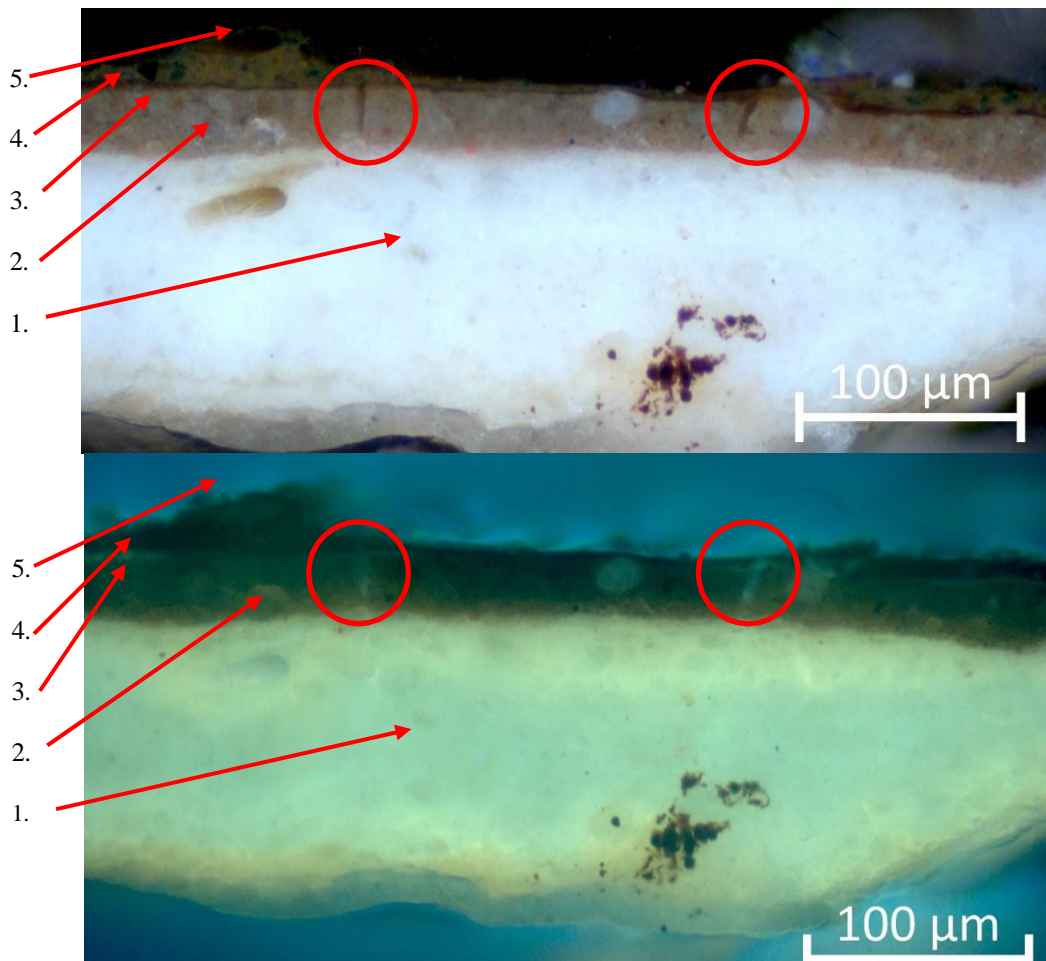
Figures 25 (top) and 26 (bottom): Cross-sections of sample #3 under microscope with 100  $\mu\text{m}$  magnification. Figure 26 under fluorescent microscopy. Painting layering structure marked and numbered: 1. white ground layer 2. Original paint layer 3. Thin dark line 4. Another paint layer (overpaint), and 5. Thick top varnish coating. Cracks on paint layer marked in red.

Similar to the previous two samples, sample #3 has a clear layering of white ground, original paint, another darker paint layer on top of the original, and a final varnish layer. The secondary varnish layer, found in-between the paint layers in the previous two samples, is harder to distinguish. The thin layer can be seen mostly on the opposite ends of the cross-section, but the image is too hazy due to polish residue to clearly identify. There is a larger presence of blue and yellow in the top paint layer suggesting that the green paint layer is also overpaint. Unlike in samples #1 and #2, two cracks were found in sample #3 (Figures 25 and 26). These cracks are present in the original paint layer. The top paint layer and varnish was applied overtop of the cracks, meaning they were added after it originally cracked further confirming the presence of overpaint. Under fluorescence, the cracks fluoresce due to the varnish entering the structure as it was brushed over the damage.

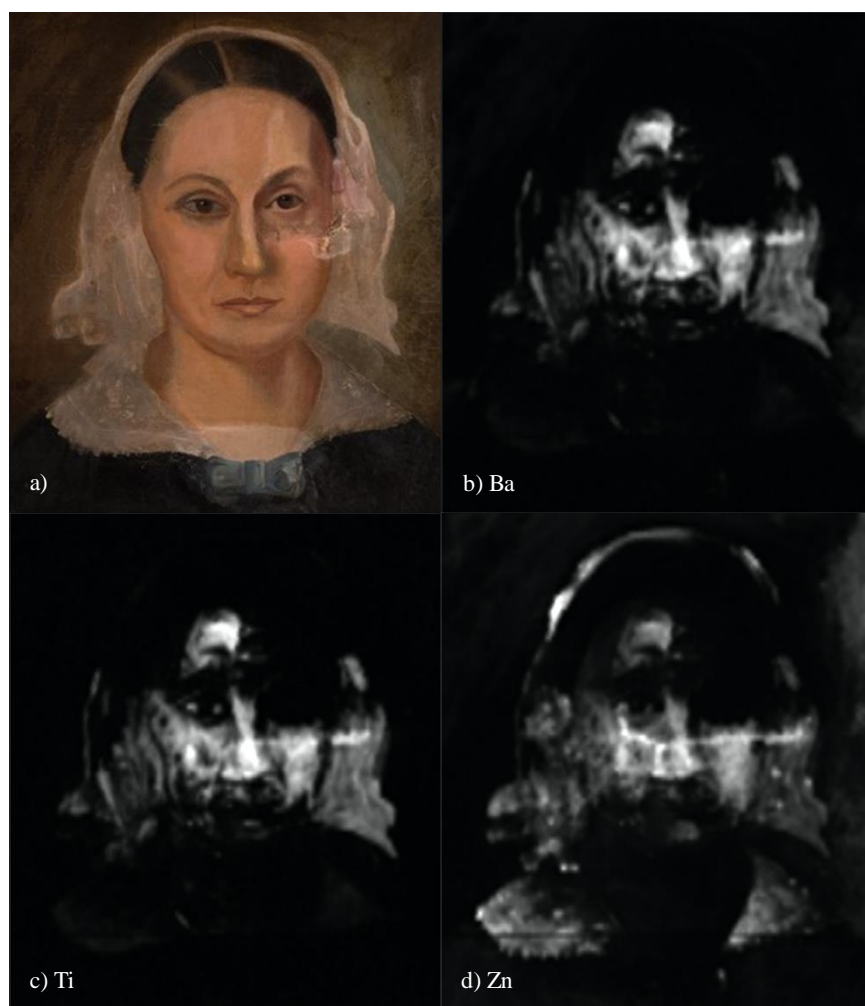
Figure 33: a) Normal image of sitter's bust. b) XRF mapping image of barium on sitter's bust. c) XRF mapping image of titanium on sitter's bust. d) XRF mapping image of zinc on sitter's bust.

Some of the XRF results emphasizes the area of overpaint on the face. On Figure 33, it shows the barium (b), titanium (c), and zinc (d) present on the face. These elements seem to be present in the same of location of where overpaint was found. It is most likely from the pigment used to overpaint the area. This can be confirmed by the FTIR results. As mentioned before, barium white was the base of the overpaint taken from the same location on the face (right cheek). Titanium was also present in the infrared spectra of the overpaint sample. Titanium white started being used as a pigment around 1916 (Bernstein, 2005). Knowing the portrait was painted in the 1840's, it can be confirmed that the titanium found is from the overpaint. The XRF mapping image of zinc was different from the rest in the sense that it was also present around the veil and on the collar. Traces of zinc were also found in the spectra of the adhesive sample extracted from the reverse. Unlike titanium white, zinc white

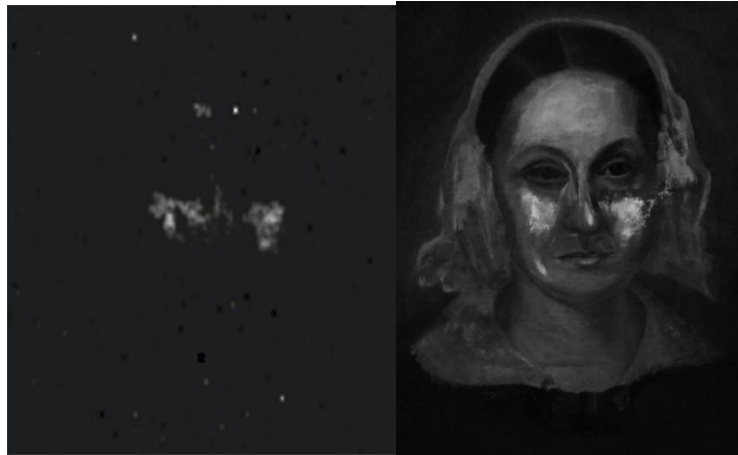
Figure 34: XRF mapping image of cadmium on sitter's bust.

Additionally, there were also traces of cadmium on the cheeks and forehead (Figure 34). Cadmium is known to luminesce under infrared luminescence. Multiple areas on the face and veil lumines under infrared luminescence (Figure 16), especially the cheeks. Despite having cadmium present in the cheeks, it doesn't seem to be present anywhere else. Cadmium pigments were introduced to artist in different years. While cadmium yellow first became available to artists around the 1830's, it was not until 1919 that other cadmiums, such as red and orange, were produced. The cadmium pigments were also known to be expensive during that time and it was not until 1920's where the cost of the pigments reduced (WILEY-VCH, 2009). It is plausible that a cadmium pigment (such as cadmium red) was used to overpaint the cheeks as if to add a blush to the complexion.

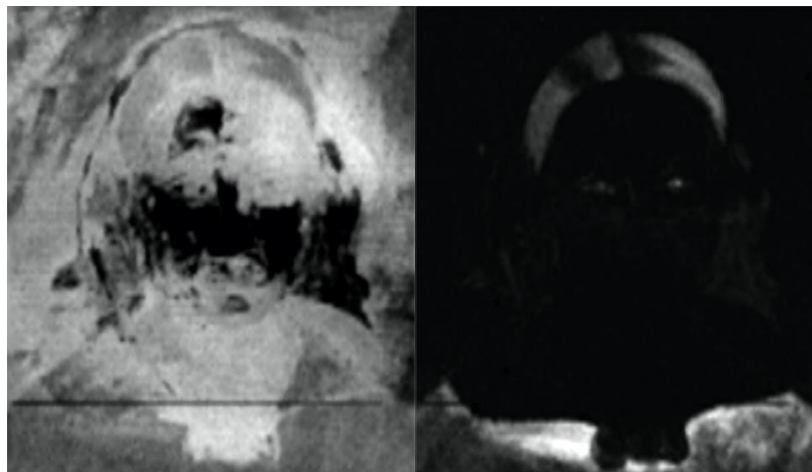
Figure 35: XRF mapping image of lead on sitter's bust.

The XRF findings of lead and phosphorous also coincide with the FTIR results. Figure 35 shows lead present basically throughout the whole painting which is confirmed by the FTIR findings of the ground being lead based. The darker areas in the lead XRF mapping image are the barium blocking the lead readings. Lastly, traces of phosphorous were found on the hair, pupils, and garment. Phosphorous is an element found in bone black. This was, once again, confirmed with the FTIR result of the black paint where the infrared spectra matched bone black.

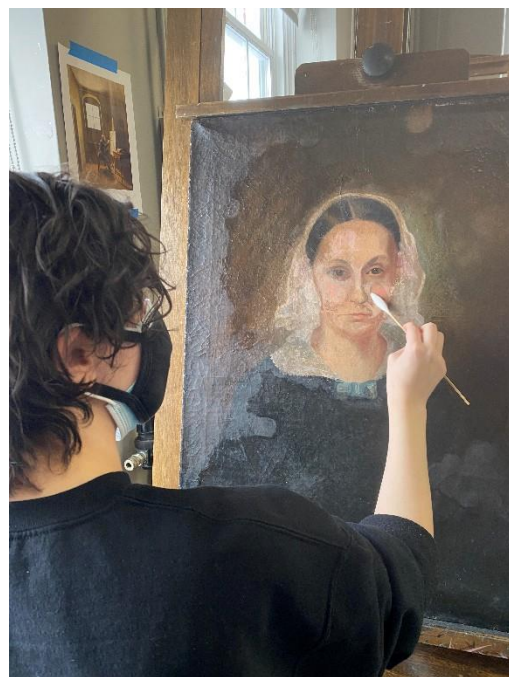
Figure 37: During varnish and overpaint removal.

The first steps of the treatment were removing the painting from the frame and backing board attached to the reverse. Dirt and grime were removed using 1% Tri-Ammonium Citrate and rinsed with Distilled water on swabs. There were not a lot of visual change as expected. The varnish was removed with ethanol: odorless mineral spirits (2:1) solution, ethanol, and, isopropanol. The ethanol: odorless mineral spirits solution was also effective in removing some of the overpaint around the neck and face. The skin tone drastically changed as the varnish and overpaint were being removed. After the varnish was removed, there were still many

layers of overpaint left on the middle of her face. There was also some overpaint (such as around the right eye) that was not soluble in the ethanol solution and needed another method to be removed. Fortunately, the majority of the overpaint on the was face was able to be removed using ethanol with 10% benzyl alcohol.

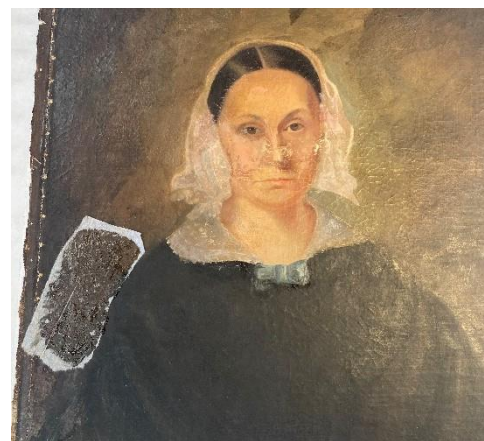
Figure 39: During overpaint removal.

used to remove the overpaint (Figure 40). As the cleaning continued, the overpaint removal became increasingly complex. Multiple solutions were used depending on how the overpaint behaved: 2:1 ethanol: odorless mineral spirits, 100% ethanol, ethanol with 2% benzyl alcohol, ethanol with 10% benzyl alcohol, and Pemulen stock gel pH7 with ethanol. Additionally, tests were conducted with increasingly polar solvents to determine whether the overpaint could be safely removed (including diacetone alchohol, dimethyl sulfoxide, and benzyl alcohol). The artwork was inspected with UVA lamps during the process to track the overpaint removal. Despite reducing the overpaint and revealing a significant amount of original artist's paint, it was not possible to safely remove all the overpaint. Stubborn overpaint is still present in several areas in the background and the garment.

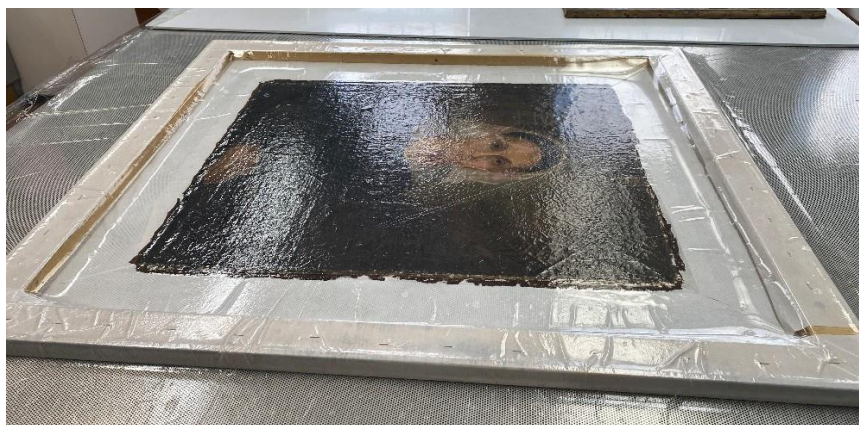
Figure 40: During humidification

The painting was humidified with the suction heat table. A dampened fiberglass fabric was dampen and placed under the painting along with a pe-cap polyester screen to prevent adhesion (Figure 39). The painting was left to humidify for about 10 minutes. Later the dampened fiberglass fabric and polyester screen were replaced with Shweitzer paper to remove the excess moisture and prevent the painting to adhere on the table. This process was repeated once more for 20 minutes.
