# A Lifetime of Stress: Analysis and Treatment of an Inlaid Chinese Box

**A Lifetime of Stress: Analysis and Treatment of an Inlaid Chinese Box**

*CNS 695 Master's Project*

Katherine McFarlin

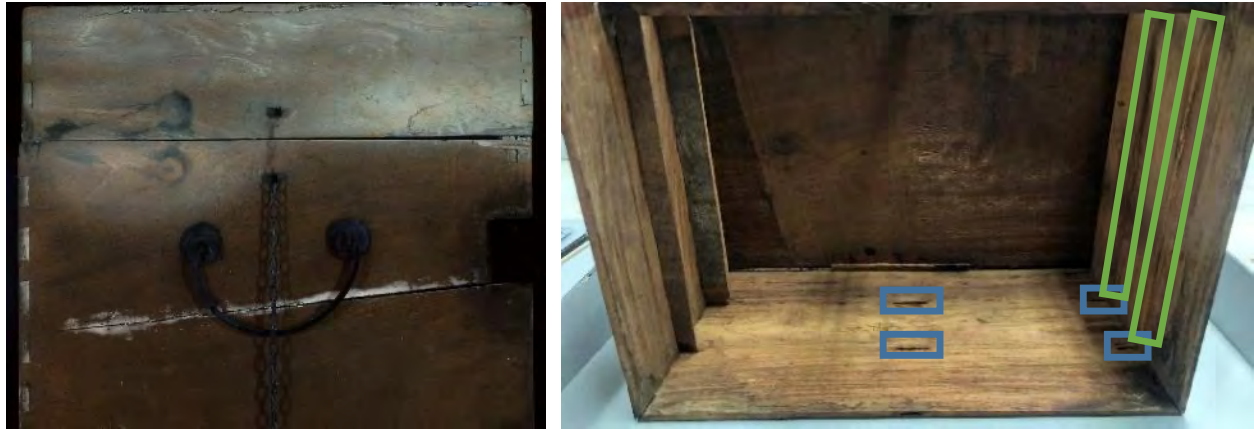
The back right joint of the main cabinet had completely opened, creating a ¼ in. gap between the side panel and the back panel. Additionally, the floor of the upper compartment partially fell out of its grooves in the back right corner, likely due to the misalignments from the opened joint. On the left side, a major split ran horizontally approximately two-thirds up the panel, widening towards the front roughly in line with the upper door hinge (fig. 5). Adhesive was visible on both connecting faces of the split, but that join attempt had clearly failed. Towards the back of the split, failures in the wood along the wood/adhesive interface were visible as thin splinters connecting across the join, indicating that the issue may have arisen from stresses across the wood rather than pure failure of a weak adhesive. The bottom edge of the panel was forced away a little over a centimeter from the front of the main structure, and this planar disruption appeared to be both aggravated by and contributing to the split. The gap was particularly visible at the lower left tenon of the drawer spacer piece as seen above in figure four, where the tenon had come slightly out of joint.

**Fig. 5.** Left: upper half of the left panel under UVA-induced visible fluorescence, highlighting the split running horizontally through the panel, and traces of a prior hinge attaching the lid. Right: Interior of the main cabinet, viewed from the underside. Adhesive glue lines from the missing side runners are outlined in green, and the hidden mortises for the runners are outlined in blue. The mortise for the base connection is also visible in the lower middle.

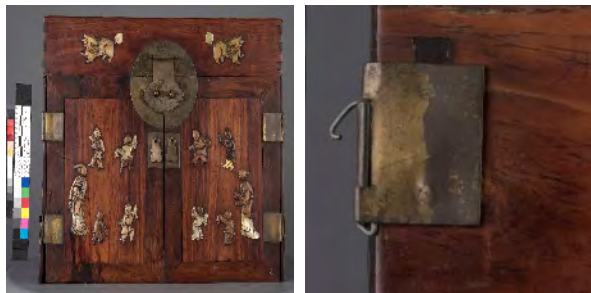
Many of the hinges were bent or damaged. On the left door, the upper hinge was in good condition, but the lower hinge was in poor shape with some components bent out of position. The pin in the lower hinge also appeared slightly bent. On the right door, the pin was completely missing from the lower hinge, while the upper hinge was held in place with a modern metal wire acting as the pin (fig. 7). This modern wire was bent into loops at both ends, which stuck out significantly from the hinge assembly. On the lid, the proper left back hinge was missing a rivet in the lower placket, and the pin holding the hinge together was loose and slightly corroded. The other back hinge seemed to be in good working order, though it did not lie perfectly flush and had two extra holes going through it into the back panel, perhaps from an earlier attempt to re-align or re-attach the hinges.

**Fig. 7.** Left: Lower hinge of left door, with knuckles broken and bent outward, and plate distorted. Right: Modern metal wire acting as a temporary pin for the upper hinge of the right door

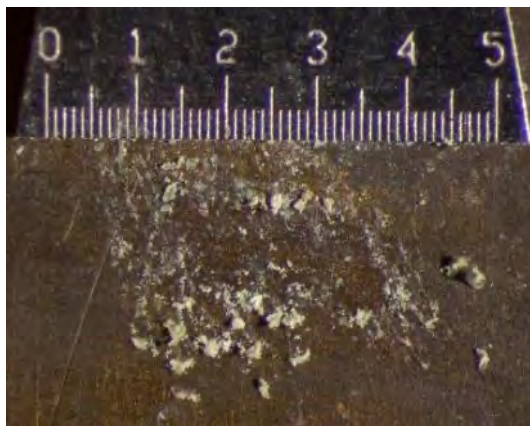
**Fig. 16.** Macrophotograph showing milky green flakes of solubilized coating during solvent cleaning of the brass hardware. The scale is marked with millimeter increments.

Overall, cleaning was successful and proceeded without issue. The hardware was not re-coated as any coating would need regular upkeep or renewal to prevent further damage, and such maintenance could not be ensured. Additionally, allowing for natural aging and patination would allow for visual cohesion with the rest of the piece, and would be sympathetic to the intention for the piece. In many East Asian cultures, signs of age are considered to have value, and a natural patination is preferable over any attempts at full polishing or restoration. Natural aging and patination will also provide a slight protective layer for further handling, and will require the least maintenance from the client.

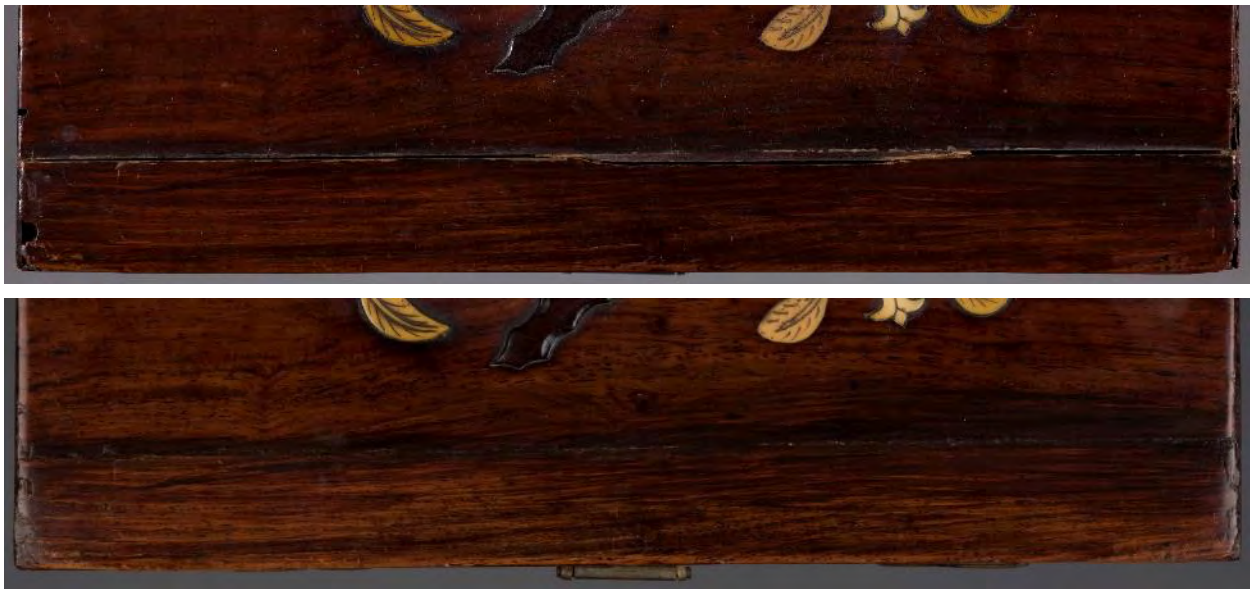
The top panel of the lid was overall in poor condition, largely due to a major split running completely through the entire width of the upper lid panel, about an 2.5 cm from the front edge. The front strip was completely separated from the rest of the panel at this split, and appeared to have detached completely from the piece and re-adhered at some point. The front right edge sat slightly proud of the front face of the lid, perhaps from misalignment during this repair. The rest of the top panel had started to detach from the both side walls and had lifted slightly. The rest of the wood was in good condition, with only slight scratches and dust, and a partial split in the wood at the lower right corner of the front of the lid. Most of the inlays were in good condition and all were securely in place. The inlay flower in the upper right had a small abrasions near the center and right, and the lower left branch had a small loss in the distal end.

The lid was glued back together in stages with liquid fish glue, with at least 24 hours spent clamped under pressure between each step (fig. 19). First, the front outer edges of the top panel were aligned and glued to the front edge, and the split between the front fragment and the main lid panel closed. However too little adhesive was used during this first attempt, and the front edge did not fully adhere. This join was loosened and the join properly flooded to join the front top edge together. Once dry, the side edges of the top panel were rejoined with the side panels, making sure to properly flood the joints. In these scenarios, the fish glue acted both as an adhesive and a non-aesthetic gap filler, to ensure sufficient points of contact for a strong join. After all joints were dry, any excess fish glue was reduced with lightly damp cotton swabs followed by a dry cosmetic sponge to minimize the dwell time of the water and maximize the mechanical removal of the adhesive bulk without damaging the wood finish.

**Fig. 19.** Front edge of the lid, before (top) and after (bottom) treatment. The split was successfully rejoined and secured to the side panels, and losses were toned and filled to blend with the surrounding wood.
