LEVEL OF COASTAL PROTECTION DAMAGE AND PRIORITY OF HANDLING: (CASE STUDY OF ALUE NAGA - NEUHEUN, ACEH BESAR, INDONESIA)

Syahrul Mauluddin¹, Ella Meilianda^{1,2}, Syamsidik^{1,2}

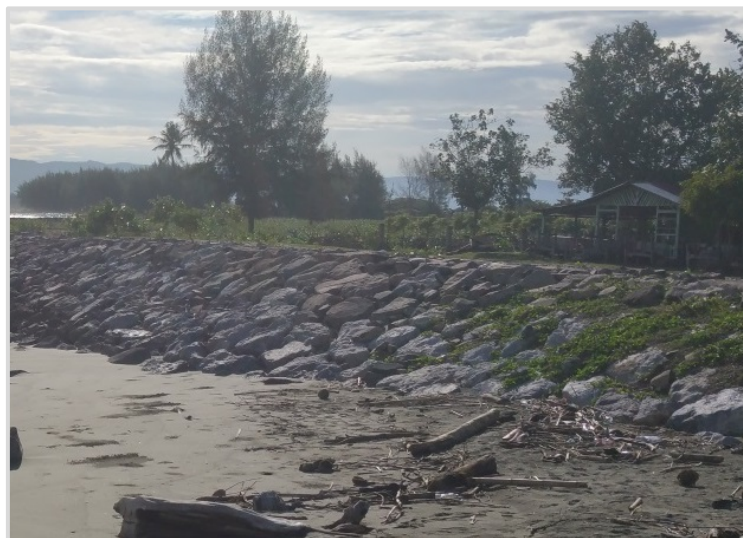
Figure 3. Condition of revetment point 1

Calculation of shoreline changes is carried out at location CS-1 with a shoreline of 1,100 m. The coast experienced erosion along the east side, experienced an erosion rate of -0.43 to -7.56 m / year (Figure 12) and a distance of change from 0.14 to 78.79 m from the shoreline from 2007 to 2017. The total coastal erosion was 17,768.96 m² or 1.77 Ha, on average the coast experiences erosion rates of -4.05 m/year. Whereas for the west coast shoreline there is an accretion rate of 0.02 to 9.06 m/year experiencing sedimentation of 12,959.96 m² or 1.29 Ha. The beach changes the longest and newest shoreline distance 3.74 to 65.77 m. Significant sedimentation occurred in front of the building at point 1 (Figure 3), the rate of change occurring at this point reached 9.06 m/year.

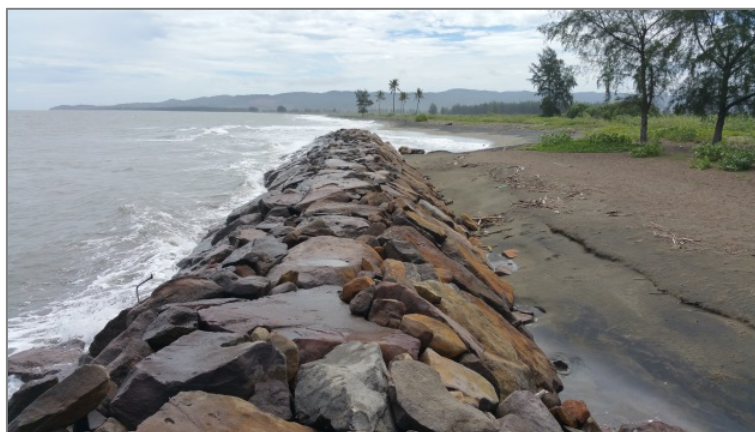
Figure 4. Condition of revetment point 6

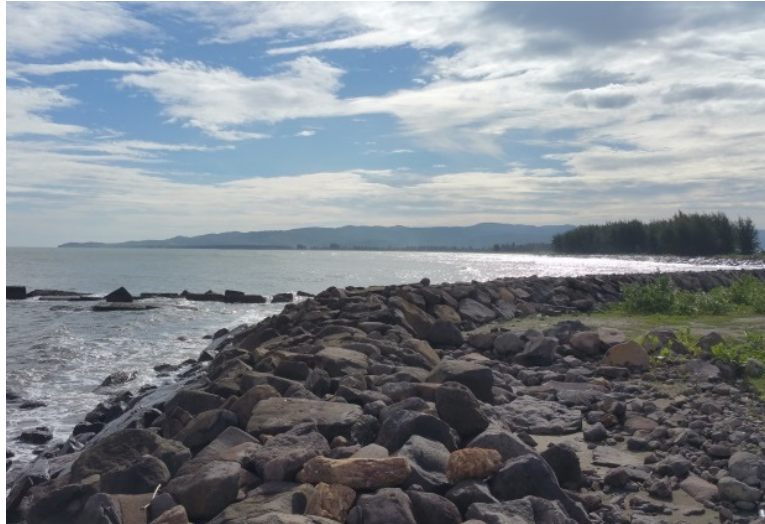
Figure 5. Condition of revetment on the track 2

The next condition of the revetment building suffered minor damage from the track length of 2 - 333.71 m, along points 3 to 4 with the position of the building slightly towards the land, making the front flow of the building experience strong friction. Some visible material under the building has a 3-5-meter shift in the direction of the sea and land, visually this condition is seen at points 2 and 3 (Figure 4). The indications of the building were damaged due to the presence of water behind the building between points 3-4. This very possible factor is caused by runoff of water that passes through the roof of a building, causing some top layer material to shift until it falls rolling.

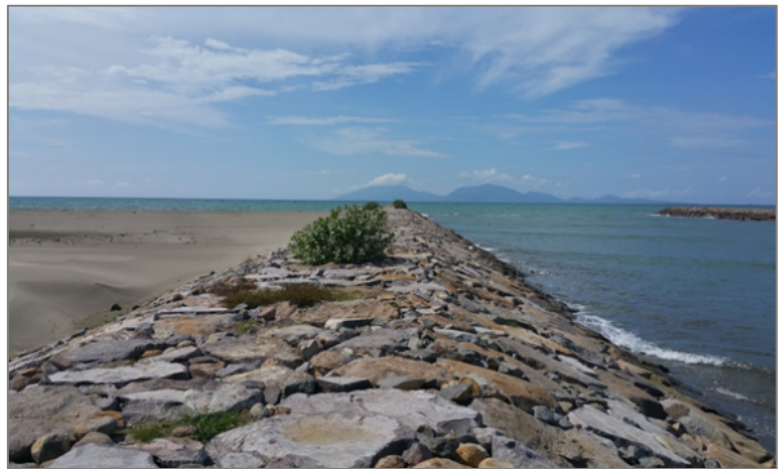
The location of the CS-2 building in the form of a jetty, having a length of 485.57 m, is located at coordinates 95 coordinate 23'0 "E - 95°23'30" E and 5°37'0 "N - 5°37'15" N (Figure.6). The construction of jetties is carried out in 2016 on the west side, and in 2018 on the east side, the main function of the building is aimed at navigating fishing boats and preventing flooding when heavy rains reach residential areas. Assessment is carried out on the construction of jetties that have been carried out in 2016 on the west side. Overall the building is still functioning properly. The condition at point 6 shows that the building material is still very good > 75%. The jetty code also experiences a buildup of sand to cover several parts of the building (Figure 8). This indicates that the beach is prone to accretion.

Figure 7. Condition of jetty at point 6

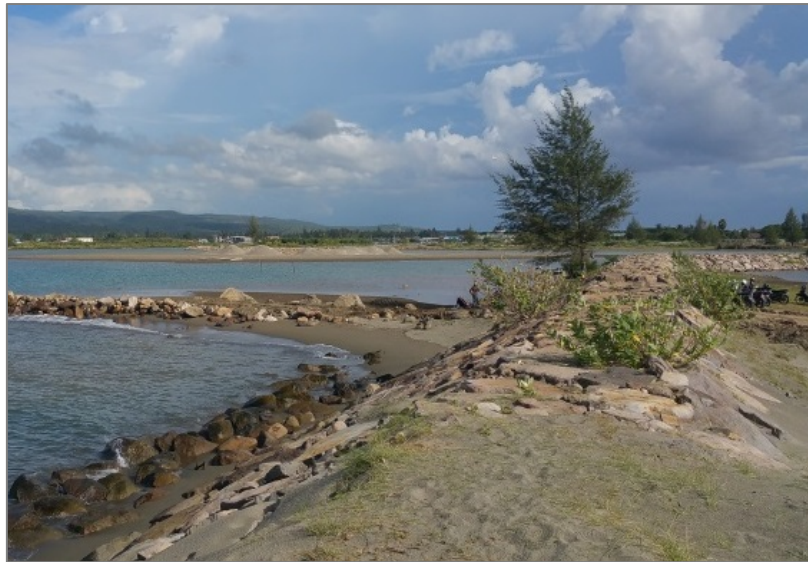
Figure 8. Condition of jetty at point 7

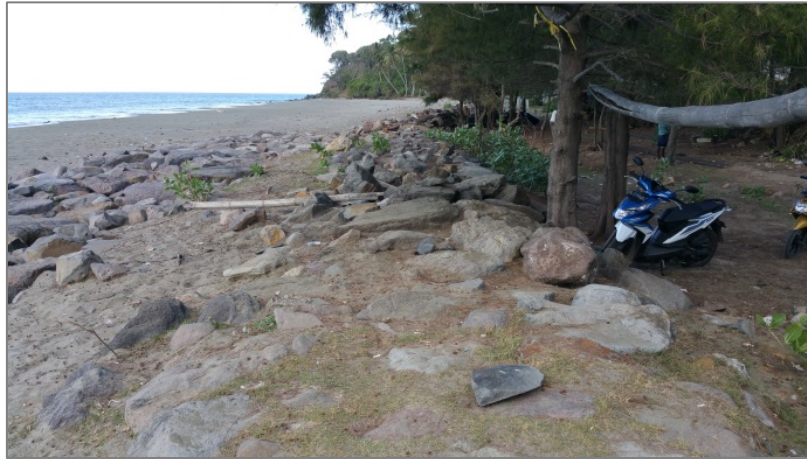
The building at CS-3 location is a building with a type of revetment, located at $95^{\circ}24'40''$ E - $95^{\circ}24'56''$ E and $5^{\circ}38'40''$ N - $5^{\circ}38'46''$ N with sandy beach types. This building is located next to the cape which is on the east side with a length of 535.39 m. Building construction was carried out in 2009, functioned as a protection for brackish water infrastructure under the Ministry of Maritime Affairs. The assessment of buildings found that the entire building suffered severe damage to function $20 > 25\%$. Along the track-5 situations seen building material has been detached (Figure 9). However, in some locations the building has been covered with sand until the building is overgrown with vegetation (Figure 10). Buildings suffer very heavy damage but do not interfere with environmental damage.

Figure 10. Condition of building jetty at point 8

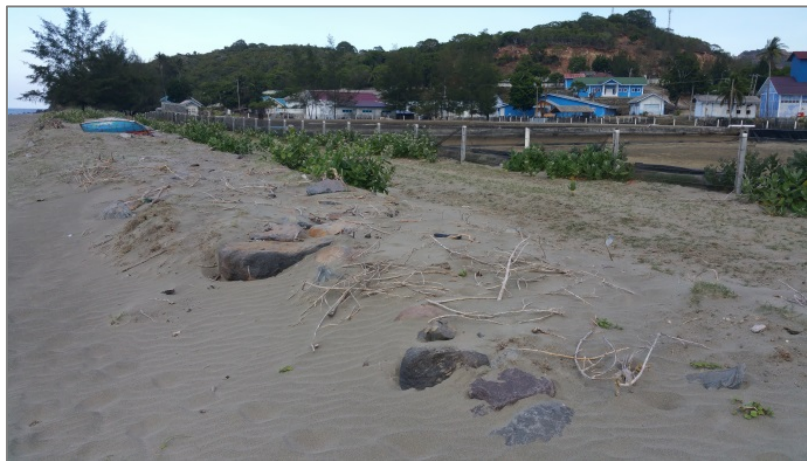
Figure 11. Condition of jetty at point 9

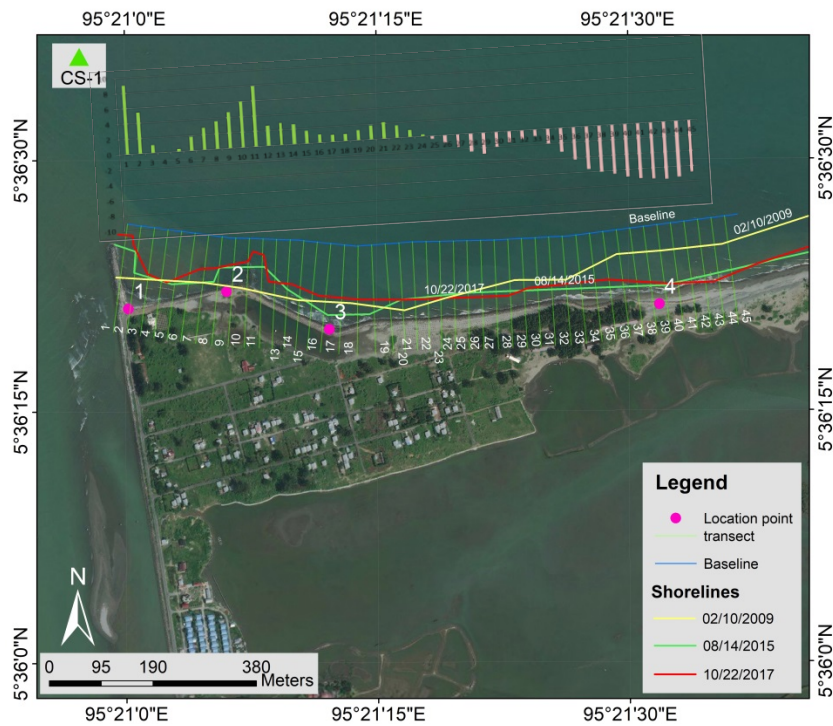
Figure 12. Map of the rate of change of shoreline location CS1 in 2009-2018

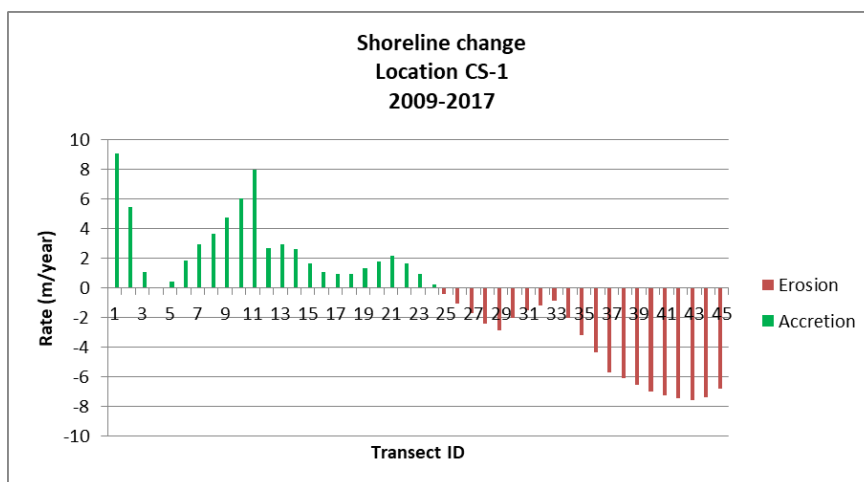
Figure 13. Shoreline change analysis of DSAS calculation CS-1

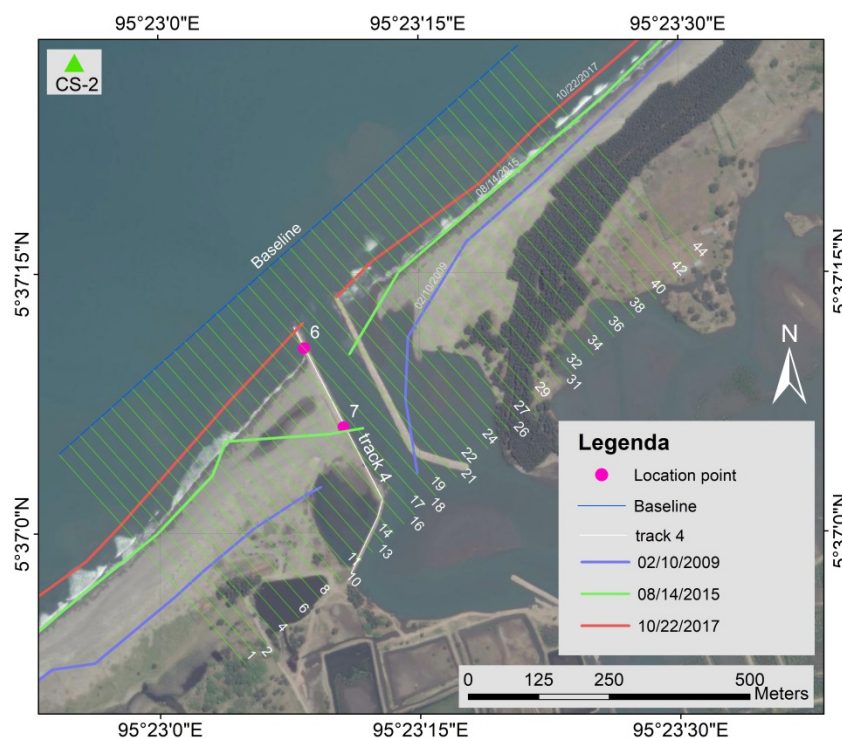
Calculation of shoreline changes at CS-2 location was calculated using baseline with a beach length of 1090.60 m (Figure 13). The calculation of the shoreline was carried out for the period 2009 - 2017, where the coast experienced accretion of 7.21 to 91.45 m/year. The average shoreline experienced accretion of 21.13 m/year and the distance between coastal changes 2007 - 2019 averaged 127.29 m. The appearance of the coastal calculation graph experienced the highest accretion at the point of transect ID 18-21, which is the mouth of the estuary. Interviews with fishermen stated that at the time of silt estuary when the lowest water level of the lowest low water level (LLWL) of fishermen was constrained to sail to pass through the inlet, so they had to wait a moment for the highest water level rise (HHWL). Changes in shoreline caused by accretion do not cause negative impacts on the surrounding environment, except for fishermen to influence access to the navigation path when they are about to sail. While the reduction due to flooding during heavy rains, the construction of a jetty has been able to direct the flow of surface water flowing into the ocean.

Figure 14. Location of changes in shoreline CS-2

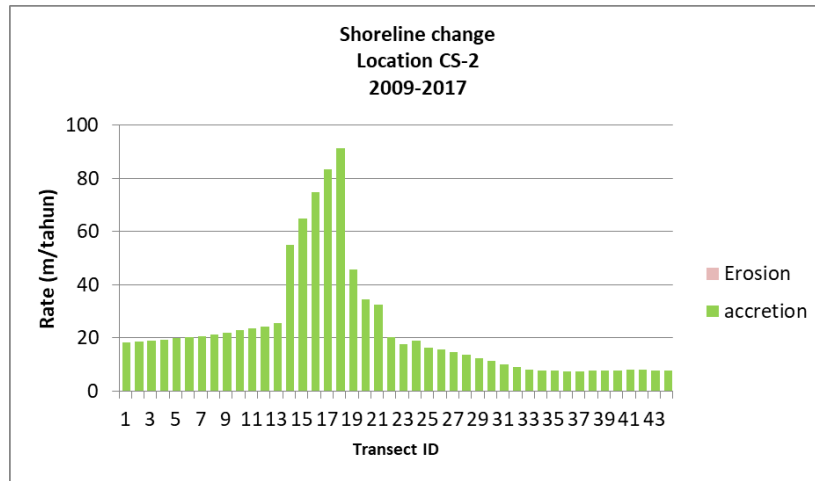
Figure 15. Rate of shoreline change CS-2

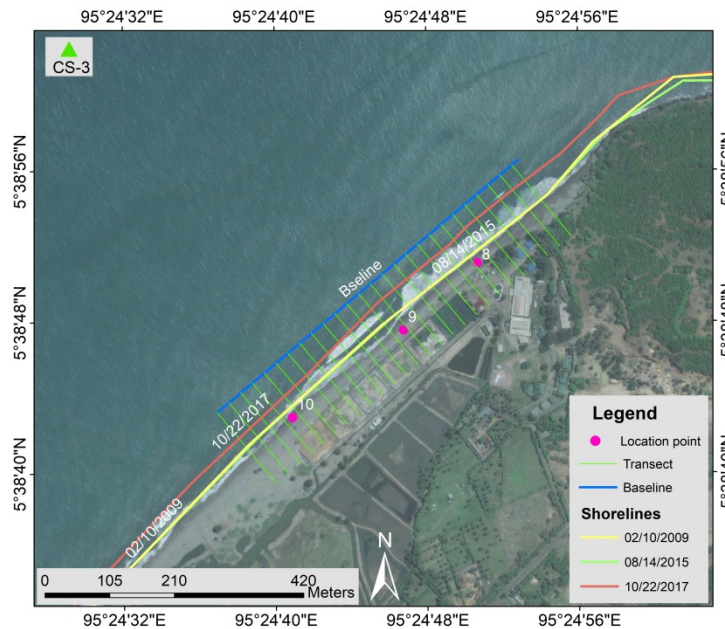
Calculation of changes in shoreline location CS-3 has a baseline length of 637.89 m with a type of sandy beach. The beach has a very heavy accretion tendency > 2 m/year (Figure 16). During the period 2009-2017 there was accretion between 2.14 to 4.78 m/year which caused almost all coastal buildings to be covered by sand (Figure 10). The high accretion rate caused the beach's natural protective feature to form sandbanks along the coast. The construction of the wall appears (Figure 17) as a barrier to protect cultivation ponds from siltation due to high accretion.

Figure 16. Location of changes in shoreline CS-3

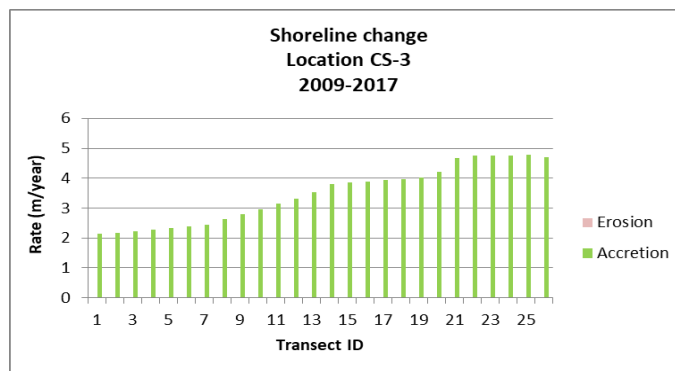
Figure 17. Rate of change in shoreline CS-3
