MODAL STRAIN ENERGY BASED STRUCTURAL HEALTH MONITORING ON RIB STIFFENED COMPOSITE PANELS

*Jason S. Hwang^{1,2}, Richard Loendersloot², and Tiedo Tinga²

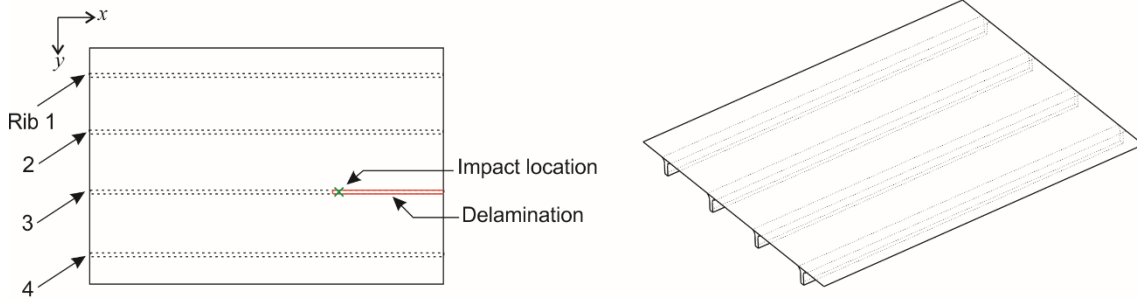
Panel 5565 and 5567 have been subjected to a single impact load each. The panels were clamped on four edge sides, while stiffeners were kept unsupported such that a typical aircraft skin-stiffener condition is created. The impact was applied on the skin side, directly underneath stiffener 3 (see Fig. 2 and 3). The impact location on both panels is identical: $x = 450$ mm and $y = 250$ mm. The impact energy on panel nr. 5565 was 18 J, while panel nr. 5567 was impact loaded with 14 J. Nondestructive inspection with an ultrasonic probe revealed that both impacts have

Fig. 2. Schematic drawing of the rib-stiffened panel. Delamination size and location are similar to both panels

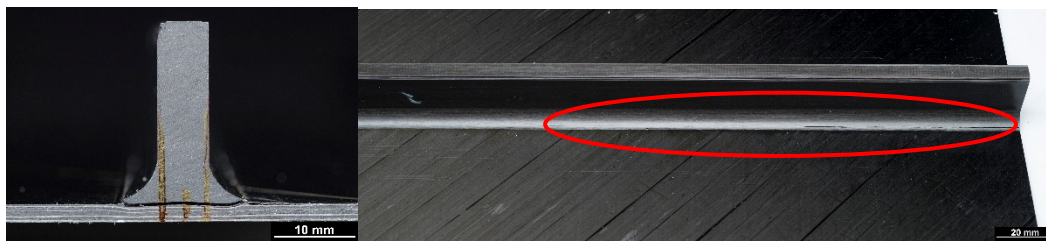
caused a similar delamination at the skin stiffener connection. The impact loading on the outer skin side has caused no visible damage from the outside. However, skin stiffener connection is deteriorated significantly over a length of 150 mm (see Fig. 3, red ellipse).

Fig. 3. Close up on the damage in panel 5565.

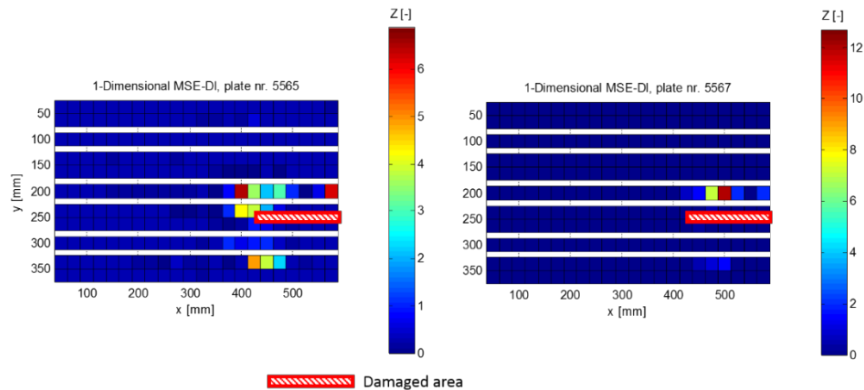
Fig. 4. MSE-DI extracted from panel 5565 and 5567

This result shows that damage has been detected successfully on both panels, although the peaks appear at different locations, indicating an inaccurate damage localization. The highest normalized damage index is found adjacent to the damaged area between stiffener 2 and 3. However, a number of additional peaks in the MSE-DI appeared in panel 5565, despite the impact being applied at the same location.
