Climamed 2017 – Mediterranean Conference of HVAC; Historical buildings retrofit in the Mediterranean area, 12-13 May 2017, Matera, Italy

## The energy efficiency challenge for a historical building undergone to seismic and energy refurbishment

A case study in L'Aquila city center is proposed in this work. The building, belonging to listed buildings for its historical value, being built in the 1930s, underwent to seismic and energy refurbishment, since it was damaged by the earthquake of 2009. The solution proposed aimed at improving the energy efficiency of the structure, by using an additional insulating layer, made of natural material (i.e. hemp), on the inside of the wall. The ceilings of the unheated spaces have been insulated, too, by using pure cellulose flocks.

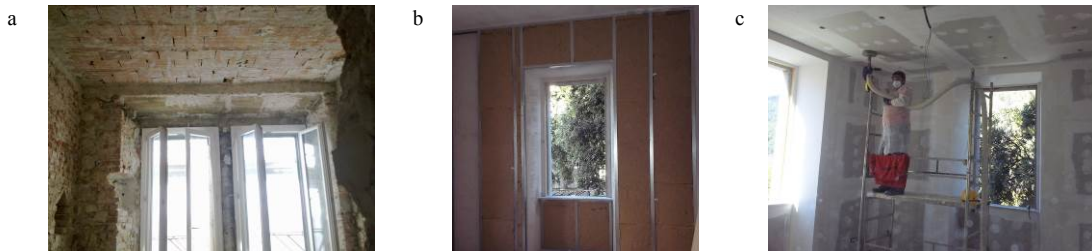
The unevenness of the wall assembly of masonry walls is quite common for this building typology. In this case, it is clearly visible in Figure 4-a, that shows the wall and ceiling of a flat after the plaster removal (which was a

Fig. 4. Progress of the retrofit intervention: (a) wall and ceiling without plaster; (b) hemp fiber panels mounted on steel frames; (c) cellulose flocks blowing on the ceiling.

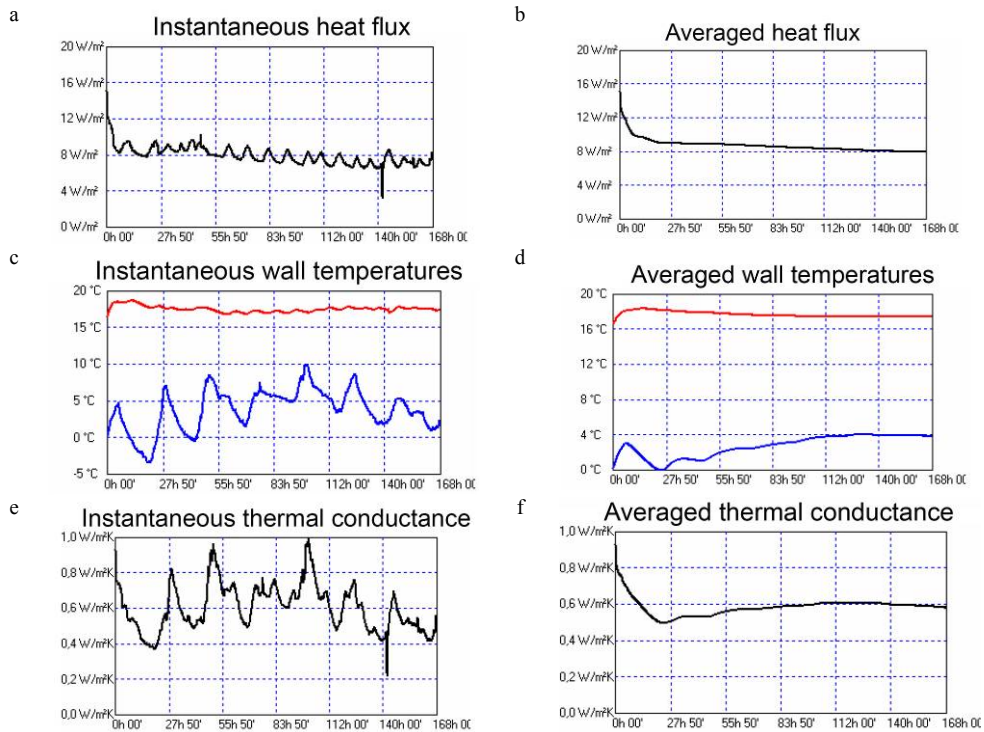
The final thermal transmittance, obtained with the progressive method, is 0.53 W/(m<sup>2</sup>K).

Fig. 5. Instantaneous (on the left) and averaged (on the right) trends of the recorded quantities.

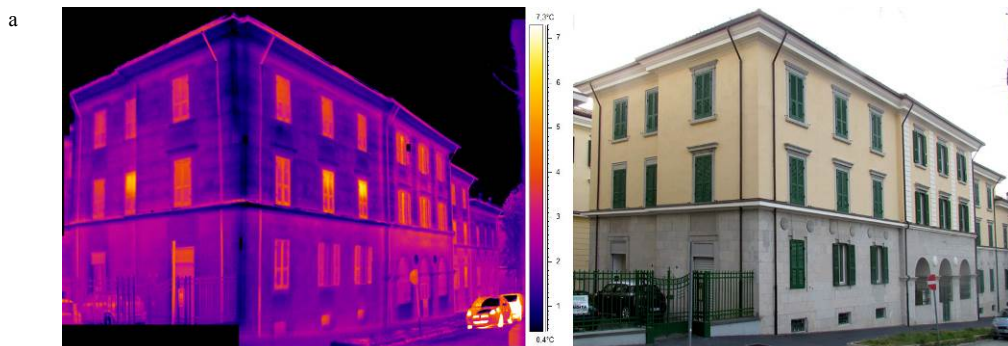
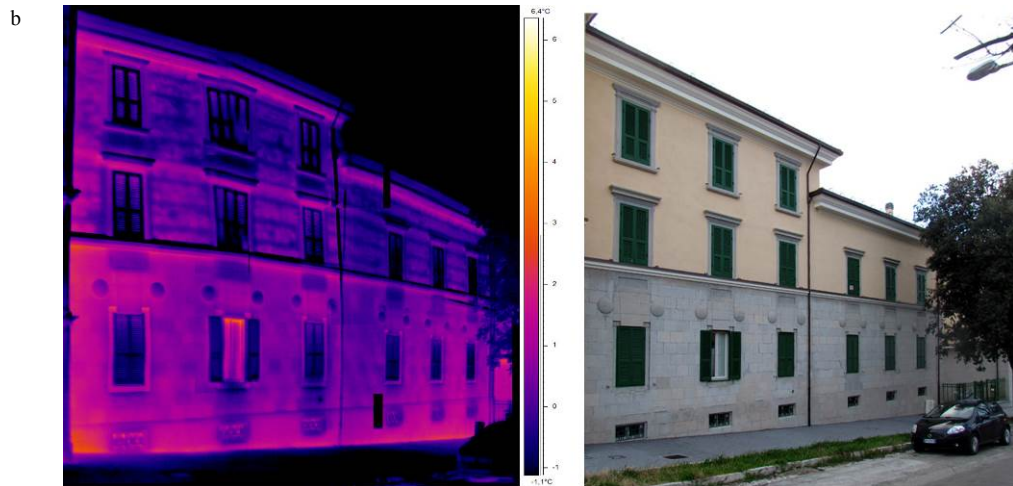
Fig. 6. Images of the investigated building in the IR (on the left) and visible spectra (on the right).

The images show the particular wall texture of the building.

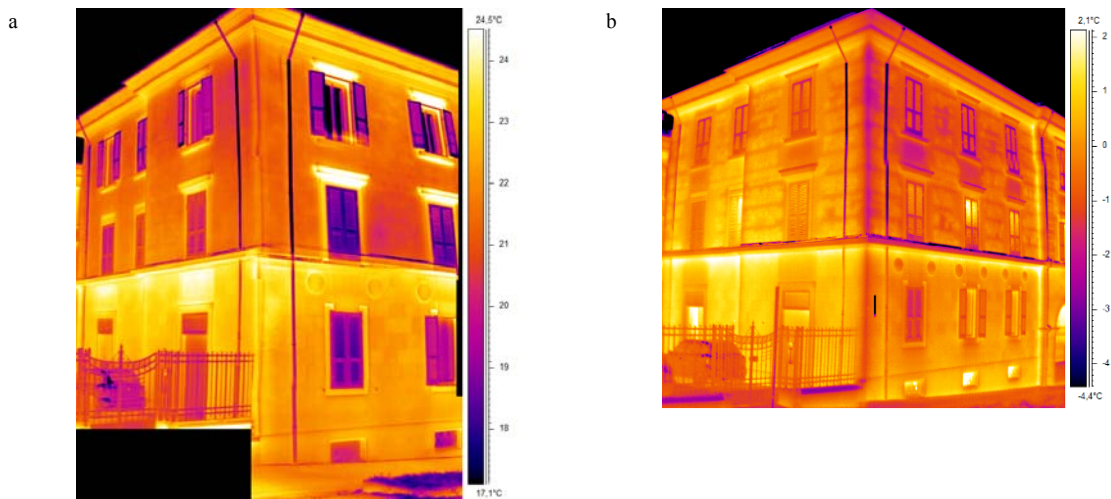
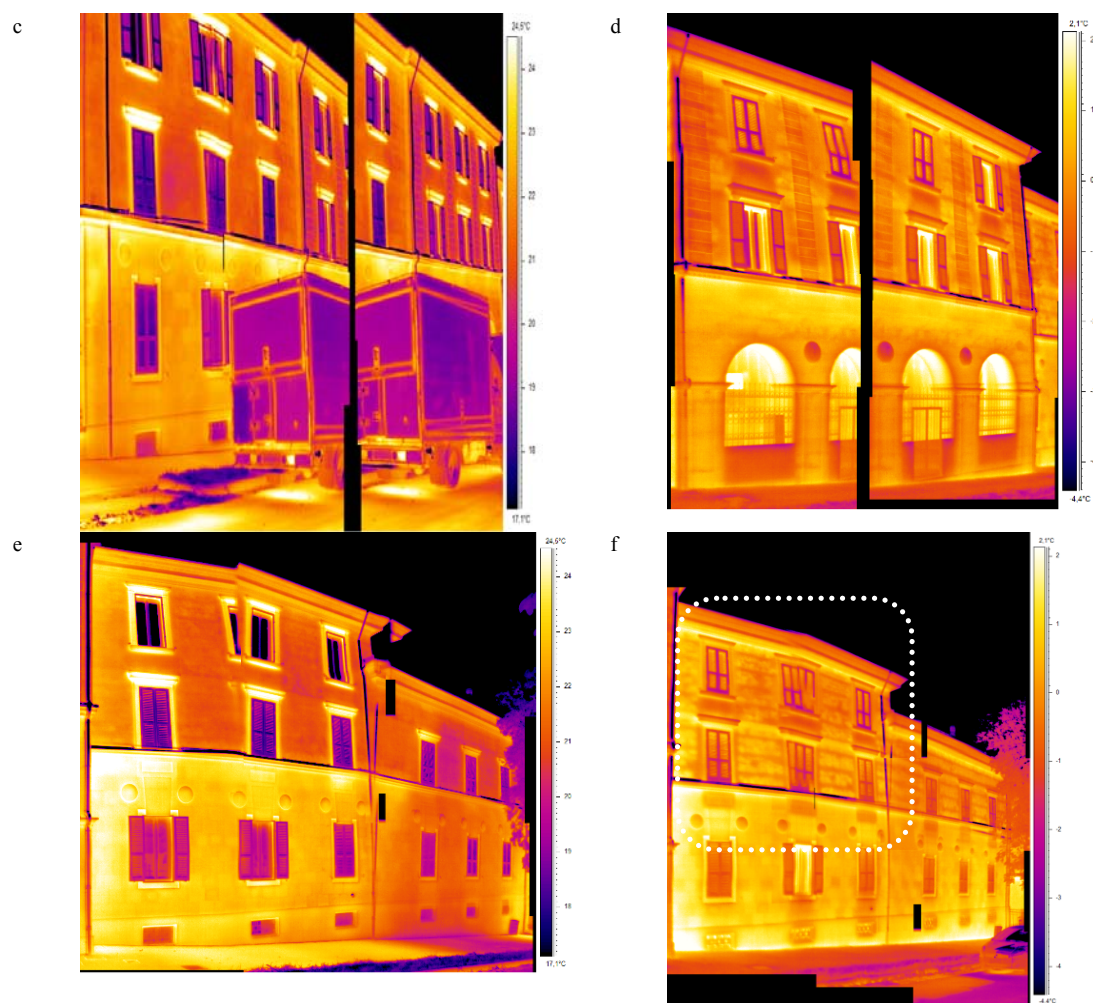
Fig. 7. Thermal images of the building taken in summer (left column) and winter (right column). Viewing angles are those numbered in Fig. 1.

The thermal images clearly show the horizontal layout of bricks in the masonry walls. This arrangement was also documented by photographs taken after the earthquake, as the one of Figure 8 which reproduces the detail of the portion of wall also shown, in the IR spectrum, in Figure 7-f and contoured by a dotted white line.

Another peculiarity revealed by the thermographic inspection concerns the parts of walls which stand below the windows. In fact, since all the spandrels have been insulated with hemp fiber panels thicker than the ones employed for the “regular” vertical walls (since they had thinner wall section, as also shown in Figure 4-b), they reveal a thermal behavior different to rest of the wall.

The paper focuses on the refurbishment of the opaque vertical envelope, realized with the addition of insulating layer from the inside, i.e. by adding hemp fiber panels and two layers of plasterboard. The results show an increase of the thermal performance, which was the purpose of the intervention. Nevertheless, some critical points still remain on the spandrels, as the IR images show.

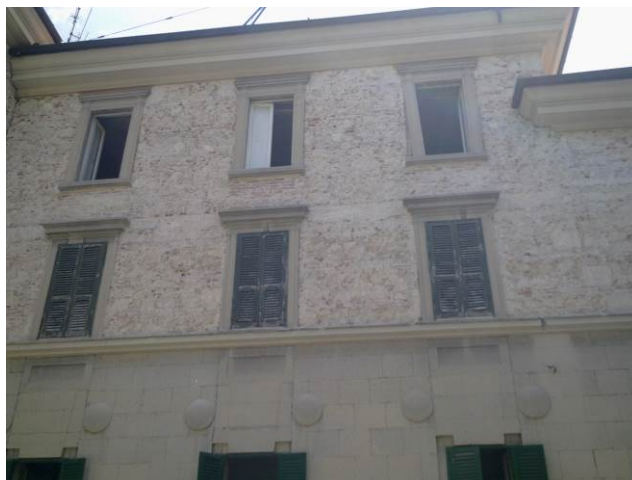
Fig. 8. Detail of bricks layout on the west wall, third floor.

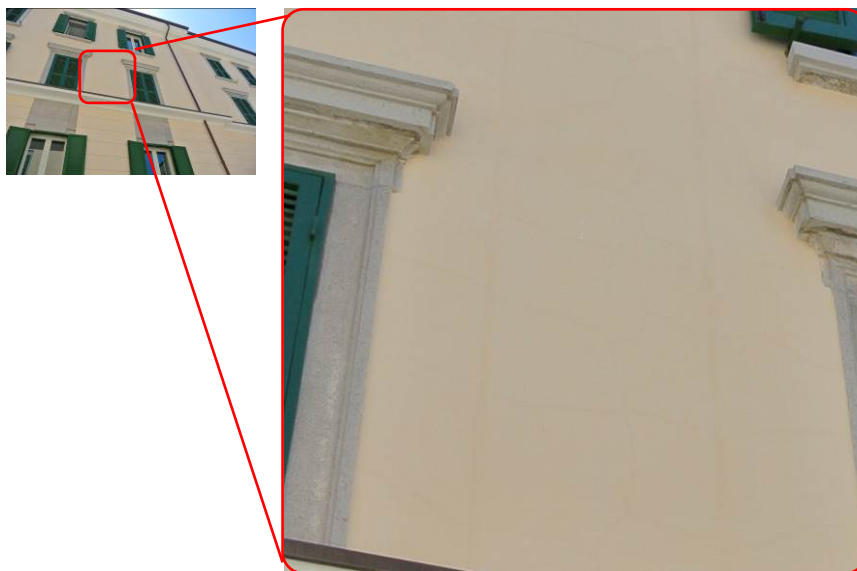
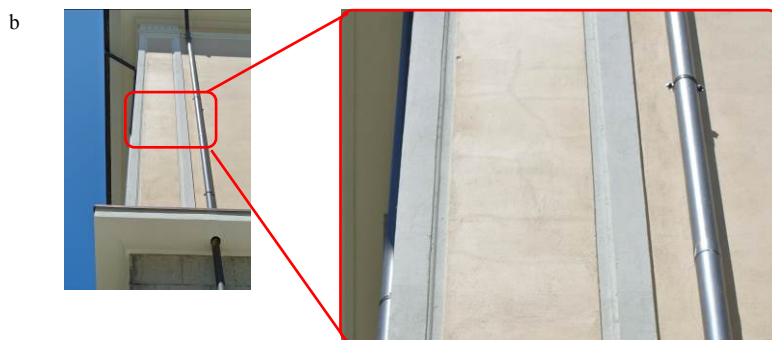
Finally, a detailed examination of the aspect of the façade has been carried out. The building has been visually inspected, together with the two twin buildings that stand on the East side (visible in Figure 1). These two buildings have been refurbished, too, but without the employment of any particular paint on the external wall. The accurate inspection revealed that the employment of the thermoshield paint on the wall lend more elasticity to the plaster. In fact, there aren't cracks or craquelure on the external wall, despite what retrieved on the twin buildings. Figure 9 shows a detail of such micro-cracks.

Fig. 9. Details of craquelures on the building façade not treated with the endothermic membrane. (a) near the window; (b) in proximity of a corner.
