Integration of ground-penetrating radar, ultrasonic tests and infrared thermography for the analysis of a precious medieval rose window

L. Nuzzo¹, A. Calia², D. Liberatore³, N. Masini⁴, and E. Rizzo⁵

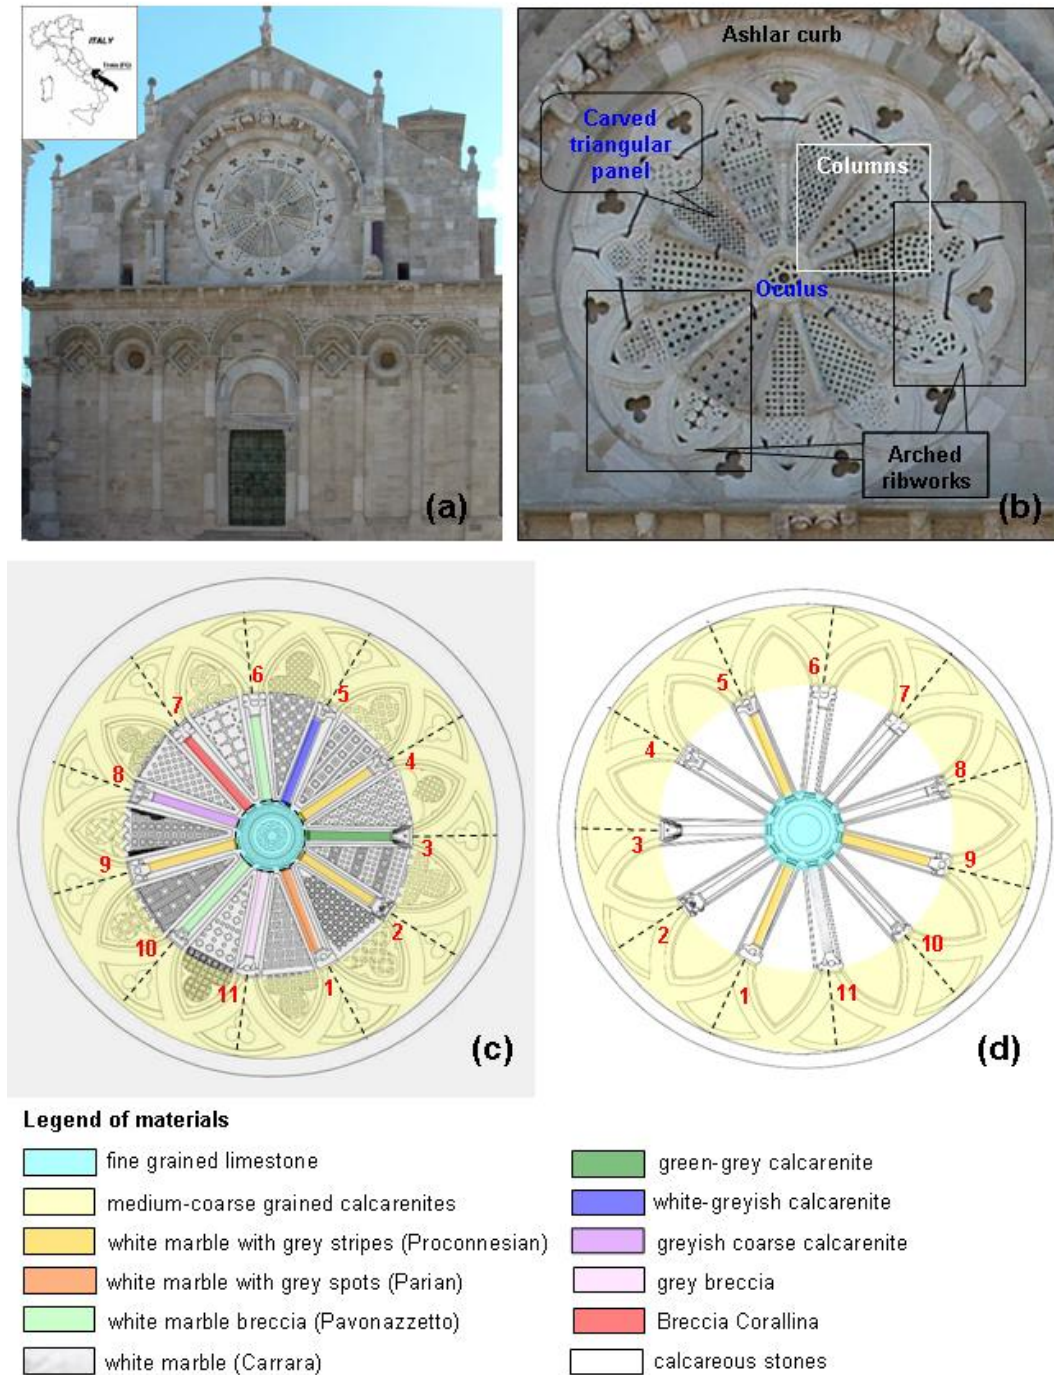
Fig. 1. (a) Façade and (b) rose window of Troia Cathedral (Apulia, Italy). (c) External and (d) internal building materials.

The damage of the façade is also confirmed by the damage of two couples of columns at the sides of the rose window (Fig. 1a). The columns on the right appear splintered, with damage especially pronounced for the column in red porphyry, which has also conchoid fractures in the upper part and in the capital. Both columns are slightly tilted towards the right and inwards. The couple of columns on the left

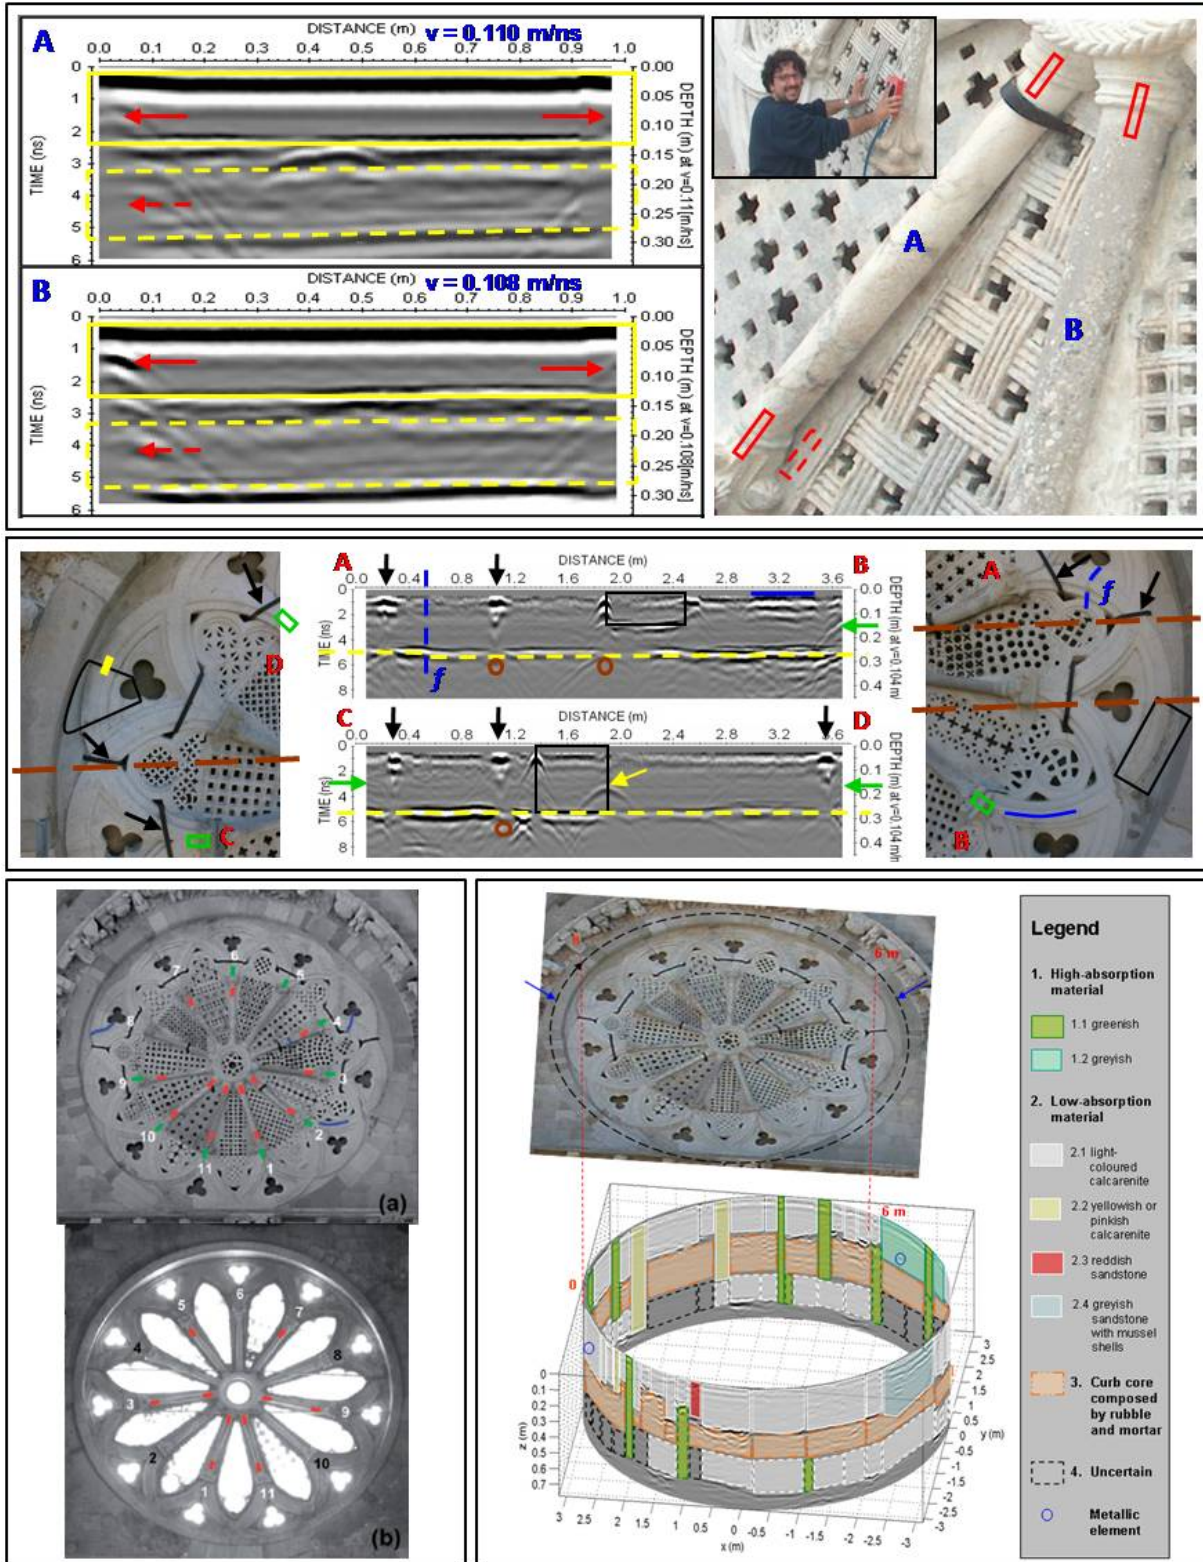
Figure 3 (top) shows the 1500 MHz unmigrated radargrams related to two columns, A made of Pavonazzetto marble and B of grey breccia (right). Each radargram evidences three reflections referable to interfaces between the different materials (external column, inhomogeneous material, internal column). The columns are 10–11 cm thick and are separated by a 3–5 cm thick middle layer, where the carved panels are joined together by rubble and mortar, with possible voids accounting for the hyperbolas in the centre of radargram A. The semi-hyperbolas at the ends of the columns are attributed to the edges of iron anchor bolts linking the columns with the capital and penetrating inside the columns for about 5 cm (red arrows). The different building materials of the external columns reflect into a slightly different velocity value of the EM signal.

The middle section of Fig. 3 refers to the GPR survey on two arched ribworks (left and right pictures). The radargrams show anomalies related to visible (metallic bars -black arrows, fractures -blue lines), partially visible (restored blocks -rectangles, apparently extending for the whole thickness – CD – or just halfway – AB) and invisible features, such as metallic anchor bolts linking the intersecting arched ribworks with the capital or presumably joining a restored piece to the original part (green and yellow arrows) and the metallic tie-beams behind the rose window (brown). Although made of the same stone type (calcarenite), the different reflection amplitude of the left and right part of the air interface in radargram CD denotes the presence of two different materials in the two halves of the arched ribwork in terms of slightly different granulometry and/or water content.

The bottom part of Fig. 3 recapitulates the main GPR findings, namely the location of iron bolts (red and green) and fractures (blue), on the various elements of the rose window (left) and the GPR interpretation of the internal structure of the ashlar curb linking the rose window to the façade masonry (right). It is worth noting that, for the investigated columns (numbered in white), the iron anchor bolts have been detected at both ends, toward the capitals and the oculus, for the lower columns and only toward the capitals for the upper columns (Fig. 3 bottom-left).

The various processed radargrams acquired along the ashlar curb have been joined together and visualized as a single ring-like radargram (Fig. 3 bottom-right) to allow a better appreciation of the spatial relationships and facilitate the correlation with visible features of the curb masonry (e.g. the greenish sandstone ashlars). The composite GPR section highlights alternation of zones characterized by different propagation properties and reflection/diffraction patterns. There are three main discontinuous reflections. The first reflection at 4–5 ns (20–24 cm in depth, using an average

Fig. 3. Main results of the 1500 MHz GPR survey on the columns (top), intersecting arched ribworks (middle) and ashlar curb (bottom-right) with an overview of the GPR findings (fractures and iron bolts) inside the architectural elements of the rose window from the (a) external and (b) internal side of the façade (bottom-left) (see text for details).

velocity of 0.098 m/s) is followed by chaotic diffraction patterns revealing a heterogeneous material, probably rubble. The second reflection is recorded at depths of 40–45 cm and the final reflection is at about 65–66 cm. In some cases only the final reflection is recorded, probably due to the presence of monolithic ashlar, the so-called “diatons”, inserted athwart in the masonry to connect the internal and the external rows of the curb (e.g. for those classified as material 2.2). In other zones no reflection is recorded because of the high absorption of the electromagnetic energy of some ashlar (e.g. for those classified as material 1.1). In most cases these high-absorption zones correlate well with the location of the greenish sandstone ashlar visible from the surface and are more abundant in the upper part of the rose window. In addition, two point-like diffractions (blue circles) are recorded inside the two largest ashlar close to the beginning of the overhanging sculptured arch (blue arrows), exactly where the main failures and rotational strains occurred. The absence of similar anomalies in the nearby arched ribworks suggests that these anomalies could be due to metallic anchor bolts connecting the curb to the external sculptured arch.

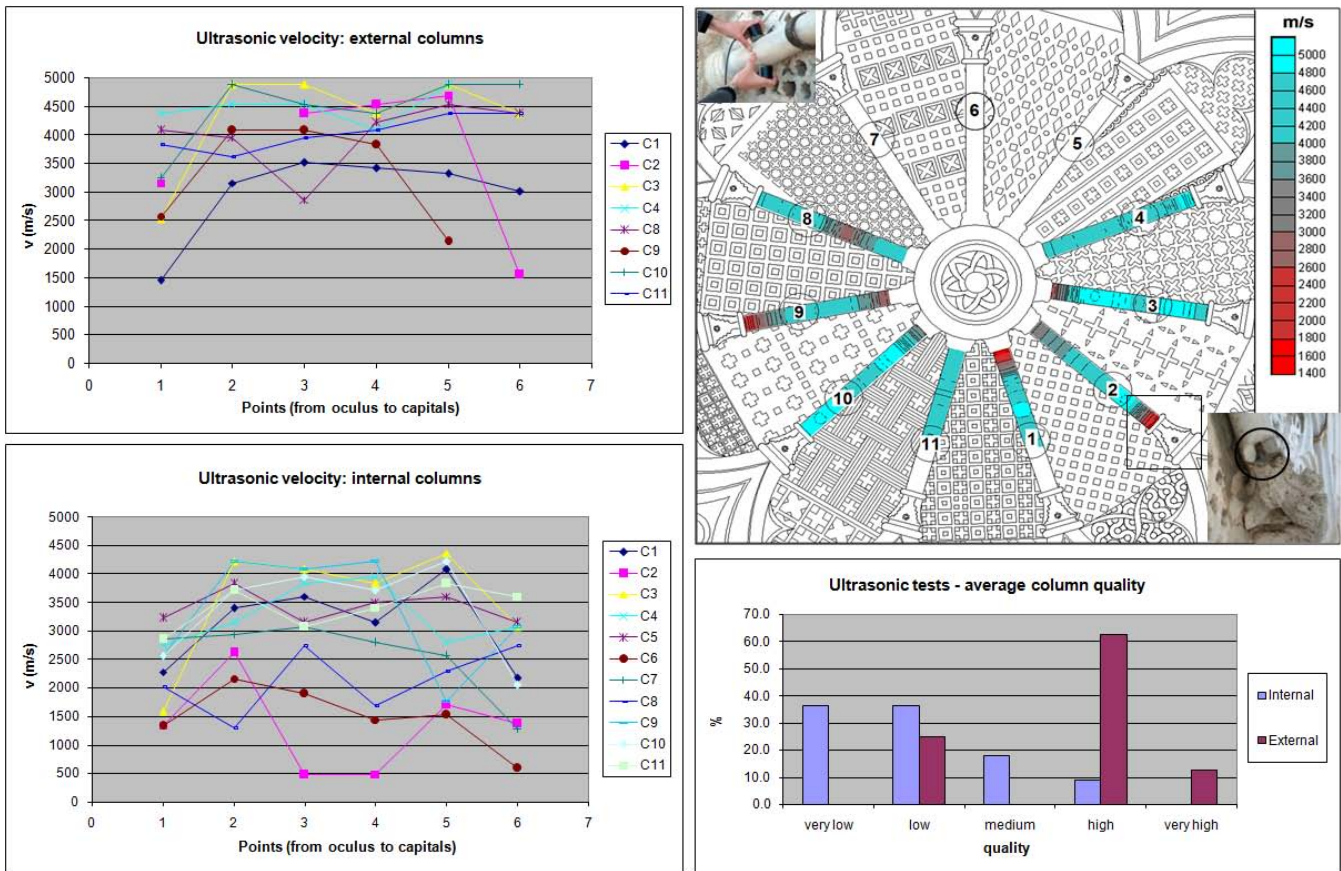
Fig. 4. (Left) Results of the ultrasonic tests on the external and internal columns. (Top-right) Ultrasonic velocity distribution on the external columns with (lower inset) example of low-velocity anomalies related to cracks or material detachment exposing a metallic anchor bolt. (Bottom-right) Column quality classification according to the ultrasonic results.

portion of marble has exposed the iron bolt connecting the column to the capital (lower inset of Fig. 4). Serious deterioration problems leading to material detachments affect also column 9, both near the oculus (see bottom of Fig. 5) and close to the capital. Another notable feature is the local velocity decrease in the middle of column 8 (and to a lower extent in the middle of column 4). This anomaly could be the visible expression of the location of the rotation axis during the past seismic event that caused the rose window to be displaced outwards in the upper part and inwards at the centre, but could also be related to additional (expulsive) strains induced by the metallic tie-beams running just behind them (dashed lines). The internal columns (Table 2) are characterized by a broader distribution of the velocity values with generally much lower average velocity (from about 1500 to 3500 m/s) than the external ones. This reflects the higher heterogeneity and apparently lower quality of the materials employed. In addition to localized defects, it is not excluded that some very low values of the ultrasonic velocity could have been caused by the loss of adhesion of the probes to the stone surface due to the thin plaster covering most of the internal columns.

In order to obtain a semi-quantitative quality classification of the columns based on the ultrasonic velocity, after eliminating the lowest velocity value (linked to defects or poor coupling) their mean velocity to standard deviation ratio has been calculated. Subsequently the columns have been divided into five groups according to a scale from 0 to 25 based on this parameter. In this way, as for their “defect-free” portion, it has been noticed that 5/8 (60%) of the external columns fall into the high-quality category, whilst 8/11 (70%) of the internal columns fall into the low and very-low quality groups (Fig. 4. bottom-right). This is not surprising as more precious materials (mainly reused marbles) have been used for the visible part of the façade and poorer materials (such as bricks and calcareous stones) for its hidden side. Finally, Table 3 summarizes the results of the ultrasonic survey and correlates the measured velocity with the column materials and observable state of decay.

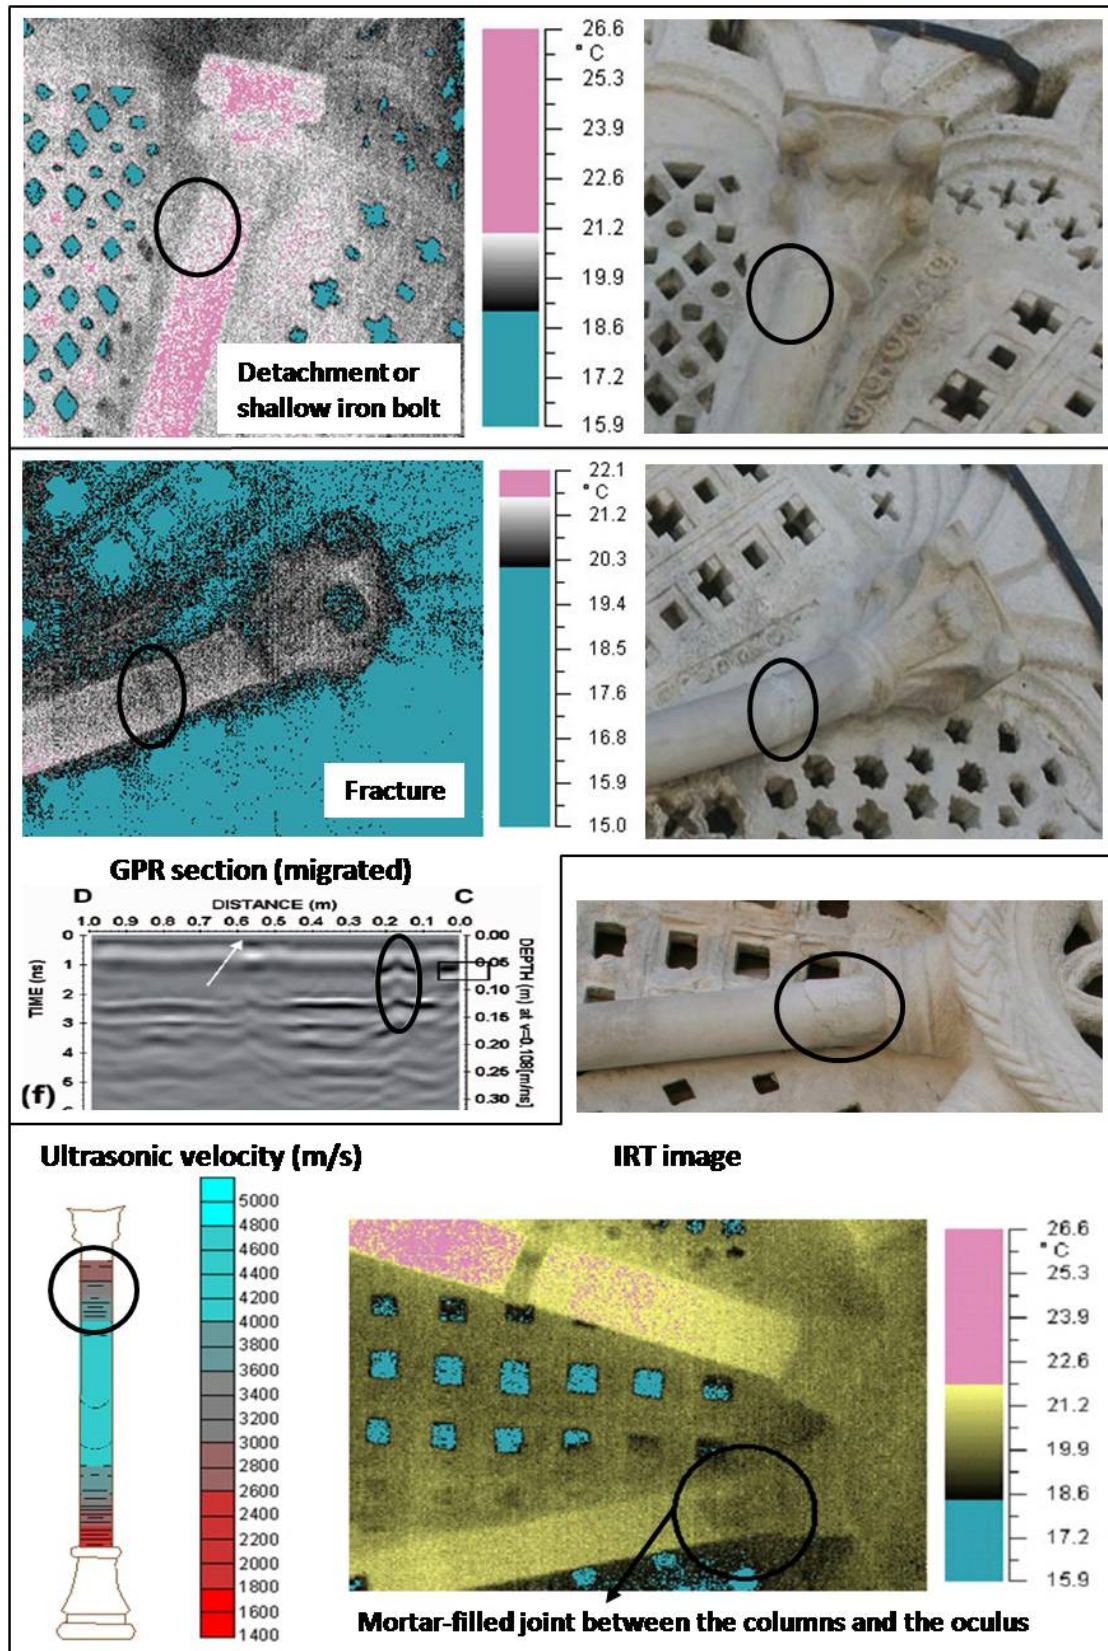
(8–10 μm) where most of the objects at ambient temperature emit the maximum energy. The system has a thermal resolution of 0.15 °C and a spatial resolution of 14.0 mm \times 13.7 mm at a recording distance of 10 m. Minimal image processing was applied to enhance subtle temperature variations. In Fig. 5 the most important thermal anomalies are compared with high-quality pictures, as well as GPR and ultrasonic results. Although the fracture evidenced by the IRT image is also well visible in the picture and clearly identifiable on the corresponding radargram (Fig. 5 middle), the presumable detachment (or the presence of a shallow iron bolt colder than the embedding stone) causing a subtle thermal decrease near the capital is hardly recognizable to the naked eye (Fig. 5 top). In addition the IRT technique was able to detect conservation treatments, such as the thermal anomaly related to the mortar-filled detachment near the joint between column 9 and the oculus that correlates well with the low-velocity value in the corresponding ultrasonic test (Fig. 5 bottom).

Fig. 5. Examples of IRT images and comparison with high-resolution photographs, 1500 MHz GPR investigations (middle) and ultrasonic tests (bottom).
