Chinese Journal of Aeronautics

# Data-driven reliability analysis of Boeing 787 Dreamliner

Guru PANDIAN<sup>a</sup>, Michael PECHT<sup>a,\*</sup>, Enrico ZIO<sup>b</sup>, Melinda HODKIEWICZ<sup>c</sup>

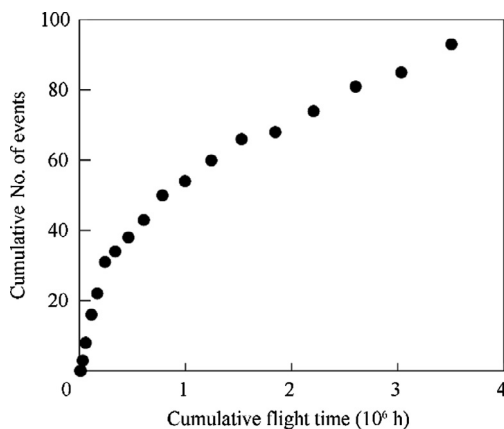
Fig. 1 is a time-cumulative event plot of event data from Table A1 and A2 and other databases mentioned above. We note that the slope of the plot decreases with increasing time. This is indicative of increasing reliability. The Duane plot in Fig. 2 shows the trend of cumulative Mean Time Between Failures (MTBF) over the flight hours. It can be seen that there is a sharp inflection point at around 115000–160000 hours, which corresponds to the period in the first quarter of 2013. The approximately straight line after the inflection point suggests that the data are consistent with an NHPP (Non-Homogeneous Poisson Process) power law model, which allows us to model the reliability growth using the Crow-AMSAA model.<sup>22</sup>

Fig. 1 Number of flight time hours vs. failure events of the 787 aircraft.

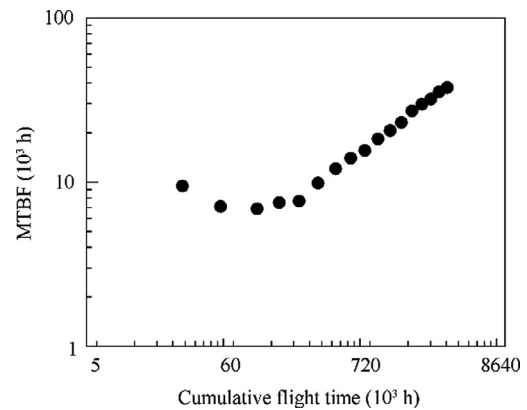
Fig. 2 Duane plot of flight time vs. cumulative mean time between failures (MTBF).

The value of  $β$  of 0.7 ( $< 1$ ) in Table 2 suggests a decrease in failure rate over time and is indicative of reliability growth. Examining Fig. 2, it can be seen that the reliability of the 787 aircraft (as measured by the MTBF) was deteriorating until the grounding and started improving after the aircraft returned to service (fourth data point). Other parameter estimates such as DMTBF (demonstrated or instantaneous mean time between failures) and DFI (Demonstrated or instantaneous Failure Intensity) are also reported. Their positive values follow from the corrective actions taken by Boeing during the aircraft grounding period, as well as due to a somewhat natural reduction of those problems that typically emerge during the initial stages of the aircraft operation.
