Microstructural investigation on an Al 6061 T6 alloy subjected to ballistic impact

C. Mapelli^a, A. Manes^{a*}, M. Giglio^a, D. Mombelli^a, C. Baldizzone^a, A.
Gruttadauria^a

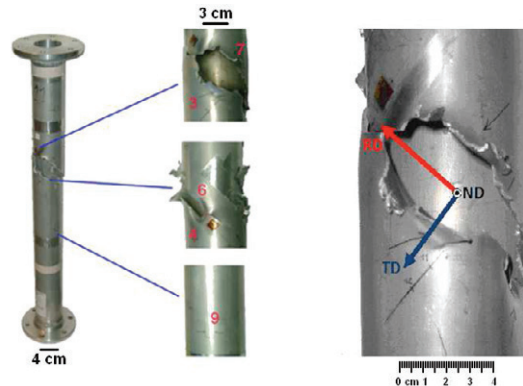
The Fig. 1 shows the damage configuration caused by the high speed impact produced by the bullet on the rotor shaft surface; the highlighted areas correspond to the sites where the investigated specimens are harvested. Sample #3 and #7 have been taken in the area adjacent to the exit zone of the projectile; this area is affected by compression residual stresses. While sample #4 and #6 have been taken in the area adjacent to the entry zone of the projectile; this area is affected by tensile residual stresses a [5]. Specimen #9 is selected such as reference zone in order to investigate the crystallographic configuration of healthy (far from damage) rotor-shaft.

Fig. 1: Image of the whole rotor shaft studied and of the specific areas of interest (on the left), representation of the reference system employed for the EBSD analysis (on the right). RD=Rolling Direction, TD=Transverse Direction and ND=Normal Direction.

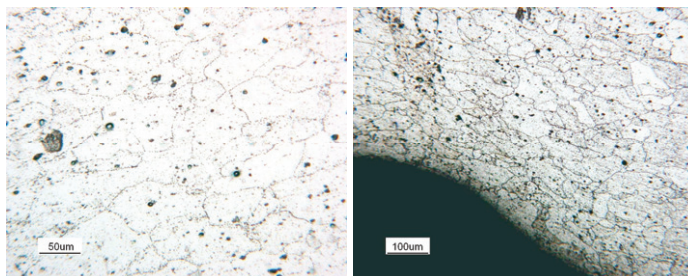
The early stage of the work concerns microstructure investigations obtained by direct observation of the micro etched sample surfaces (Fig. 2). The microstructure on the edges of the damage features more elongated grains in the impact direction, while moving away from the fracture the grains appears to be randomly dispersed. Thus, it is safe to assume that such deformation is directly related to a dissipation phenomenon of the propagation stress, as the deformation is exclusively related to the rim of the damage. The comparisons among undeformed grain and the ones near the damage surfaces point out a significant deformation.

Fig. 2: Micrographies of (a) undeformed structure (#9) and (b) edge of damaged area (#3)

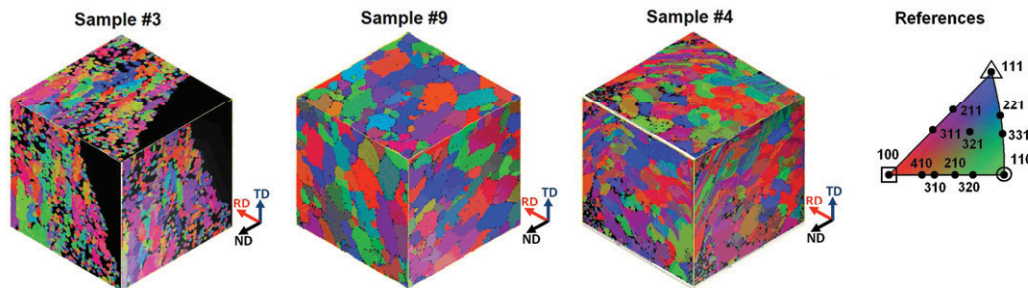
Fig. 3: Diffraction images along the three directions, normal, rolling and transverse of samples #3, #9, #4.

As evident from comparing the images for the different conditions, the areas not affected by the ballistic damage differ quite a bit from the edges of the fracture (Fig. 3). Specifically, the specimens harvested from areas distant from the damage indicates a quite isotropic orientation distribution, i.e. the diffraction images shows a wide dispersed range of orientation and the inverse polar pictures do not indicate any preferential direction (Fig. 3, #9 and Fig. 4, #9). On the other hand, the EBSD analysis on the area close to the damage produces diffraction images where the grains on the rim presents a quite precise and intensive rotation along the propagation axis (see the grains featured by a purple and brown colours on Fig. 3, #3 along RD direction). This observation is further confirmed by the inverse polar images, which describe a structure featuring few defined orientations (Fig. 4, #3). Therefore, it is safe to conclude that, as observed by means of optical microscopy, the damage causes a transition from an isotropic dispersion to a narrower

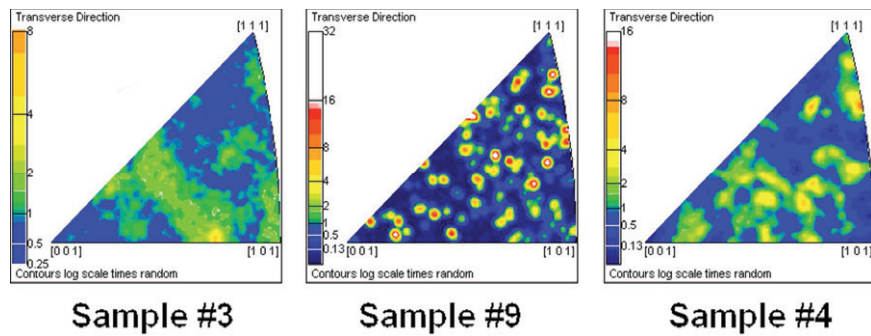
Fig.4: Inverse polar figure, respectively in the region undergoing tensile stress, undeformed region, then the one undergoing compression one.

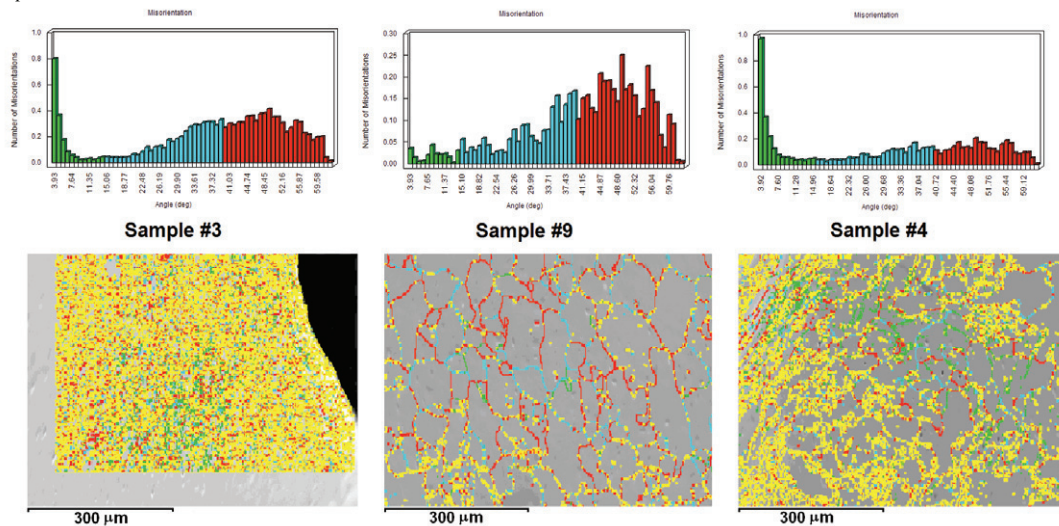
Fig. 5: Misorientation distribution of the different areas of the rotor shaft examined.

The comparison among the grain boundary misorientation featuring undeformed region and the one deformed by bullet impact points out that after the impact the angle of misorientation between the different grains is strongly lowered toward low boundary angles (lower than 15°) (Fig. 5). The increase of

the number of boundary featured by low misorientation (Fig. 5, #3 and Fig. 5, #4) constitutes a very favourable pattern for the successive propagation of a fatigue crack, because it is known that fatigue cracks do not recognize low angle of misorientation as grain boundaries that can constitute obstacle to surface propagation [5,6]. Fatigue crack can nucleate and growth on the edge of the damage during application of spectrum load representative of a recovery mission of the helicopter after the damage [7]. The zone interested by tensile residual stresses, #4, shows a more distributed textural situation (Fig. 4, #4) indicating that a higher number of deformation pattern have been activated as shown by less intense alignment of the grains along particular fibre, while the grains of the region subjected to compressive stress, #3, tend to concentrate in a narrow textural pattern (Fig. 4, #3). This implies that during an eventual successive loading the compressive residual stresses regions, #3, are featured by a lower attitude to dissipate the provided work. This conclusion is further confirmed by another EBSD analysis conducted by the same authors on mechanical test specimens subjected to different load conditions [8].
