## Failure analysis of a shaft of a car lift system

D. Crivelli<sup>a</sup>, R. Ghelichi<sup>a</sup>, M. Guagliano<sup>a,\*</sup>

<sup>a</sup>*Politecnico di Milano, Dipartimento di Meccanica - via La Masa 1, 20156 Milano (Italy). Tel: (+39) 0223998206*

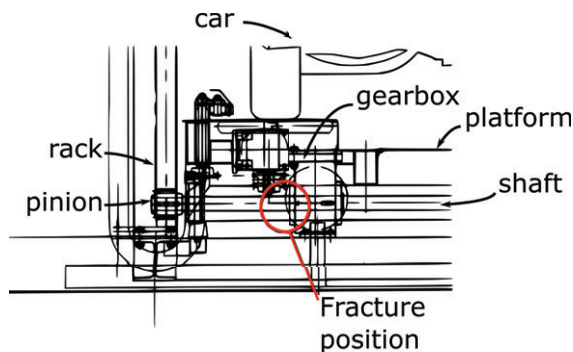
The elevator consists of a platform (Figure 1), on which the car is placed by the driver. The platform is moved and supported by a rack-and-pinion system. The platform is placed on two shafts, connected to a motor with a gearbox. It is interesting to note that the gearbox is not centered longitudinally; this makes the torque not well balanced between the two sides of the supporting shaft.

**Figure 1:** Detail of the elevator platform

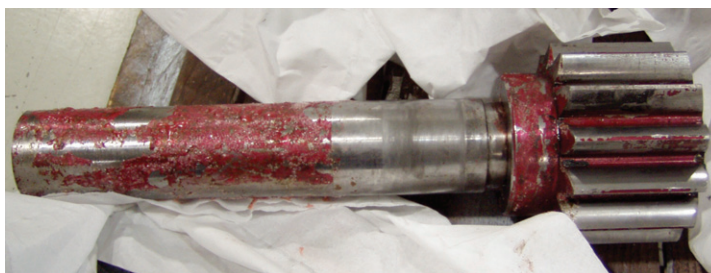
**Figure 2:** Section of the broken shaft with the pinion still mounted

The documentation available also proved that the maintenance had been regular. Since the damage was evident (the shaft was split in two parts, see Figure 2), only the two shafts that sustained the platform, along with the gearboxes, were taken away.

The shaft broke near the gearbox enclosure. The breaking zone lies near a slot, which is situated in the *short side* of the shaft. The slot is used to fit a seeger ring for the mounting of a gear.

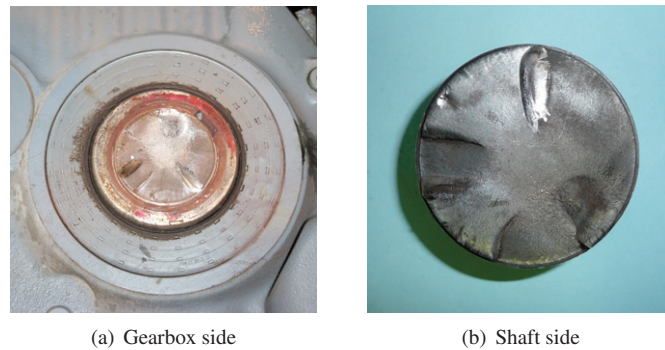
The fractured surface doesn't show noticeable deformations. A very wide shiny zone, typical of fatigue damage, can be seen in Figure 3.

**Figure 3:** Fracture section surfaces

There appear to be multiple crack nucleation points on the outer circumference; this is typical of strong notch effect zones. The final fracture area is small, which leads to the conclusion that the section has been safe (at least statically) regarding applied loads.

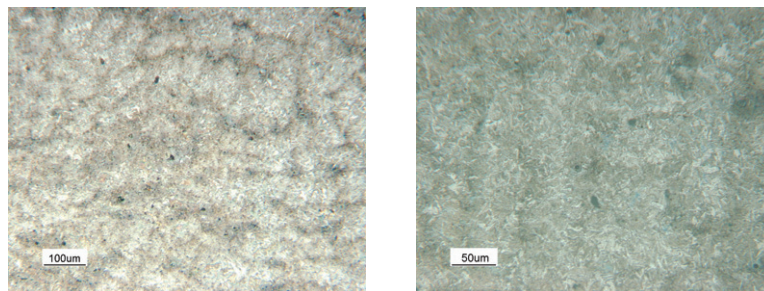
**Figure 4:** Optical microscope images

Observation on both samples showed a mainly martensitic structure. The chemical composition is reported in Table 2. The Cr levels are unusually high for this material (C45), and include

(besides Fe and C), also Chromium (1%), Nichel (0.5%). This may indicate that the material was a more performing steel than C45. Additionally, no relevant defects or inclusions were visible.

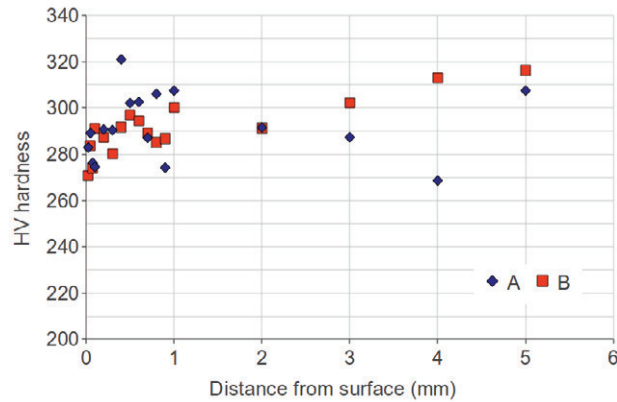
The hardness tests confirm the results of the chemical analysis, leading to think that this steel has an ultimate strength of about 900-1000MPa.

**Figure 6:** Microhardness tests on sample B, positions A and B

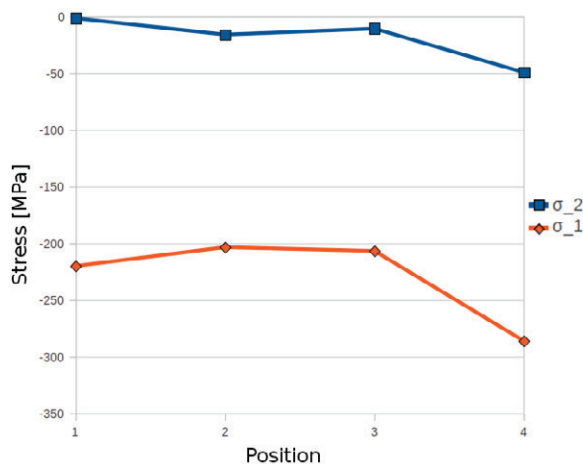
The principal stress direction is mainly in the machining direction (turning), in the tool cut-

**Figure 7:** Residual principal stresses  $\sigma_1$  and  $\sigma_2$  on the sample

ting direction the stresses are compressive and with an amplitude which is coherent with the machining method. The  $\sigma_2$  stress is negligible. Since the stresses are compressive they are considered not dangerous.

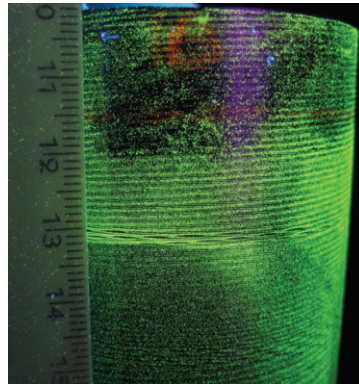
**Figure 8:** MPI inspection: signal of a turning problem

During this inspection no fracture was found. However the particles highlighted that the surface roughness degrades in the direction of the gearbox, and a signal of problems during the turning of the shaft was found (Figure 8).

We also proposed some corrective actions to avoid such failures, to be verified during the re-design process: modification of the geometry of the critical section. in particular by removing or smoothing the slot; modification of the turning process parameters, ensuring a more uniform surface roughness of the shaft; execution of a surface treatment to increase the fatigue life of the component, such as shot peening or induction hardening.

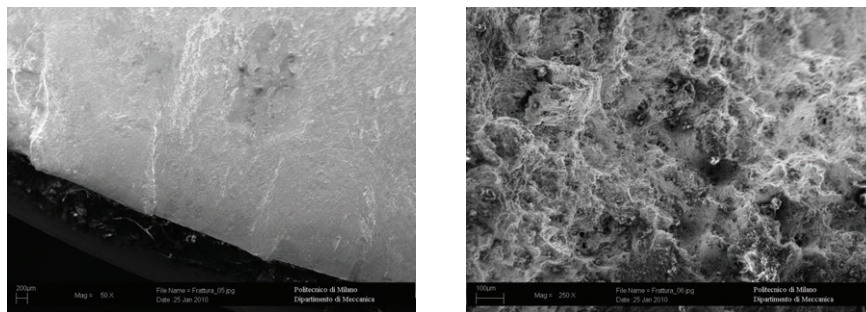
We analyzed the fracture surfaces at a electron microscope (SEM). The fractographic analyses evidenced the presence of multiple surface crack initiation points, due to a severe stress intensification factor. The sudden breakage zone is small, as said before. In Figure 9 the crack initiation points can be noticed, and the breakage zone has a ductile aspect. Also, no signs of corrosion were found, neither in the surface nor in the crack initiation points.

Figure 9: SEM fracture surface images
