Use of FBG sensors for monitoring cracks of the equestrian statue of Bartolomeo Colleoni in Venice

F. Felli, A. Brotzu, D. Pilone, C. Vendittozzi

KEYWORDS. FBG sensors; Health monitoring; Crack monitoring; Restoration; Colleoni equestrian statue.

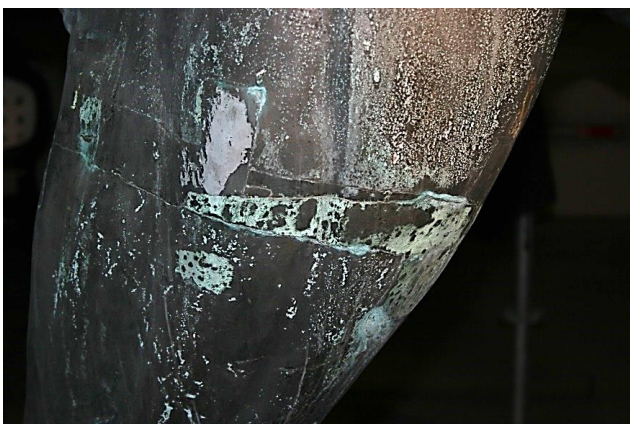
On the right foreleg in correspondence of the welding seam an extended crack affects almost the whole section of the thigh (Fig. 1). In some places the crack branches into two or more paths. This crack was probably formed already during the welding seam cooling, in fact it is possible to find in it shrinkage cavities. The reinforcement of the right foreleg with an internal iron bar (Fig. 2) suggests that Leopardi had already identified this crack.

Figure 1: Macrograph showing the crack in the right foreleg of the horse.

The monument repair by means of welding was not recommended considering that welding could have a negative impact on the monument with unforeseeable consequences. For that reason the crack has been monitored by means of FBG sensors that should allow to evaluate the crack criticality and to check the crack propagation over the years. Obviously this methodology can be used only if sensors are left on the statue and appropriately hidden.

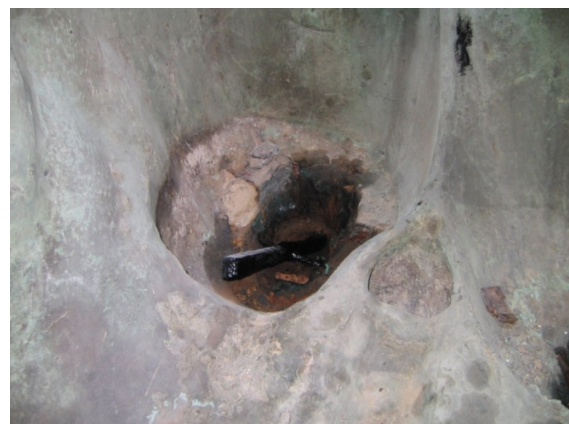
Figure 2: Detail of the internal part of the horse right foreleg showing the iron bar used as a reinforcement.

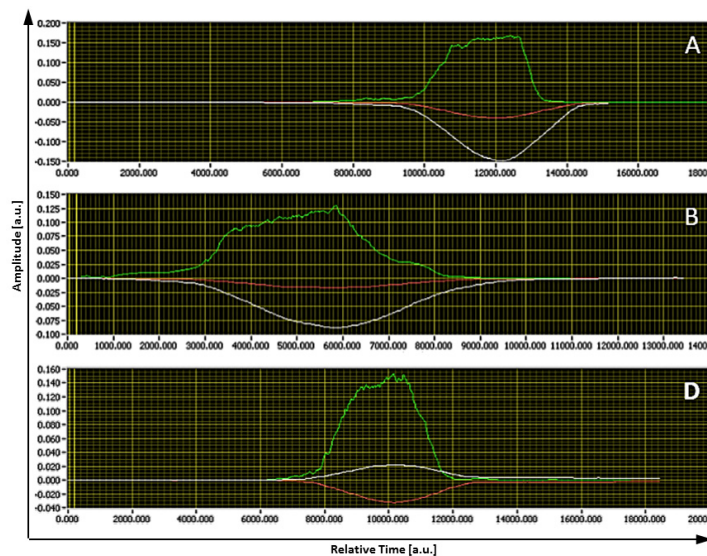
Tests highlighted the good response of the sensors showing that when load is applied on the points A and B the crack closes (compression) while the application of a load on the point D produces an area subjected to compression and an area subjected to tension. Fig. 8 shows the graphs of the second array of sensors, always in arbitrary units. They highlight again the deformations detected by the sensors but in this case, as indicated in the figures, the load trend is represented by the blue curve.

Figure 7: Deformation detected by sensor 1541 (white line) and by sensor 1545 (red line) when load (green line) is applied in correspondence of points A, B and D.

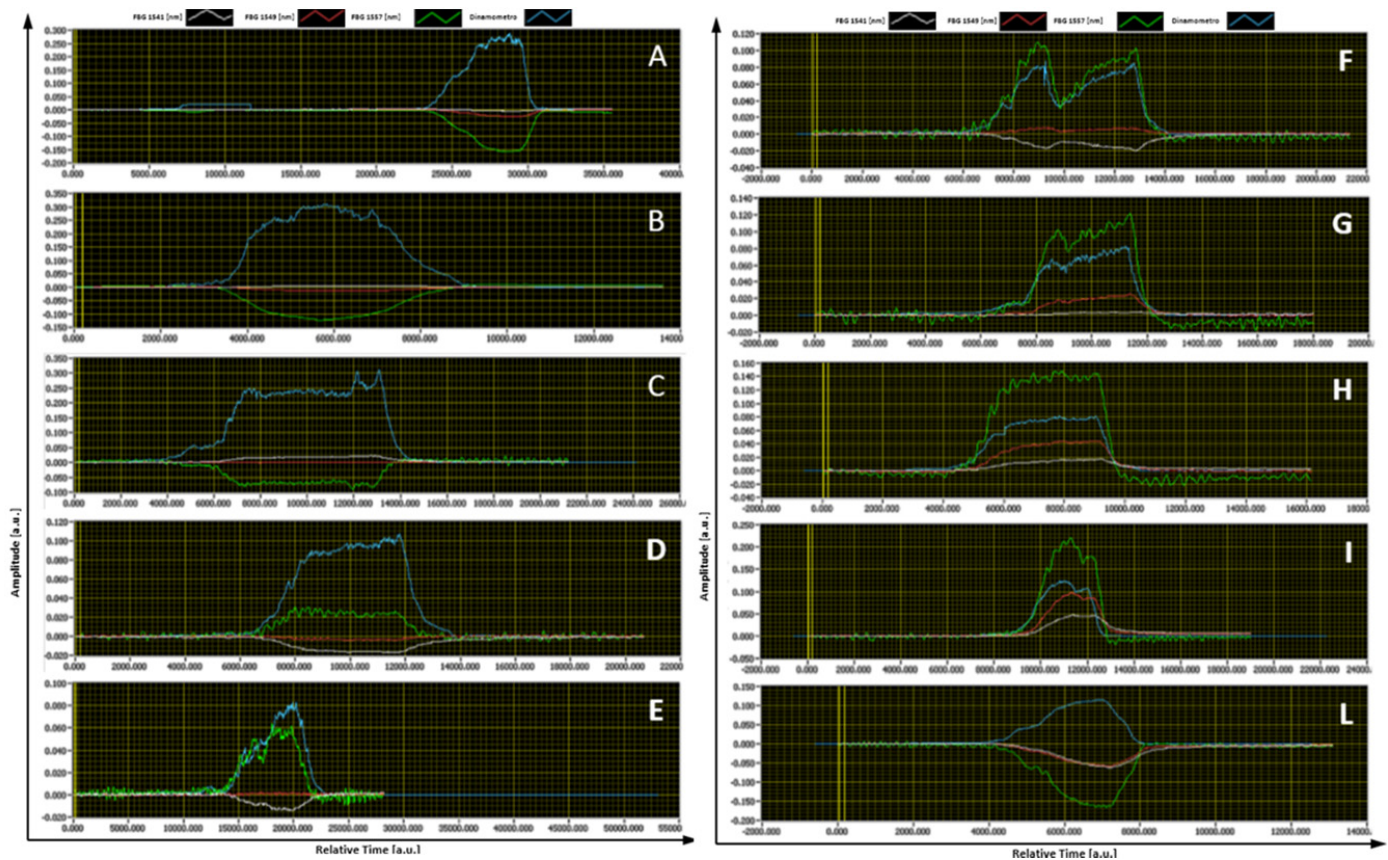
Figure 8: Deformation detected by sensor 1541 (white line), sensor 1549 (red line) and sensor 1557 (green line) when load is applied in correspondence of points A, B, C, D, E, F, G, H, I and L. The load trend, measured by a 500 N dynamometer, is described by the light blue line.

It should be immediately pointed out that the most stressed crack area was on the front of the horse where the sensor 1557 is located. By moving towards the rear of the foreleg deformations are significantly reduced (sensor 1541). A further important information can be gathered considering the points of load application and distinguishing those on the right (L, A, B, C, D) from those on the left (I, H, G, F, E) of the horse. The points are taken from the front to the rear of the horse. When loads are applied on the right side the crack always closes. The only exception is the position D, at the extreme rear of the horse, where the load application determines the crack front opening. When loads are applied on the left side of the horse the crack opens predominantly on the front (sensor 1557). Even in this case by applying the loads in the posterior areas of the horse (F and E) the rear part of the crack behaves differently and closes (sensor 1541).

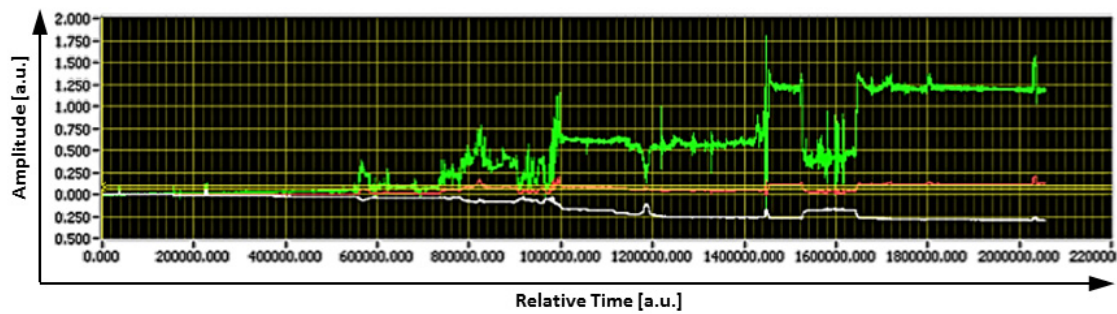
The plot in Fig. 9 shows the trend of the crack deformation during the repositioning of the rider. It highlights an important opening of the crack always in the front area where the sensor 1557 is located. The crack does not deform in his central area (sensor 1549), while it closes in the posterior part of the foreleg (sensor 1541).

Figure 9: Data acquired during the rider repositioning by means of sensor 1541 (white line), sensor 1549 (red line) and sensor 1557 (green line).

It was possible to measure in real time the crack deformation while repositioning the rider on the horse. The obtained data highlighted that the crack was not critical.

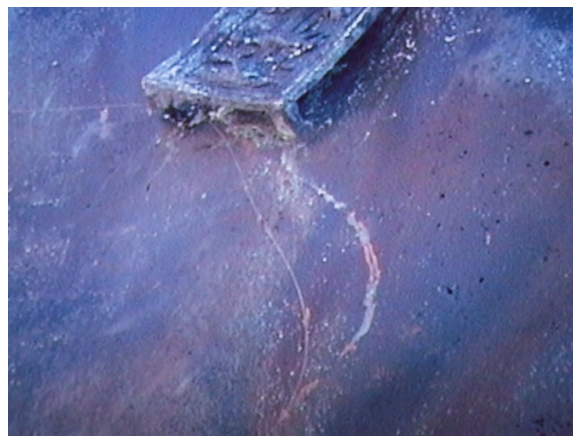
In 2006 the monument restoration was completed but the crack monitoring over time was not possible because of logistical and bureaucratic problems. For this reason the results of this research have been published after several years. In any case a photographic reconnaissance carried out after 4 years in the area in which the sensors were positioned showed that the sensors detached from the metallic surface (Fig. 10). This suggests that more efforts must be devoted to the study of sensors' bonding and coating in order to ensure long lasting bond [8, 9].

Figure 10: Macrograph showing the sensor detached from the metallic surface.

As far as the continuous monument monitoring is concerned some bureaucratic, technical and logistical difficulties arose. Especially the sensors' gluing and coating durability over time is a considerable problem. In future research efforts should be made to increase their durability with the aim of making the proposed technique reliable over time.
