AIAS 2018 International Conference on Stress Analysis

Fatigue life evaluation of car front halfshaft

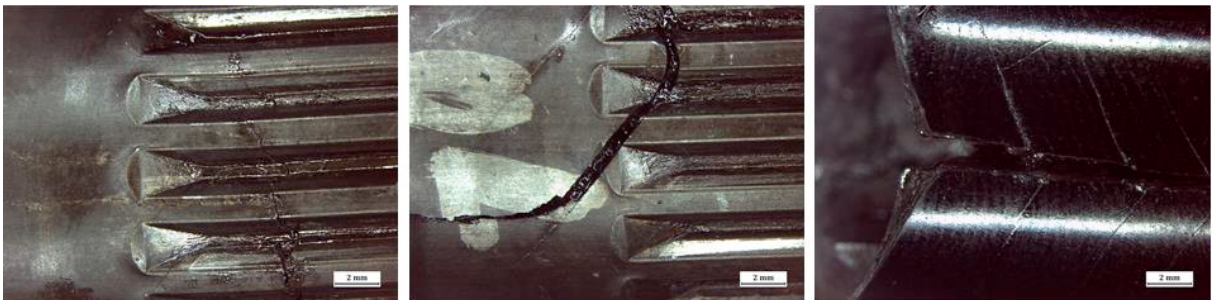
produced by hammering prior to the break, and a rough area, due to a sudden brittle failure. Detailed observation at microscope of the crack shows that it starts from the root of the spline profile (Fig. 5a), propagate transversally along the teeth then it deviates from an angle of 45° (Fig. 5b) and propagate longitudinally up to the failure zone (Fig. 5c).

One of the reason because the crack starts at the spline profile is due to the complex geometry and the local mechanical machining which lead to a high stress concentration factor. Another reason could be the forcing of the tripod on the spline profile, which causes residual stresses in that critical zone of the halfshaft.

Fig. 5. (a) Crack at the root of the spline profile; (b) Crack propagate along the teeth; (c) Crack propagate lengthwise up to the failure zone.
