Fatigue Design 2019

Recent Advances in Spline Couplings Reliability

F. Curà^{a,*}, A. Mura^a, P. Saenz de Ugarte Sevilla^b

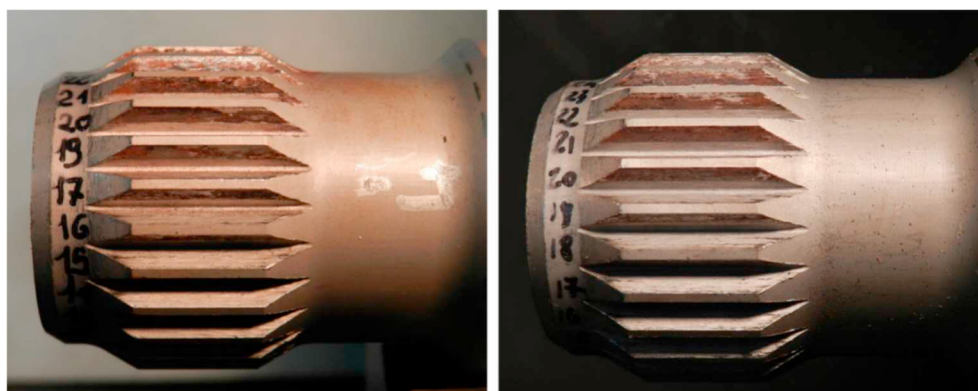
Fig. 3. Fretting wear: spline coupling after 500.000 cycles (left) and after 2.000.000 cycles (right).

Figure 3 shows the spline coupling after respectively 500.000 cycles (on the left) and at the end of the test (on the right). Surface damage identified as fretting wear can be seen in both images; iron oxide traces may be observed more evidently on the surfaces of teeth 21, 22, 23.

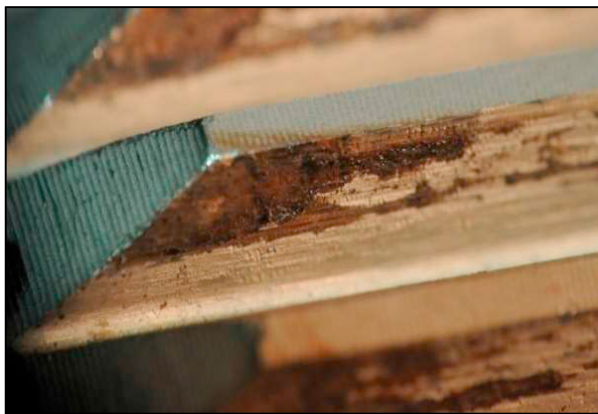
Figure 4 points out a particular zone related to the previous image represented in Fig. 3 on the right. On one side of the tooth, some adhesion may be noted.

Adhesion is caused by transfer of material from one tooth surface to another due to microwelding and tearing.

It generally can be categorized as mild or moderate if it is confined to surface films and oxide layers on the tooth surface, as in this case.

Fig. 4. Tooth area subjected to fretting wear retting wear after 2.000.000 cycles.

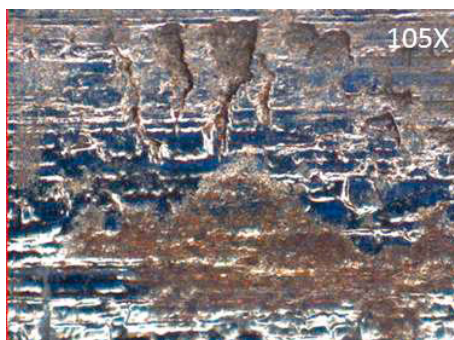
At the end of the test (2.000.000 cycles) it is evident (see Figure 5) the polishing effect on the teeth surfaces, that is more emphasized respect to the first part of the test (after 500.000 cycles).

As observed in ANSI/AGMA 1010-F14 (2014) for gears, polishing is fine-scale abrasion that causes the teeth surfaces to have a bright mirrorlike finish. Under magnification (see Figure 5), the surface appears to be covered by fine scratches that are oriented in the direction of sliding.

Fig. 5. Polishing after 2.000.000 cycles.

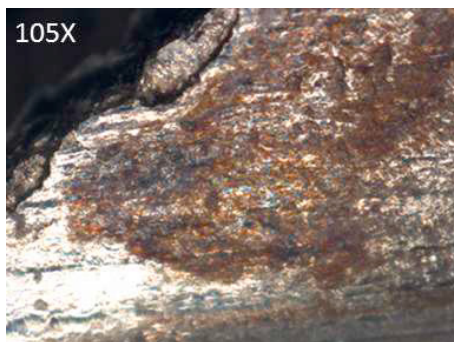
Also micropitting may be observed on the spline coupling at the end of the test, as shown in Figure 6.

Generally, micropitting is influenced by operating conditions, particularly load, speed, temperature, lubrication. Under magnification, as showed in Figure 6, the surface appears to be covered by very fine pits that are typically less than 10 - 20 μm deep.

Fig. 6. Micropitting after 2.000.000 cycles.

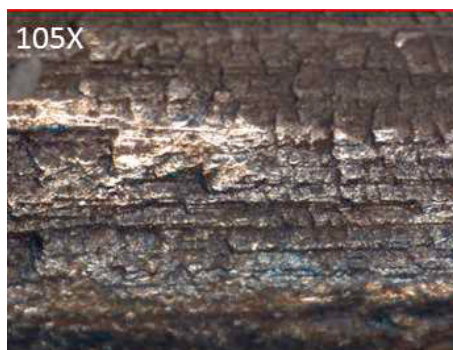
Some area of abrasion (scoring) may be also identified in the specimen. Abrasion is the removal or displacement of material due to the presence of hard particles: for example, metallic debris, scale, rust, sand, or abrasive powder, suspended in the lubricant or embedded in the flanks of the mating teeth. Abrasion causes scratches or gouges on the tooth surface that are oriented in the direction of sliding; under magnification, the scratches appear as parallel furrows that are smooth and clean, as shown in Figure 7. In this case, abrasion becomes more severe during the second part of the test.

Fig. 7. Abrasion (scoring) after 2.000.000 cycles.

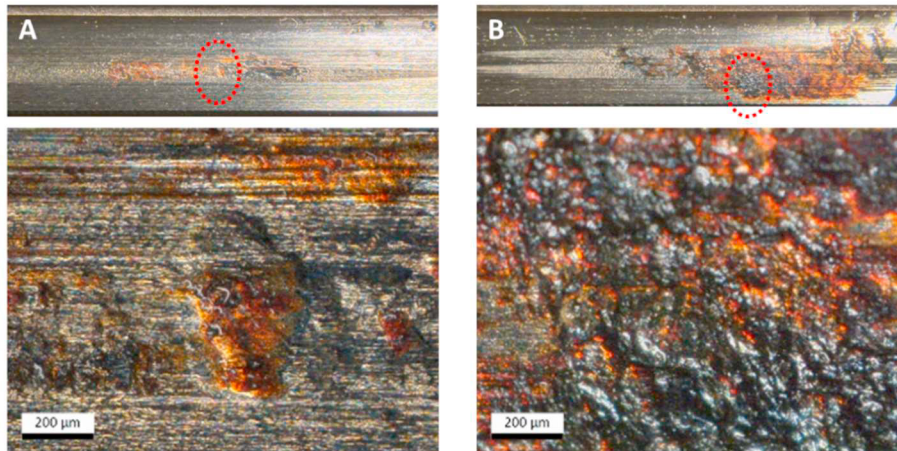
The main identified wear damage is an extended corrosion that can be associated to fretting corrosion (Fig. 8). A kind of abrasion was also identified (Fig. 9).

Fig. 8. Example of wear damage (fretting corrosion) on spline coupling lubricated with grease/GNP compound.

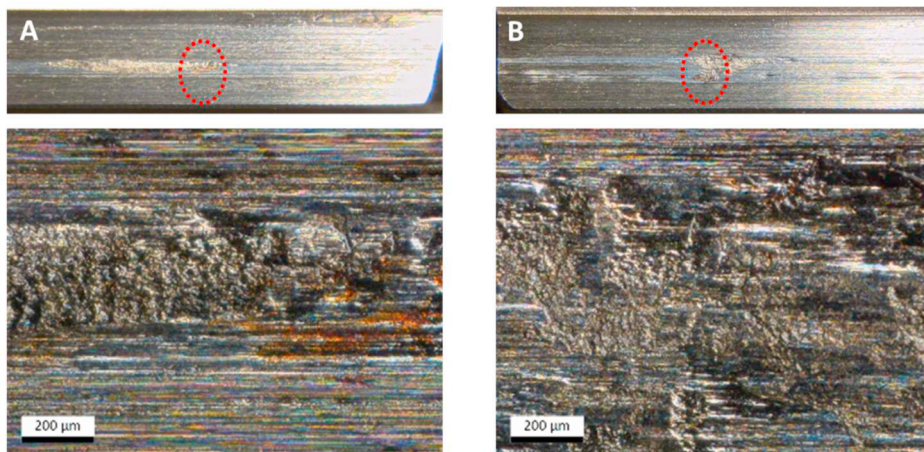
Fig. 9. Example of wear damage (abrasion) on spline coupling lubricated with grease/GNP compound.
