ECF22 - Loading and Environmental effects on Structural Integrity

# Hydrogen Embrittlement in pipelines transporting sour hydrocarbons

G.Gabetta<sup>\*a</sup>, F.Pagliari<sup>a</sup>, N.Rezgui<sup>b</sup>

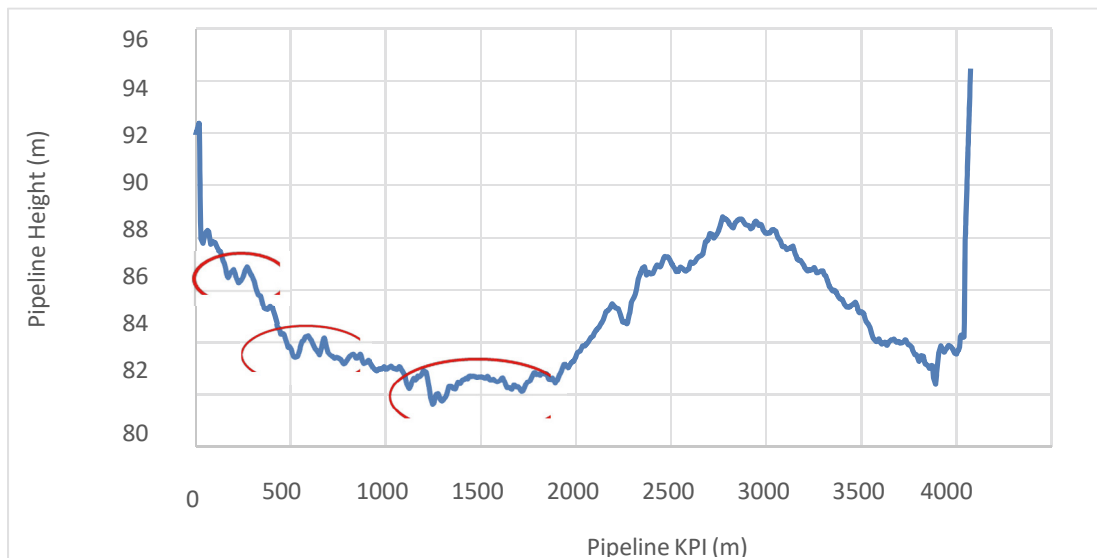
A flow-dynamics simulation of the geometric shape of a 14” pipeline was made. The examined pipeline is supposed to carry a fluid with water cut equal to 1.4%. In this situation, the flux is dispersed and no water hold up is evidenced. To obtain a sensitivity analysis, the run was repeated with the following values for Water Cut (WC): 5%, 10%, 15%, 20%, 50%. Results show that water hold-up can be expected - only for WC larger than =15% - in the pipeline sections evidenced in red in Figure 2.

Fig. 2: Water Hold-up location estimate in a pipeline

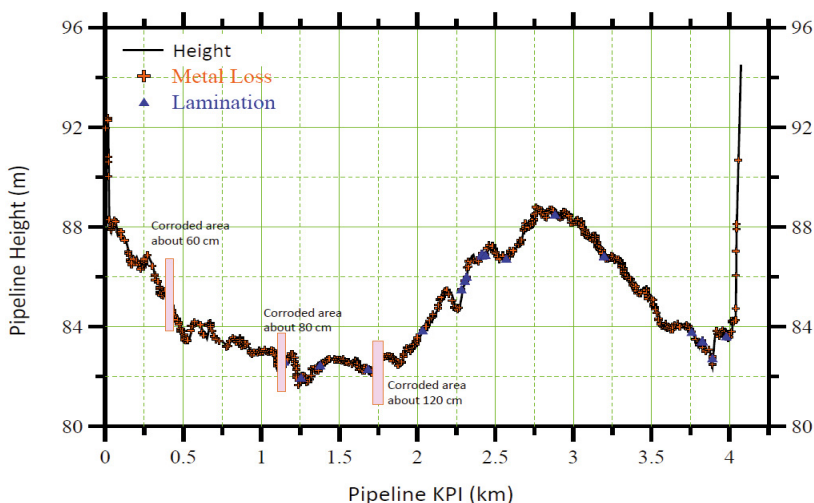
The position of corroded areas observed by the MFL pig run in 2013 (see the pink marks in Figure 3 below) is roughly corresponding to the hold up positions predicted by the flow assurance study. The information about internal corrosion is missing in the second ILI report, obtained by UT tool. This tool is not effective in detecting internal loss of thickness due to corrosion; it is much more effective in evidencing milling defects such as lamination.

Figure 3: Position of corroded areas and defects inside a pipeline (MFL and UT pig).

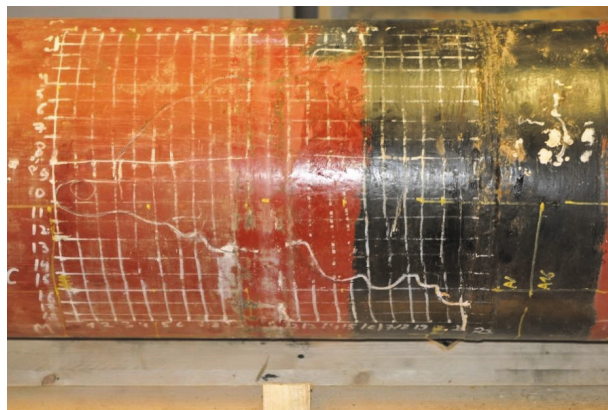
After removing a section of a pipe where a large lamination was detected, manual UT does confirm the presence of a large defect of triangular shape, as shown in the picture in Figure 4. Dimensions of the defects measured by the ILI tool are compared with manual UT, performed in field and at the testing laboratory. The length of the defects, compared using different methods and tools, is in good agreement; differences are larger for width, as shown in Table 1. For comparison, dimension of the lamination detected with the MFL tool at a close KPI are shown in the same Table.

Fig. 4: Examined spool with indication of UT results (courtesy of EniProgetti).

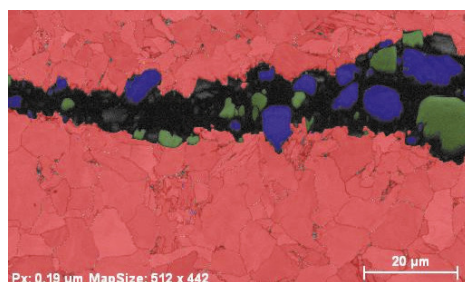
In the removed spool, defects are mainly string of inclusions. The distribution in volume of the inclusions can be mapped with X-ray tomography (Figure 6), which can help to select specimens position. Closer examination with Scanning Electron Microscope equipped with X-Ray diffraction tool, allows a better understanding of inclusion composition. As shown in fig. 7, inclusions are mainly Aluminum oxide (blue particles) or Spinel (double oxide, green particles) in the ferritic-pearlitic structure of the steel (red). The presence of such compounds in a killed steel is not surprising; however, further study is necessary to understand the effect of these inclusions on HE susceptibility, Elboujdaini and Revie (2000) and the threshold conditions for blisters formation. The activity is underway and will be completed with laboratory tests in environment simulating service conditions.

Fig. 7: Example of inclusion shape and composition (courtesy of EniProgetti Venezia).
