**TESTING OF NEW BRIDGE RAIL AND TRANSITION
DESIGNS. VOLUME 3. APPENDIX B. BR27D BRIDGE
RAILING**

Testing of New Bridge Rail and Transition Designs

Volume III: Appendix B

BR27D Bridge Railing

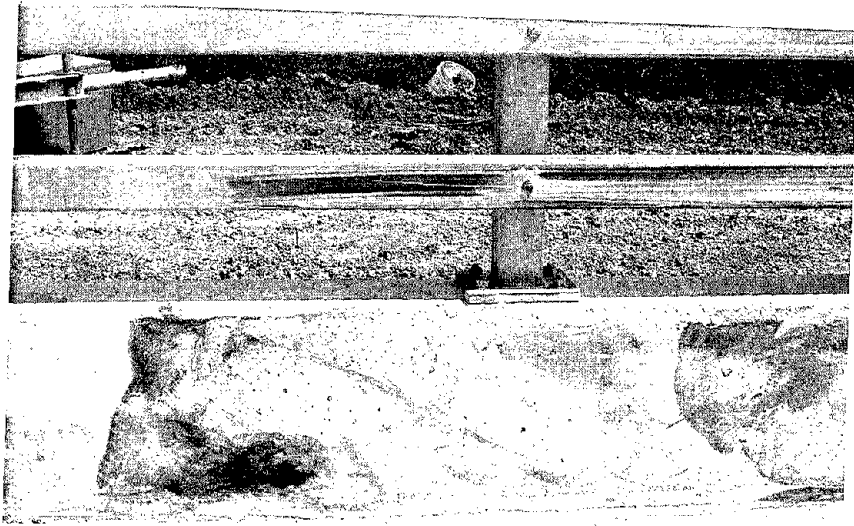
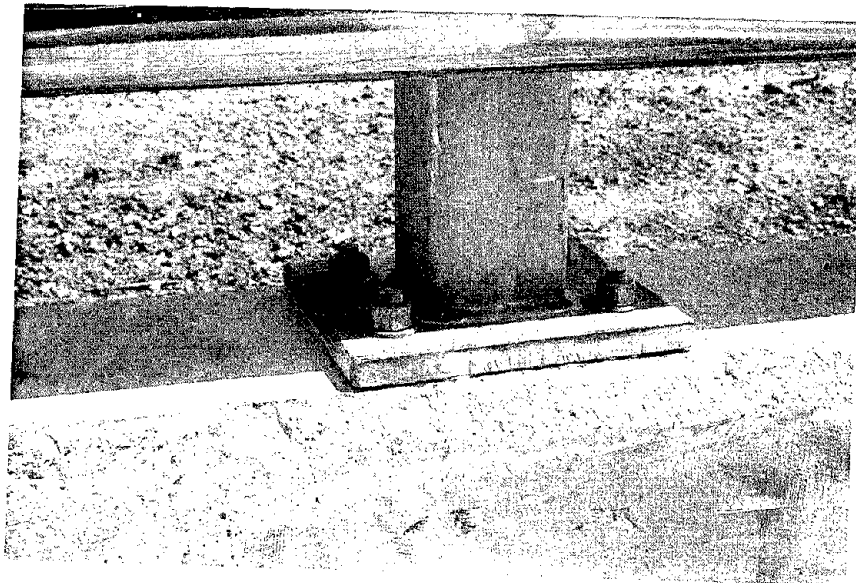
Figure 20. BR27D bridge railing on sidewalk after test 7069-23.

As can be seen in figures 20 and 21, the bridge railing received minimal damage. The maximum permanent deformation to the railing element was 0.5 in (13 mm) between posts 5 and 6. Posts 5 and 6 were also pushed rearward approximately 3/16 in (4.8 mm) as shown in figure 22. There was only cosmetic damage to the concrete parapet. There were tire marks on the concrete parapet, on the face of the lower metal railing element in the area of impact, and also on the lower part of post 5 and 6. The vehicle was in contact with the bridge railing system for 12.8 ft (3.9 m).

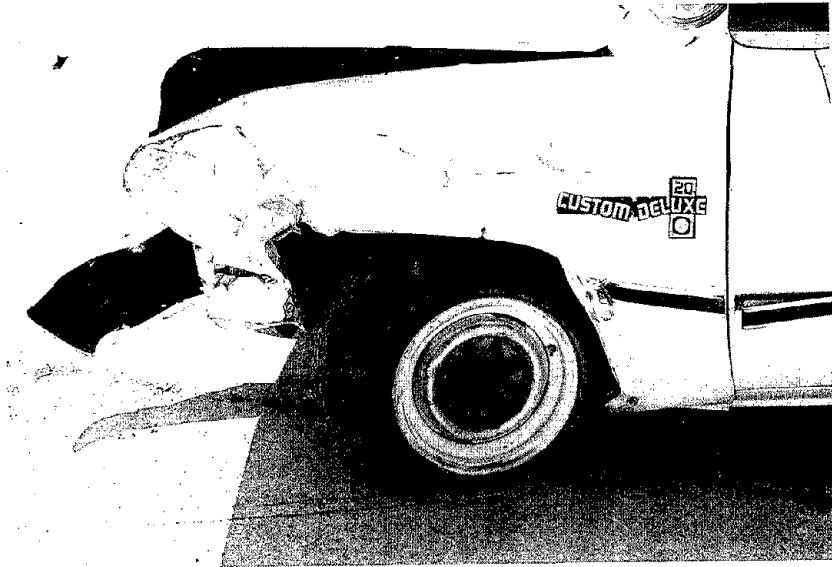
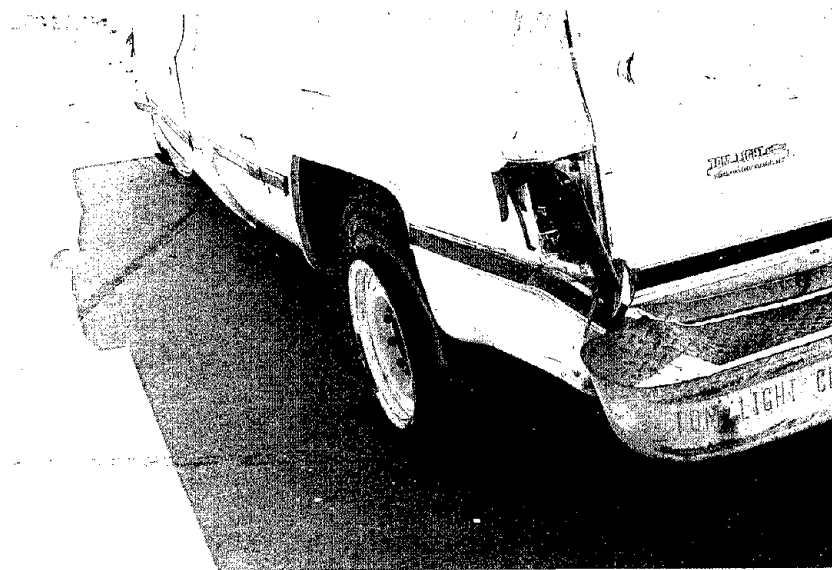
Figure 23. Vehicle after test 7069-23.

The vehicle sustained damage to the left side as shown in figures 23 and 24. Maximum crush at the left front corner at bumper height was 12.5 in (318 mm) and the right side was deformed outward 5.0 in (127 mm). Also, damage was done to the front bumper, hood, grill, radiator and fan, left front quarter panel, left door, left rear quarter panel, left front and rear tires and rims, rear bumper, and right front quarter panel and right door.
