TURBOMACHINERY & PUMP SYMPOSIA

Investigation of a Compressor Coupling Failure by Torsional Excitation

A Problem of a Complex Interaction
where a Structural Natural Frequency
Excited a Torsional Natural Frequency

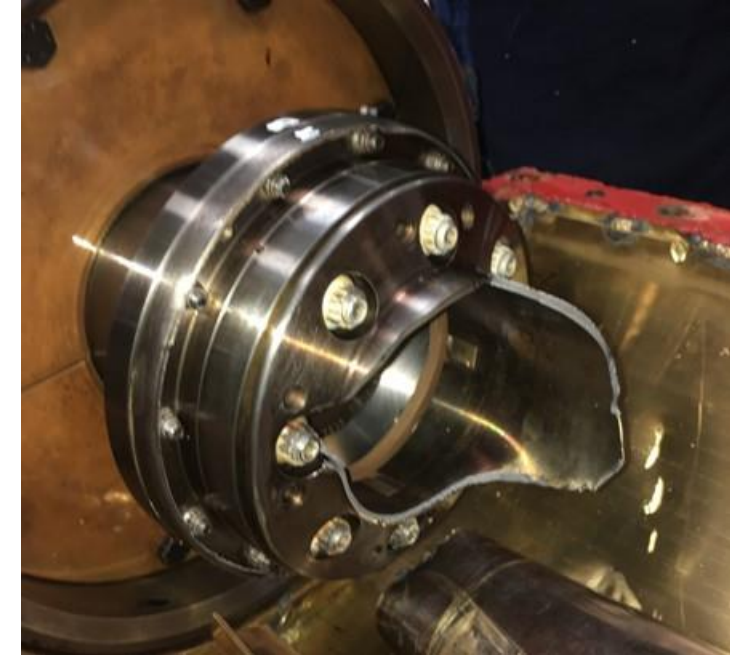
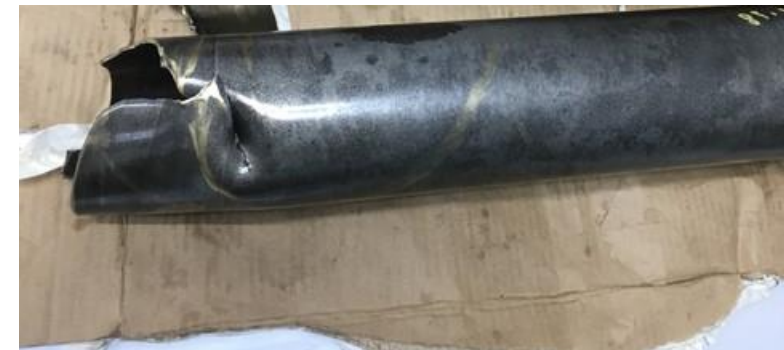
- Mature installation with ~17 years run time
- Two lube oil contamination events with seawater over years prior
- Lube oil temperature control valve failed 5 days prior to 1st failure causing oil temperature to rise from 45°C to 58°C
- Intermittent casing vibration alarms on the gearbox casing detected prior to 1st failure
- Gearbox casing vibration reached alarm level and tripped on high shaft vibration when the coupling failed
- Original RCA pointed to axial misalignment and issue was corrected
- After restart, repeat periods intermittent elevated casing vibration (at frequency 9x pinion speed) and noise
- Troubleshooting continued, 2nd coupling failed after 4 days

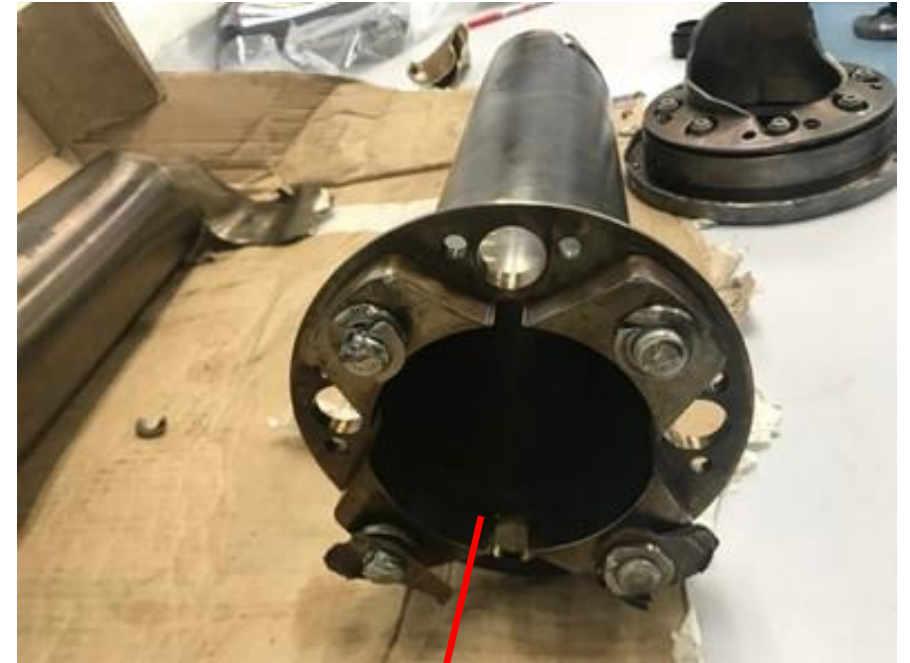
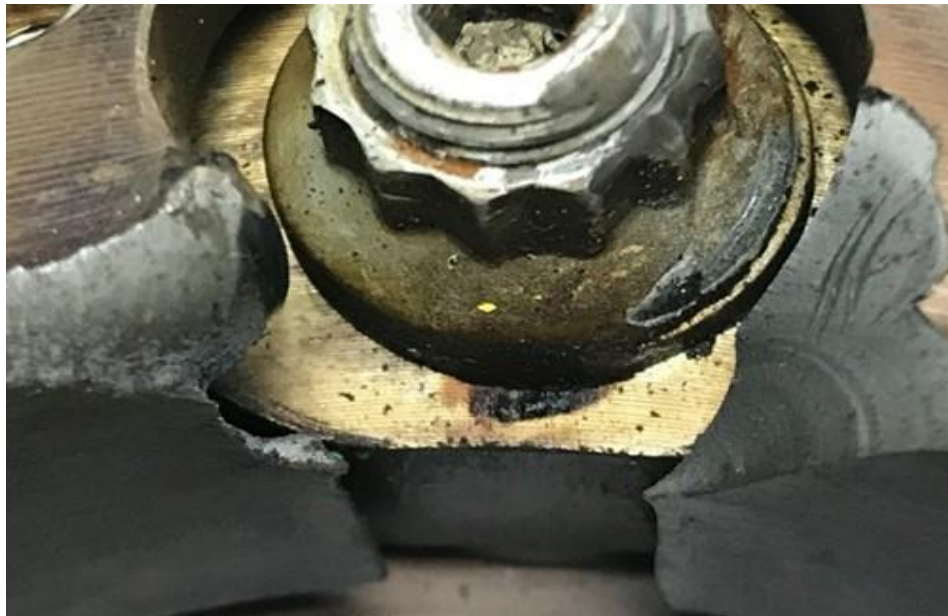
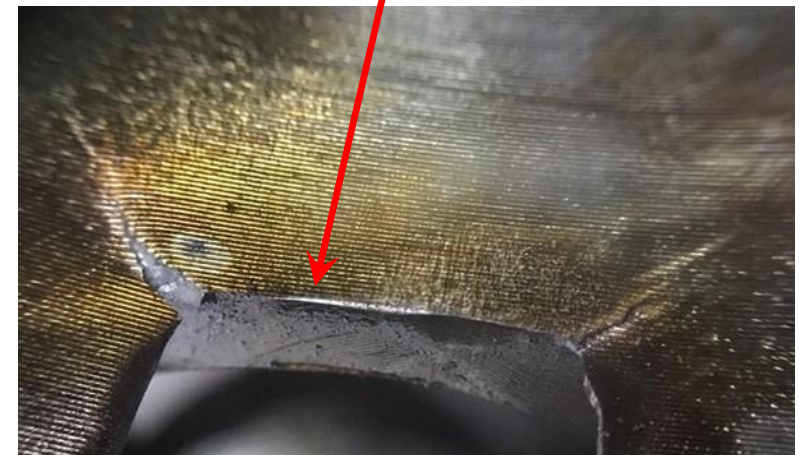
Observations 2nd Failure of Coupling

- Clear indications of torsional fatigue failure
- Multiple crack initiations in both forward and reverse rotation directions
- Gear tooth wear indicating torque reversal
- Crack initiation sites on both gearbox and compressor ends of coupling spacer

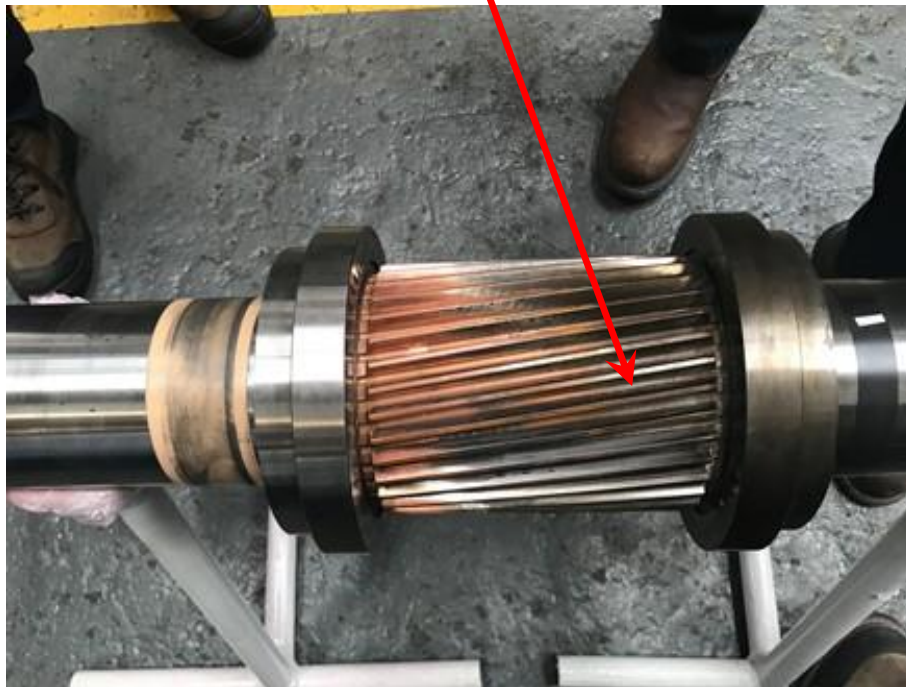
- Pinion shaft gear tooth profile showed severe wear compared to original
- Gear tooth wear pattern on both loaded and unloaded flanks

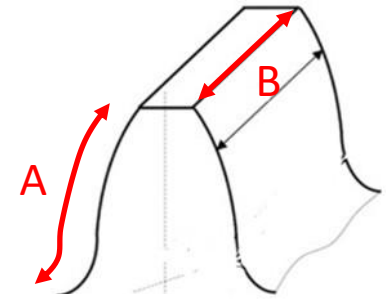
A: Pinion Flank Profile

To be repaired pinion shaft - as found

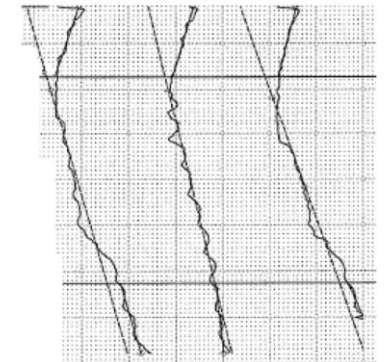
B: Pinion Flank Line Profile

To be repaired pinion shaft - as found

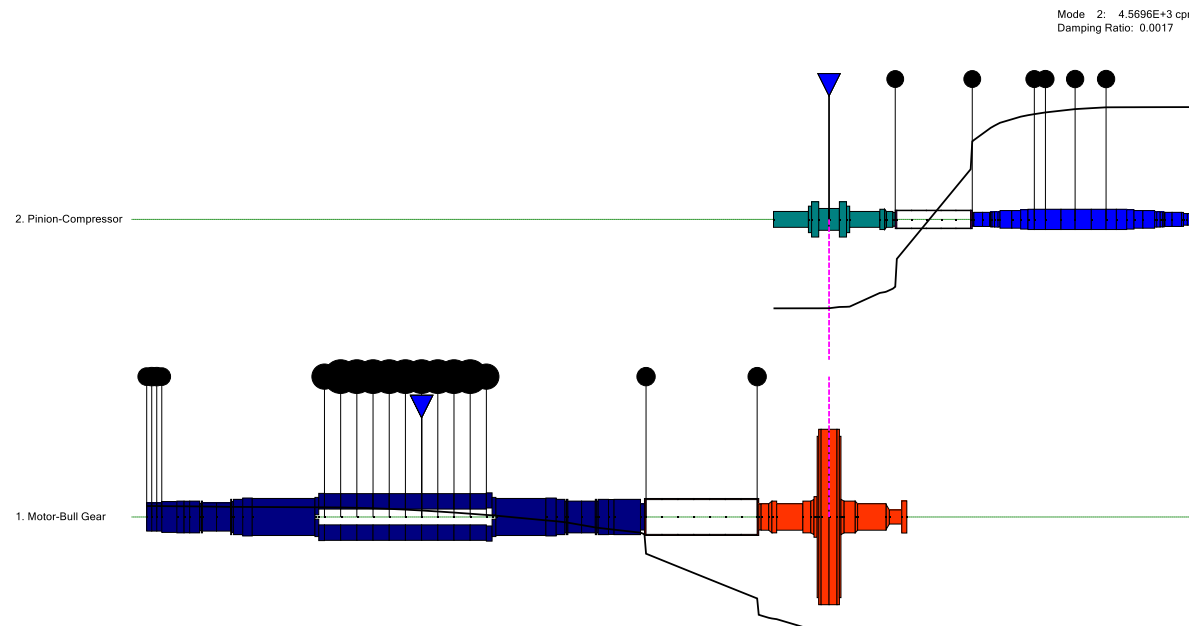
Figure from TNF Analysis

- Torsional oscillations and fatigue observations led to commissioning of detailed torsional analyses, focus on high order interferences (9X high speed interference based on observed vibration spectrum)
 - Multiple analyses corroborated no interference at higher orders; likely excitation of 2nd mode based on mode shape (69 Hz - ~3X gear speed)
 - Forced response analysis to understand stresses

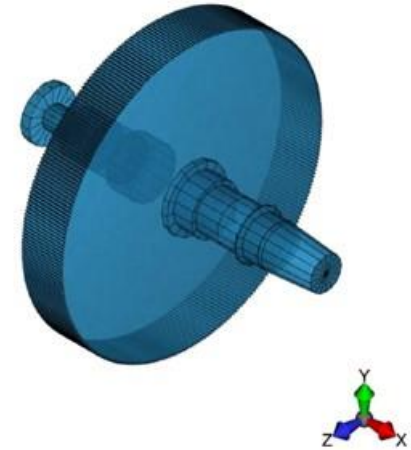
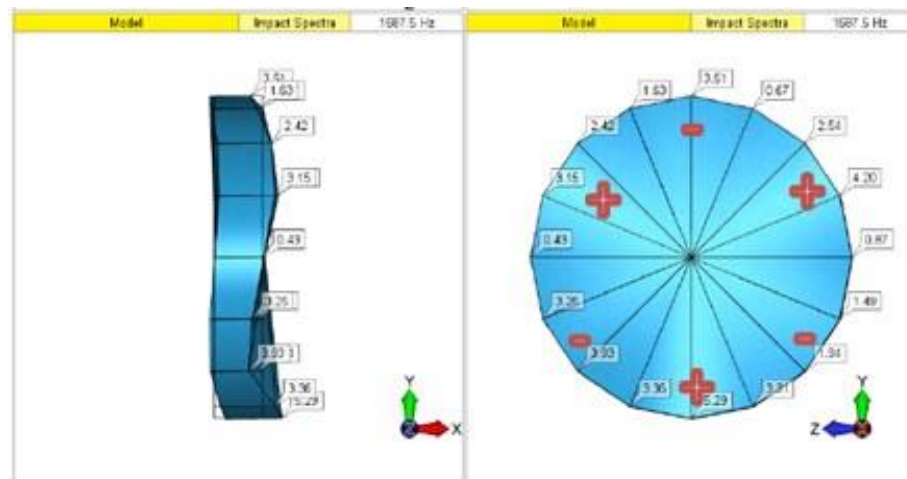
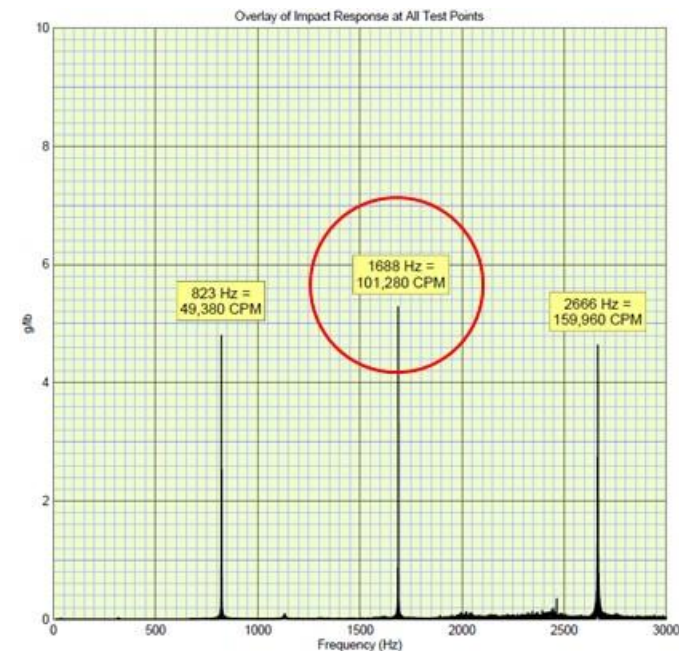
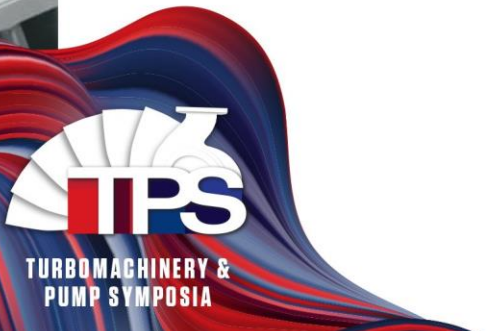
Gear Modal Analysis

- TAMU TPS paper (*Practical Solutions to Complex Gear Problems by John B. Cary*) reference showed pattern of gear teeth wear due to gear resonance
- Modal analysis showing bull gear mode shape
 - Method using multiple accelerometer measurements with calibrated hammer around the bull gear
 - Indicated 9X pinion speed detected on the casing was a gear structural natural frequency
 - Mode shape at 1688 Hz indicated below with 3 lobes

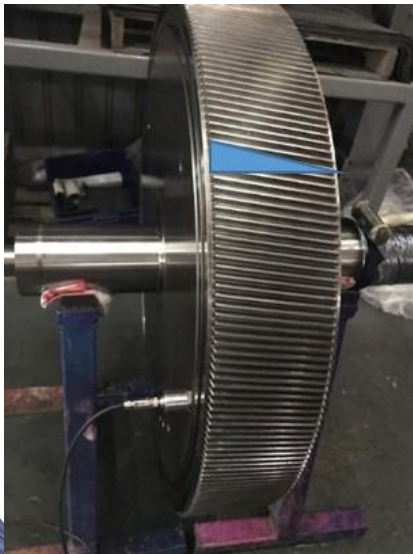
Advancement of gear tooth

- The displacement of the single helical gear teeth due to modal oscillation resulted in a relative tooth advancement at the lobes.
- With the relative tooth advancement of the bull gear and axial inertia of the pinion gear, there were intermittent contacts of the gear teeth to create an effective torsional excitation at 3x of the low-speed shaft (74 Hz), which was close enough to intermittently excite the 2nd TNF of 69 Hz.
- Once the 2nd torsional natural frequency was excited, the train experienced torque reversal as evidenced by unloaded flank tooth wear, gear vibration increase and audible noise..
