using proximity probes on rotating machines

Guillaume Christin Nicolas Peton

In this session, a brief introduction about electrostatic discharge phenomena will be done. Then three historical cases with Electrostatic Discharge (ESD) issue will be analyzed in order to explain how to detect Electrostatic Discharge using proximity probes. It will point out that the vibration behavior in case of ESD is not always the same.

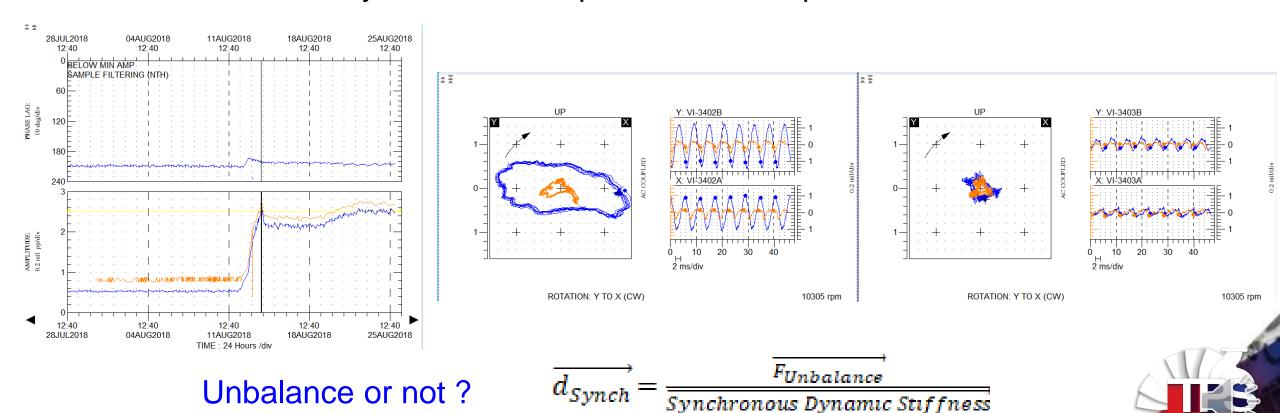
- Only steady state data are available.
- During 2 days the level of vibration increases from 0.5mils pp to 2.5mils pp (from 13µm pp to 64µm pp)
- Vibration are mainly 1X / Forward precession / Elliptical orbits

Position of the shaft moves from left to right and the 1X level of vibration increases.

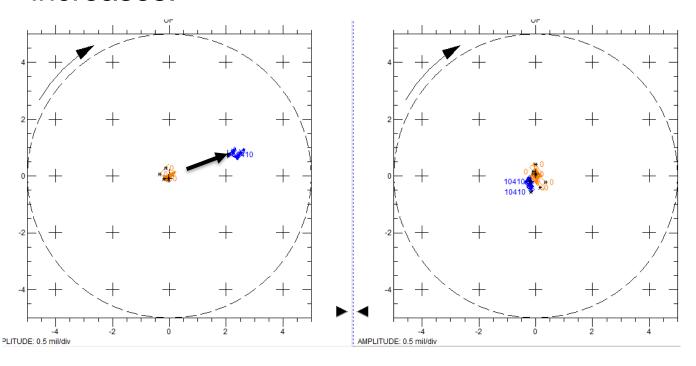
It means that the shaft operates in a position where the dynamic stiffness is lower than before

Metal Brg Temp

decreased

Metal bearing temperature dropped by 20°C when the shaft moved from one position to another one

It confirms that the movement of the shaft is real

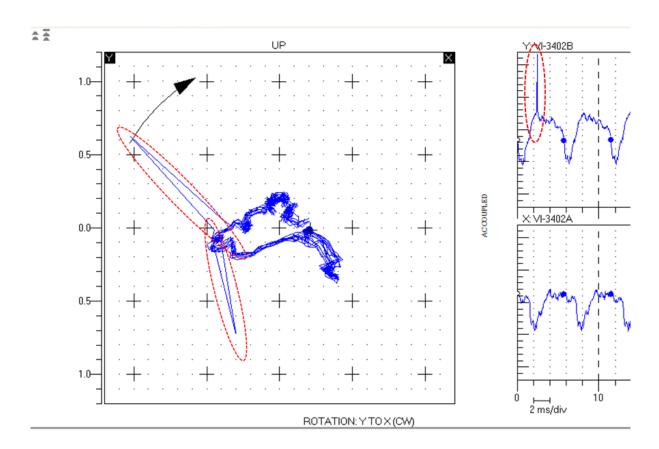
Erratic peaks on waveform confirms Electrostatic Discharge (ESD).

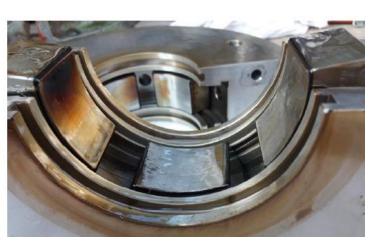
Bearing clearances Increased!

RCA: Two main options

- 1- Static charges may build up from droplets of water being thrown off blades in wet stages of the turbine
- 2- Residual magnetism in parts

However customer solves the issue by installing grounding brushes

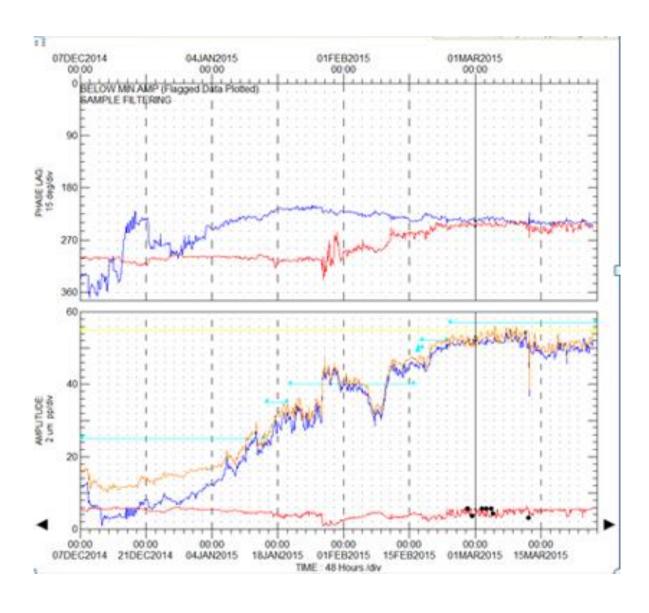
- Only steady state data are available.
- During <u>several months</u> the level of vibration increases from 0.6mils pp to 2.4mils pp (from 15µm pp to 60 µm pp)
- Vibration are mainly 1X

The vibration levels on NOx Compressor started to increase, triggering at one moment the management/SW alarm (Direct, 1X, 2X)

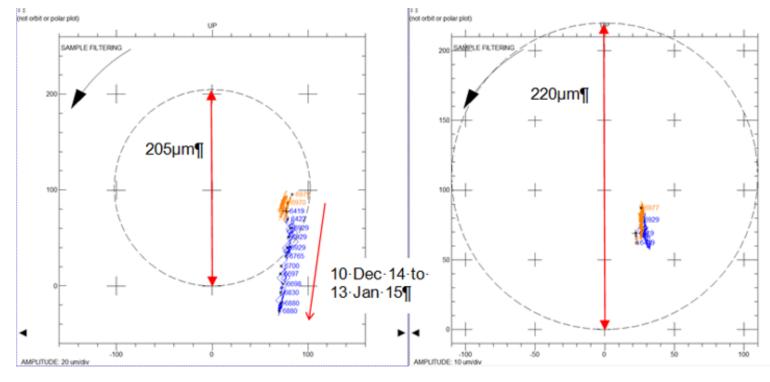
Position of the shaft moved down and the 1X level of vibration increased.

It means that the shaft operates in a position where the dynamic stiffness is lower than before

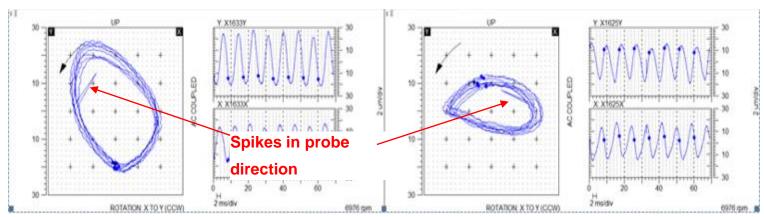
Erratic peaks on waveform confirms Electrostatic Discharge (ESD).

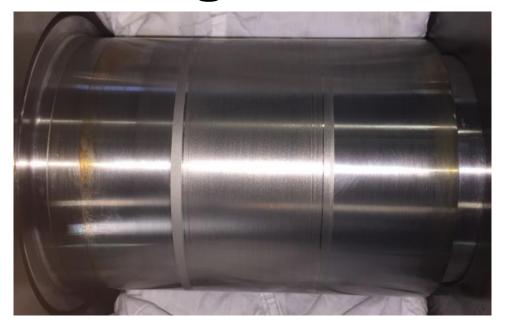
Journal area of the NOx compressor drive-end bearing, showing "frosting" in the area of the oil deflectors

RCA results was found to be a damaged grounding brush

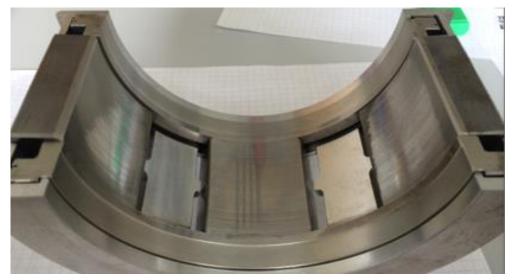
Bearing diametric clearance was found 0.48mm, double then allowed (0.2mm-0.26mm)!

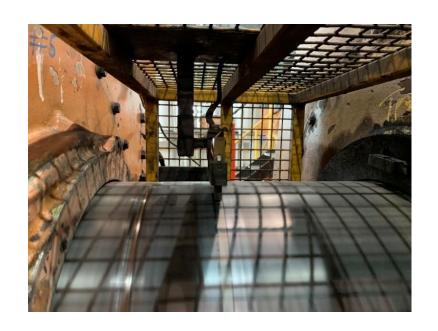
RCA: loose grounding brush

1 - Brushes should be maintained in working condition

2 - Demagnetization of the rotating and stationary parts is advised.
