51ST TURBOMACHINERY & 38TH PUMP SYMPOSIA

Integrally Geared Compressor Failure due to excessive pipe strain

Marcela Lopez – Rotating Systems Engineer
Robert C. Eisenmann Jr. - Rotating Systems Advisor

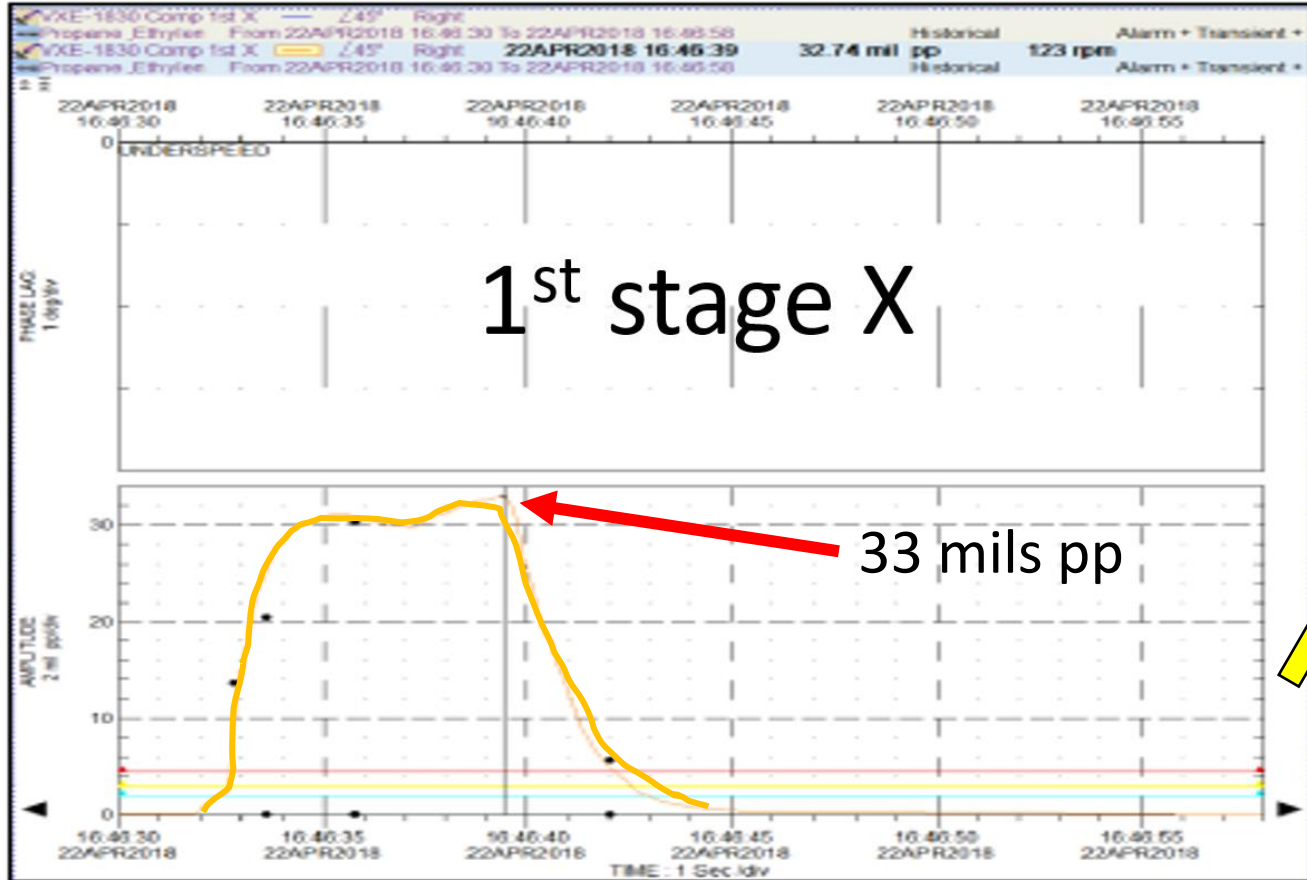
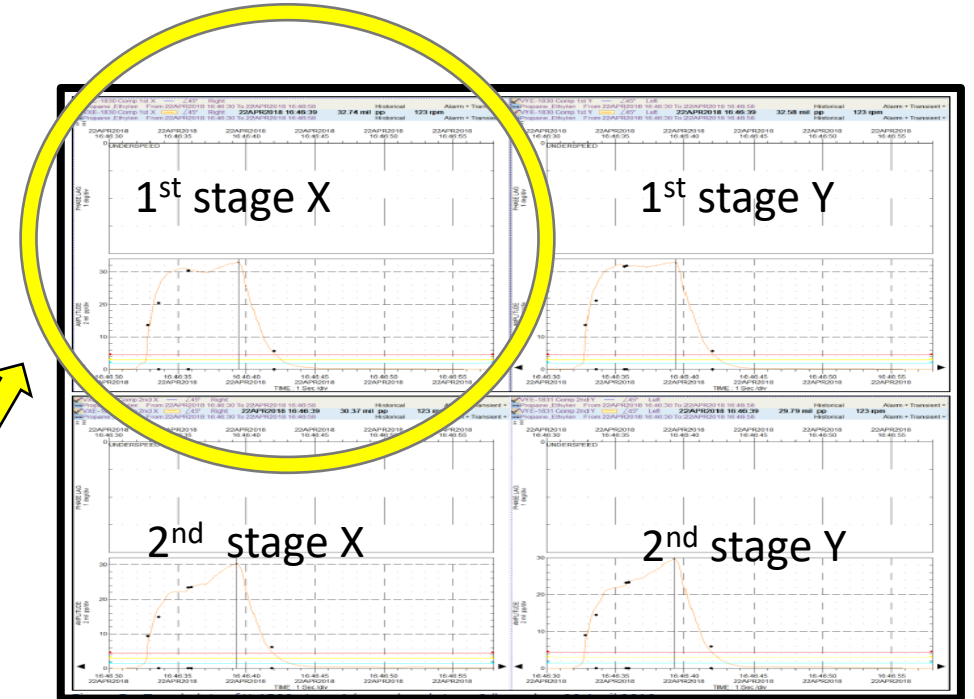
Propane Compressor Radial Vibration

High Vibration across all stages

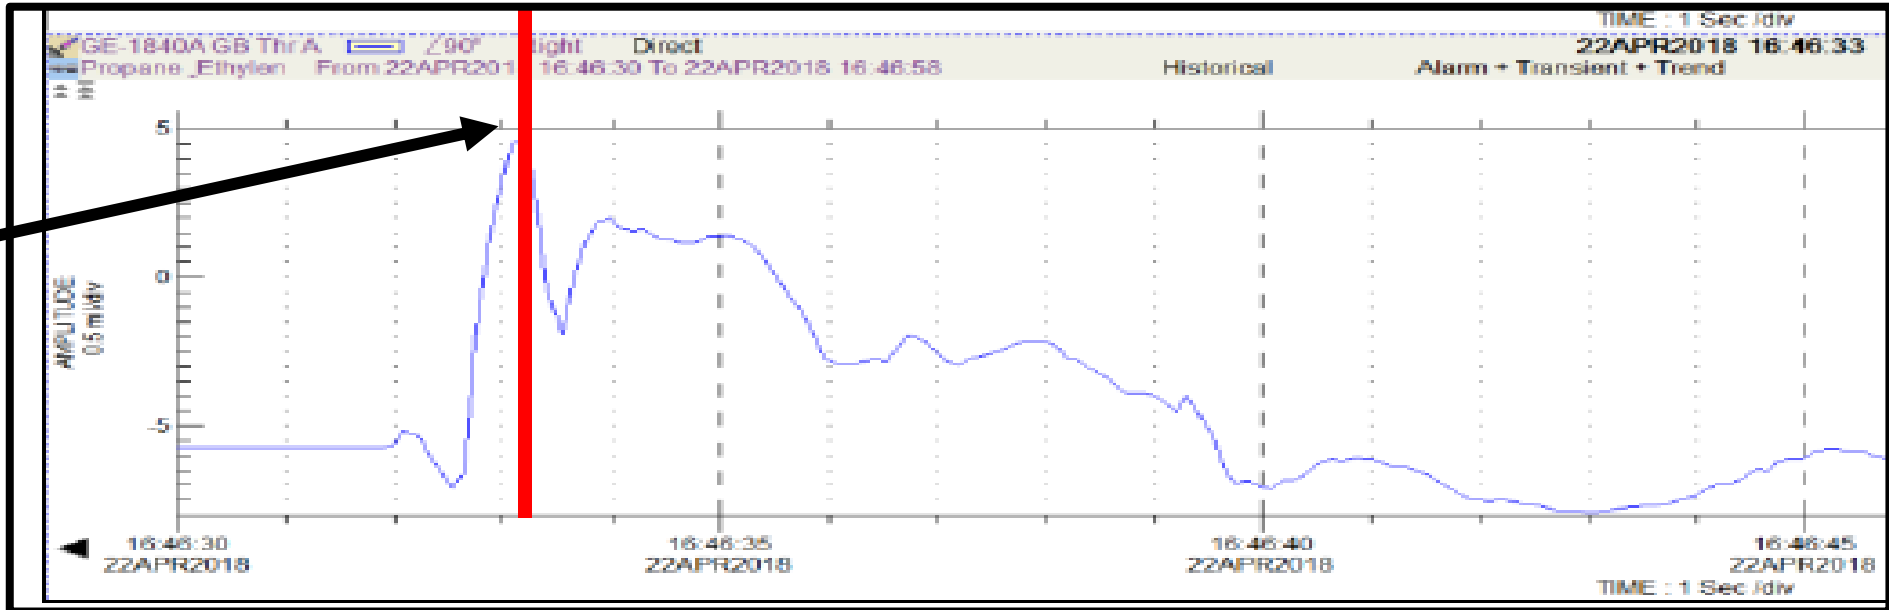
Propane Compressor Coastdown

Peak axial movement

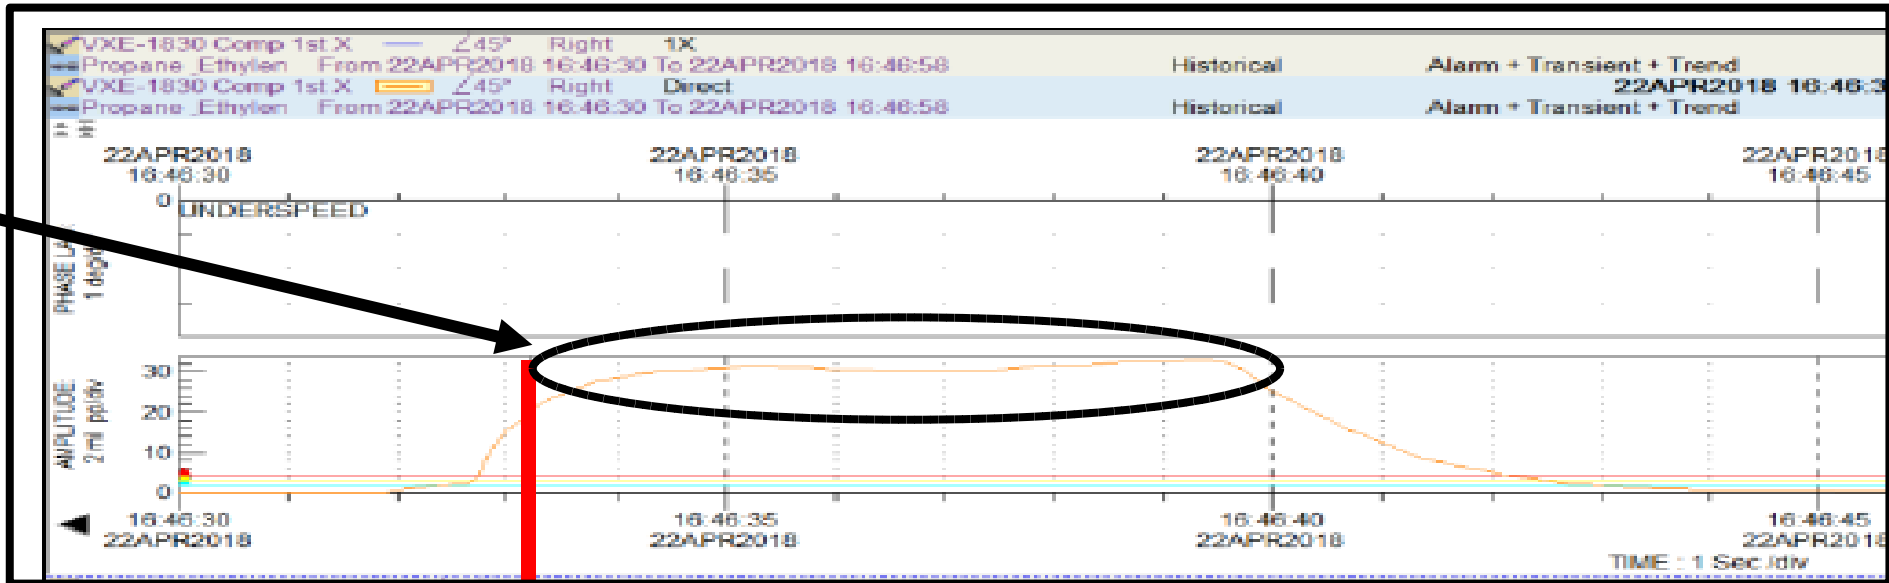
Radial vibration continued to increase

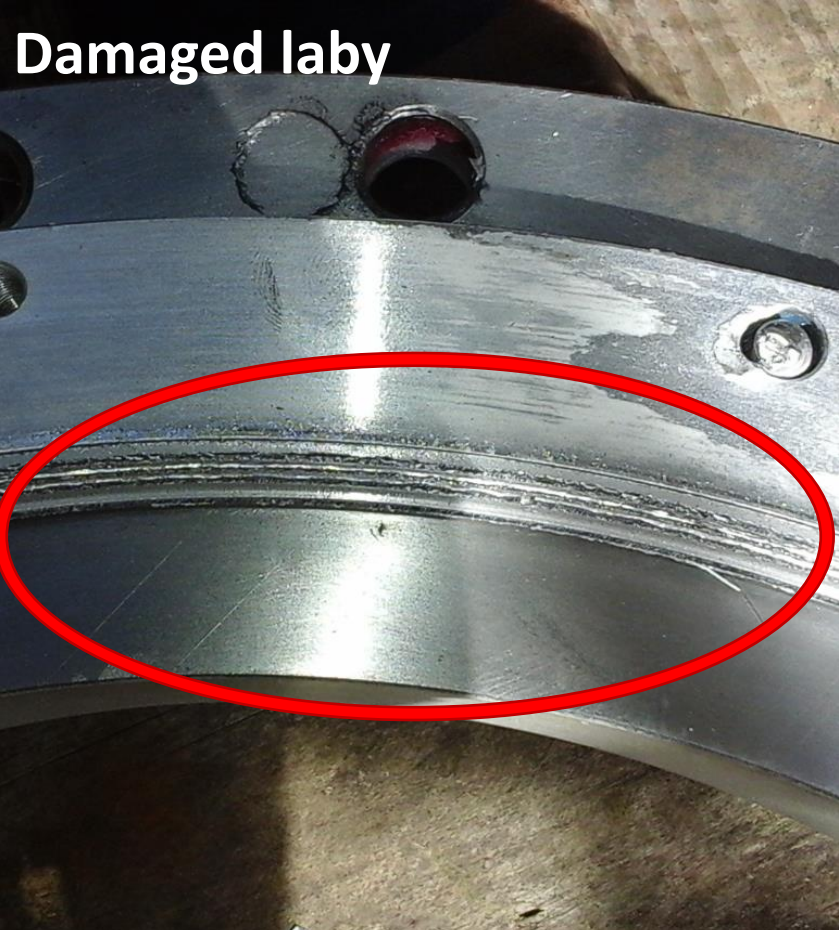
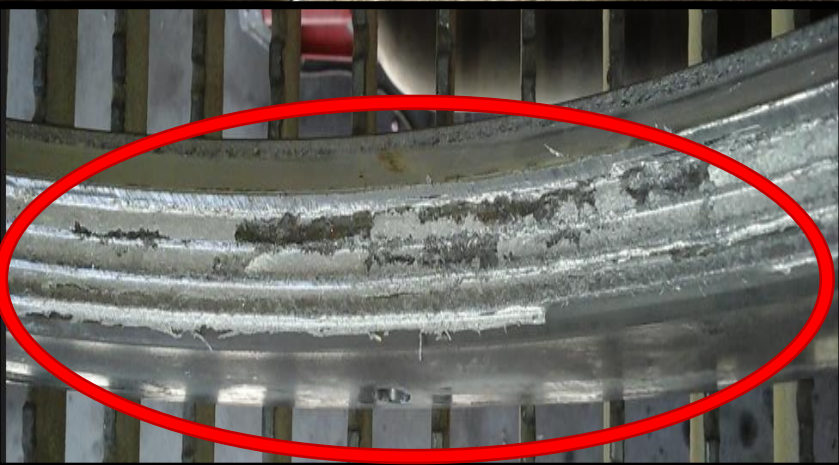
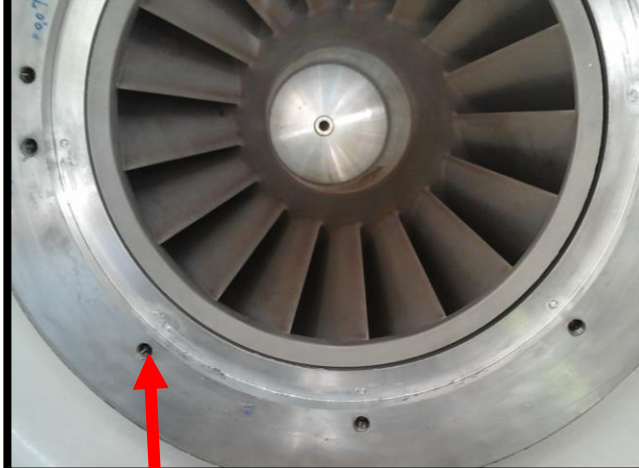
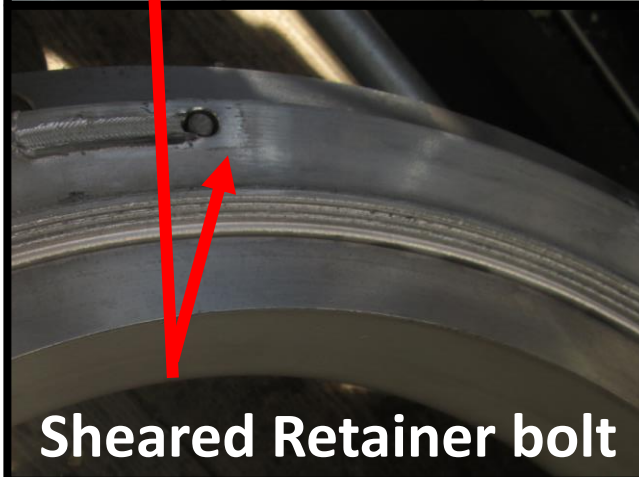
Damaged laby

- Labyrinth seal damage on 1st, 3rd and 4th stages
- Dry gas seals
 - 1st stage primary seal leak
 - 2nd stage seal failed - primary and secondary leak

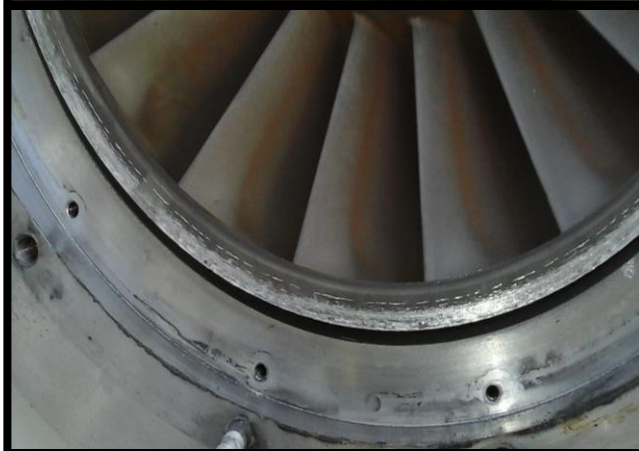
Sheared Retainer bolt

- **Deficiency of overhaul and assembly – Contributing cause**
 - Labyrinth seal installation deficiency
 - Volute insert installation blocks not in correct position and fully seated in volute fit
 - Rotor Assembly - Inadequate bolt tension of impeller hirth coupling
 - Tension bolt installed 3rd 30% below and found 4th stage at 30% of target (vibrations)
 - Utilized faulty tooling

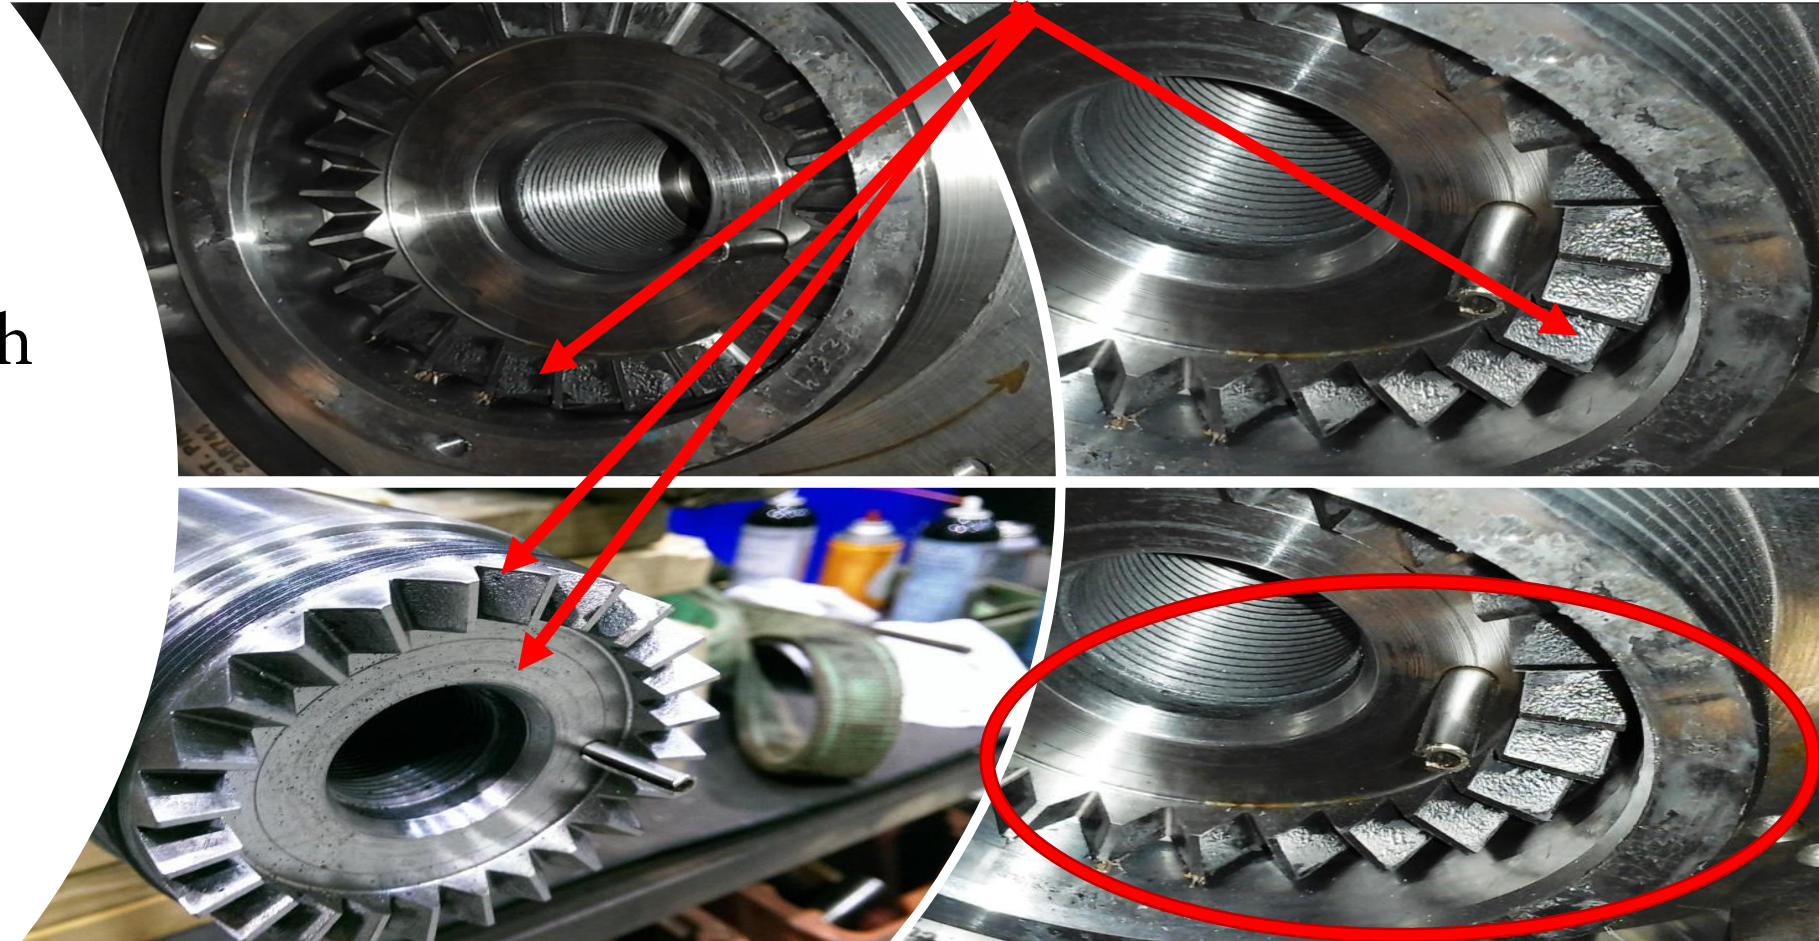
Findings - Hirth Tooth Coupling Damage

- Surface damage - high loads in 7 sec run

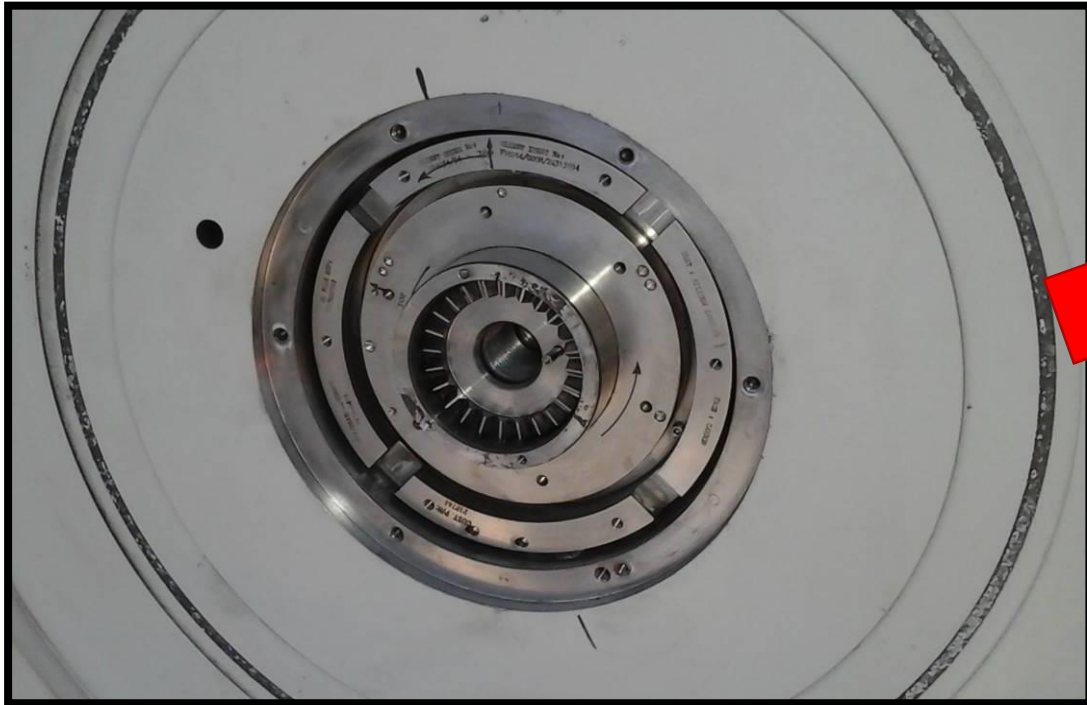
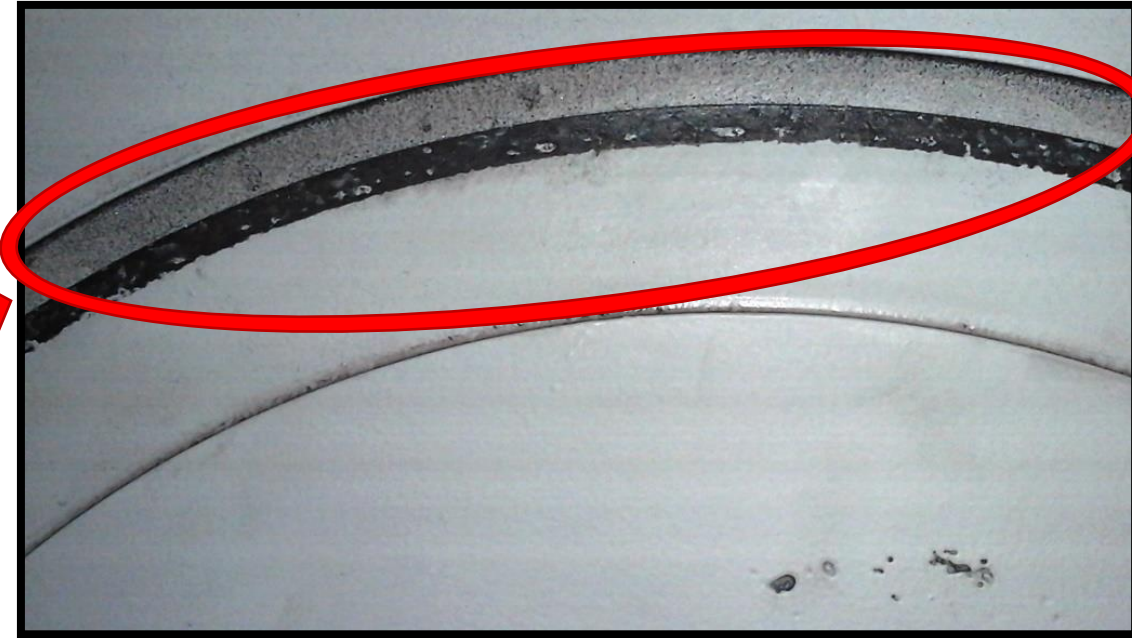
Findings - Volute & Back of Impeller Rub

- Rubbing contact on back side of impeller

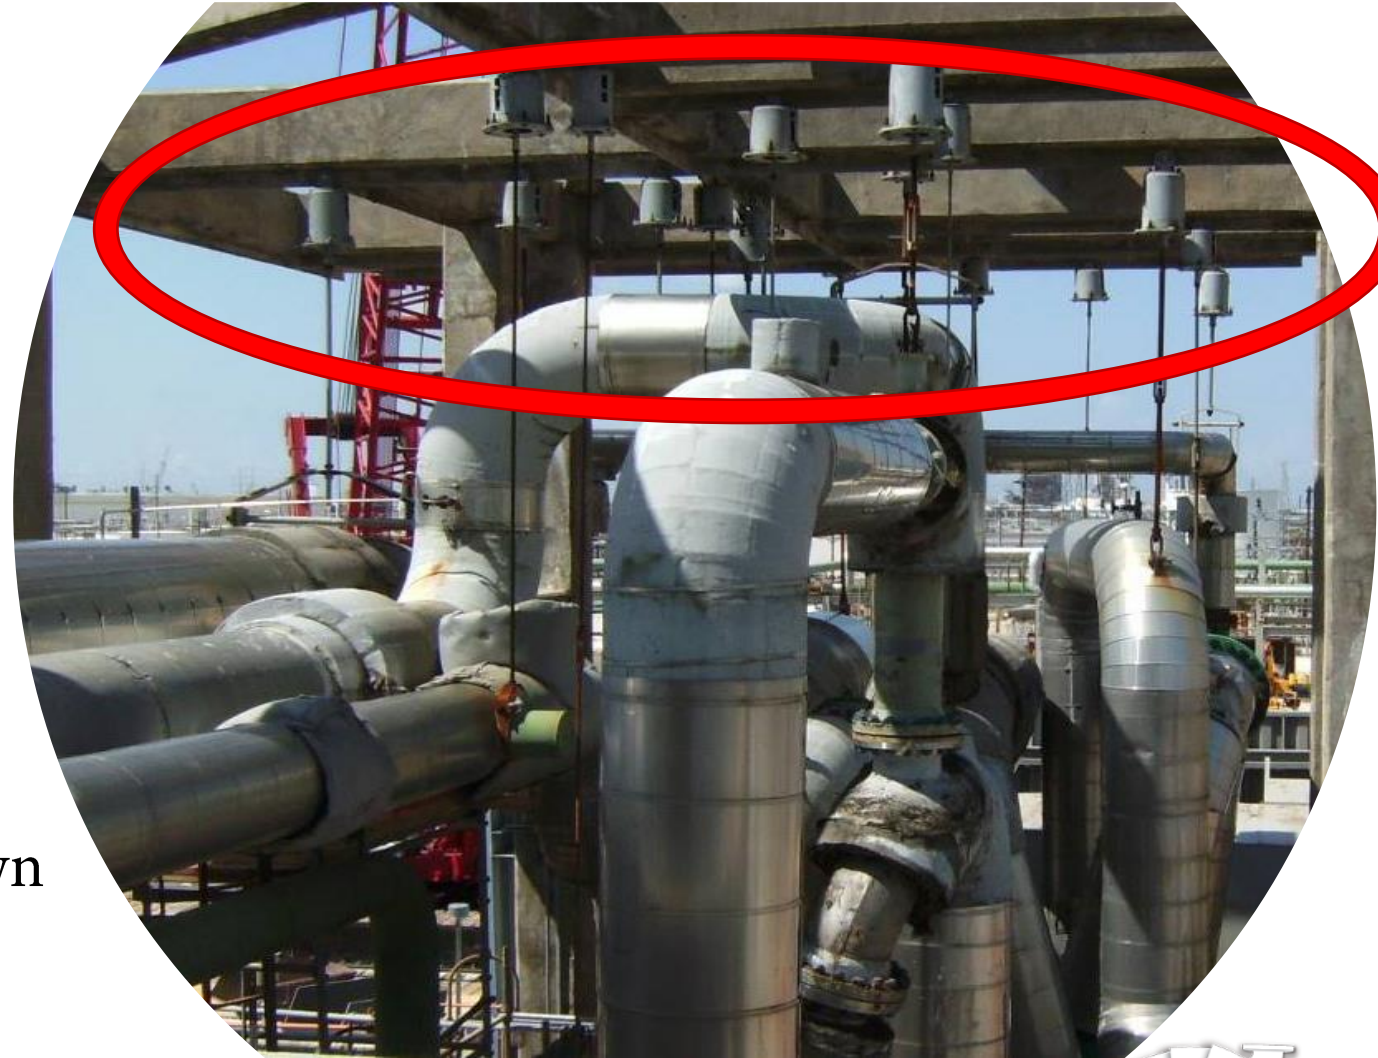
Primary Cause

- **Pipe Strain – Primary Cause**
 - **Piping Alignment**
 - Step by step piping alignment not followed in sequential order
 - **Spring Cans**
 - Piping installed with spring cans locked and unlocked only after installation of all piping to compressor case was completed
 - Spring cans final position unknown + not documented
 - Only verbal communication that deflections on the machine were monitored

- Defined sequential order of piping connection/installation
- Defined communication plan onsite to ensure coordination of different discipline crews to achieve defined sequence
- Unchoked spring cans before installation and adjusted during installation to ensure adequate load setting
- Implemented QA/QC and check sheets
- Engineering witness points at all piping reassembly monitoring volute deflection
- Updated site procedures
