Moto-Compressor coupling failure:

API 10% separation margin to
calculated or to real critical
torsional speeds?

TURBOMACHINERY & PUMP SYMPOSIA

This case study will present the failure of the LS coupling of a variable speed moto compressor, due to a resonance of the first critical torsional speed while running at Minimum Operating Speed. The path followed for the investigation and to define design modifications will be presented, followed by a discussion and lessons learned about separation margins to torsional critical speeds on variable speed trains with disc type couplings.

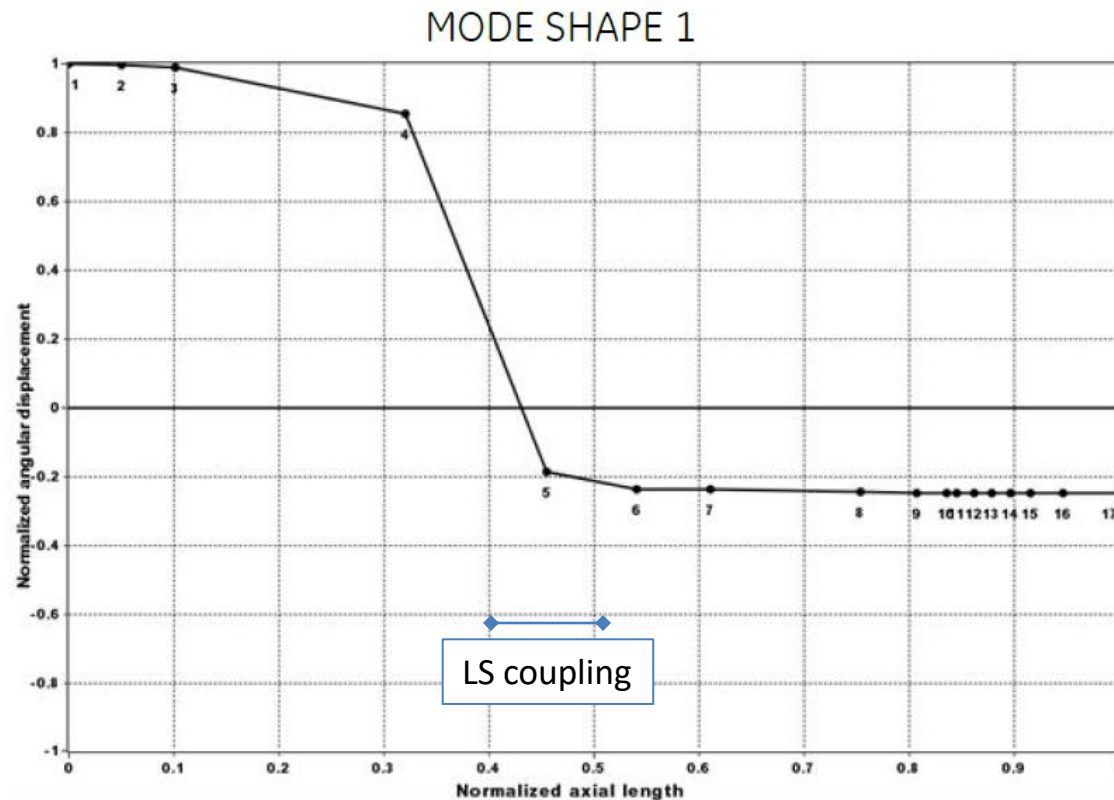
By design, the train 1st torsional critical speed was 15.75 Hz = 10% lower than the min operating speed (1050 rpm = 17.5 Hz) to comply with API separation margin requirement.

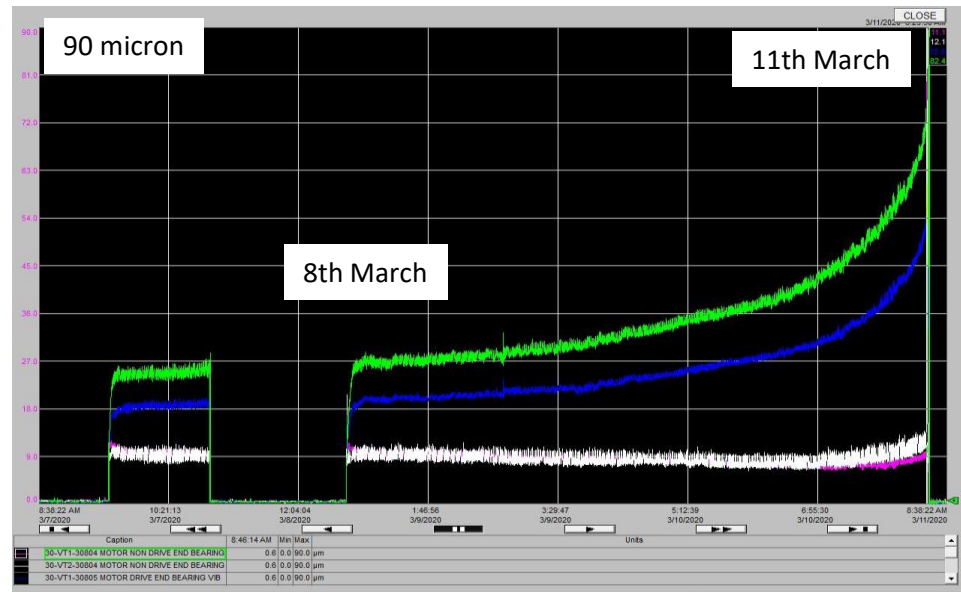
A total of 133 minutes of operation at 1050 rpm were done in between 1st Feb and 7th March
8th March: Noise disappeared. Site personnel believed the issue was solved and left unit in service.
11th March: LS coupling failed

Train repair 12th March - 29th April

- Replaced all damaged structural elements and piping.
- Replaced main electric motor
- Full GB inspection
- Replacement of both couplings
- Package Alignment

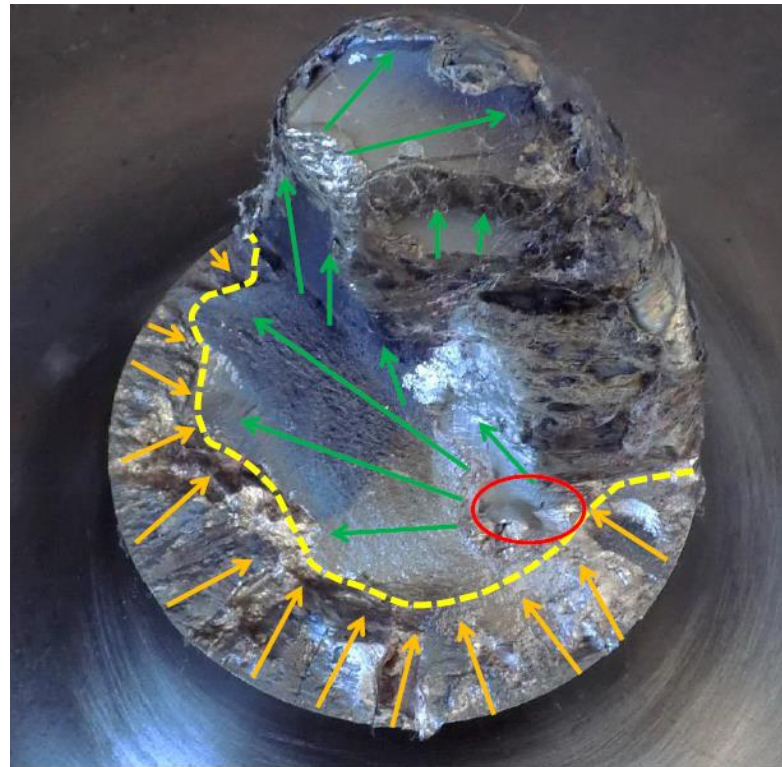
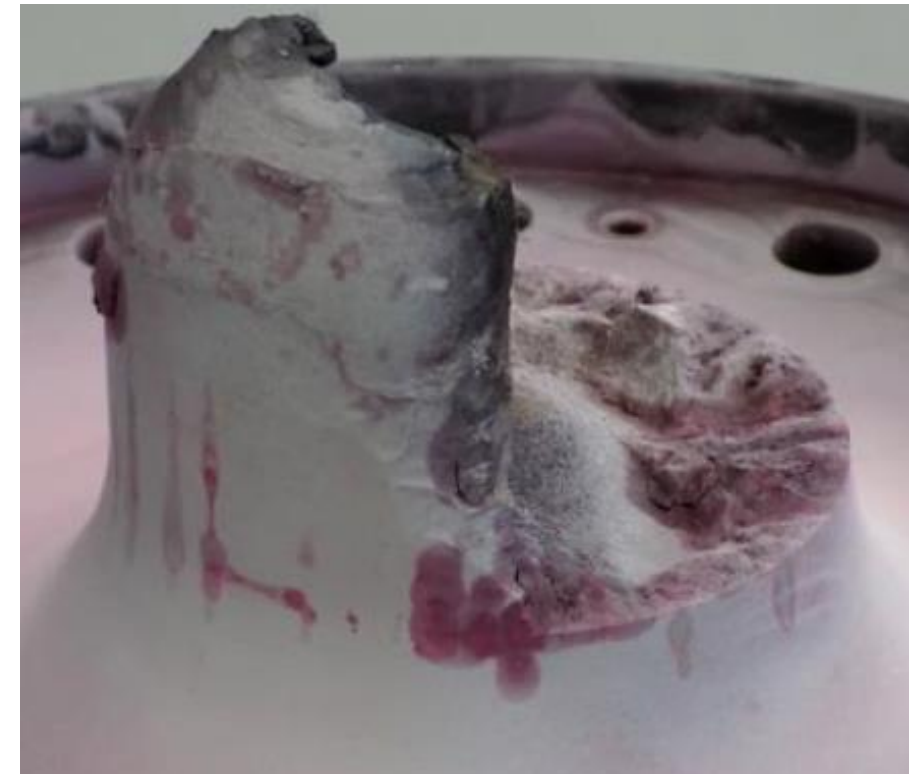
- Failure by fatigue
- Coupling had cracks in longitudinal direction
 - not operational stress => pre-existing cracks
- 20% difference in material properties: motor vs GB side
 - Heat treatment? high residual stresses?

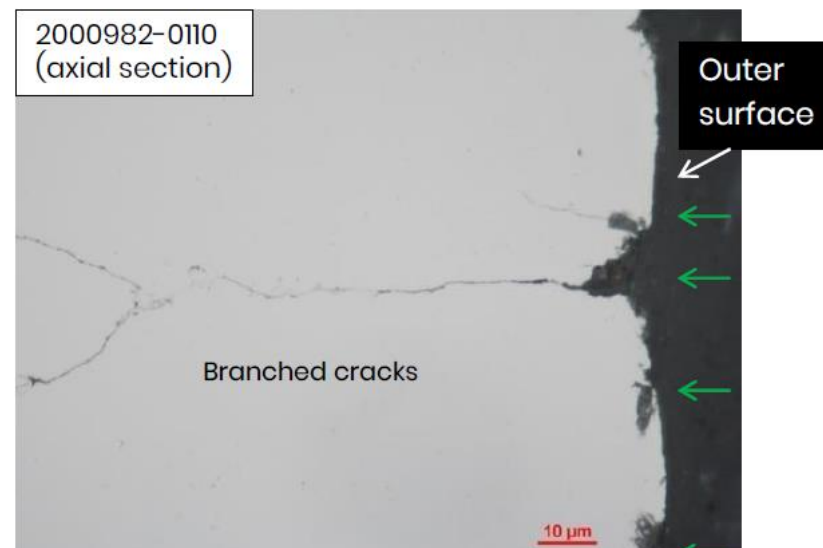
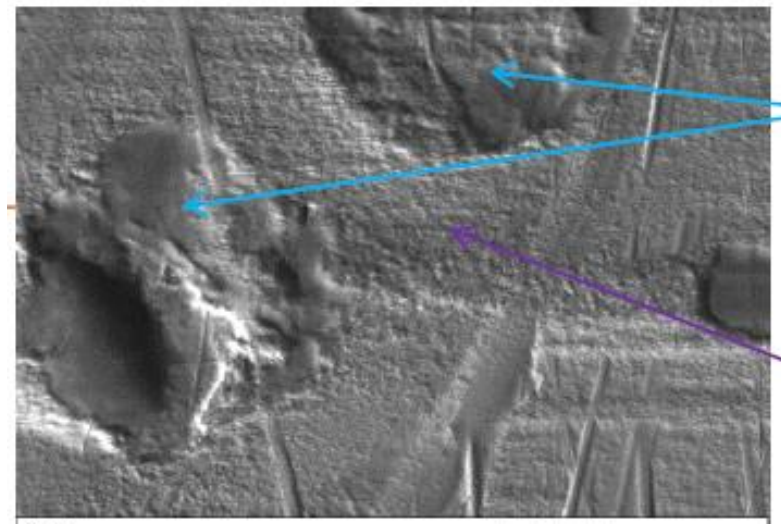
- Failure by fatigue
- Coupling had cracks in longitudinal direction
 - not operational stress => pre-existing cracks
- 20% difference in material properties: motor vs GB side
 - **Heat treatment? high residual stresses?**
- Multi branched cracks starting from “craters” covered with phosphate crystals + Sulphur residues
- Multi branched cracks up to 200 microns depth also found on Motor side.
 - **Surface attacked with Sulphur during phosphating process?**

Stress Corrosion Fatigue initiated cracks

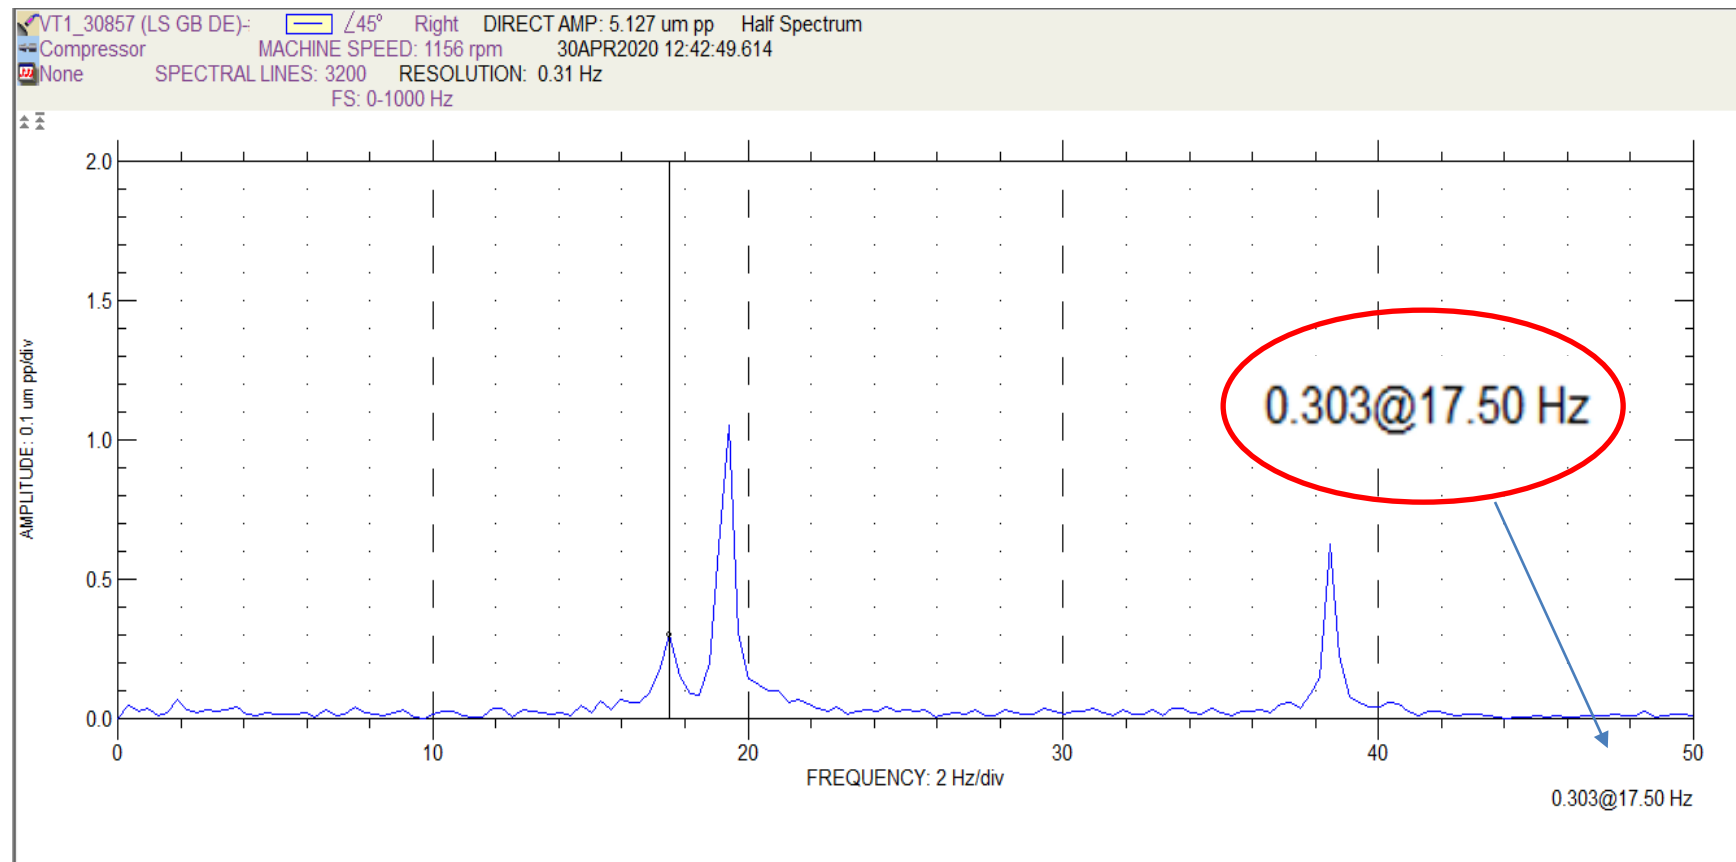
- 30th April: Package run with spare LS coupling “as it was” with min speed increased to 1150 rpm (100 rpm higher than original minimum operating speed)
 - Peak observed at 17,5 Hz, possibly torsional critical speed.
- 1st May-12th May: Removed coupling, machined out 1mm in radius to the spacer and re-installed.
 - Stiffness should reduce by 9%
 - Expected shift in torsional critical speed was $17,5 * \text{sqrt}(0,91) = 16,75 \text{ Hz} = 1005 \text{ rpm}$

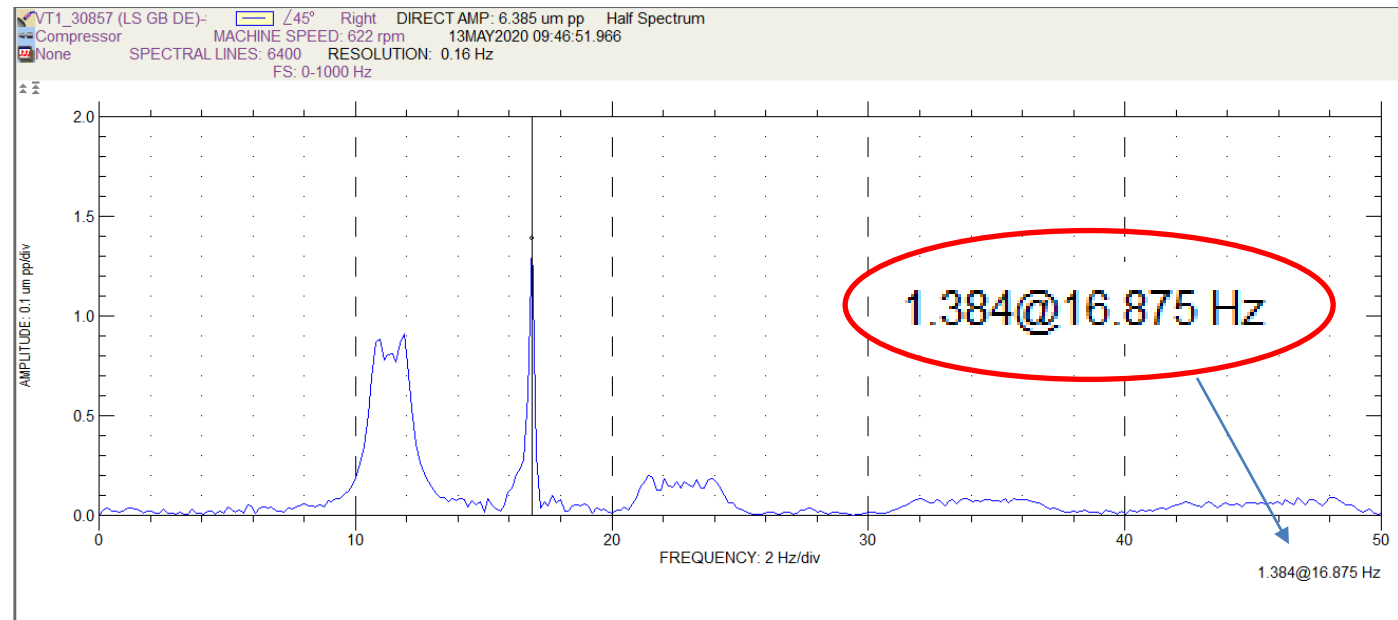
- 30th April: Package run with spare LS coupling “as it was” with min speed increased to 1150 rpm (100 rpm higher than original minimum operating speed)
 - Peak observed at 17,5 Hz, possibly torsional critical speed.
- 1st May-12th May: Removed coupling, machined out 1mm in radius to the spacer and re-installed.
 - Stiffness should reduce by 9%
 - Expected shift in torsional critical speed was $17,5 * \text{sqrt}(0,91) = 16,75 \text{ Hz} = 1005 \text{ rpm}$
- 13th May Run the package with the machined coupling. **Shift of critical speed as per expectation**

The package has been in service with increased min speed and modified LS coupling since 13th May 2020 with no further issues

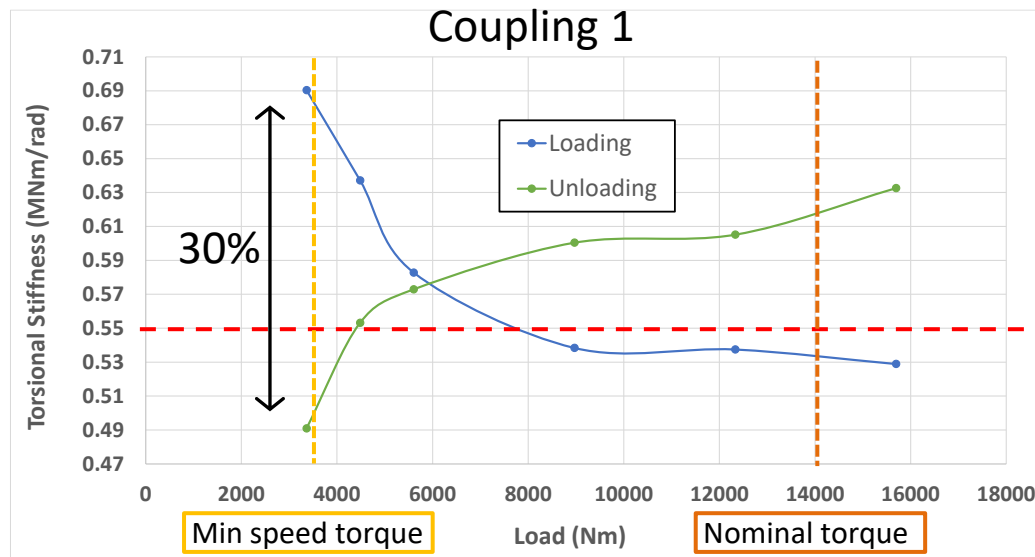
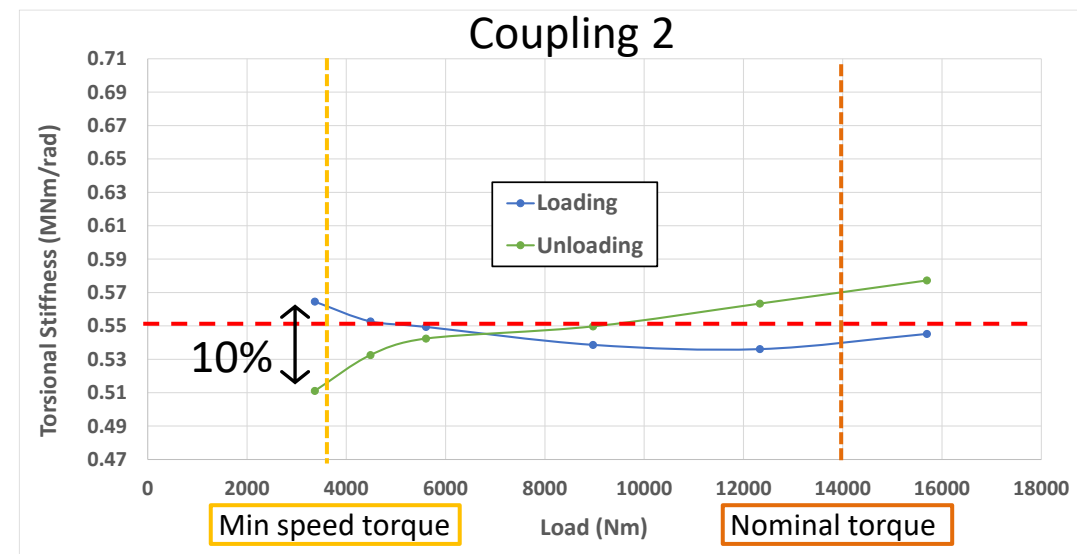
- As backup, in May 2020, two new couplings were ordered to 2 different suppliers.
 - Within Covid-19 context it was risky to have only one order to one manufacturing location
- Torsional stiffness tests were done on both couplings
 - Same static rig with optic deflection measurements
 - Both couplings had a quoted stiffness of **0,55 MNm/rad** on drawing

10% change in torsional stiffness = ~5% change in 1st torsional critical speed
30% change in torsional stiffness = ~15% change in 1st torsional critical speed

30% change in torsional stiffness on a $\varnothing 78\text{mm}/450\text{ mm}$ long bar shaft
what to expect on stiff spacers ???
