Vibration issue on Compressor in a Nitric Acid Plant (Part 2)

ASIA TURBOMACHINERY & PUMP SYMPOSIUM

SYMPOSIA: 24 – 26 MAY 2022
SHORT COURSES: 23 MAY 2022

Problem Statement

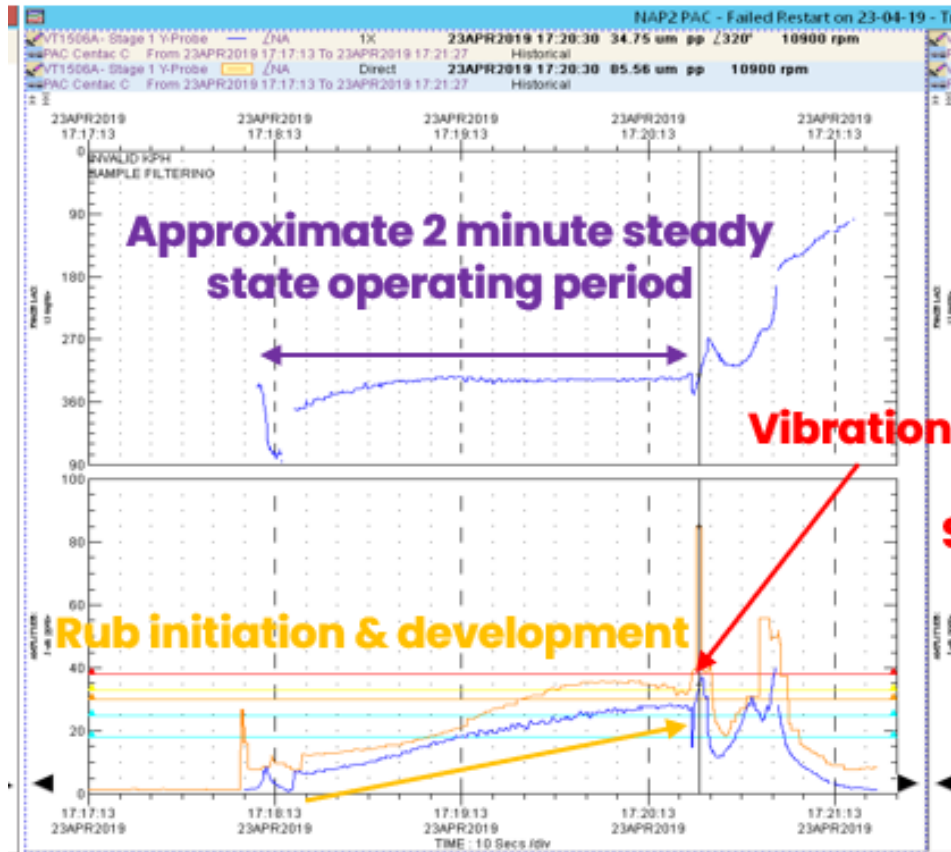
Data & Analyses – Rub Plots (23-04-19)

- On 23-04-19 the NAP2 plant was shutdown due to a plant process related issue. During the subsequent re-start (approx. 3 hours later) 1st stage direct & 1x synchronous trend plots (above right) verified a rub event which was initiated immediately after reaching full operating speed with the OEM Danger (Severity 4) trip set-point breached @ approx. 17:20:27, 2 minutes after the re-start.
- During the subsequent shutdown vibration related trip event the compressor 1st stage experienced two stall events @ approx. 11,350 rpm and approx. 5,600 & 4,300 rpm.

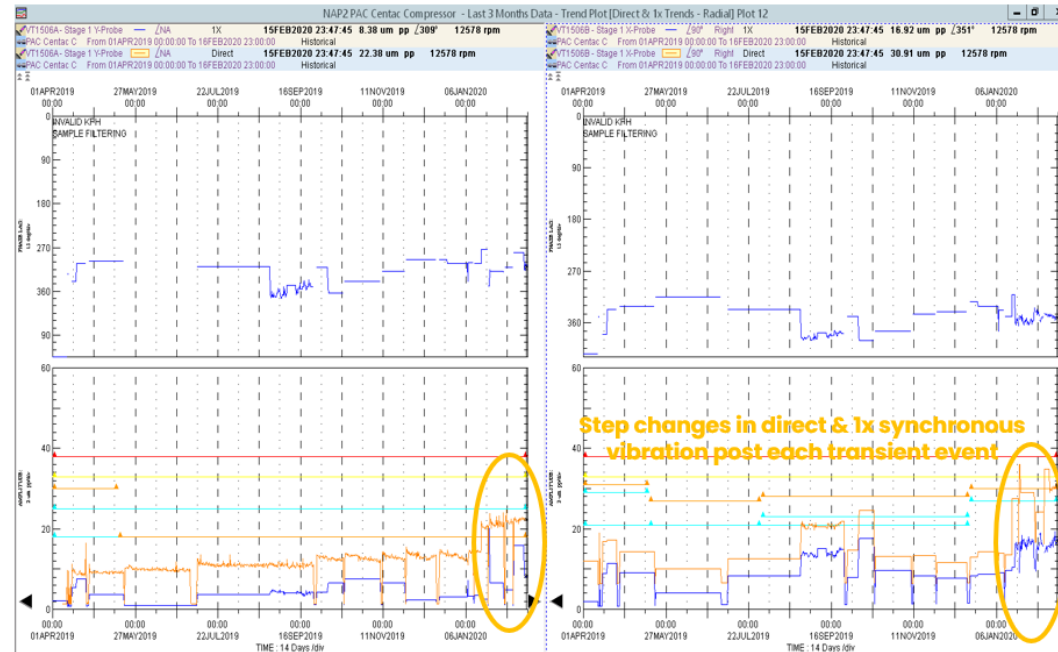
Data & Analyses – Long-Term Trends

- The compressor 1st stage direct & 1x synchronous long-term trend plots verify a series of step changes in direct values post each shutdown transient event associated with increasing -3X reverse component vibration with amplitudes as high as 14 um pp measured on February 6th 2020.
- 1X synchronous trended values were also noted as being variable post each shutdown transient event as well as during steady state operation.
- Direct values became highly variable in January 2020 breaching the OEM Alert value of 33 um pp, but remaining marginally below the Danger (trip) set-point of 38 um pp.

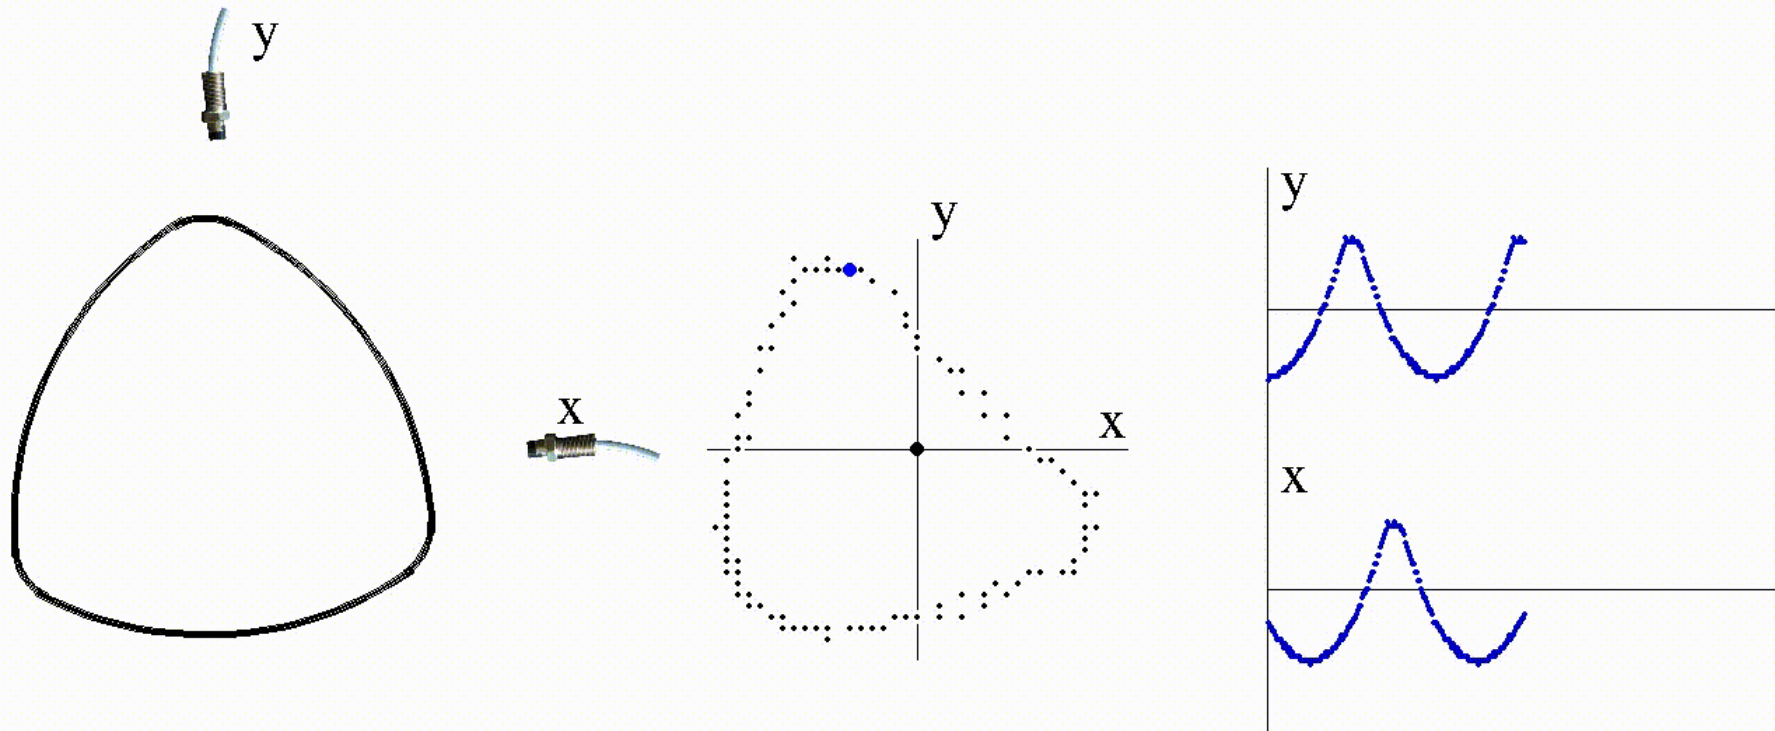
3x Reverse precession simulation

The constant amplitude -3x reverse component vibration measured throughout the entire speed range during each of the NAP2 PAC shutdown transient events specifically relates to run-out measured at the probe-tracking region of the 1st stage journal, rather than a rotor dynamic issue. However, Bently Nevada deemed that the increasing 1st stage run-out (increasing -3x reverse component amplitudes post each shutdown transient event) was **an indication of a defect progression specifically associated with the impeller to journal fit**.

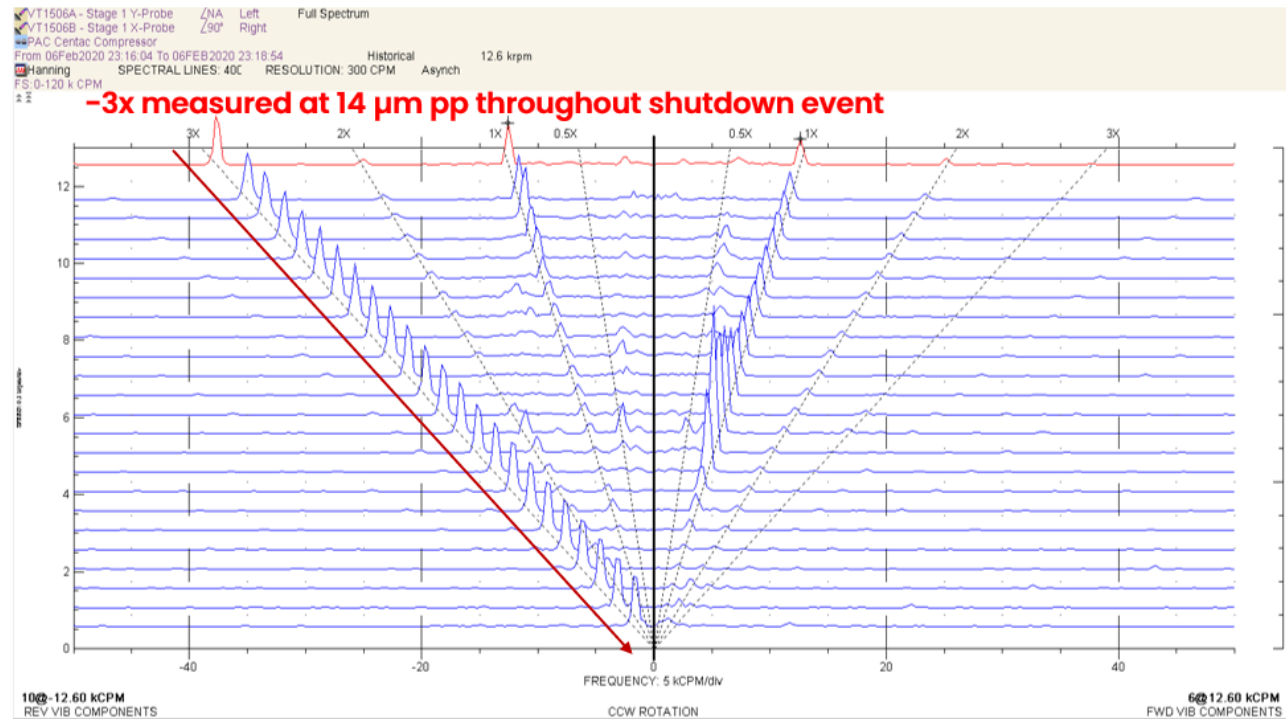
Data & Analyses – 1st stage Run-Out

- The February 6th 2020 shutdown was the last shutdown transient event prior to the OEM site based repair at the end of that month. The Compressor 1st stage full spectrum cascade plot indicates -3X reverse component vibration measured in the region of 14 μm pp throughout the Feb 6th 2020 shutdown.
- 1x synchronous reverse vibration amplitudes are also higher than the forward components, the exception being as the rotor transitioned the 1st (translational) critical speed range.
- The -3X reverse component indicated a compromised fit between the impeller bore and the rotor journal (tapered polygon P3 design) resulting in journal deflection during steady state and transient operation.

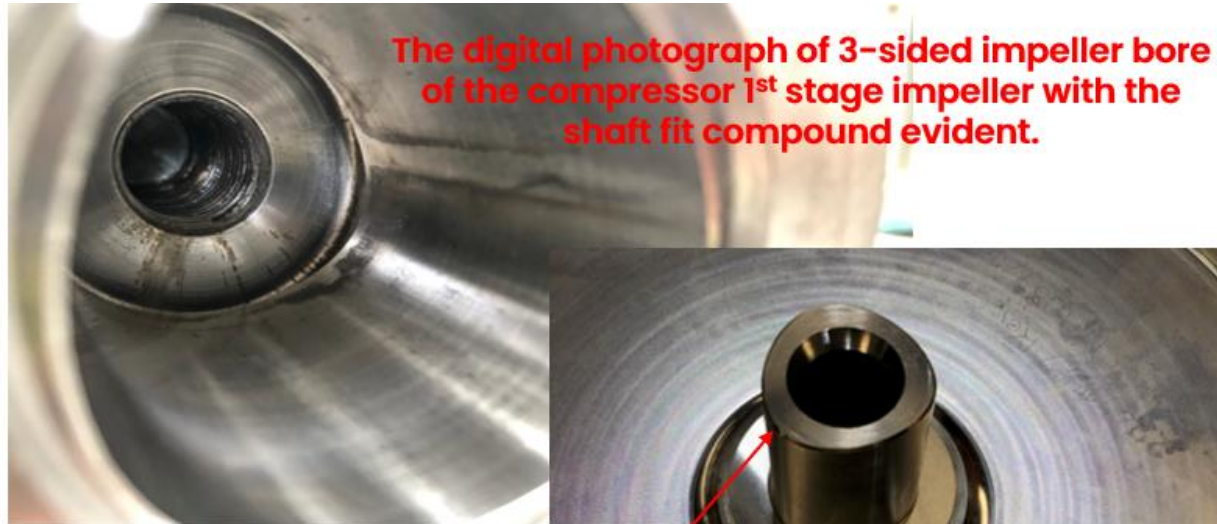
Maintenance Findings

- 1st stage tilting pad bearing indicated signs of heavy rub on the bottom two pad edges.
- 1st stage cylindrical bearing indicated signs of rub at the top of the bearing and heavier at one end.
- 1st stage impeller bore indicated evidence of anti-seize/slip compound used during the impeller installation at the OEM factory in Italy.
- 1st stage tilting pad bearing replaced.
- 1st stage cylindrical (outboard) bearing replaced.
- 1st stage impeller was slow-speed balanced (dedicated shop balancing machine - in a low-speed balancing machine).

- **1st stage tilting pad & cylindrical bearings were supplied with incorrect dimensions,** radial bearing clearances are not checked by OEM prior to installation (mandrel checks) with only the thrust bearing end float checked/verified.

The shop balanced original impeller was re-installed onto the 1st stage rotor journal as per OEM specifications with no anti-seize/slip compound applied.

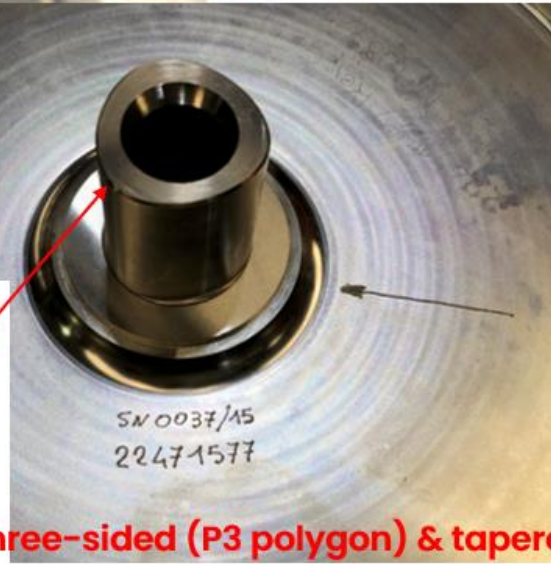
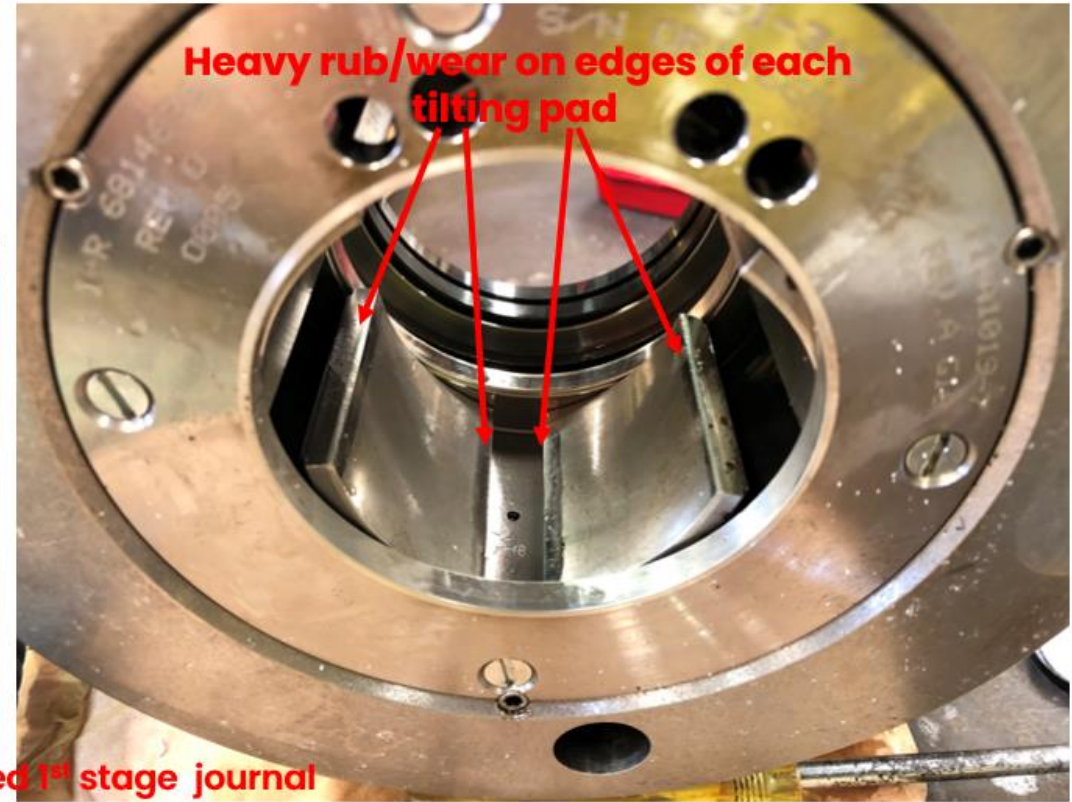
• P3 Profile

P3 profile has a three sided configuration. This polygon profile is used in cases where the female profile of the polygonal connection must be ground, and also for tapered profiles. With this polygon profile the female hub can be finished ground on the machine for a highly precision fit. P3 profile is ideal for **high torque** and **high stress** applications.

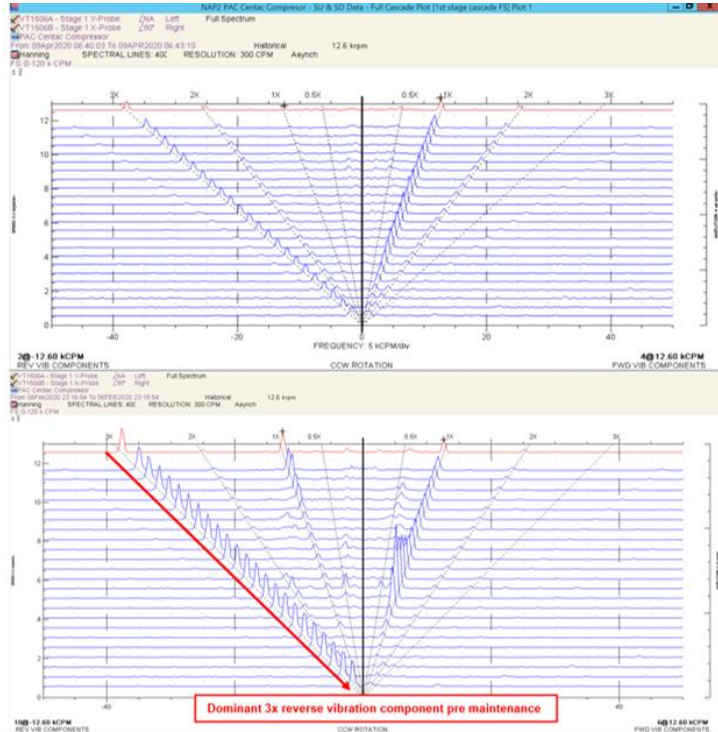
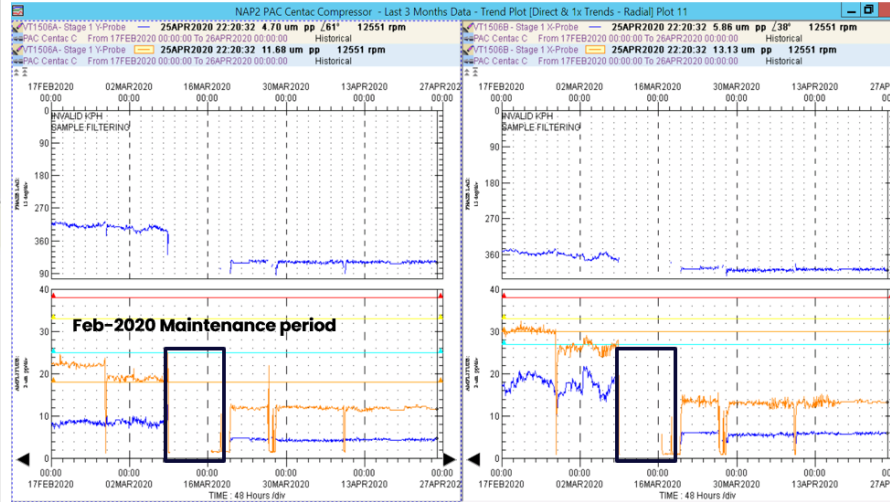
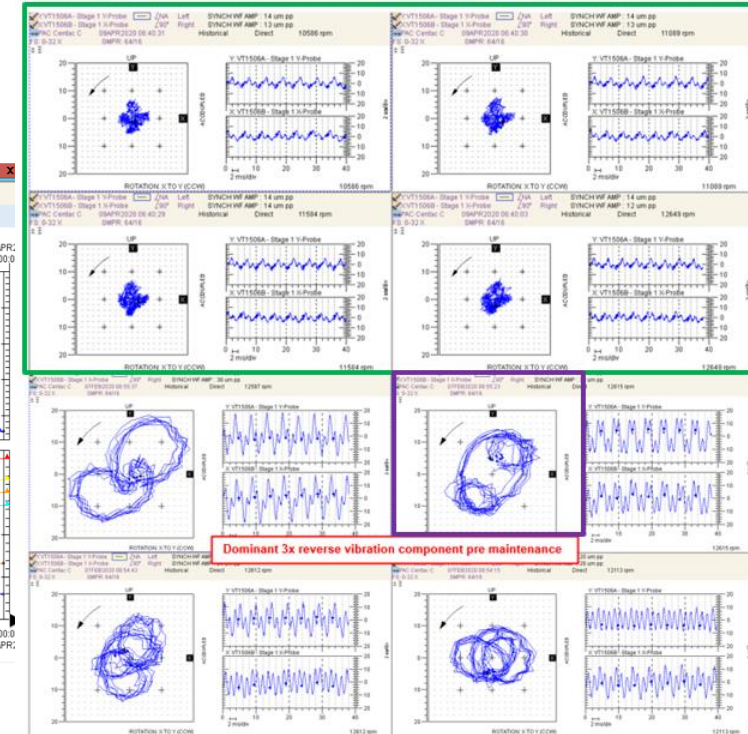
Pre/Post Repair 1st Stage Data

- Post the repair there was a step decrease in compressor 1st stage direct & 1x synchronous values with direct values now trending well below the OEM Alert set-point of 33 µm.
- The decrease in compressor 1st stage direct values is attributed to decreases in the amplitudes of the previously dominant 1x & -3x 1st stage frequencies (12,558 rpm rotor).
- Post the repair; full spectrum asynchronous cascade plot verifies a reduction in 1x synchronous forward vibration amplitudes during steady state operation as well as during transient events (transitioning of the 1st/translational balance resonance).
