**Corrosion Under Insulation In-Situ Testing in Marine Environment**

**Doctor of Philosophy**

**May 2023**

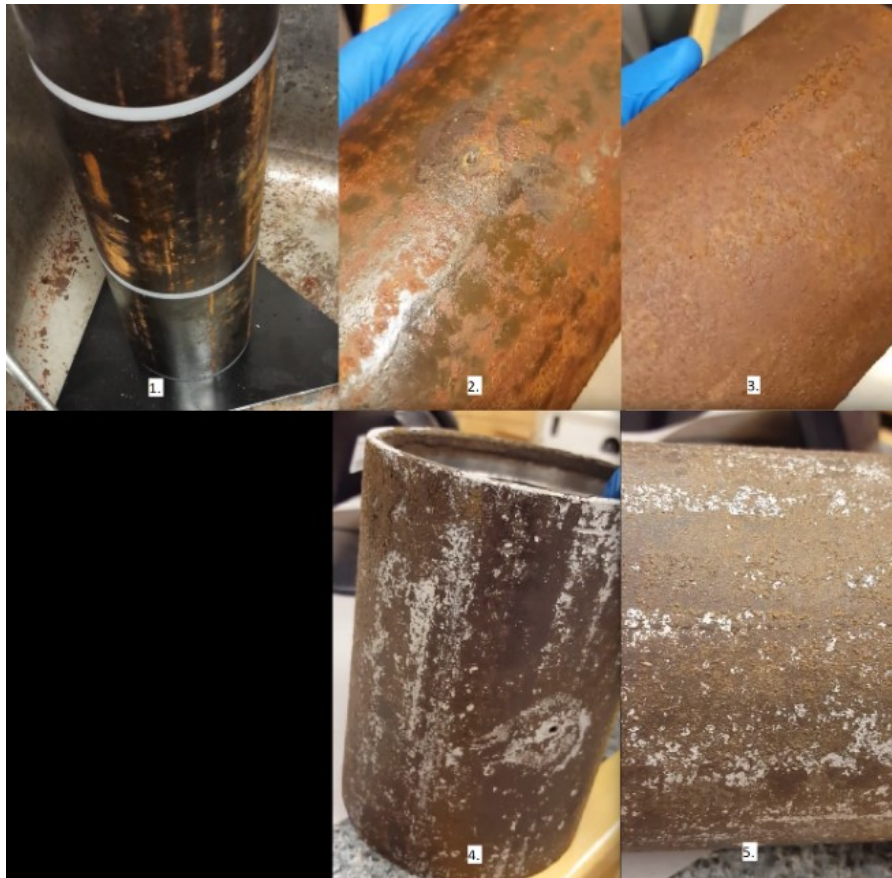
Figure 3.4: 1.) Pipeline 2, in top left initial condition Fall 2015, 2.) to the immediate right top and 3.) to the second right top Pipe 2 during Fall 2016, 4.) bottom center and 5.) bottom right after cleaning Fall 2016.

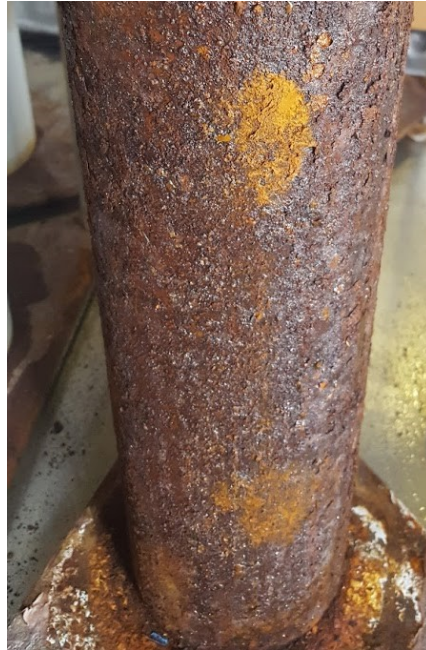
Figure 3.5: IUP pipe 26 June 2017, underwent significant CUI compared to others when inspected. Lightly bound oxide and exfoliation was over the entire surface.

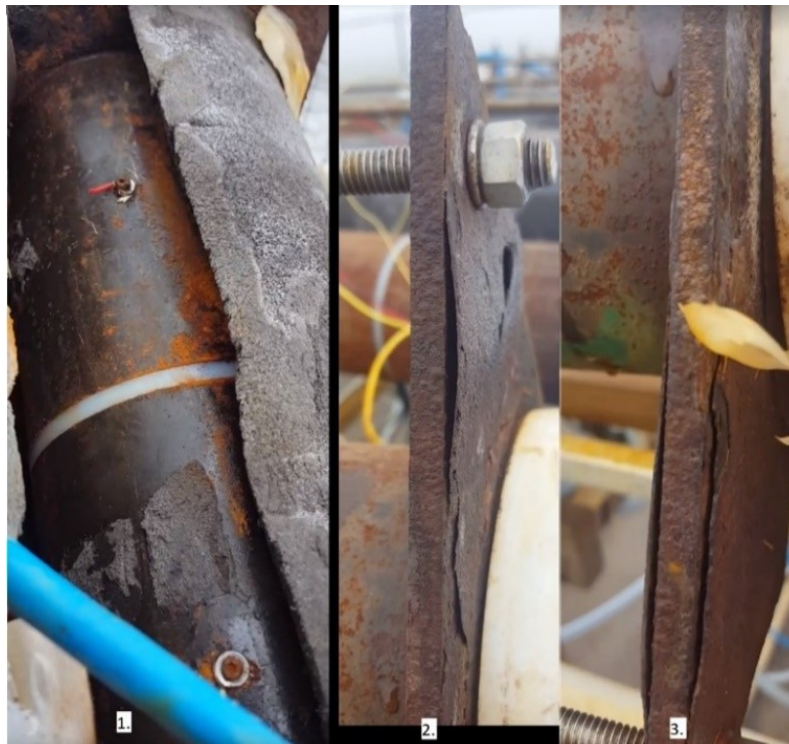
Figure 3.6: 1. One sample opened showing slight corrosion under insulation. 2. & 3. Low carbon steel triangles used for holding pipes together often flaked in large sections as exfoliation.

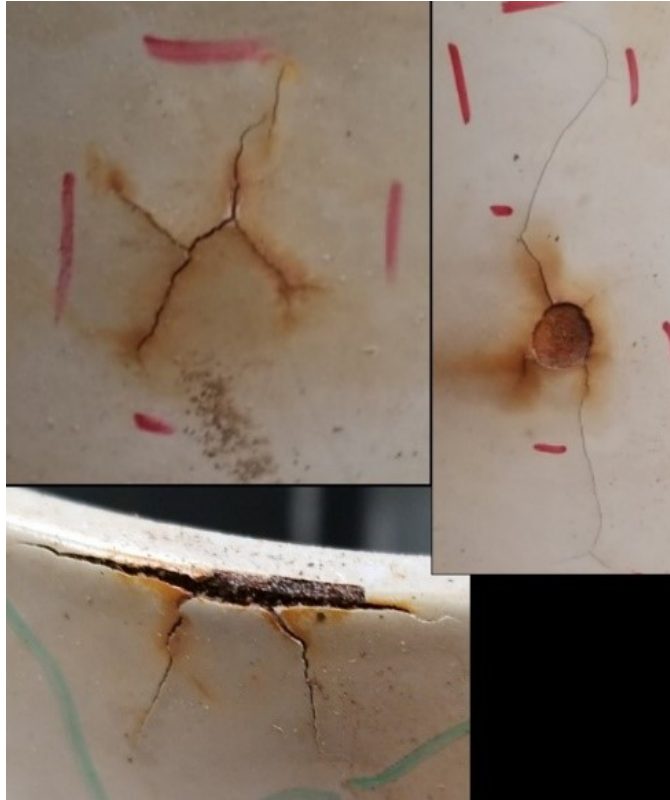
Figure 3.9: Pipe 13, Cracks in coating. Top right further examined in Figure 3.11.

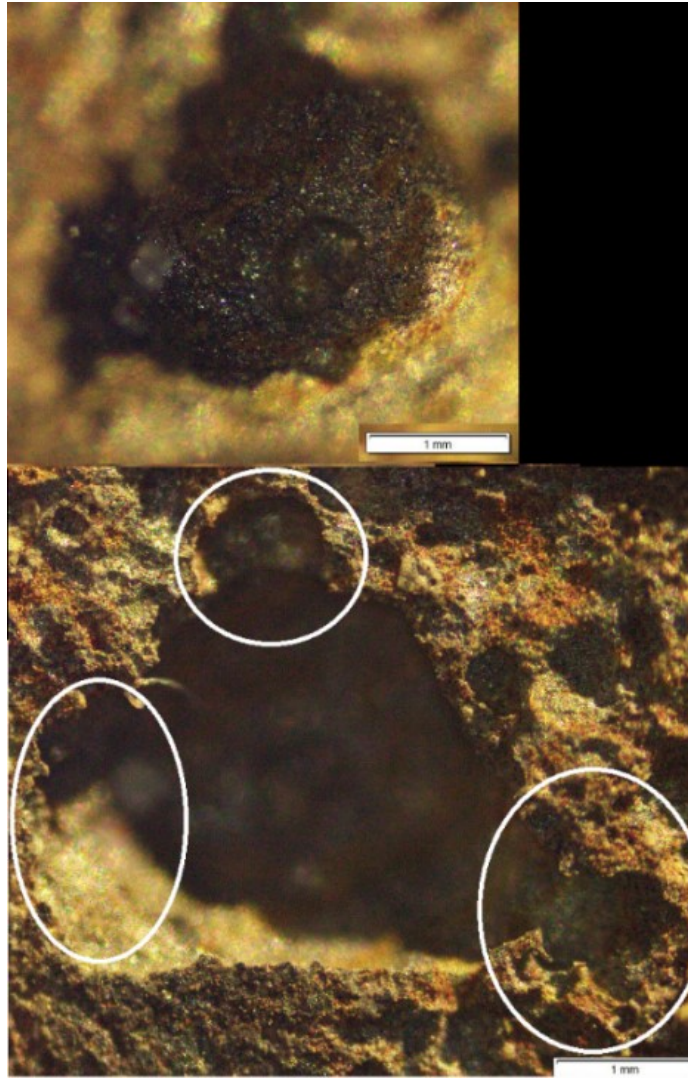
Figure 3.10: One of the largest pits measured from Pipe 26, insulated and uncoated. Scale bar is 1mm. The insulation, which should protect the pipeline became an insulation that did not allow O<sub>2</sub> to enter and create protective surface oxides.

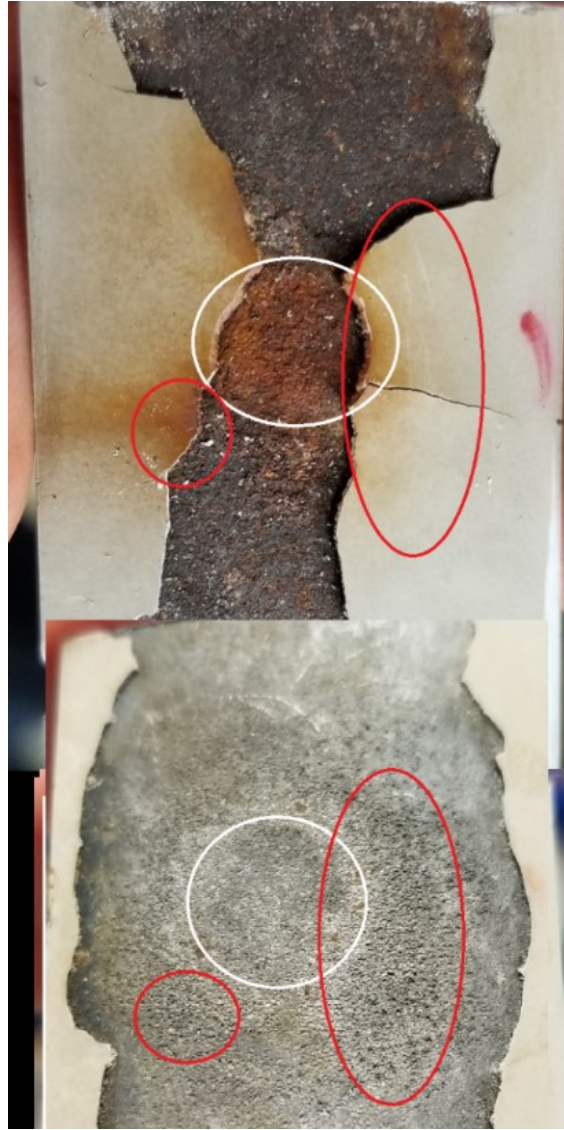
Figure 3.11: Pipe 20 which had one paint section damaged. Red circles were deepest pits. They occurred here perhaps due to the lack of free flow  $O_2$ , while away from the open surface, and away from the area still protected by coating but no electrolyte ingress.

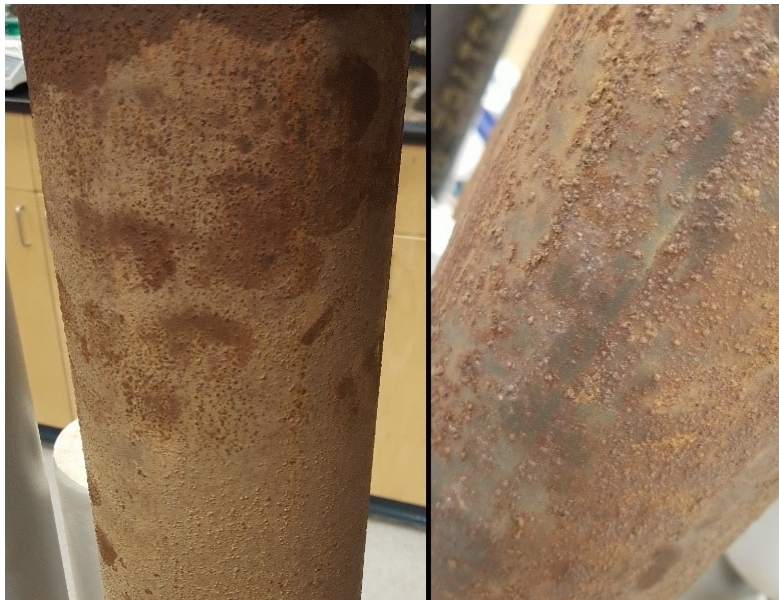
Figure 4.1: Pipe 27 showing compact light layer of surface oxide in patches. Left July, right December.

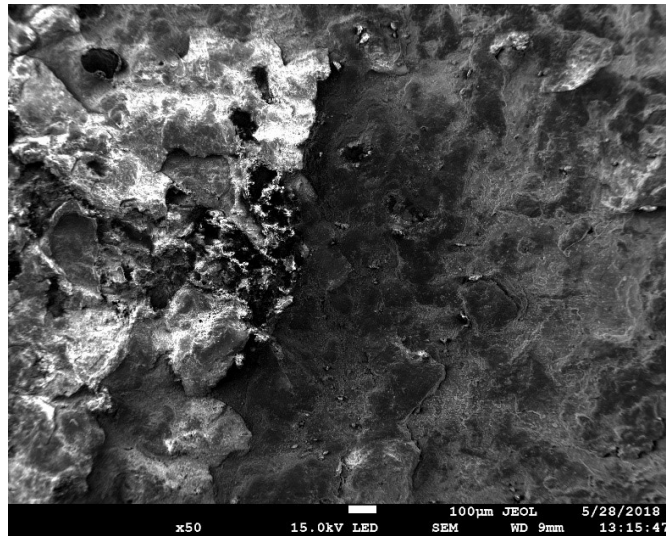
SEM image in Figure 4.2 shows a cracked and broken, uneven surface oxide on the left, while the right side is more compact, smooth. Such surfaces generally protect the steel from elements like chloride. Figure 4.3 shows a pit. EDS scans in Table 4.2 show typical marine atmosphere elements.

Figure 4.2: Pipe 27, Uncoated uninsulated, easily removed flaky oxide on the left side and the more compact darker underlayer on the right.

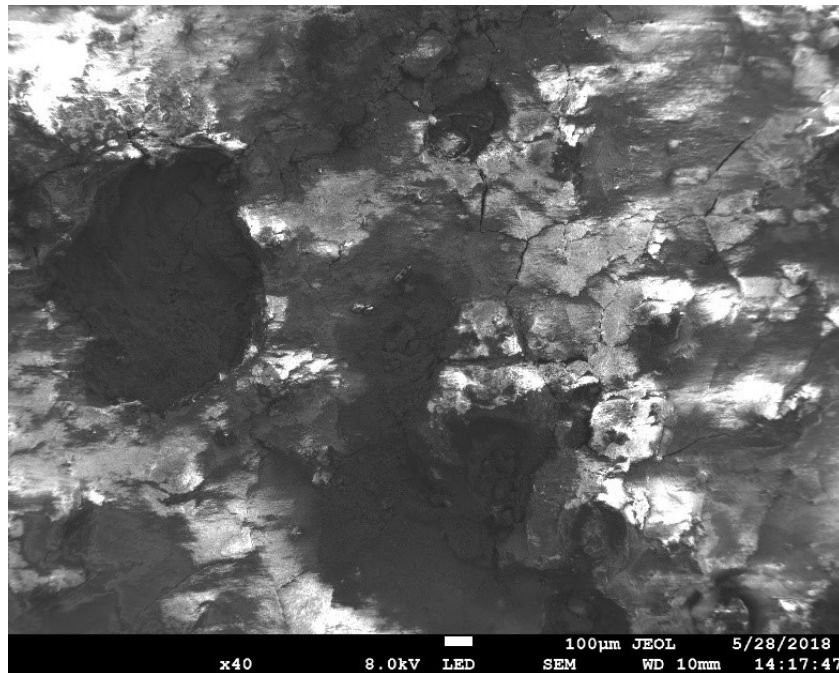
Figure 4.5, Figure 4.6, and Figure 4.7 have cracks and flattened area like valleys. Cracked and easily removed oxide surface may not protect the steel surface as well as a uniform oxide layer with a smooth surface. Typical marine elements were found on the surface listed in Table 4.4. Figure 4.8 shows typical exfoliation in marine environments where chloride oxides form higher volume below other Fe oxides, raising up layers of Fe which are easily removed.

Figure 4.5: Pipe 2B showing non protective oxide, with cracks and non-smooth surface. In the darkened areas, sandy grains appear.

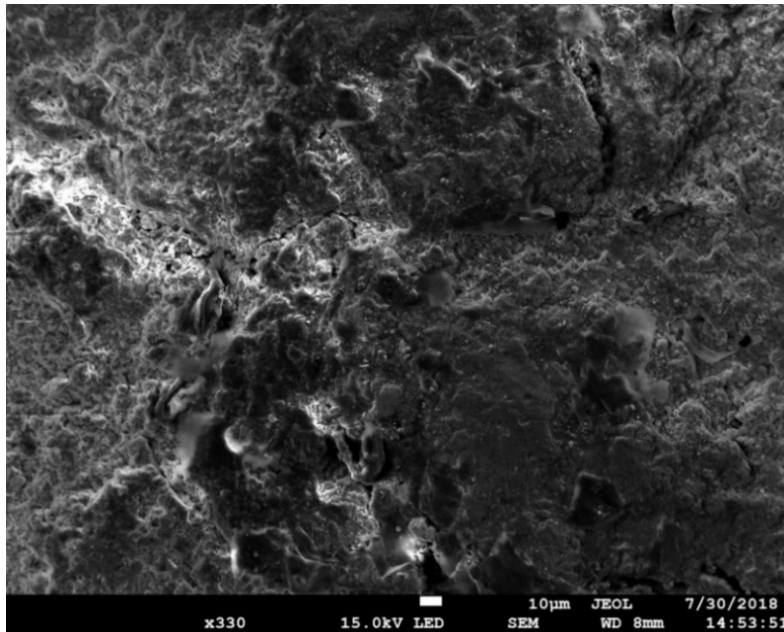
Figure 4.7: Pipe 2B showing what may be lepidocrocite and globular goethite in cracks, and globular goethite in areas of the surface. The oxide shown here is more compact than other images taken.

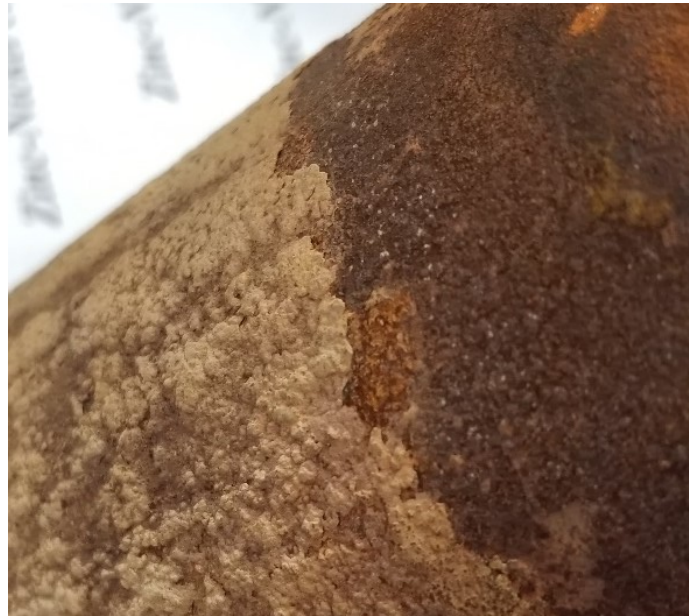
Figure 4.8: Early exfoliation, typical outer (lightly bound) and inner (strongly bound) oxides.

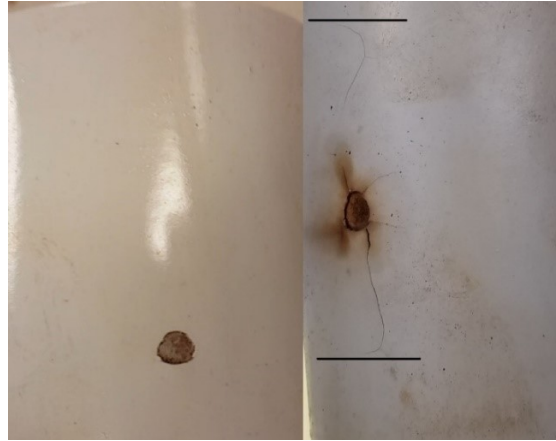
Only one random sampled pipe experienced broken coating with corrosion as seen in Figure 4.9, Figure 4.10, and Figure 4.11 showing different features and oxides. EDS scans are shown in Table 4.5. In this sample, marine moisture penetrated the insulation and attacked an area of broken coating. Corrosion then spread under the coating. This coating failed in under 2 years, while in industry coating is generally given life of 5-13years (Geary, 2013). However, 7/36 pipes which were coated and insulated did not suffer any coating breaks.

Figure 4.9: Pipe 20, July (left) vs December (right). Coating failure led to corrosion under coating which spread multiple times its initial size under the coating in 6 months.

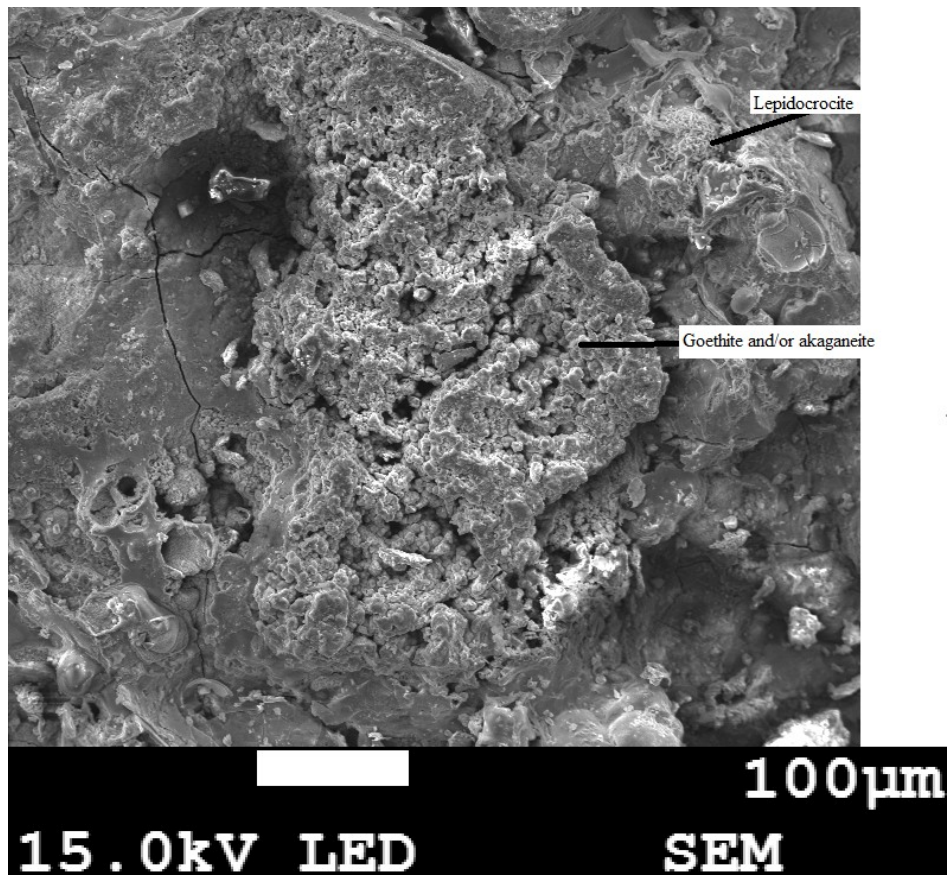
Figure 4.10: 20B showing lepidocrocite in worm nest pattern and globular goethite and/or akaganeite in center.

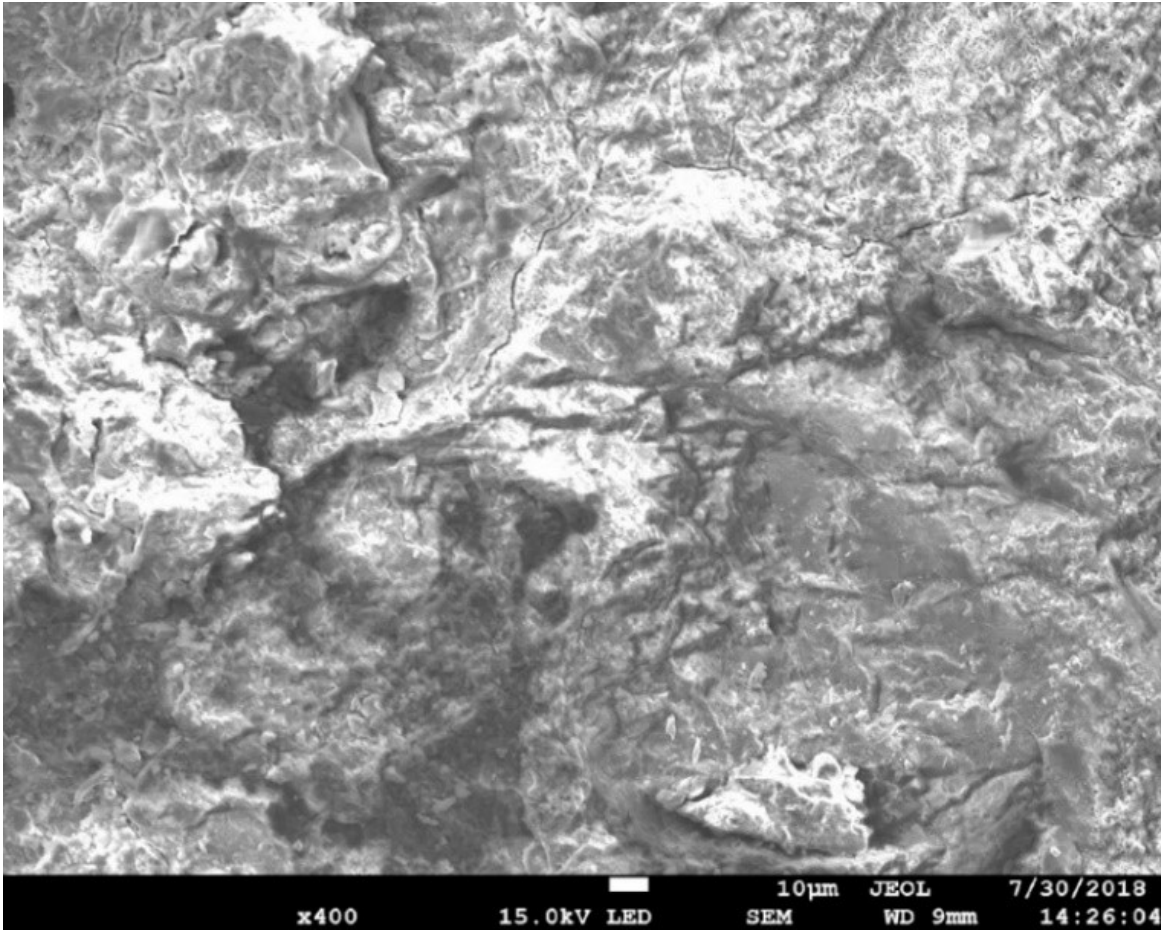
Figure 4.11: Pipe 20B (uninsulated and coated) showing lepidocrocite in and around cracks.

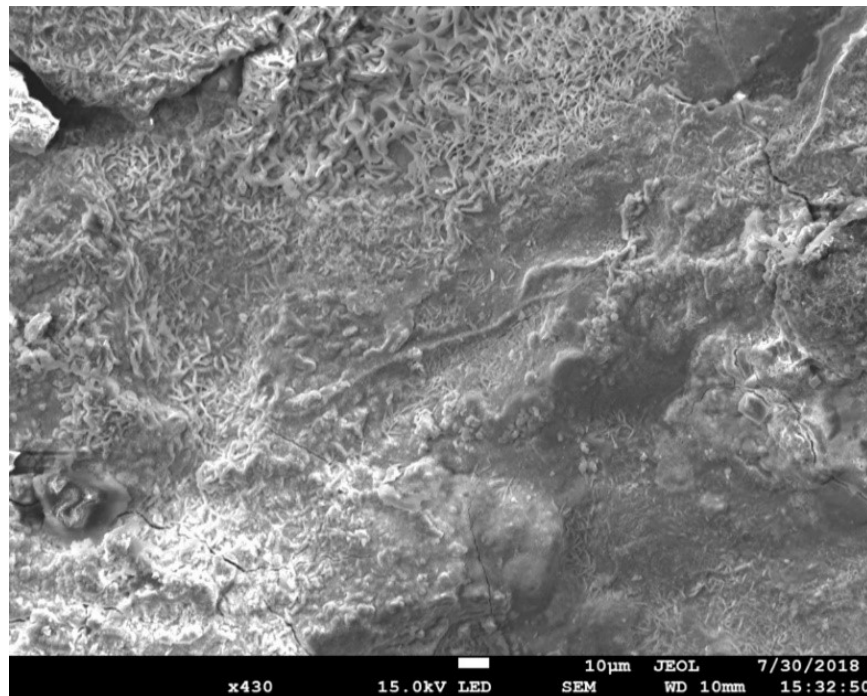
Figure 4.13: Laminar lepidocrocite over pipe 17.

Figure 4.13 shows laminar lepidocrocite over the surface, with what appears to be some globular goethite starting to form in the center. The surface is not deeply cracked compared to uncoated pipe samples in previous section. Pipe 17 was from the first year, while pipe 13 was from the second.

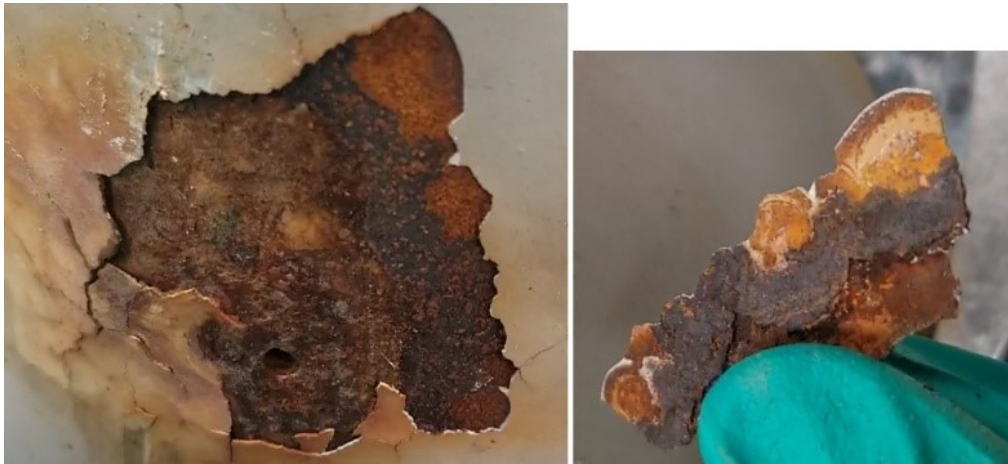
Figure 4.14: Corrosion under coating of 13C. SEM performed on epicenter of break until right edge of coating still attached. See Figure 4.15 to Figure 4.21.

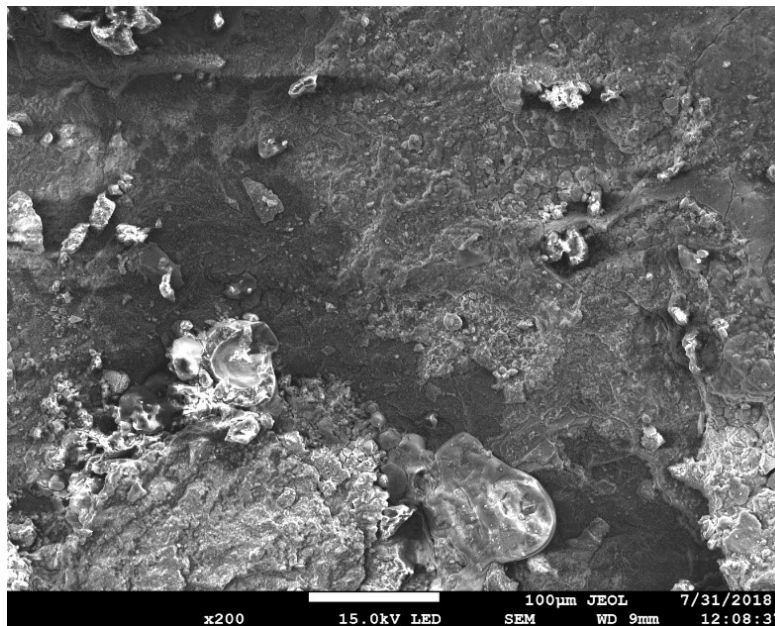
Figure 4.15: Pipe 13C showing cracks, uneven surface.

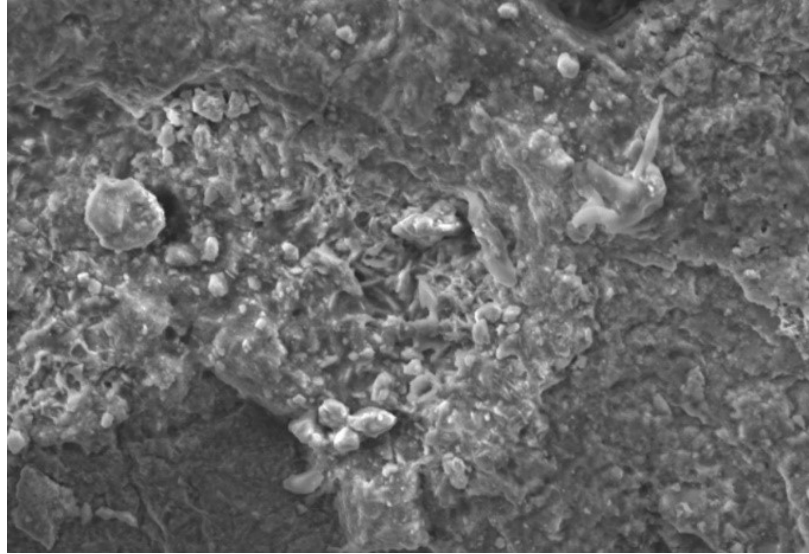
Figure 4.16: Enlarged center from Figure 4.16 showing lepidocrocite and goethite and small pits on layered sheets on bottom right side. XRD of similar pipe in Figure 4.30.

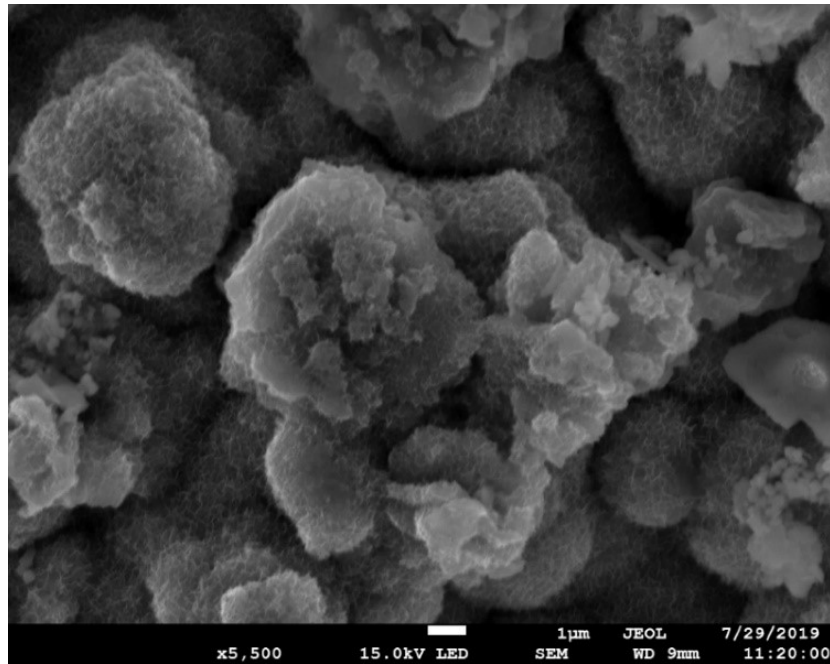
Figure 4.17: 13C mid region from coating edge to coating break location. Corrosion surface appears porous with small laminar slivers on stacks.

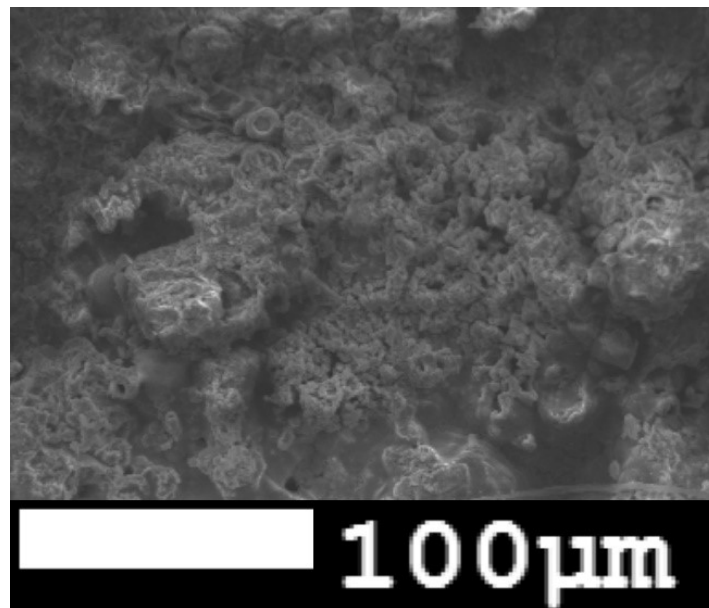
Figure 4.18: 13C near coating break showing a donut shapes, typically magnetite, in top center left.

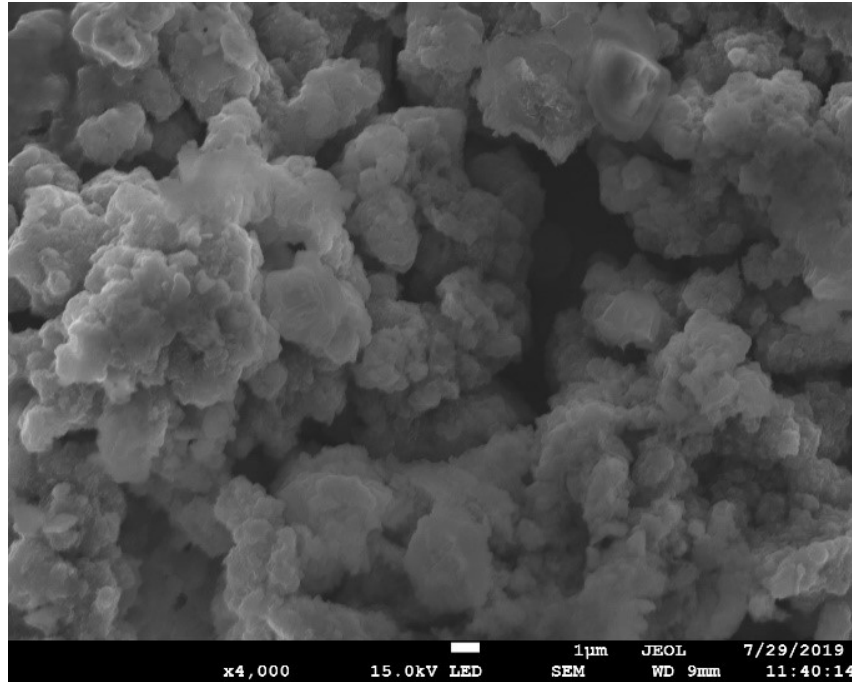
Figure 4.19: Pipe 13C near epicenter of coating break, the stacks appear with globules, smoother than in Figure 4.17.

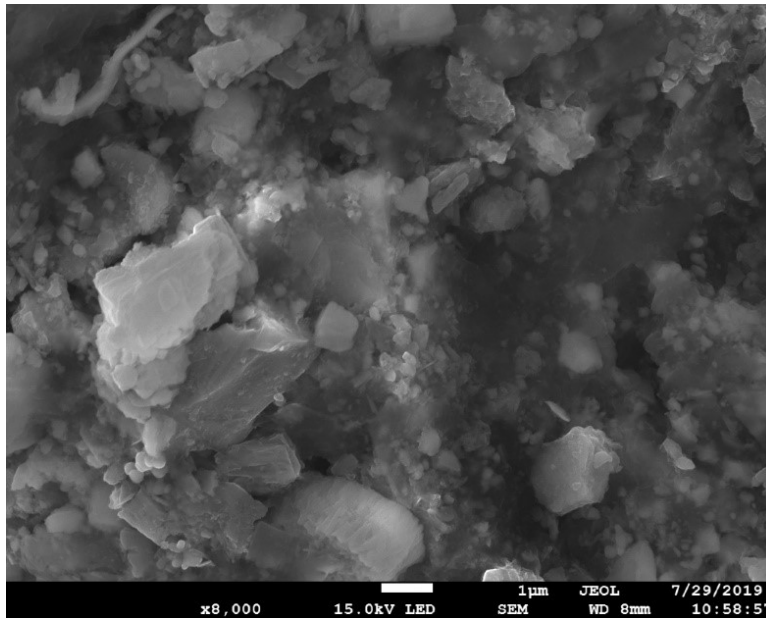
Figure 4.21: 13C Further from initial break shows crystalline species present. It may be organic matter or part of the coating still on the surface where corrosion did not yet progress.

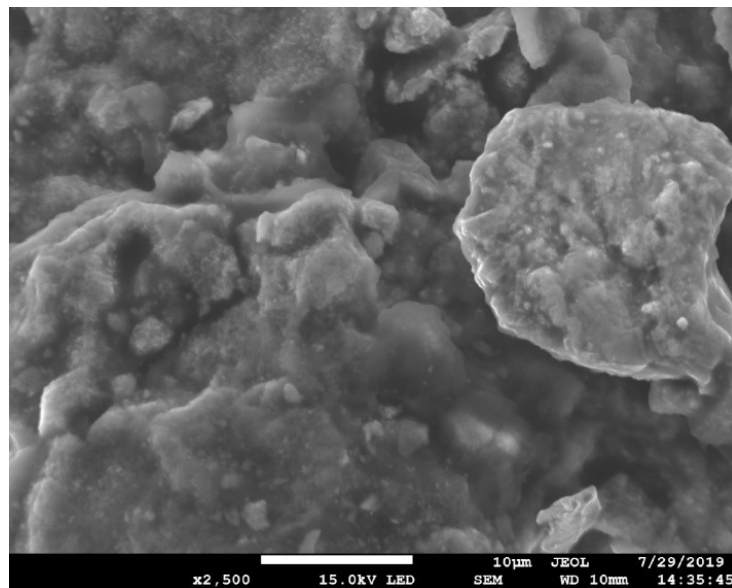
Figure 4.22: Pipe 23B showing relatively matured, smoothed surface compared to other pipes in this section. Mature products found in XRD in Figure 4.31 a similar coated uninsulated pipe.

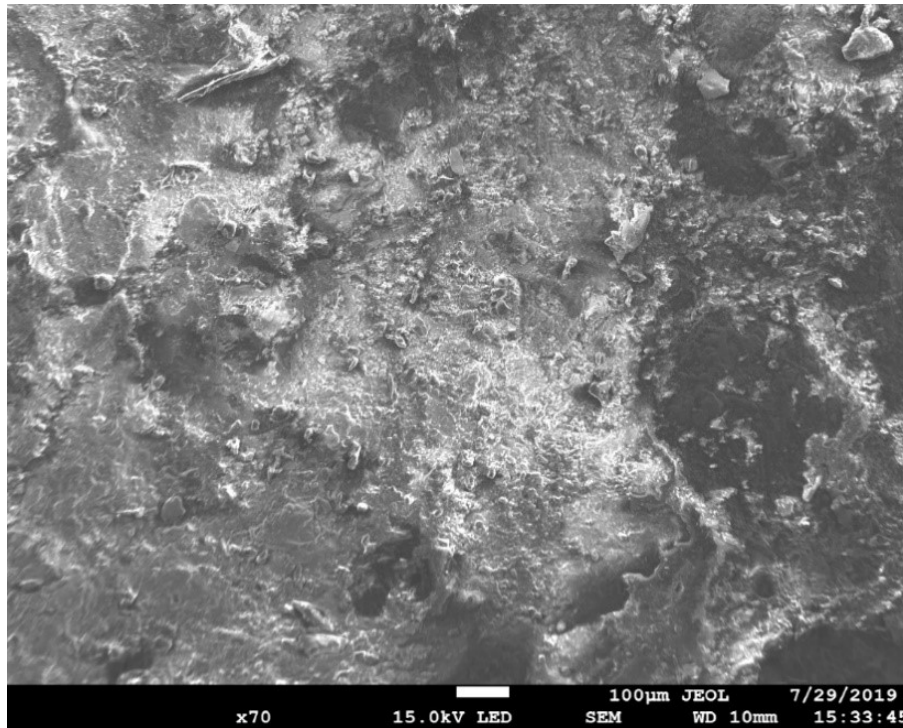
Figure 4.24: Pipe 3B showing globules and elongated cigar shapes, possibly akageneite, matching XRD in Figure 4.26: Pipe 3 XRD analysis.

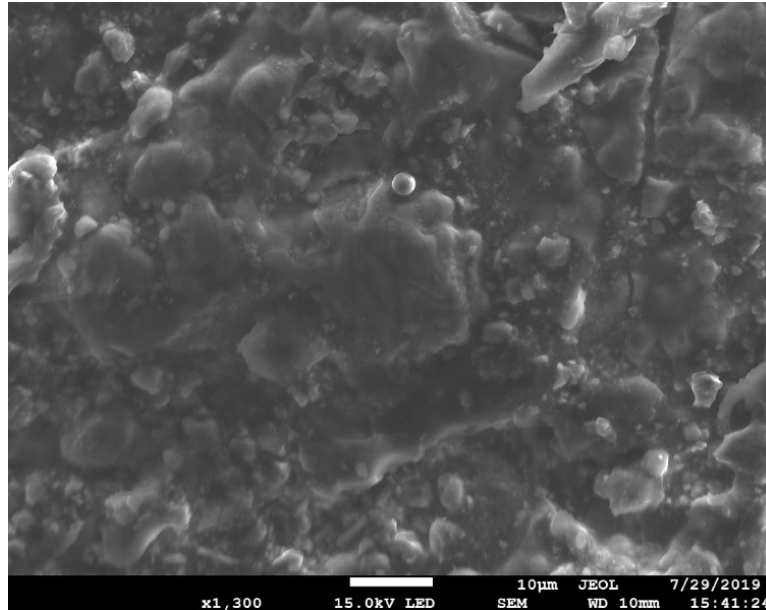
Figure 4.25: Pipe 3B globules. Compared to Figure 4.11 and Figure 4.13 the oxide is more compact and smoother showing lepidocrocite to goethite transformation and matches XRD found in Figure 4.26

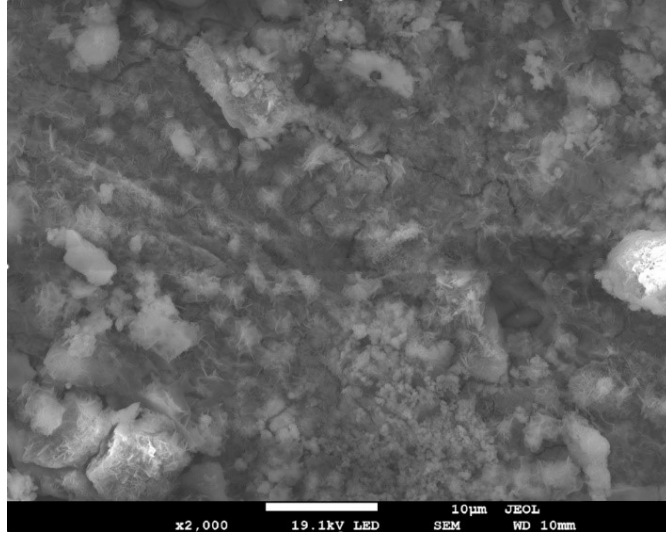
Figure 5.48: Experiment 8 with lepidocrocite, and/or akageneite, along with grain boundary cracks. Similarly found in Chapter 4
