## Preliminary analysis of the mechanisms, characteristics, and causes of a recent catastrophic structurally controlled rock planar slide in Esposende (northern Portugal)

**Abstract** A catastrophic rock planar slide occurred in the parish of Palmeira de Faro, Esposende (N Portugal), on November 23, 2022, in the middle of the night, killing two people while they were asleep in the first floor of a building close to the affected cut slope. The collapsed slope presented a maximum height of about 23 m, and was excavated in a granitic rock mass strongly weathered, in some areas by mechanical means and, locally, with the support of blasting. The displaced material, with an estimated volume of 2000 m<sup>3</sup>, described an oblique trajectory with respect to the dip direction of the slope with a maximum length of about 44.6 m. The direction of the trajectory could be explained by the strong structural control of the instability through three discontinuity sets which delimit the slid rock mass causing multiple damage on the above-mentioned building. Although further detailed studies are necessary to elucidate the causes of the landslide, the unfavorable geological conditions, the anoma

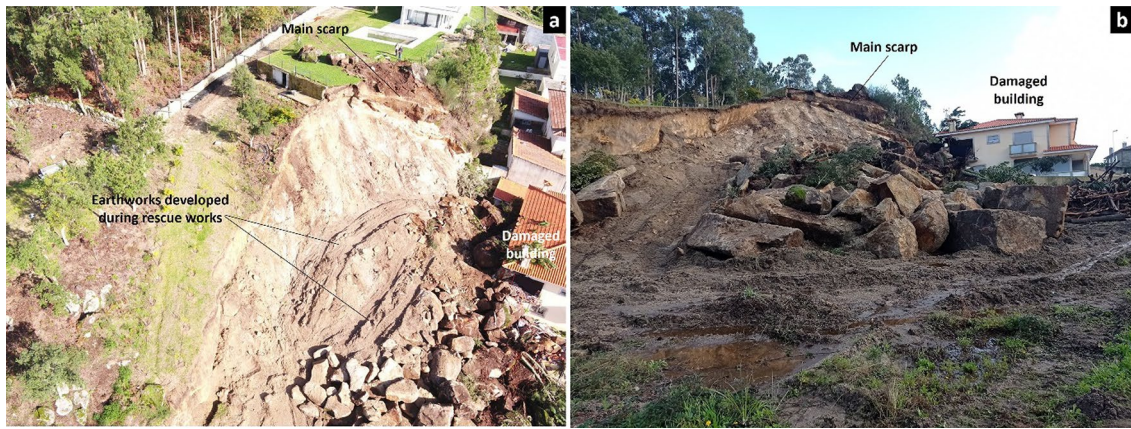
The displaced rocky material of the landslide slid on a planar rupture surface and described a clear oblique trajectory with respect to the original existing cut slope with an approximate direction of N208°E. The length of center line was 51.4 m while the total length was 55.7 m. The width of the surface of rupture and the displaced mass were 26.6 and 36.8 m, respectively, and the depth of the rupture surface and the displaced mass were 14.3 and 7.7 m, respectively. The dimensions of the landslide, as per the standardized criteria established by the UNESCO Working Party on World Landslide Inventory (1993), are summarized in Table 1.

According to Cruden and Varnes (1996), the landslide is classified as a rockslide, while Hungr et al. (2014) classify it as a rock planar slide. Additionally, the event can be classified as “extremely rapid” according to the classification of Cruden and Varnes (1996), since it developed very quickly, without any apparent previous sign of instability according to the witnesses.

Fig. 1 (a) Aerial and (b) ground general views of the rock planar slide that occurred in Esposende on November 23, 2022

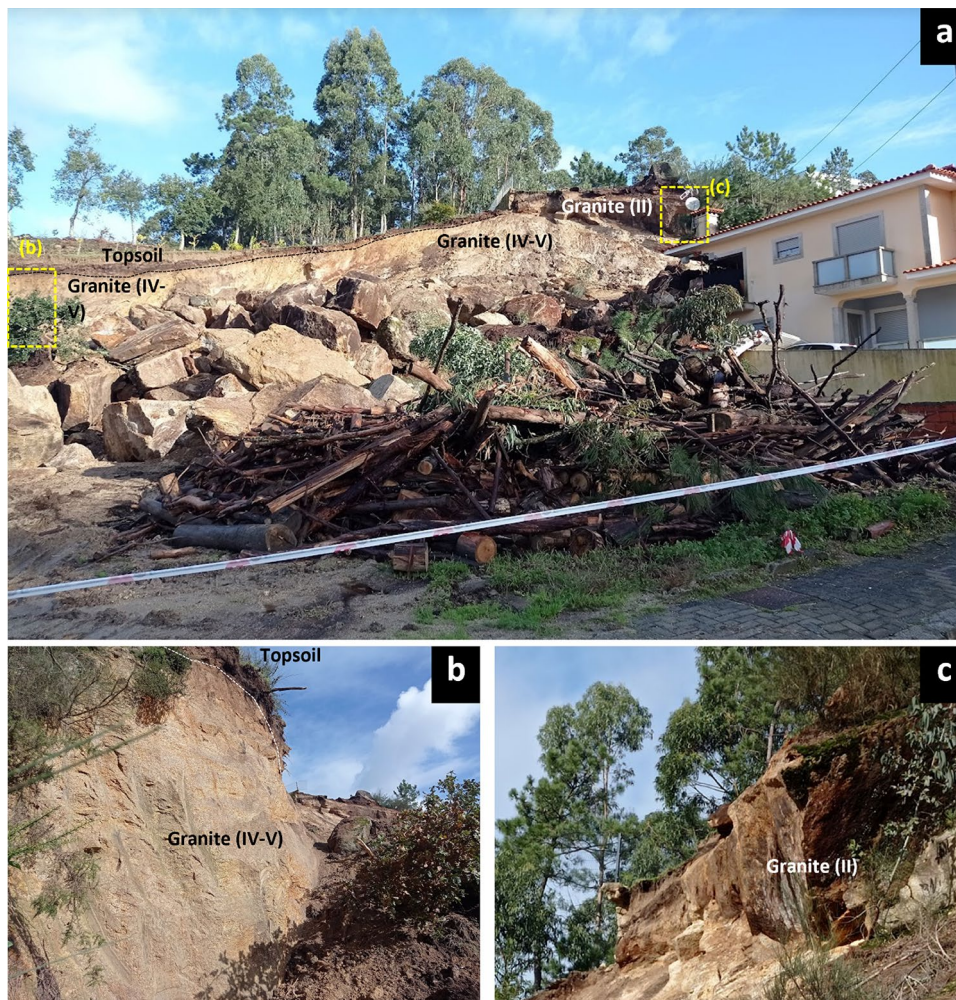
**Fig. 3** (a) Geology of the slope. (b), (c) Detail of the different defined lithological units. The weathering degree is expressed in Roman numerals into brackets. Notice tooth marks from the bucket of a mechanical excavator in the slope on (b) evidencing the high weathering of the granite in some parts of the slope

In detail, the failed granitic slope presents weathering degrees varying between II (slightly weathered) and IV–V (highly or completely weathered) following the ISRM's (1981) suggested methods. The top of the slope also presents a thin topsoil layer, being partially covered by shrubs and grass, as well as some pine and eucalyptus groves (Fig. 3).

The high degree of weathering of the rock mass (i.e., between II and V) also reduced the shear strength of the rock and the discontinuities, strongly conditioning the stability of the slope (Barton and Choubey 1977).

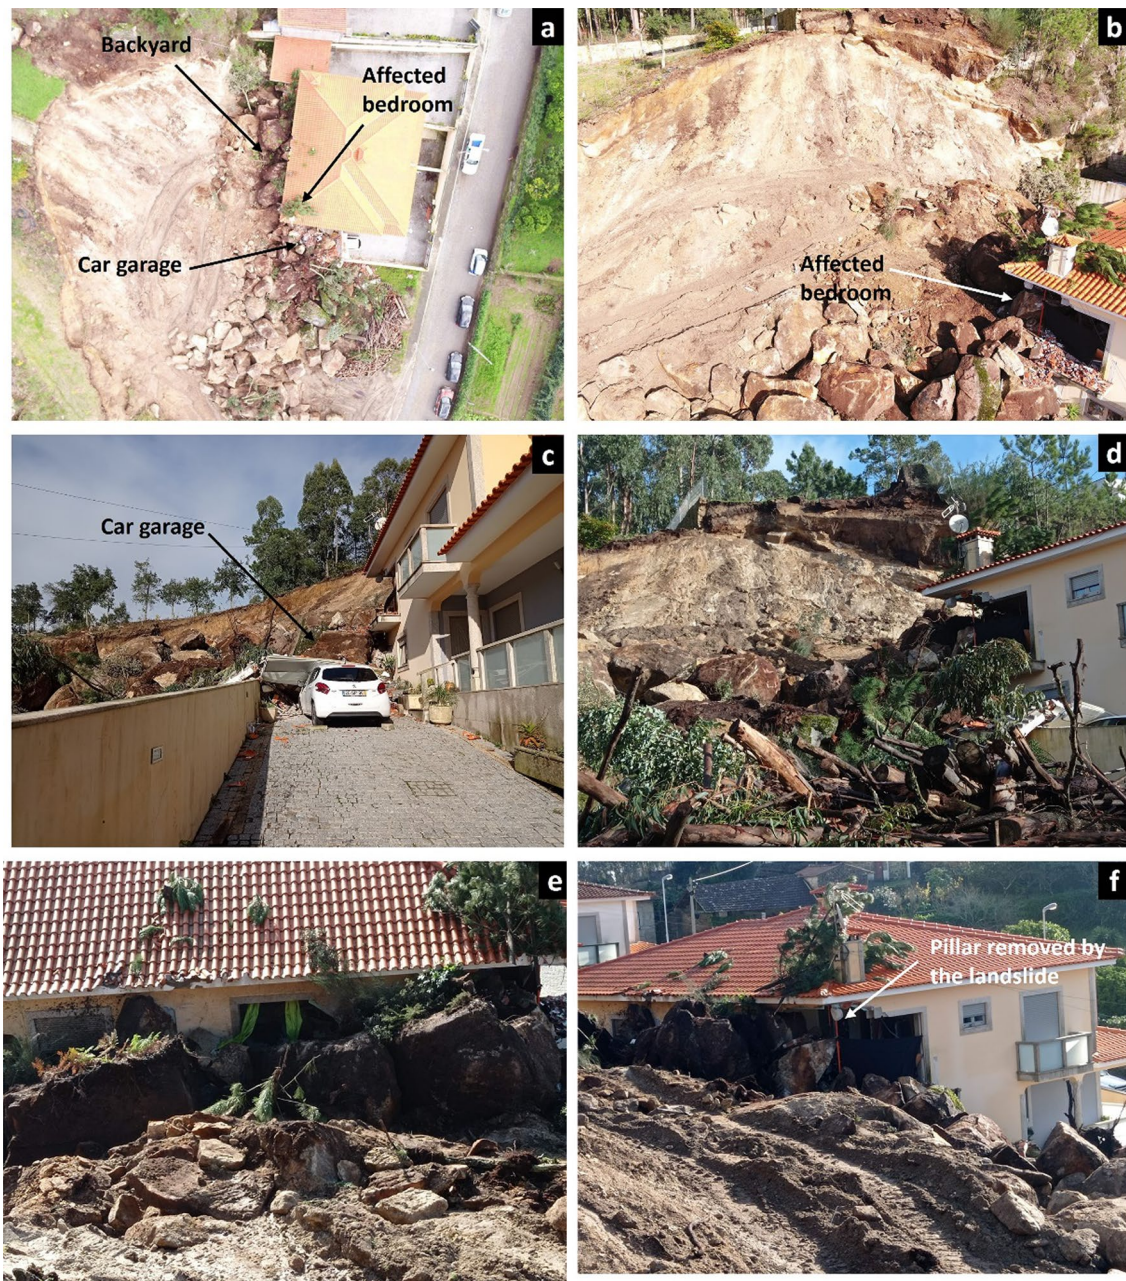
**Fig. 4** Picture of the damage caused by the rock planar slide on the building placed on the foot of the slope. **(a)** Plan view showing the different elements affected. **(b)** Oblique image of the affected building and the room in which the two deceased people were sleeping. **(c)** Car garage buried by the landslide. **(d)** Front image of the rock planar slide and the room impacted by the landslide. **(e)** Rear façade of the building in which the three bedrooms were placed. **(f)** View of the part of the building struck by the landslide in which the removed pillar and enclosure of the affected bedroom can be observed

The rock planar slide struck the rear façade of a semi-detached house built with a reinforced concrete structure, although only the NW corner of this building, in which three bedrooms were placed

on the first floor, was severely affected (Fig. 4). Since the event occurred near 3:55 a.m., the house was occupied by 5 members of a family. The two occupants of the westernmost room died while they were sleeping. Although the detached rocks and soil mass and the sucked trees also affected the adjacent rooms, there were no more injuries. The N and W enclosures of the house and the NW corner pillar were torn down by the slid soils and rock mass, although the general structure of the building did not collapse. Some adjacent constructions, as the car garage of the house, were partially buried

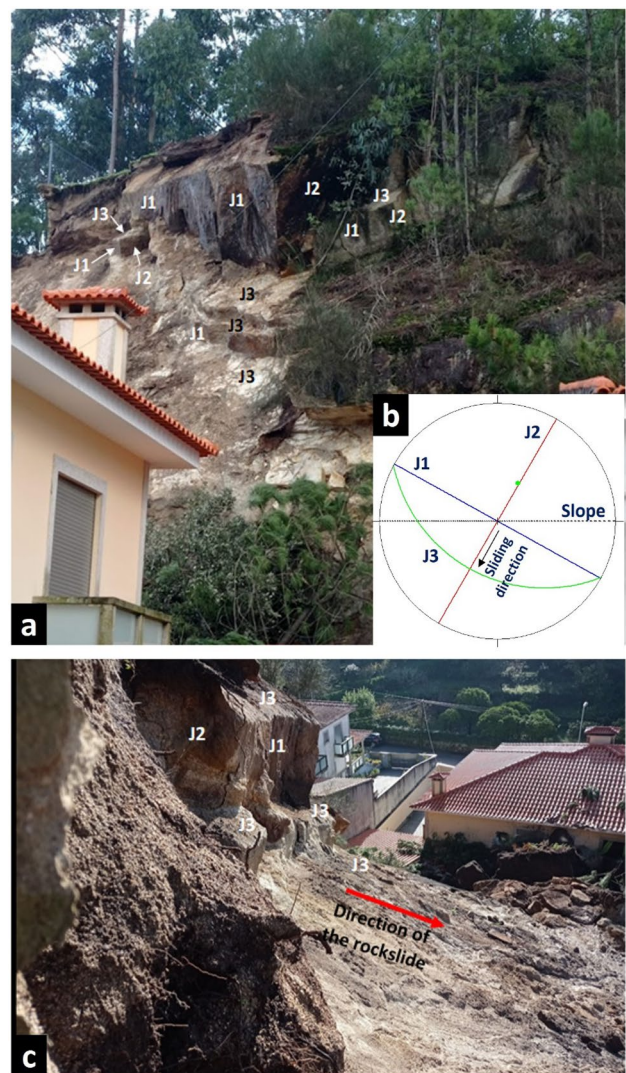
However, the main conditioning factor of the instability seems to be the existing rock mass structure. Three sets of discontinuities are clearly recognized in the source area of the landslide. Two of them are subvertical sets of discontinuities (J1 and J2) and exhibit approximate orientations N119°E and N210°E (Fig. 5), respectively. These discontinuity sets were also measured in the natural outcrop existing on a granitic rock mass placed on the other side of the road. Figure 6c shows a perfect match of the strike of J1 and J2 with the strike of the failure plane in the main scarp, and the direction of sliding derived from the topographic map obtained from the UAV imagery. Additionally, a discontinuity set J3 defines the surface of failure, which presents a similar strike to J1 and a dip value between 35 and 40° dipping towards the SW (Figs. 5, 6, and 7). The combination of the three discontinuity sets (Fig. 5b) explains the shape and the oblique direction of displacement of the rock planar slide observed in Figs. 6b, c, and 7.

**Fig. 5** (a), (c) Detail of the discontinuity sets observed in the area of the main scarp from two different points of view. (b) Stereoplot of the discontinuities

Consequently, it may be concluded that discontinuity sets J<sub>1</sub> and J<sub>2</sub> separated the sliding mass, which slid over the surface of rupture defined by the discontinuity set J<sub>3</sub>. Additionally, the cut slope placed on the right flank of the rock planar slide, which presented a high degree of weathering (Fig. 3), partially collapsed over the slid mass (Fig. 7a). Likewise, the combination of different conditioning factors, jointly with the triggering effect of rainfall and, perhaps, the excavation performed on the toe of the slope, could have caused this

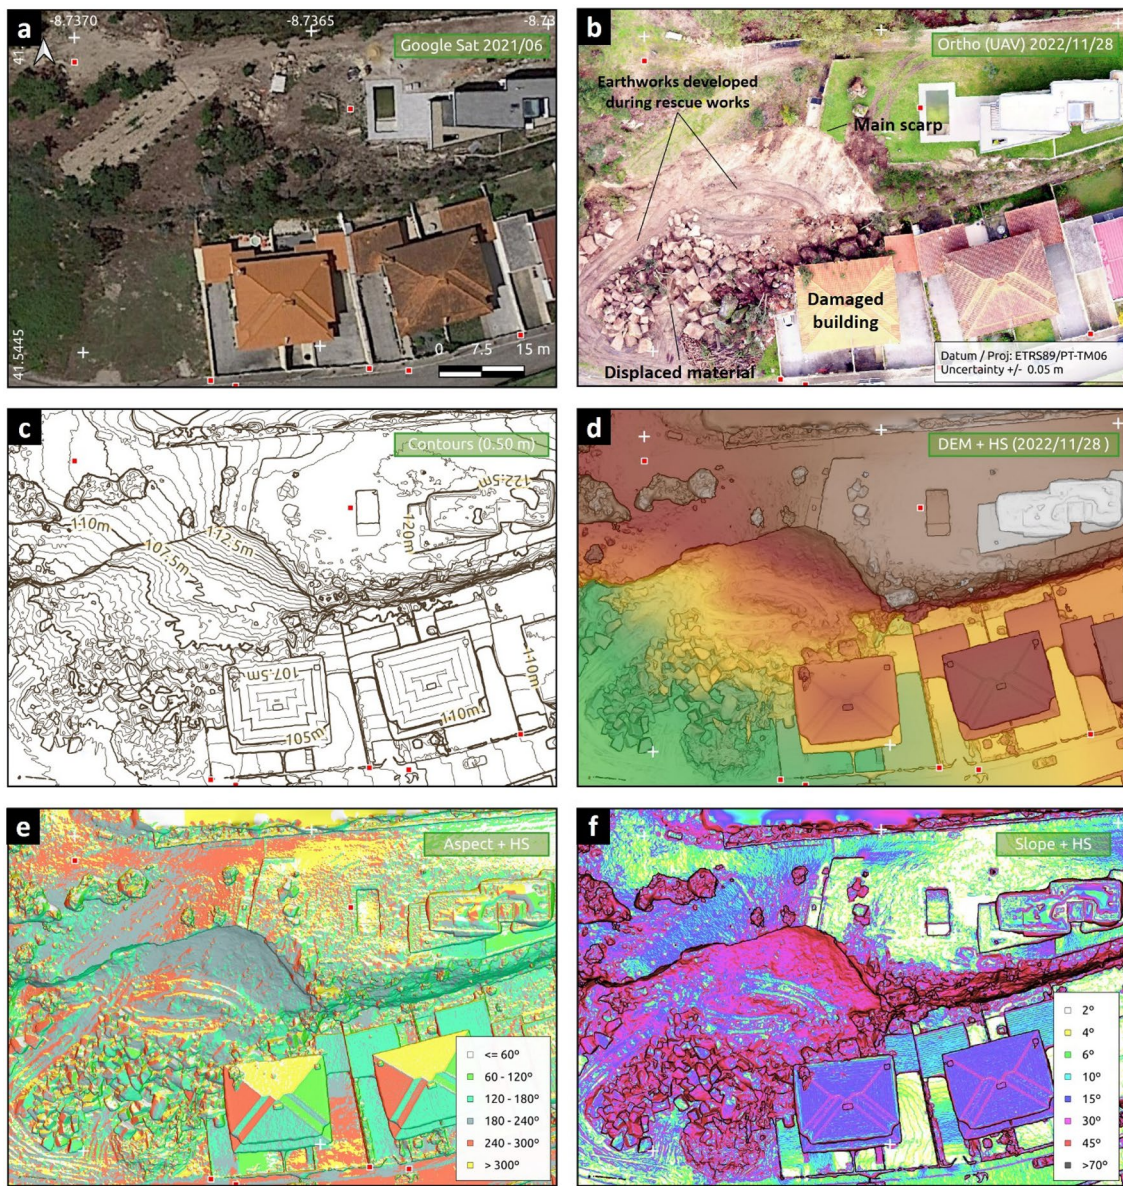
**Fig. 6** Orthophotos of the studied area acquired in (a) June 2021 and (b) November 2022. (c) Topographic map and (d) DEM produced using photogrammetric method from the UAV imagery. (e) Aspect and (f) slope derived from the DEM shown in (d)

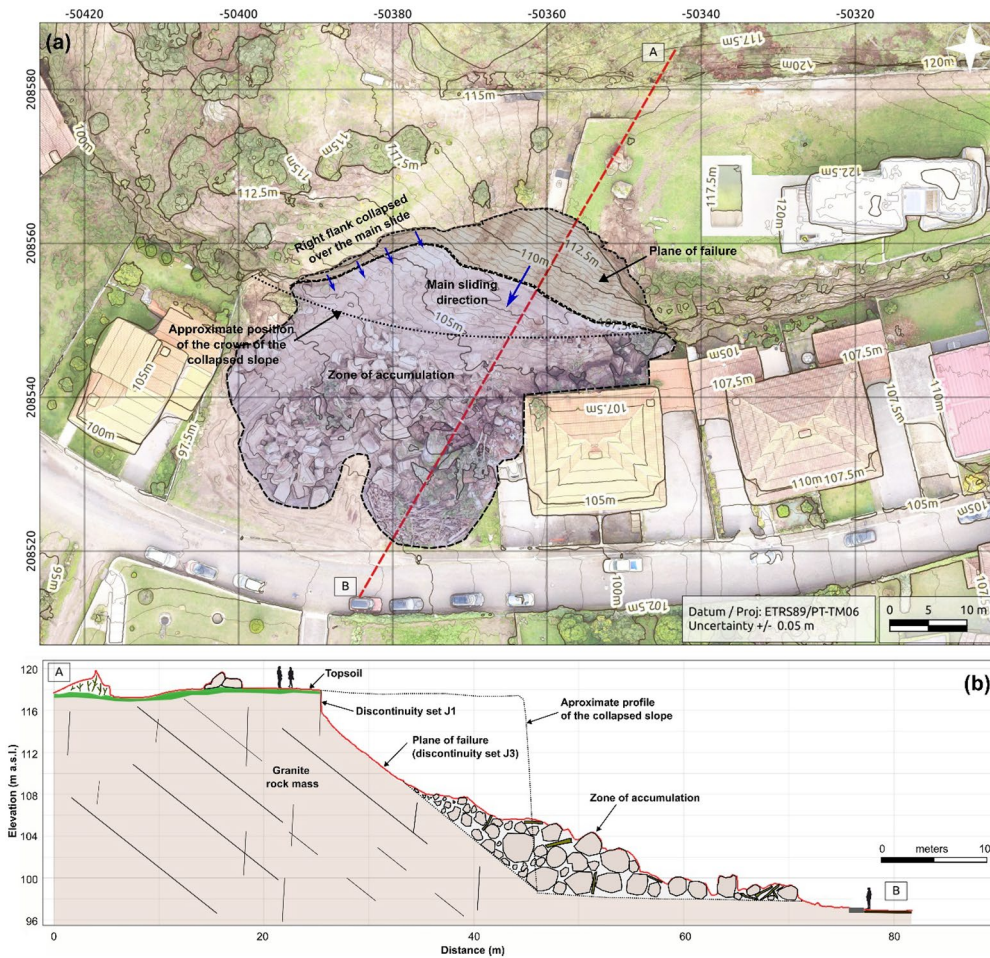
**Fig. 7** (a) Topographic map of the rock planar slide obtained from photogrammetry using UAV imagery. (b) Cross-section of the rockslide

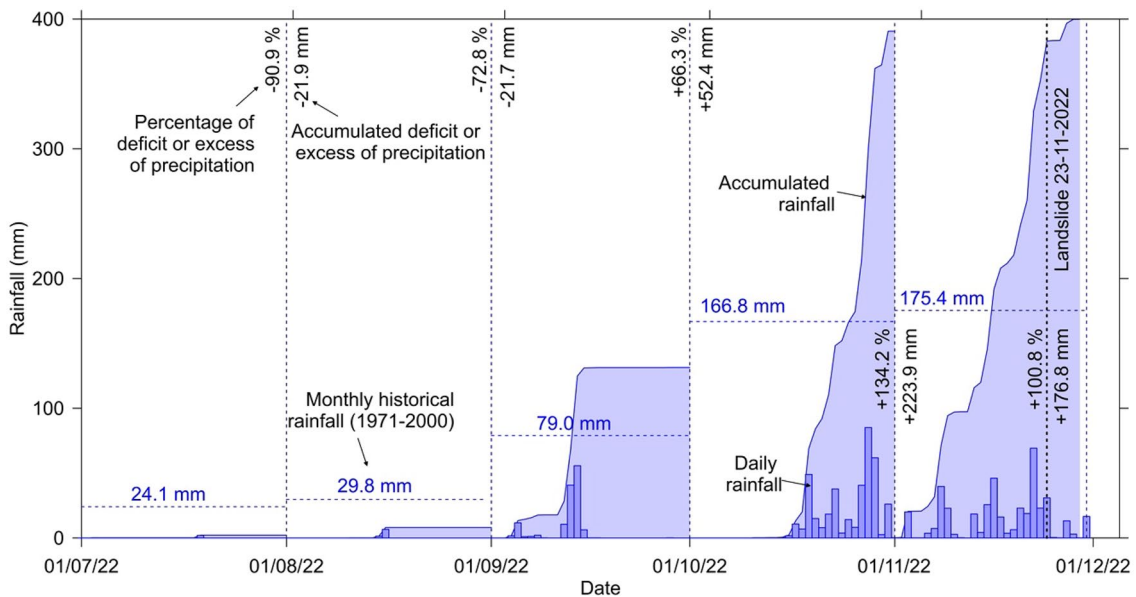
Regarding the possible triggering factors, accumulated rainfall during the month of November was exceptionally high (Figs. 8 and 9). Up to the date of the event, the monthly rainfall time series recorded in Braga 30 km away from the study area, the November accumulated rainfall was 352.2 mm, i.e., +176.8 mm more than the average for the whole month of November (Fig. 8). This value represents an increment of +100.8% with respect to the average value of the historical data between 1971 and 2000, set in 175.4 mm. September and October saw an unusually high amount of rainfall, with precipitation levels exceeding historical records by +66.3% and +134.2%, respectively. During September and October, there was an unprecedented amount of rainfall, exceeding historical records by +66.3% and +134.2%, respectively.

**Fig. 8** Daily rainfall and accumulated monthly rainfall from July 2022 to December 2022 in a meteorological station placed in Braga. Note that the mean monthly historical values of precipitation, and the percentages and accumulated deficits or excesses of precipitation are also shown in the plot

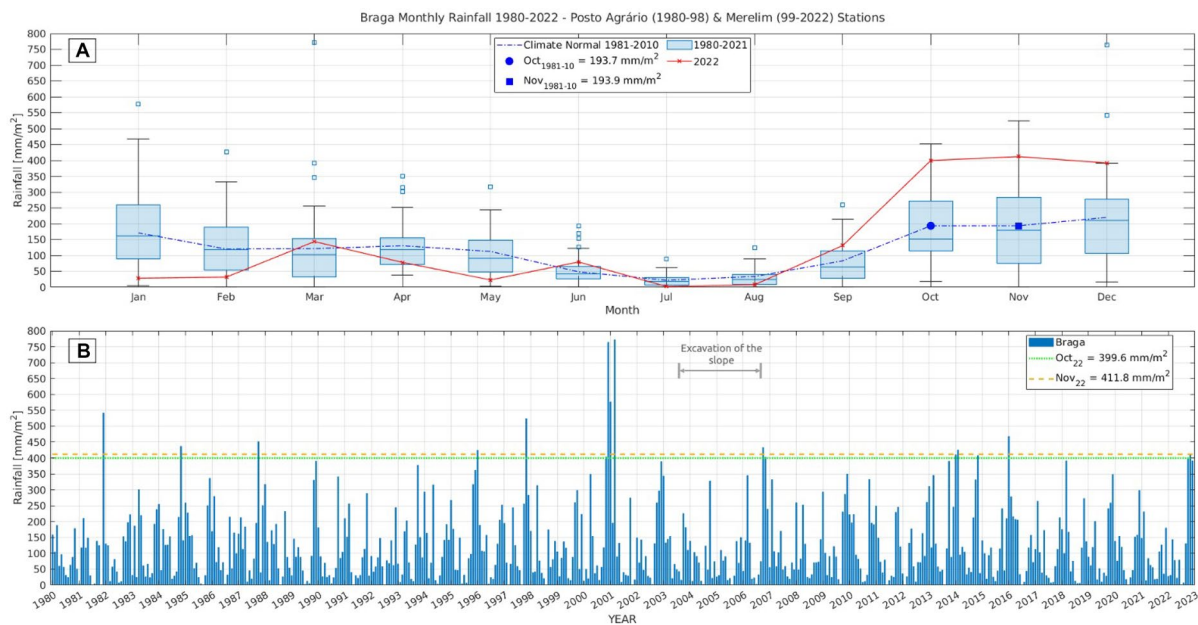
1997, November 2000, December 2000, January 2001, March 2001, October 2006, November 2006, January 2014, February 2014, November 2014, and January 2016) exceeded the recorded monthly rainfall of October 2022, while only 11 months (December 1981, November 1984, October 1987, January 1996, November 1997, December 2000, January 2001, March 2001, October 2006, February 2014, and January 2016) exceeded the recorded monthly rainfall of November 2022 (Fig. 9B). Finally, although the exact date of the slope excavation is unknown, from the beginning of excavation in August 2000 until the present day, the precipitation levels recorded in November 2022 have exceeded a maximum of three times (October 2006, February 2014, and January 2016). This data emphasizes just how extraordinary the rainfall levels were during those months.

**Fig. 9** (A) Box-and-whisker plot of monthly historical rainfall recorded in Braga. The actual monthly rainfall recorded in 2022 has been overlaid. (B) Monthly rainfall time series recorded in Braga between 1980 and 2022. Note that the monthly rainfall accumulated in October and November 2022 has been plotted as horizontal dashed lines
