Young Cities Research Paper Series, Volume 06

Construction Competencies and Building Quality Case Study Results

Bernd Mahrin, Johannes Meyser (Eds.)

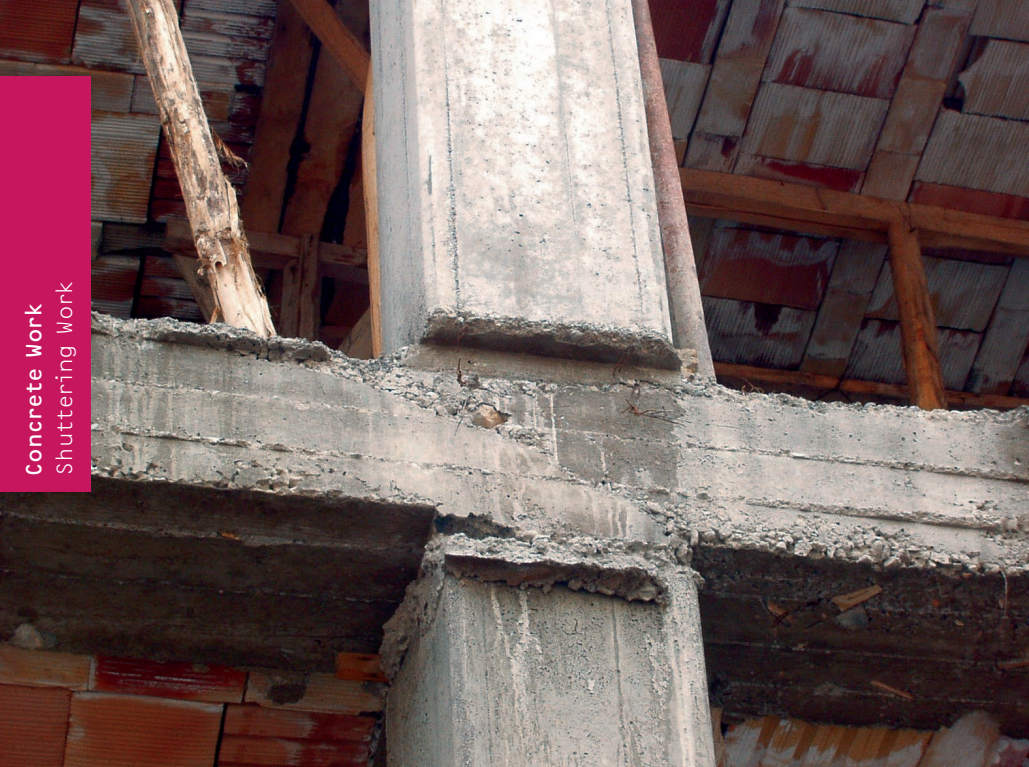
Usage of different shuttering systems
Improper shuttering execution
Inadequate concrete quality

- bad compression
- insufficient concrete coverage
- reduced load capacity due to reinforcement corrosion

- preventing the combination of different shuttering systems
- usage of formula concrete
- proper transport and installation
- proper compression and finishing treatment
- paying attention to the instructions of the shuttering manufacturer and monitoring both the concrete quality and construction steps

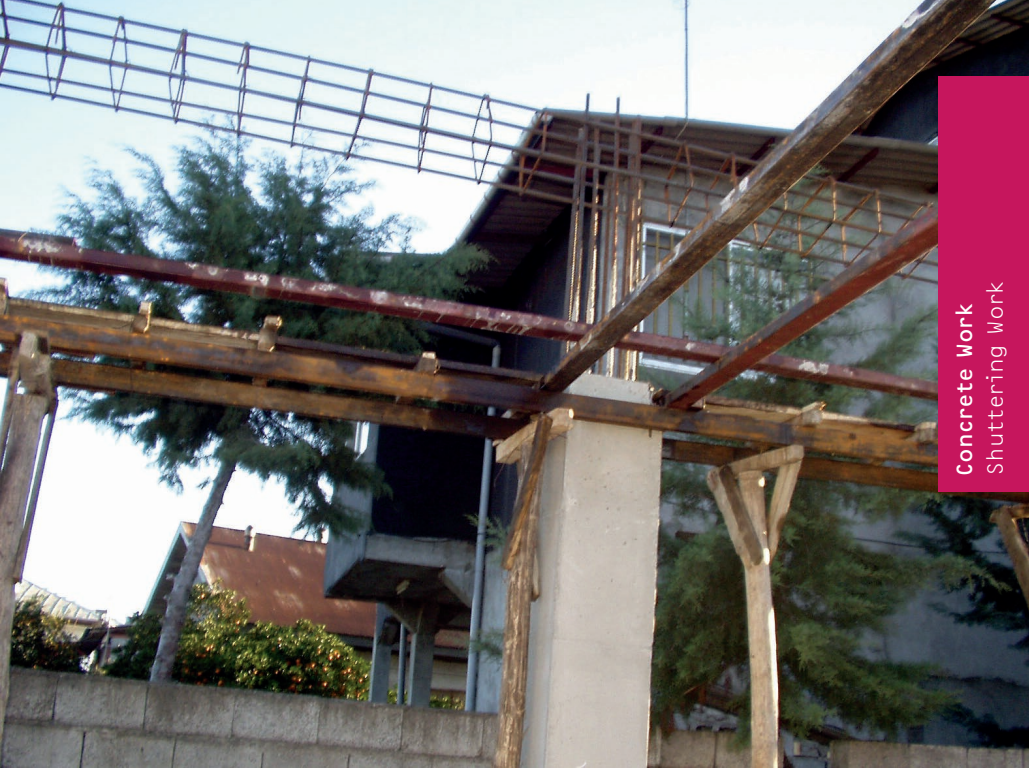
Shuttering after reinforcement Incorrect order of construction steps

- shuttering of the first side
- installation of reinforcement
- shuttering of the second side

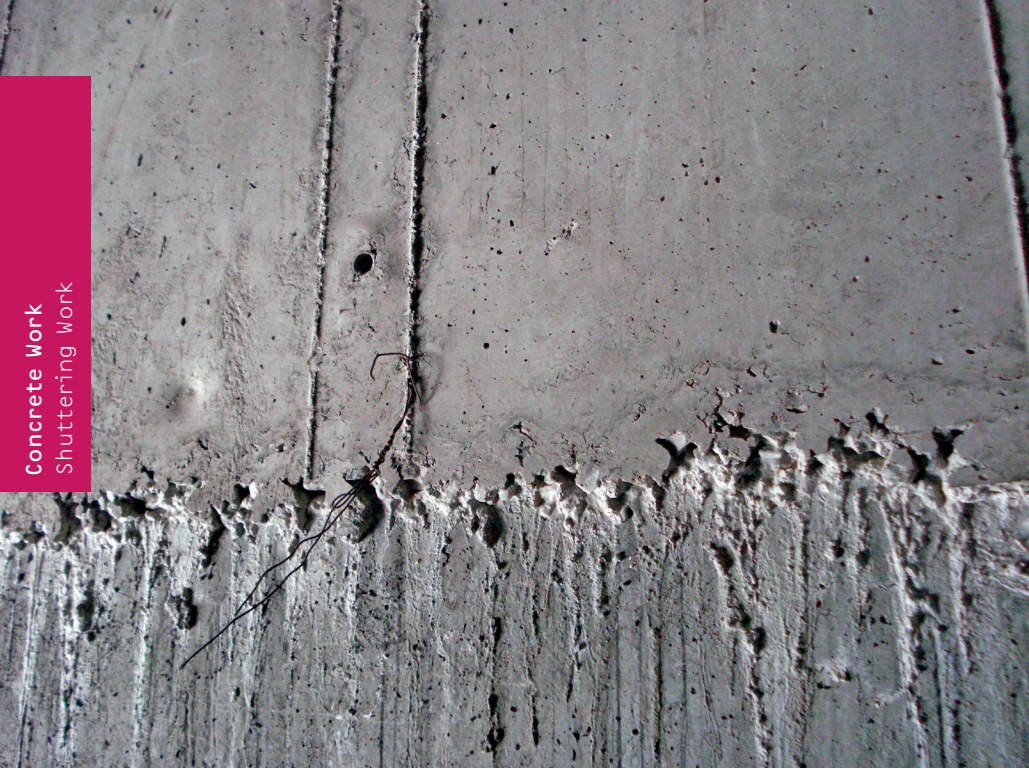
Unsatisfactory execution of shuttering work
Incorrect execution of transitions
Improper concrete consistency

- checking the shuttering before casting the concrete
- precise shuttering, paying attention to dimensional accuracy

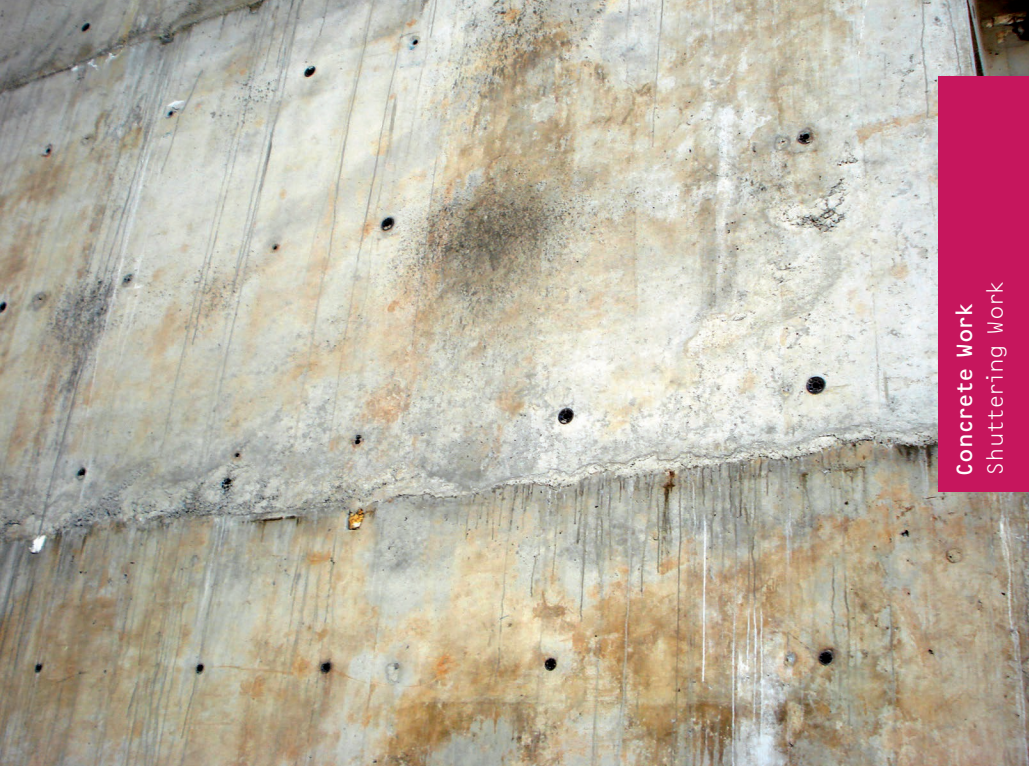
Poor quality concrete surface due to improper shuttering and/or use of too much bond breaker

- proper cleaning of shuttering elements
- spreading out bond breaker according to manufacturer's instructions

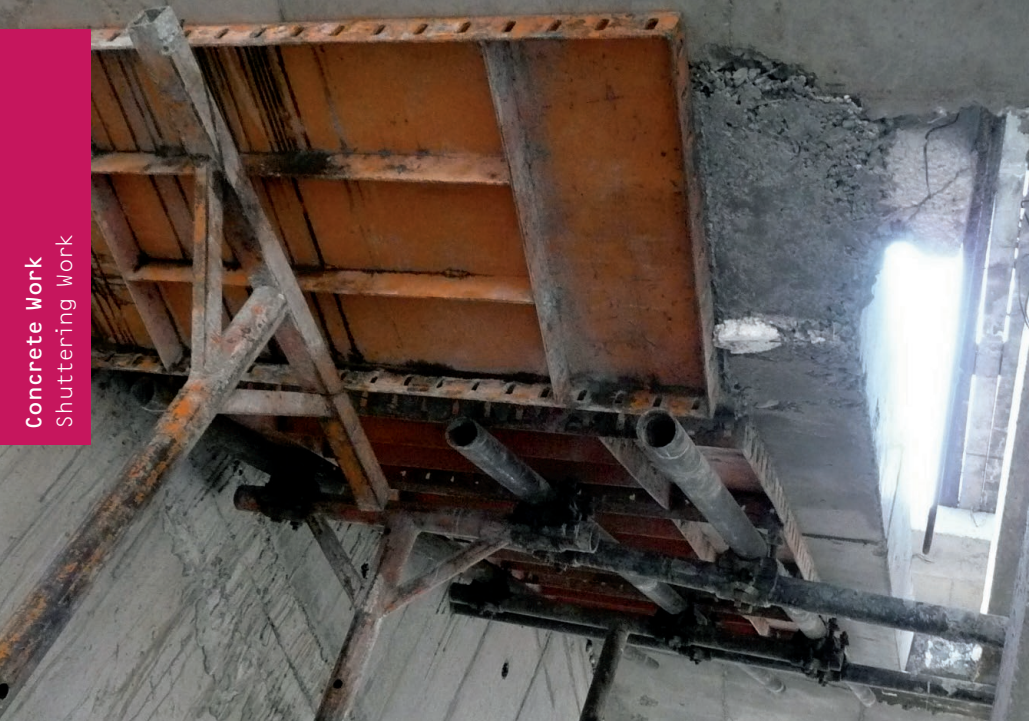
Insufficient support structure for concrete shuttering

- using the correct column dimensions
- solid anchorage of shuttering
- checking the stability and load capacity of shuttering before casting the concrete

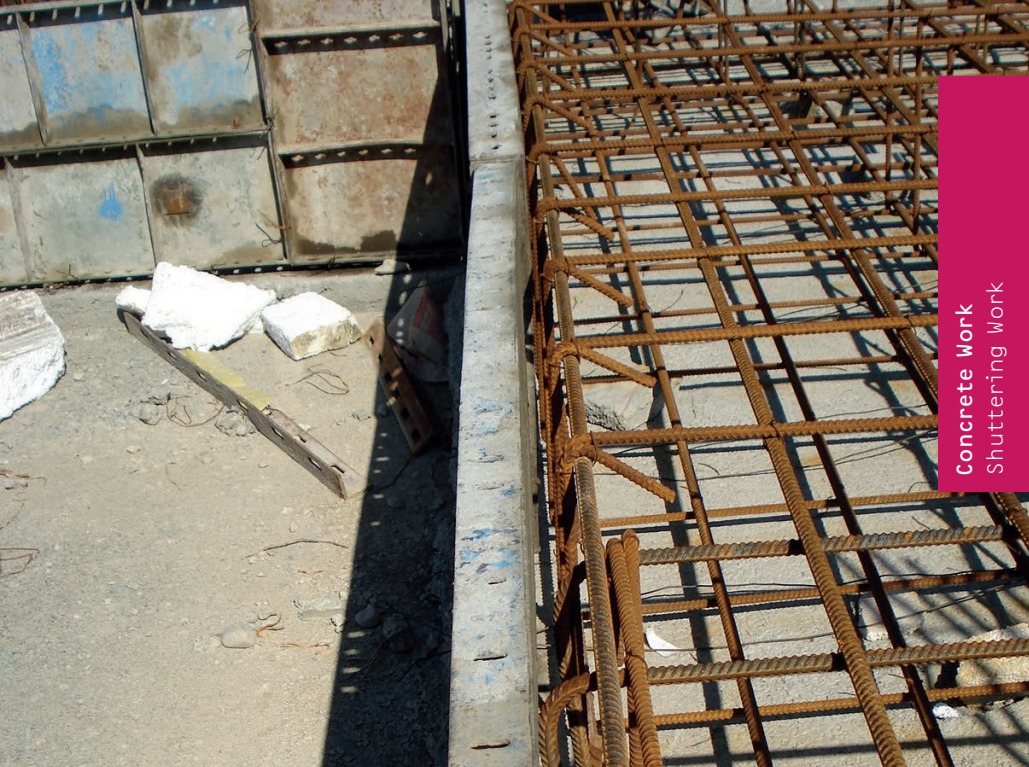
Uneven space between reinforcement and shuttering due to missing spacer
Usage of different, incompatible shuttering systems
Missing connections between shuttering elements (unprofessional connection with wire)

- see Reconstruction Options
- attention to general rules on reinforcement rules

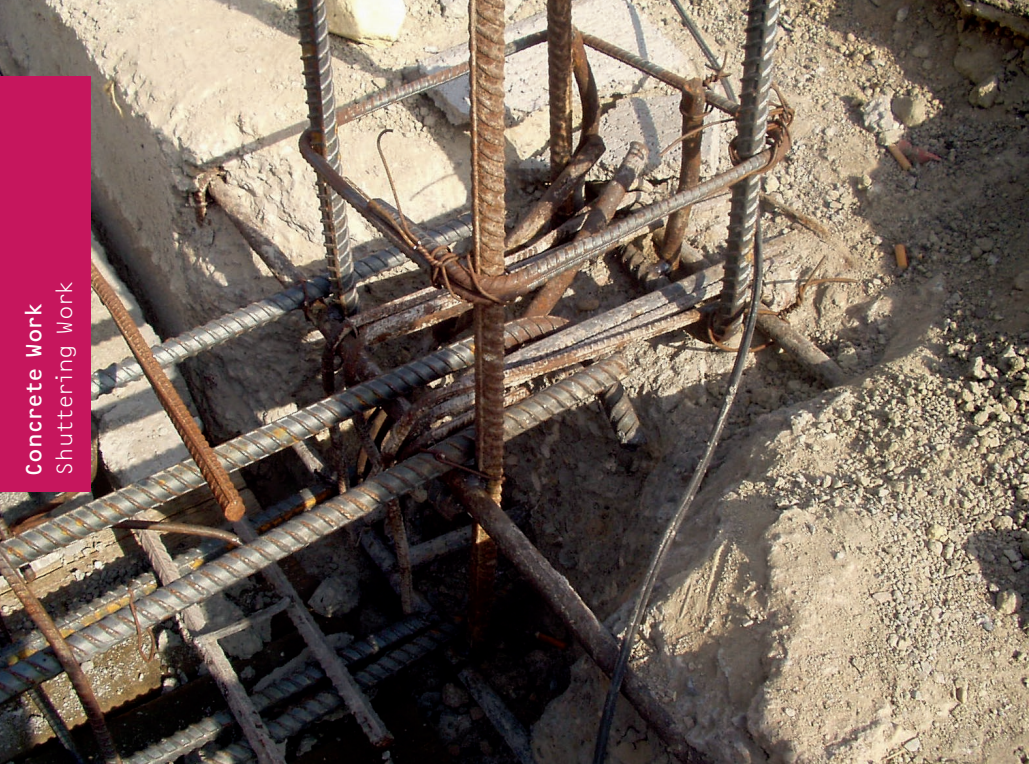
**Imprecise reinforcement path with starter bars in an already concrete encased reinforcement
Improper transmission of the load from the column to the base via the reinforcement**

- providing proper planning and reinforcement drafts at the construction site
- installation of the reinforcement according to the rules of reinforcement:
 - execution according to draft
 - sufficient anchoring lengths
 - securing the position of the reinforcement
 - assuring concrete coverage
 - paying attention to the minimum distance between reinforcements
- inspection of the reinforcement (reinforcement approval) by professionals (i.e. structural safety engineer) before placing the concrete

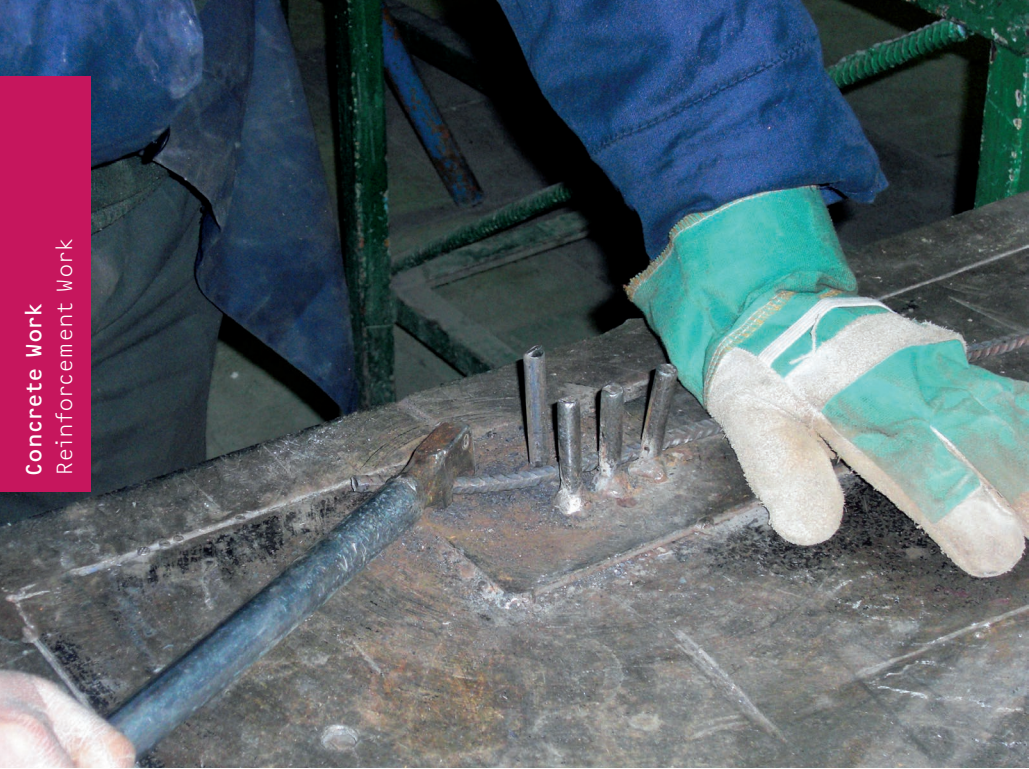
Incorrect bending radius of the reinforcement steel, leading to insufficient bending accuracy
No acceptable device for bending the reinforcement steel

- setting up an adequate work environment for bending
- providing bending devices for reinforcement steel at construction sites

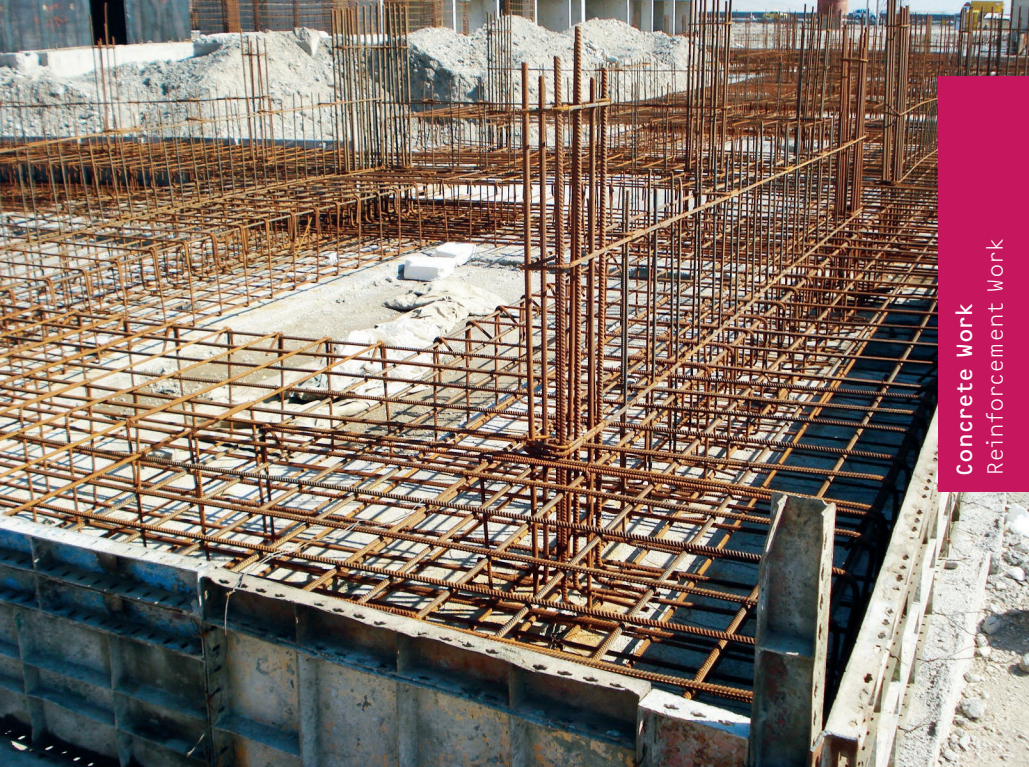
Diameter of the bending roller is too small, improper order of hoop Reinforcement (shackle locks are arranged without an offset)

- balancing of construction planning and construction
- avoiding long breaks during construction
- considering potential scheduled heightening within the draft/static

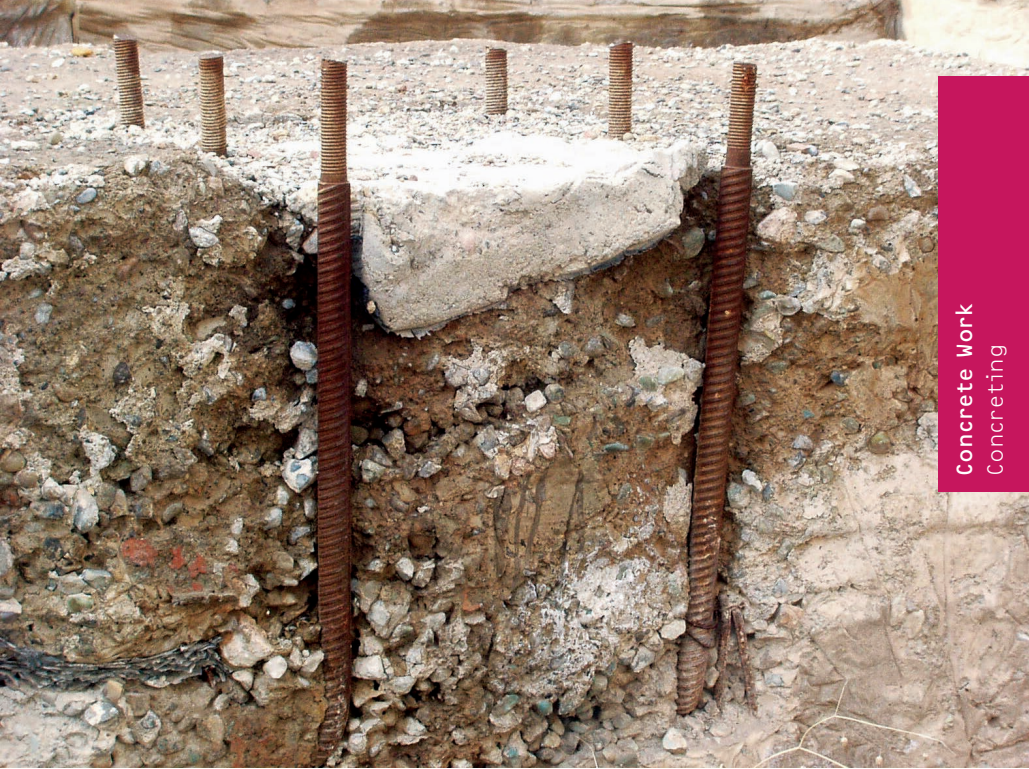
Tie bars are not surrounded by concrete
No composite action between reinforcement steel and concrete
Incorrect concrete recipe, incorrect granulometric composition of construction aggregates, no concrete compression

- ensuring correct concrete recipe
- foreign supervision
- concrete mixing process according to instructions
- sufficient concrete compression

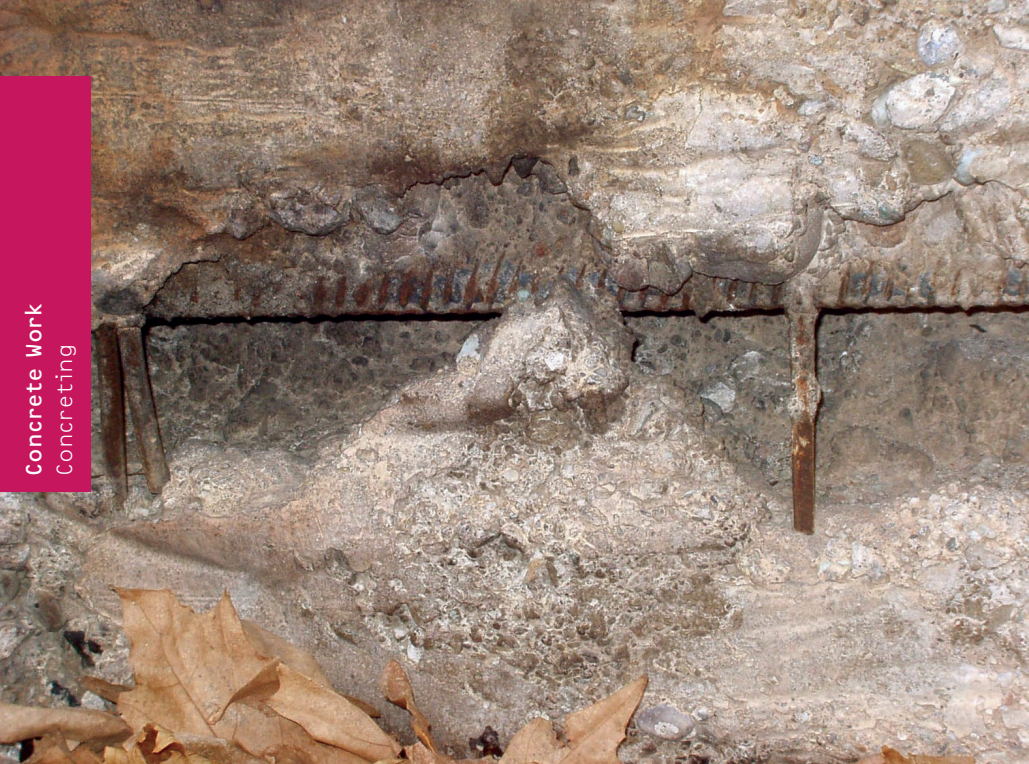
Exposed reinforcement, no concrete coverage
Inappropriate or incorrect concrete recipe
Poor or missing concrete compression

- usage of formula concrete
- supervision of concrete quality
- proper transport and installation of the concrete
- proper compression and post-installation treatment of the concrete

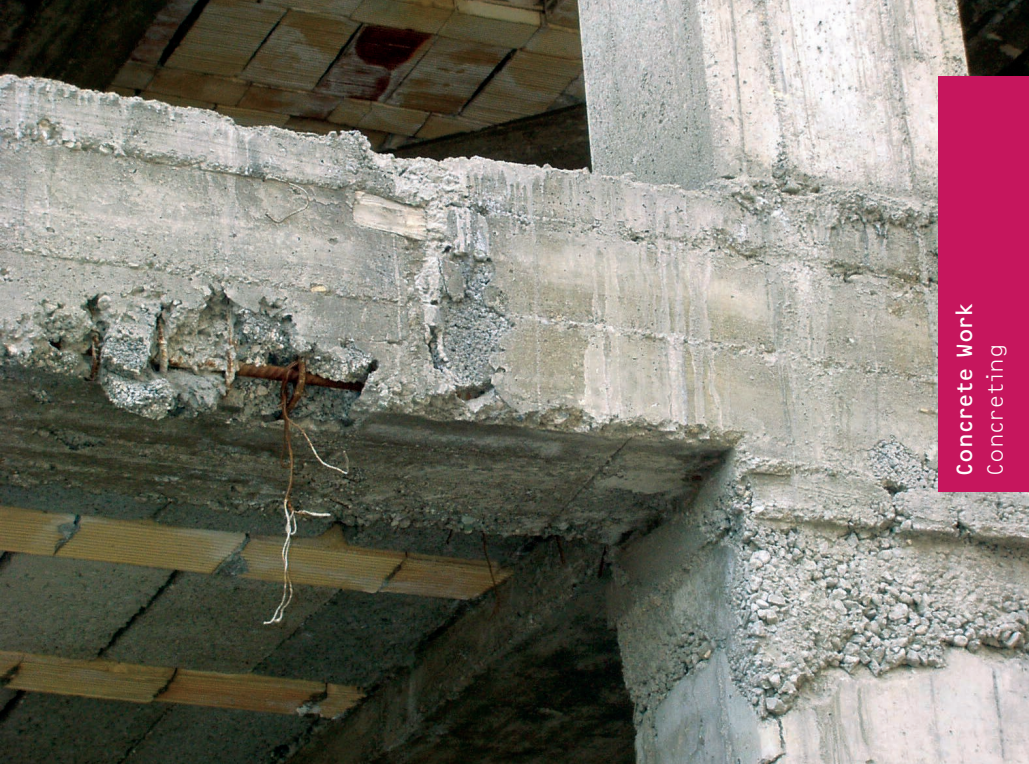
**Exposed reinforcements, clearly visible concrete transitions (ceiling—column), incorrect concrete composition, poor compression
Poor and imprecise shuttering transitions**

- accurate shuttering
- in regard to concrete coverage, the reinforcement placement needs to be approved before concreting
- supervision of concrete's production according to proper recipe
- execution of concrete compression according to the legal building code

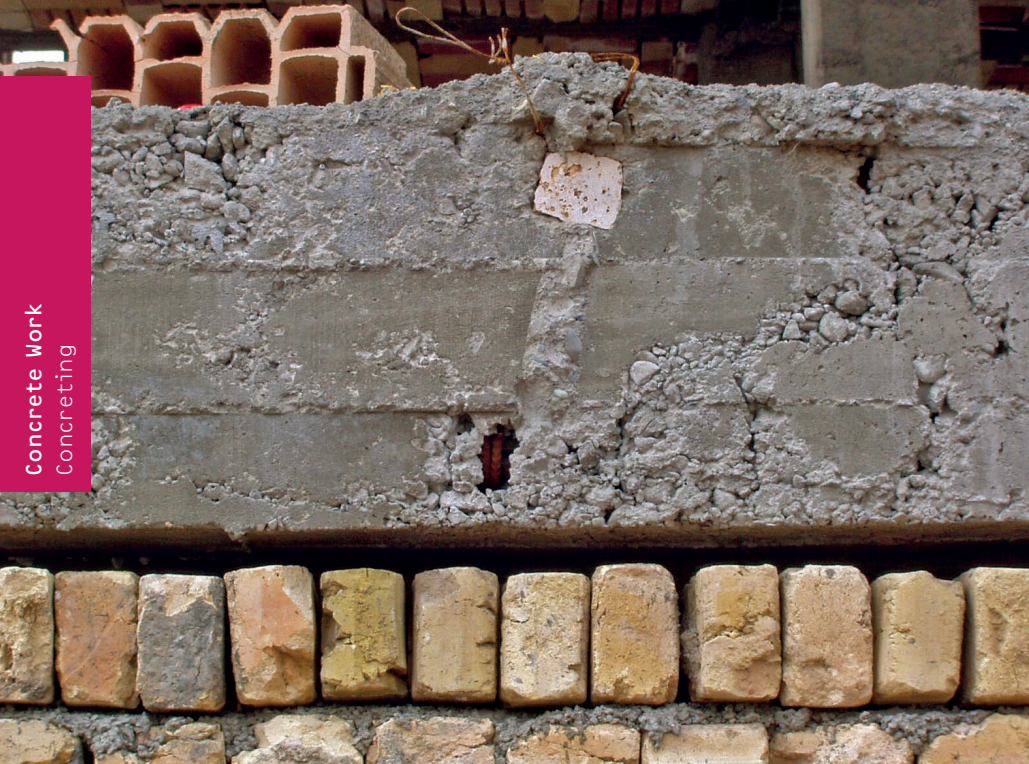
Clearly visible hollows in the concrete, exposed reinforcement, production of concrete with incorrect recipe, poor compression, poor concrete quality, clearly missing supervision of concrete quality

- accurate shuttering
- in regard to the concrete coverage, the reinforcement placement needs to be approved before concreting
- supervision of concrete's production according to recipe
- execution of concrete compression according to the building code

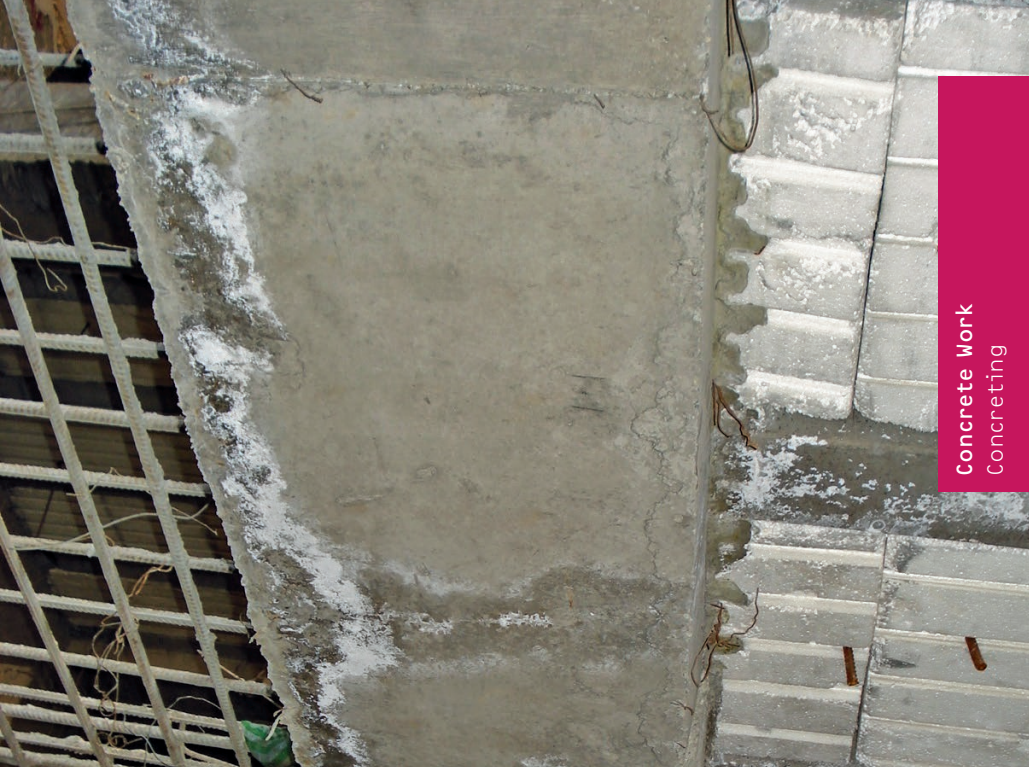
Blooms at the concrete surface, impurities in the components (i.e. chlorides and sulfates), possibly too low temperature while concreting

- verification of mixing ratio of the concrete recipe
- precise execution of concrete compression
- cleaning the shuttering after stripping (upkeep of the shuttering extends its durability)

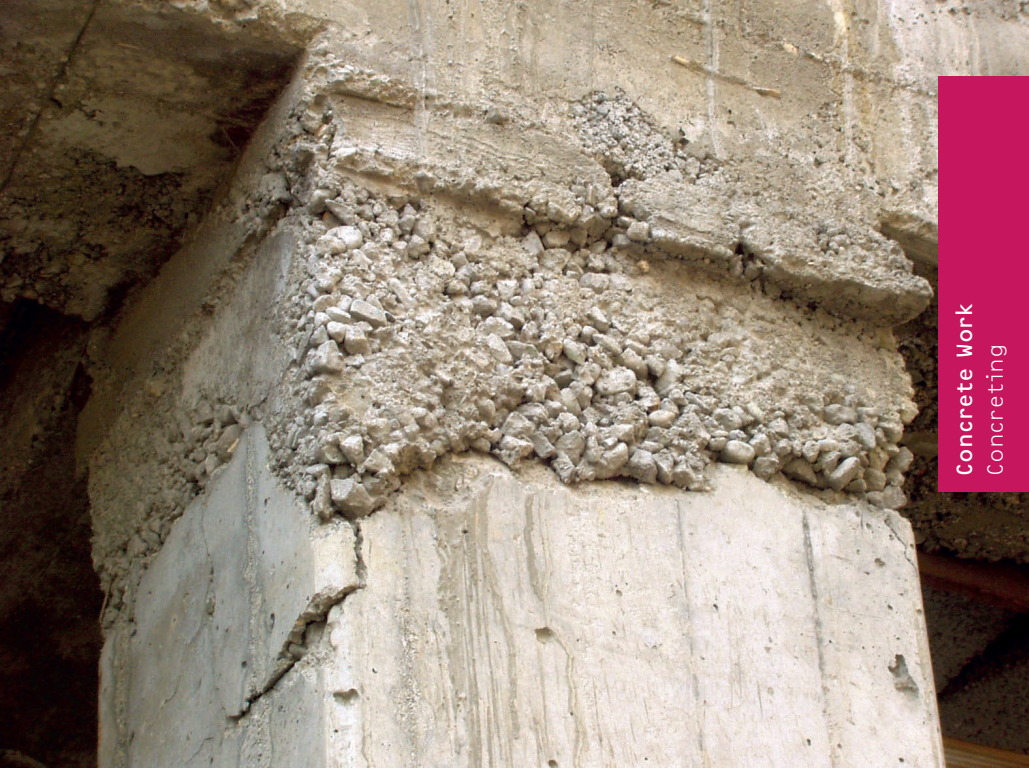
**Improper shuttering connection, incorrect consistency, erroneous mixing ratio
Improper scaffolding work**

- precise work while shuttering
- monitoring the concrete recipe and the concreting

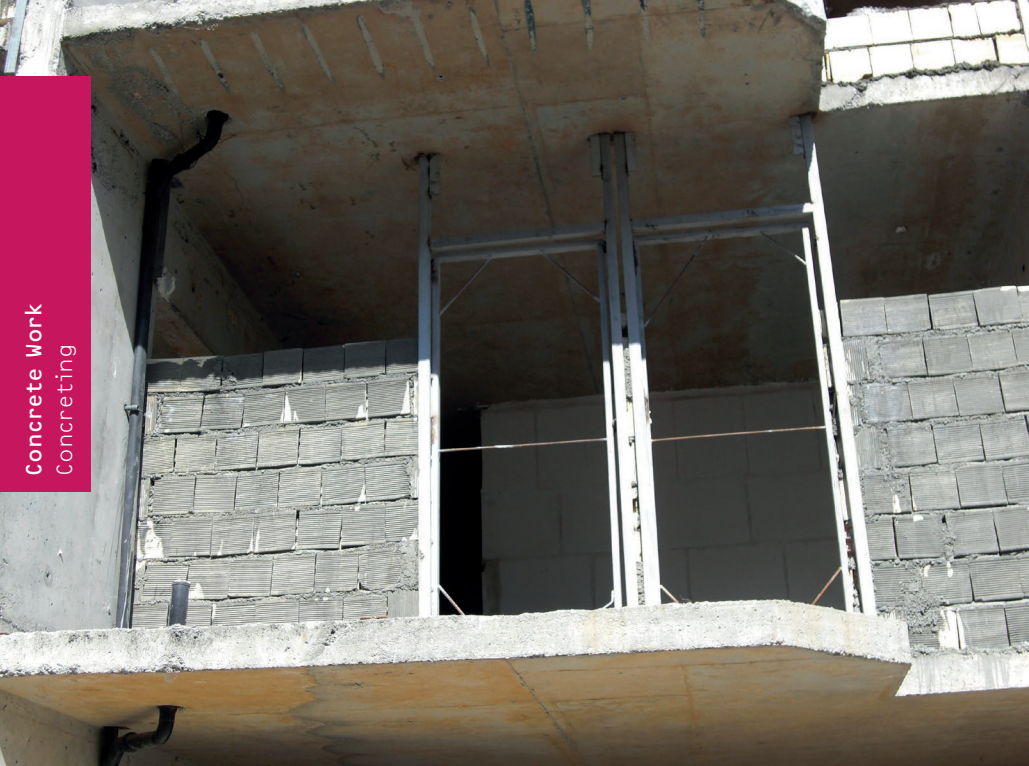
Inadequate concrete compression, consistency of concrete mix too stiff

- correct concrete consistency
- correct spacer positions
- precise execution of concrete compression

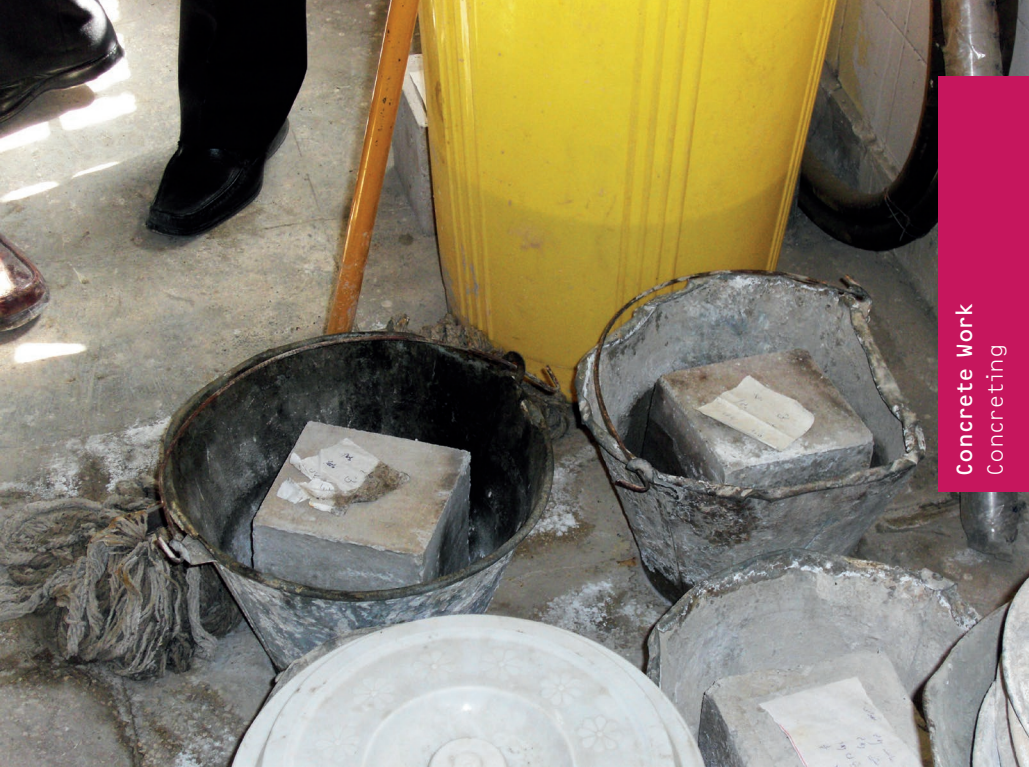
Test cubes for pressure strength test improperly stored
No proper equipment for a concrete laboratory

- storage of test cubes in climate controlled box (if available)
- alternatively: storage at a constant room temperature $20^{\circ}\text{C} \pm 2^{\circ}\text{C}$ and humidity $65\% \pm 5\%$ (supervision necessary)

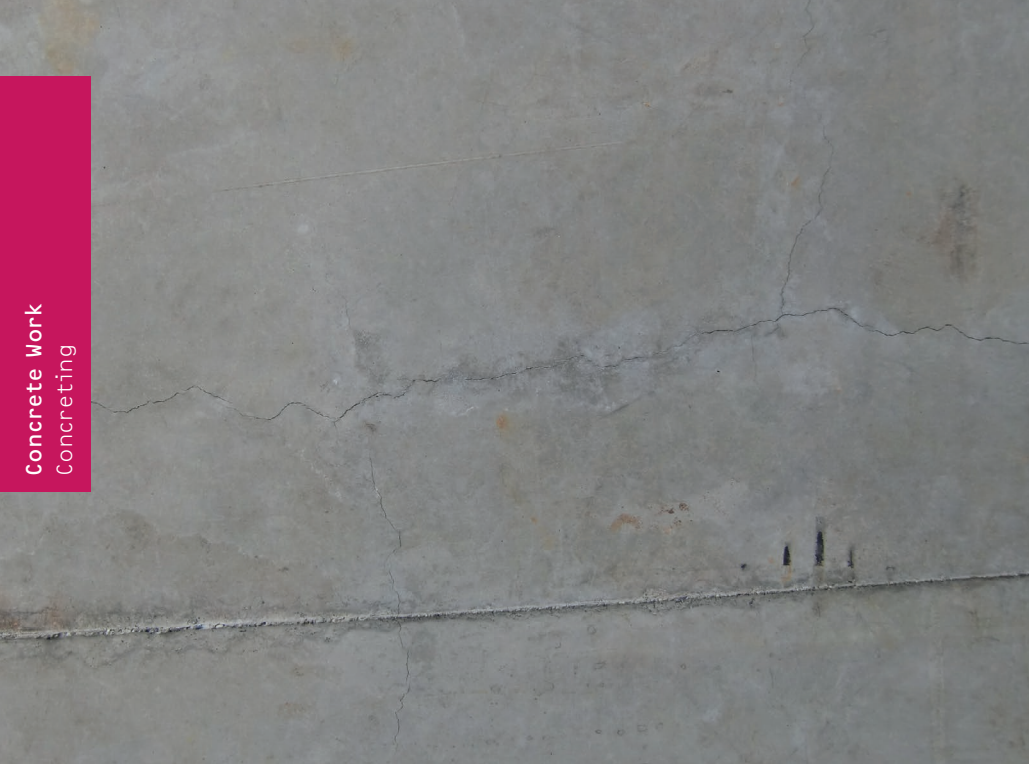
Contraction cracks located in new concrete ceiling
Improper concreting, i. e. removal of shuttering too early, too quick dehydration, wrong concrete additives

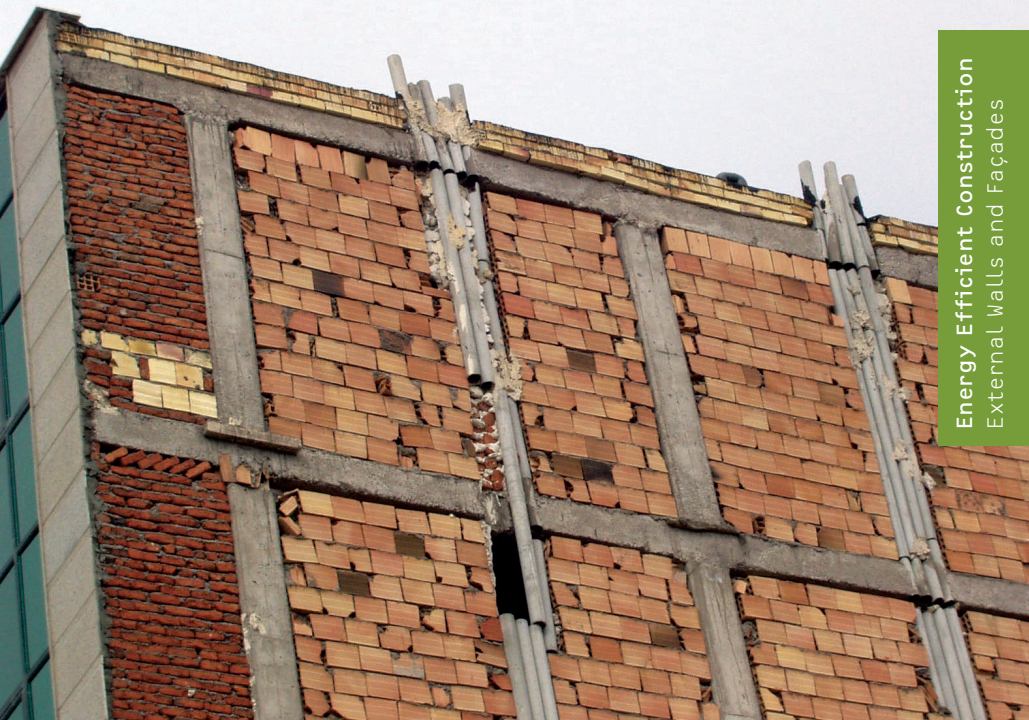
Weakening of brickwork from supply line conduits Conduit section of the brickwork missing thermal protection

- keeping slots or discontinuities in the brickwork as small as possible
- closure of unavoidable, weakened spots with proper material (i.e. high quality insulation material)

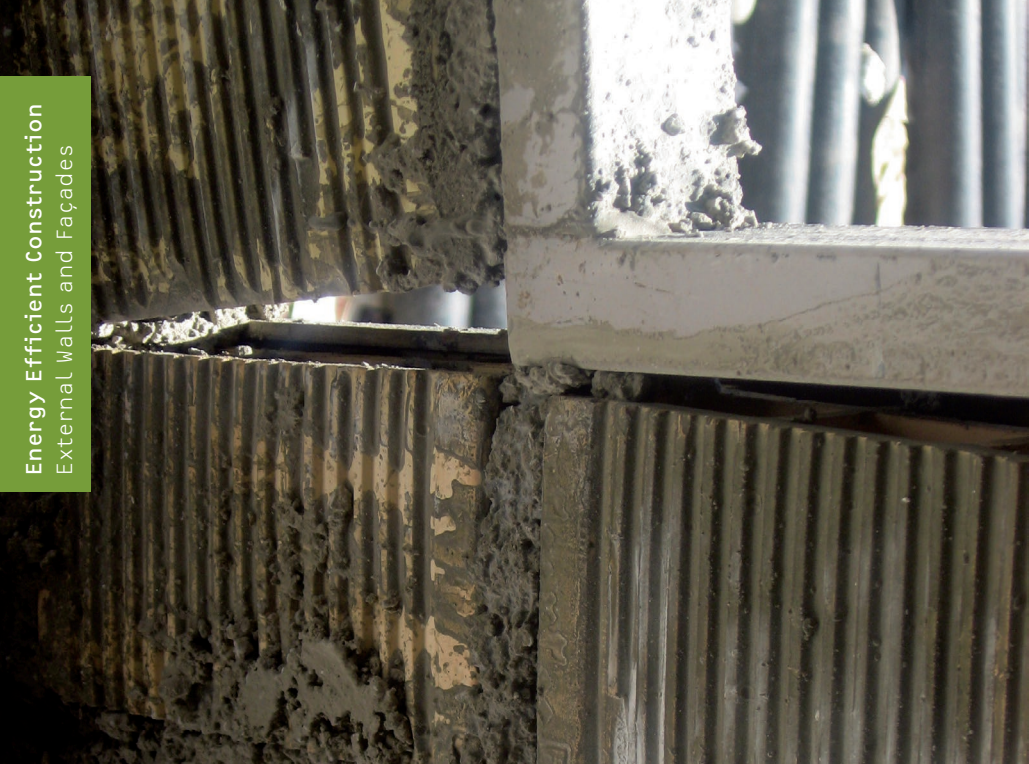
Improper joint structure (partly due to very large joint thickness, missing mortar)
No brickwork bond

- proper creation of brickwork bond according to regulations
- laying bricks in the correct direction
- usage of safe construction material

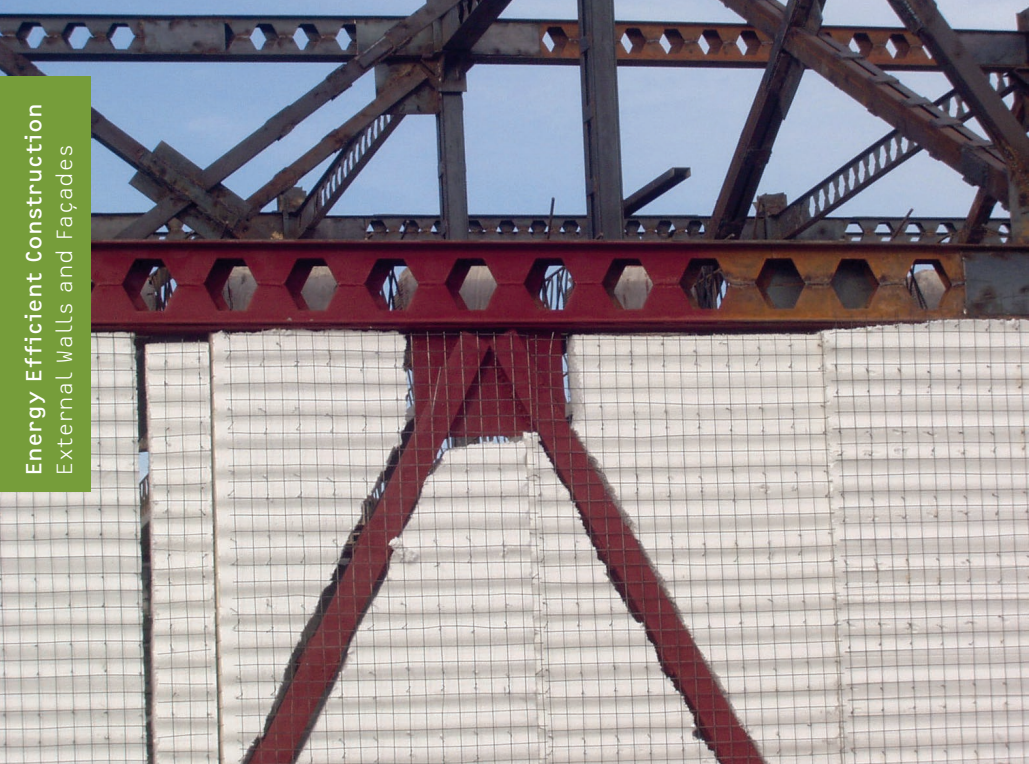
**Heat insulation reduced due to connection with the metal netting
Weakening of the insulation and development of thermal bridges
caused by piercing metal joints**

- wall construction and structure according to regulations on building physics and national requirements concerning energy efficiency of buildings (avoid planning errors!)

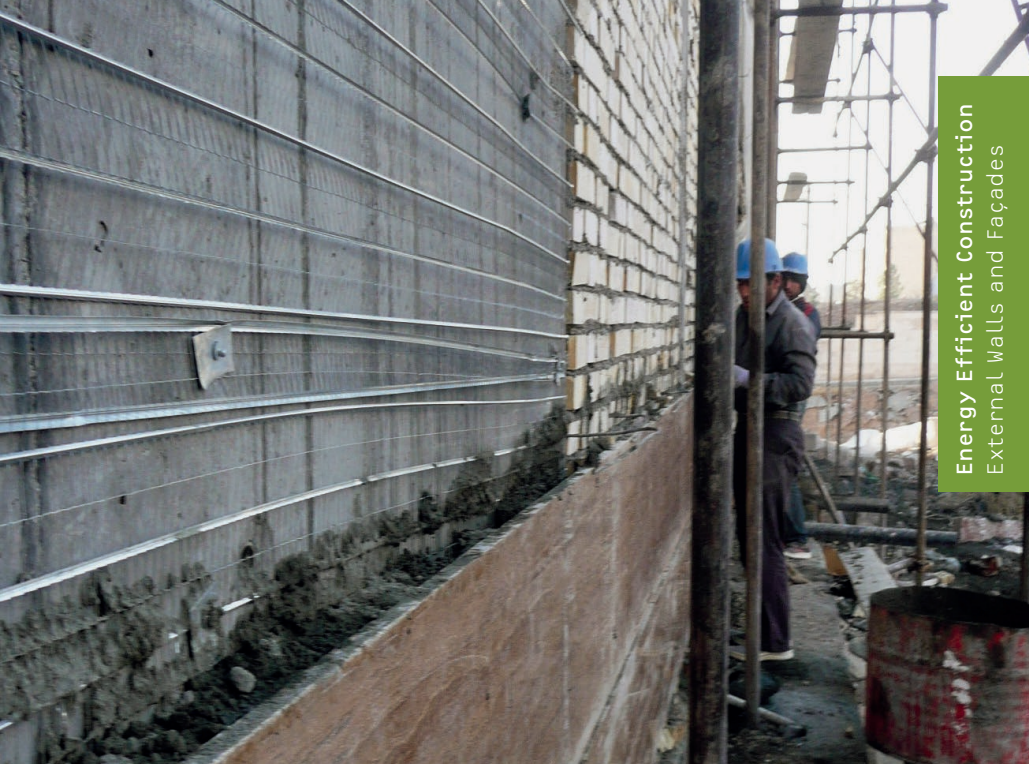
Too much distance between wall and façade elements

- stable anchorage of façade panels in consultation with a structural engineer
- usage of verified mounting systems
- supervision of execution

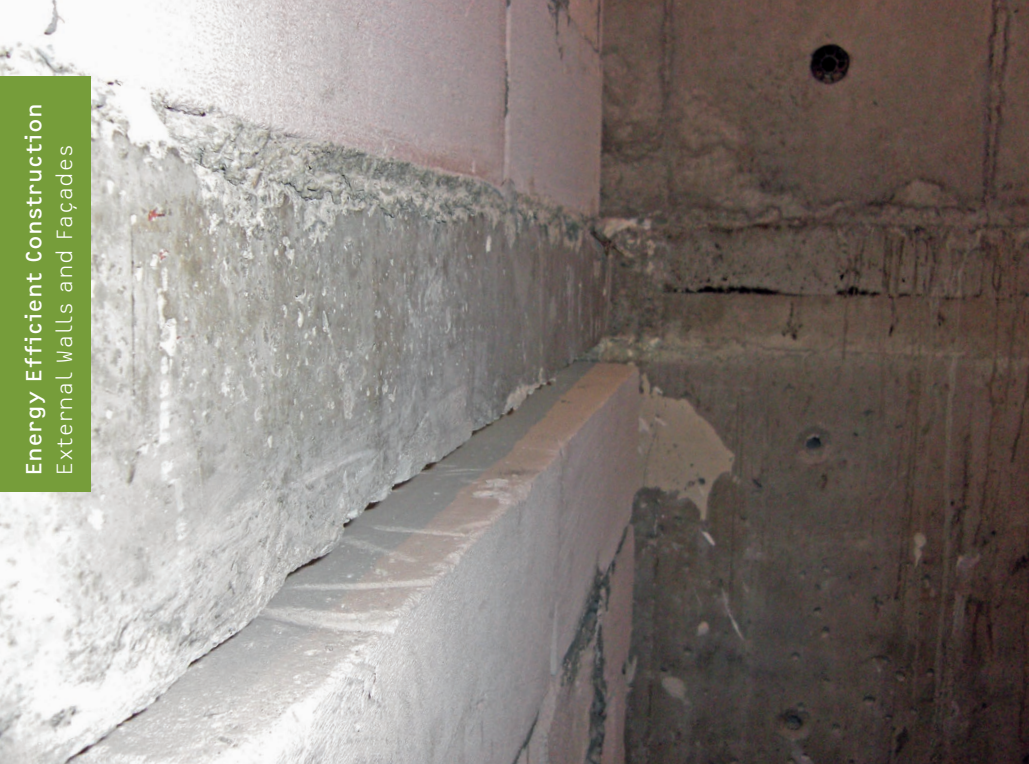
Brickwork not flush with outside concrete bar

- use of a water level
- paying attention to brickwork alignment from both the inside and outside

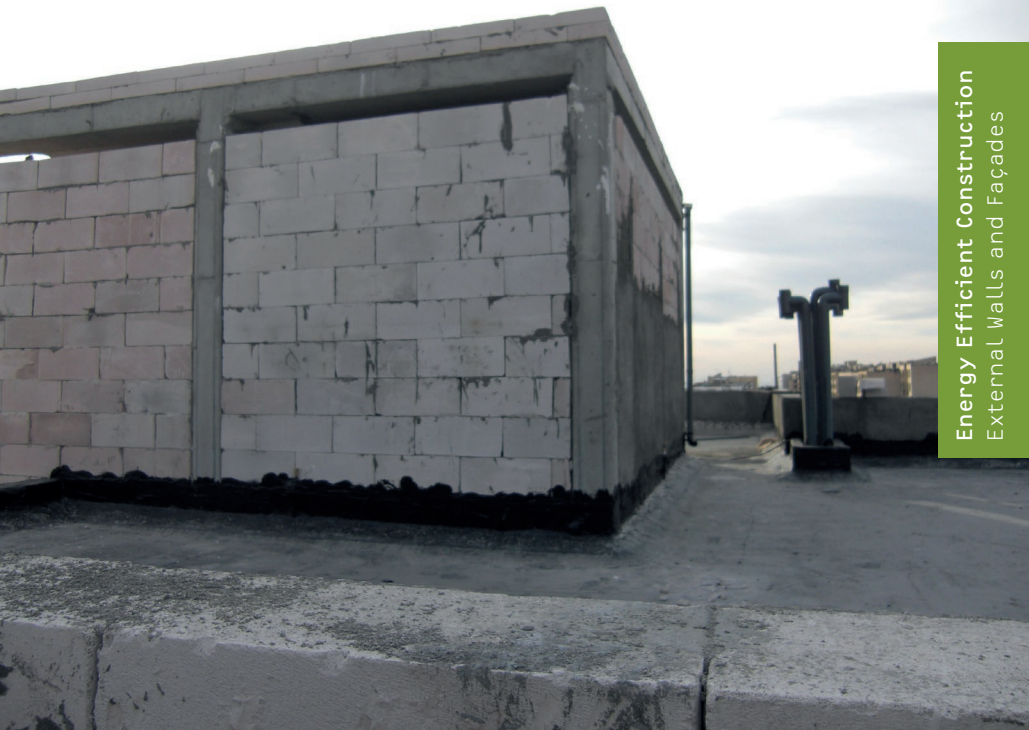
Improper execution of wall connections (no connection between wall and ceiling)

- see reconstruction options

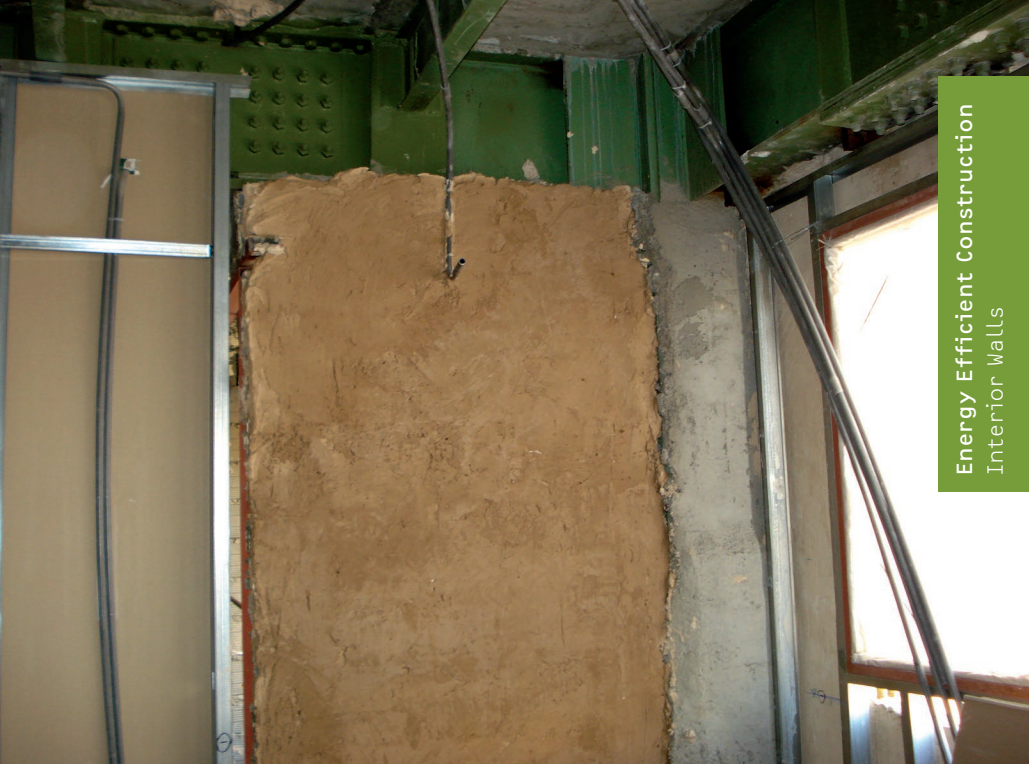
**Improper execution of profile attachment to bordering components
(i.e. missing sealing tape and sealing adhesive)
Steel structure has no fire protection (missing coverage)**

- installation of dry walls according to the instructions of the manufacturer
- supervision and verification by professionals
- proper anchorage of the substructure to the steel structure

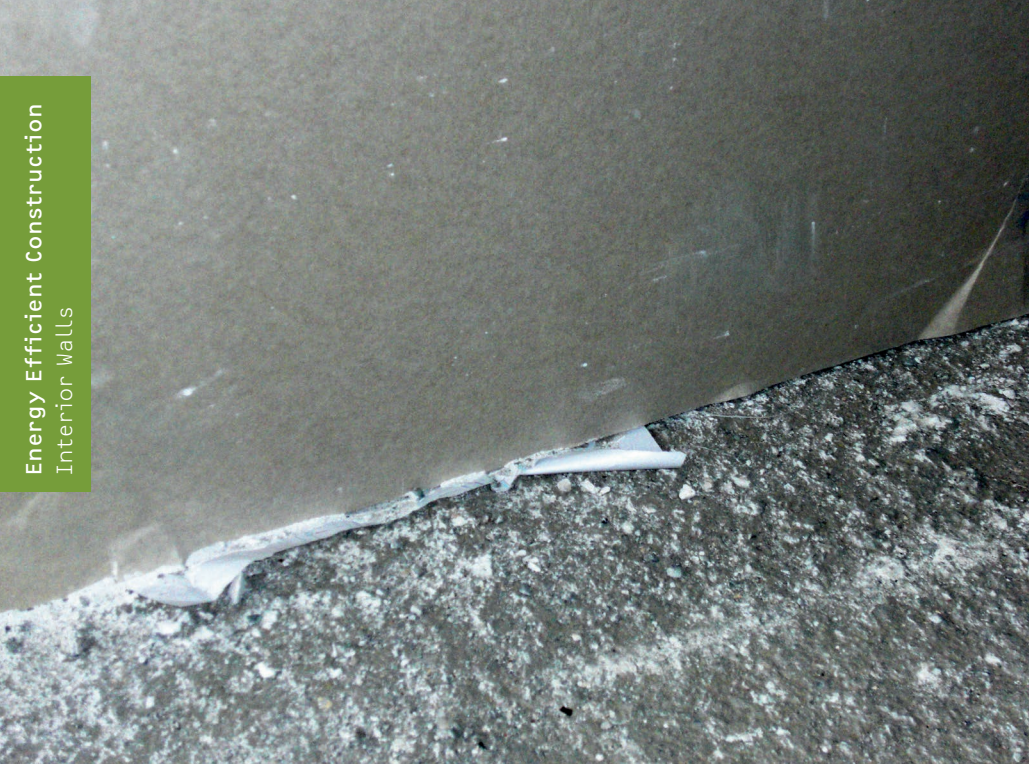
Improper connecting arrangement: gypsum cardboard is placed on the raw ceiling
Screw head punctured the gypsum cardboard (screws are screwed in too deep)
