Young Cities Research Paper Series, Volume 06

Construction Competencies and Building Quality Case Study Results

Bernd Mahrin, Johannes Meyser (Eds.)

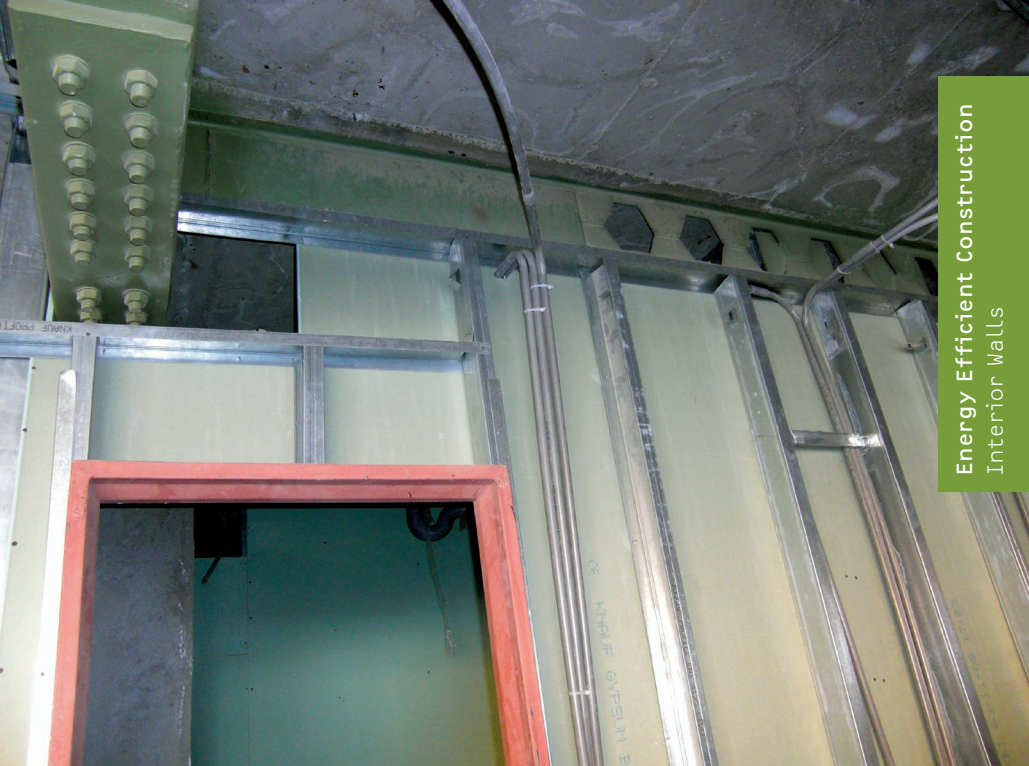
- Improper connection between doorframe and wall (missing connection profiles)**
- Irregular steel grid frame**
- Missing structural fire prevention for the steel girder**

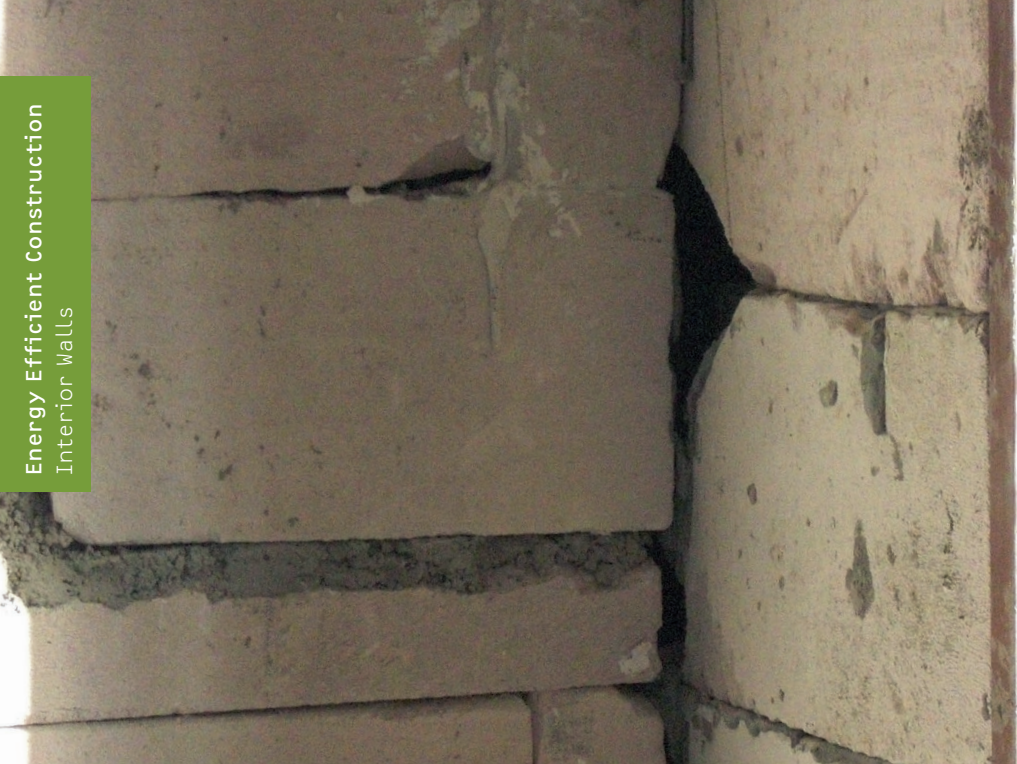
Improper masonry connection
No masonry bond (bond system)
No masonry connector (flat steel anchor)

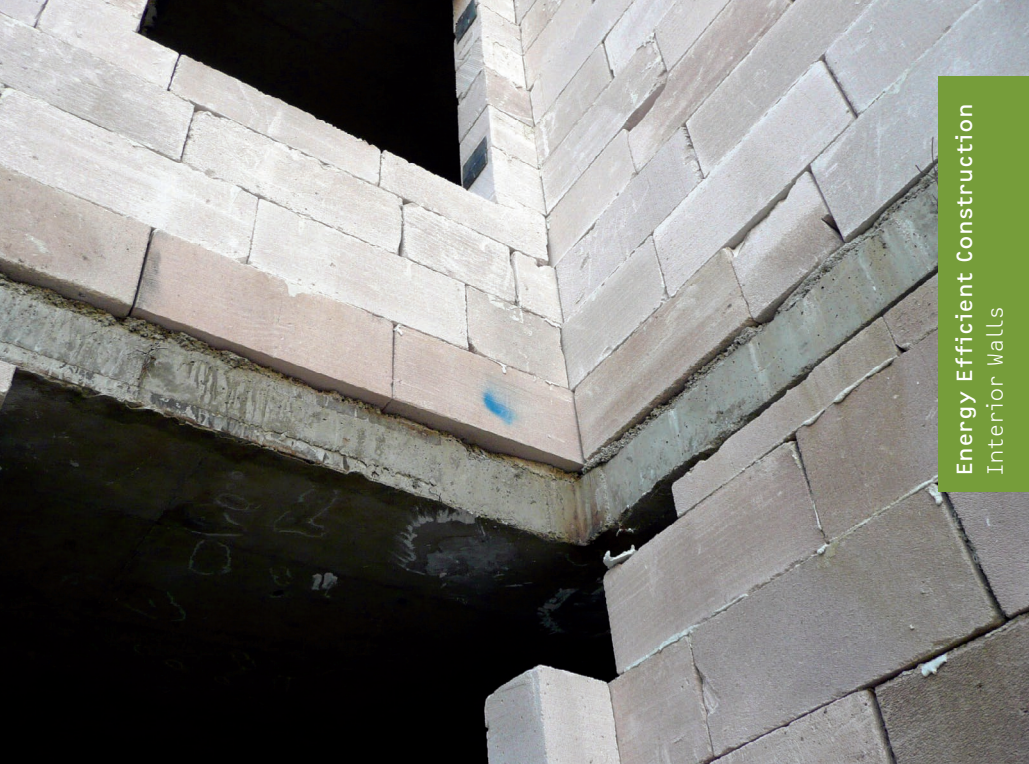
**Interior walls exceed the limits of the floors and ceilings
Walls jut out over the outer edge of the uncovered ceiling**

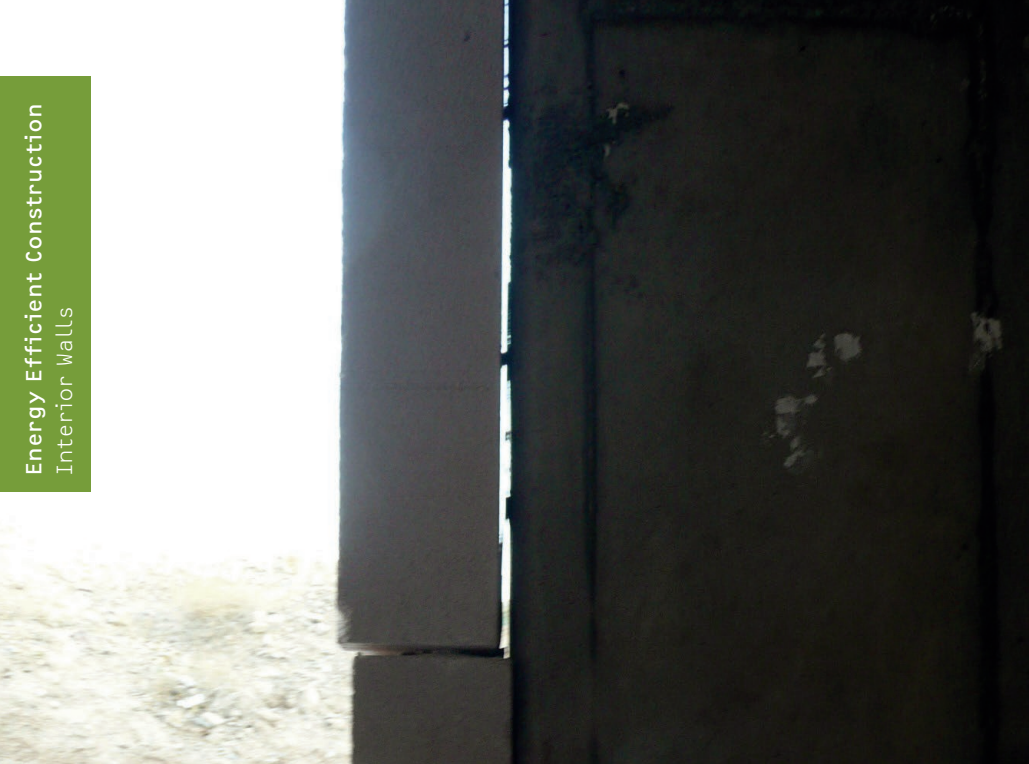
**Interior walls exceed the limits of the floors and ceilings
Walls jut out over the outer edge of the uncovered ceiling**

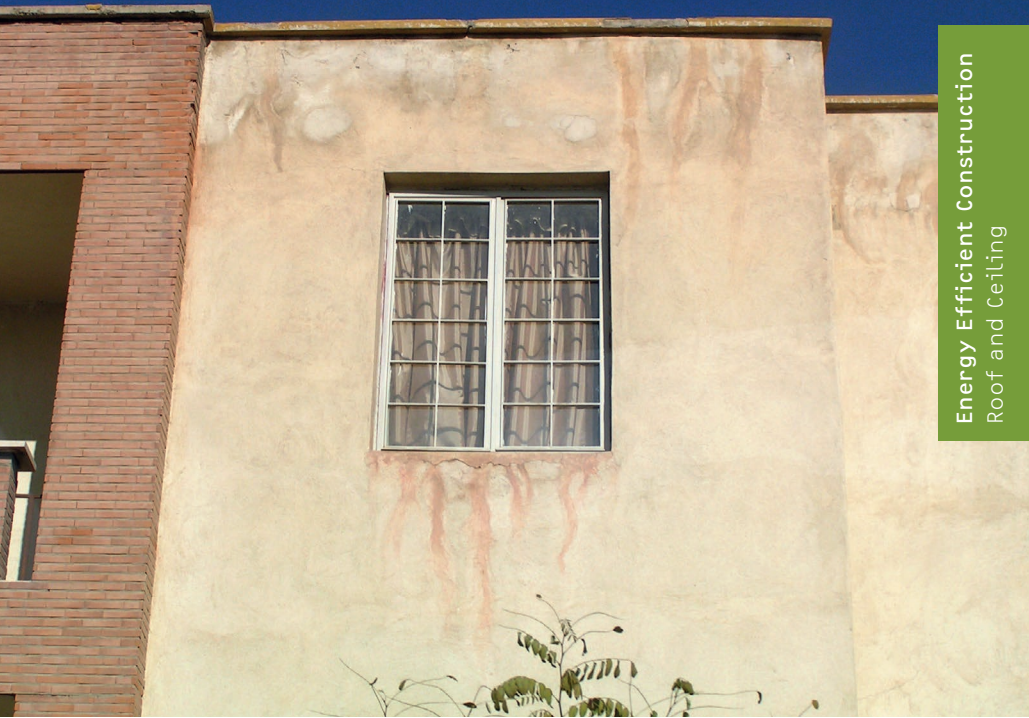
Clearly visible plaster discoloration in the upper part of the masonry, underneath the attic and windows
Attic is not covered with weatherproofed material
Insufficient covering, missing drip edges, insufficient overhangs
No window sills

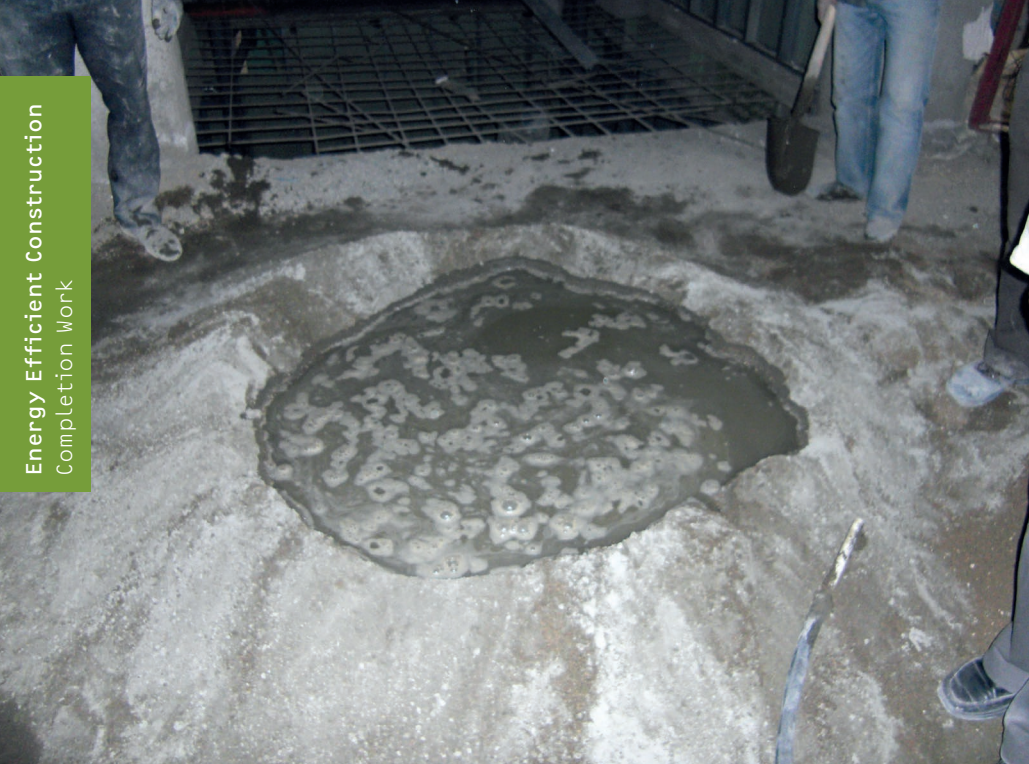
Improper manufacturing of the floor screed, making the correct mix proportion impossible

Insufficient mixing

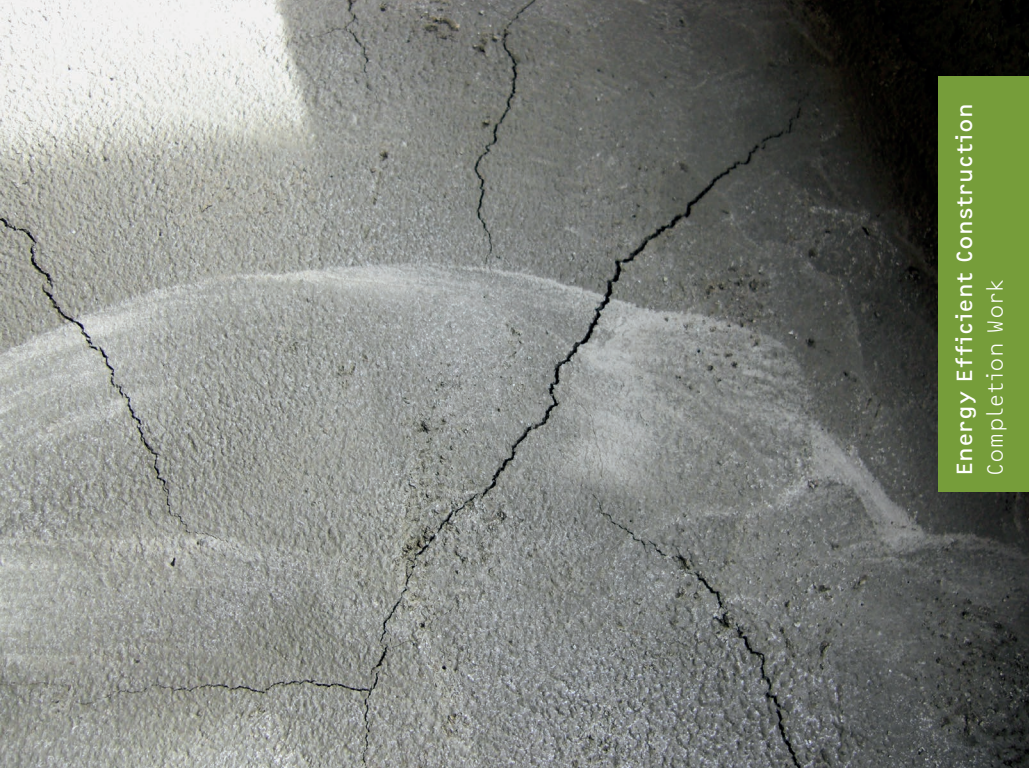
Crack formation in floor screeds surface
Incorrect floor screed recipe
Improper manufacturing process (i. e. manual mixing on site)
Possibly missing reinforcement

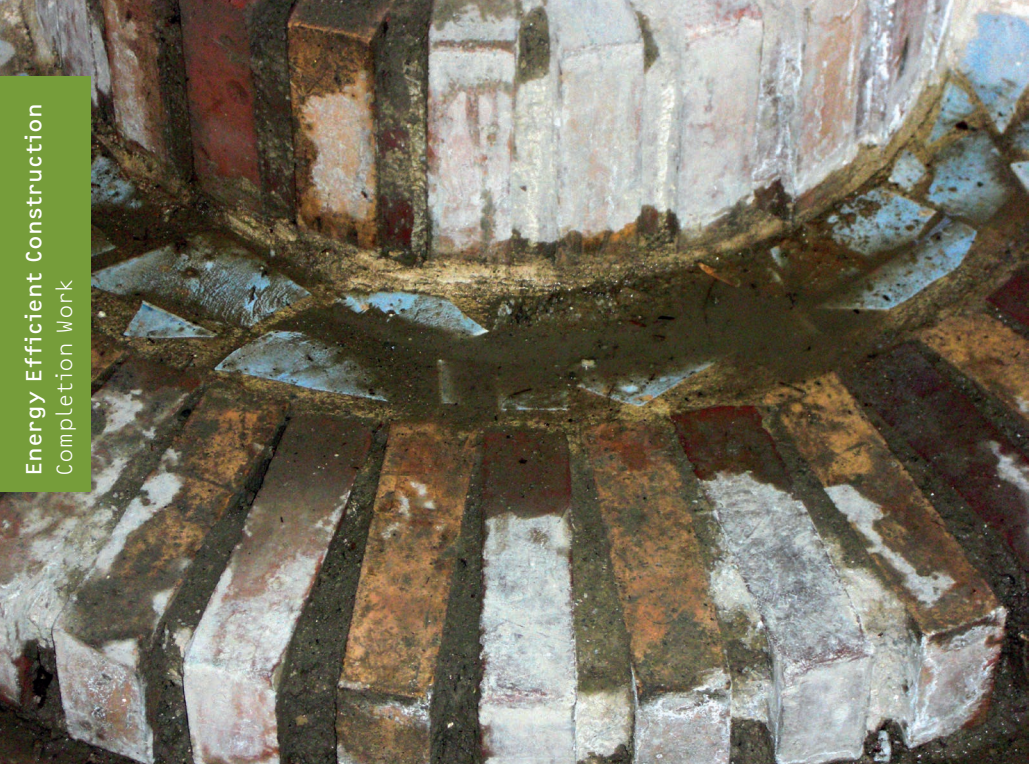
Improper execution of the arch
Unevenly laid fraction tiles
Uneven joint alignment
Sample from the training workshop (bad example)

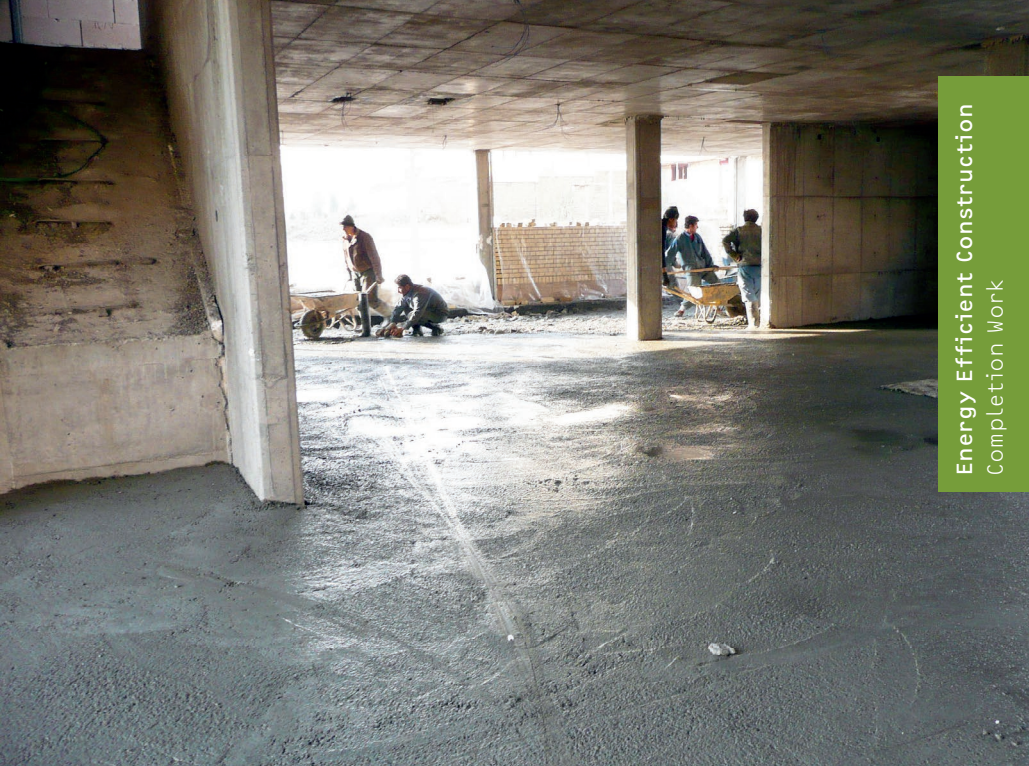
Entering recently poured screed layer, even with wheelbarrow Uneven screed surface

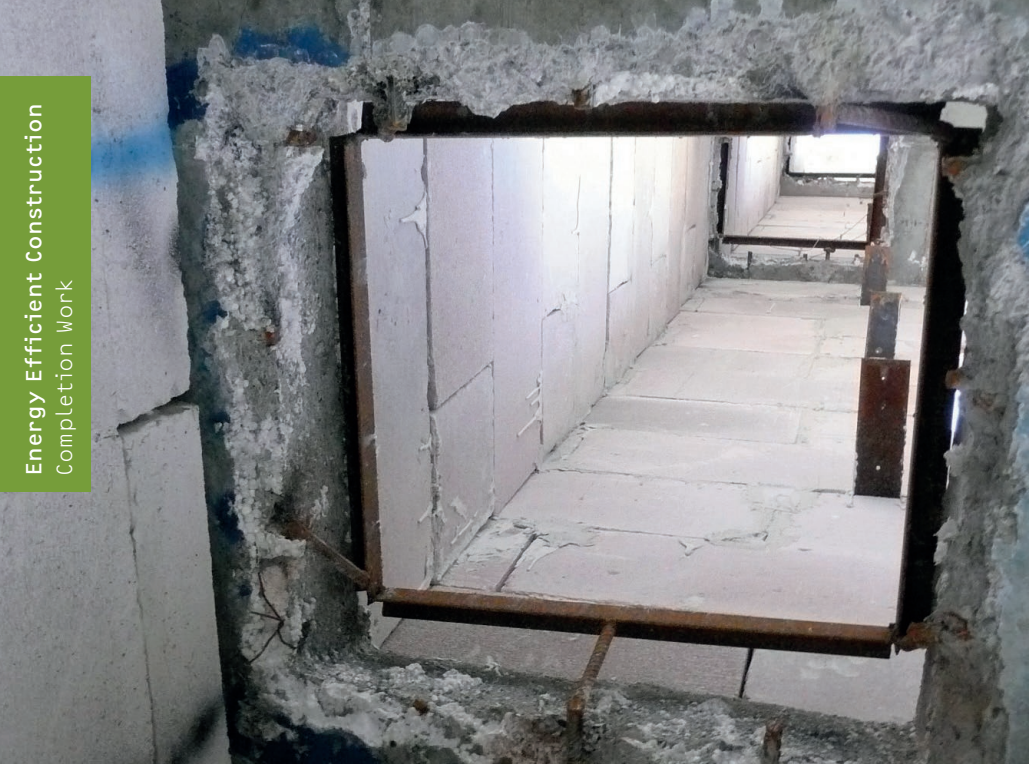
Poor floor breakthrough

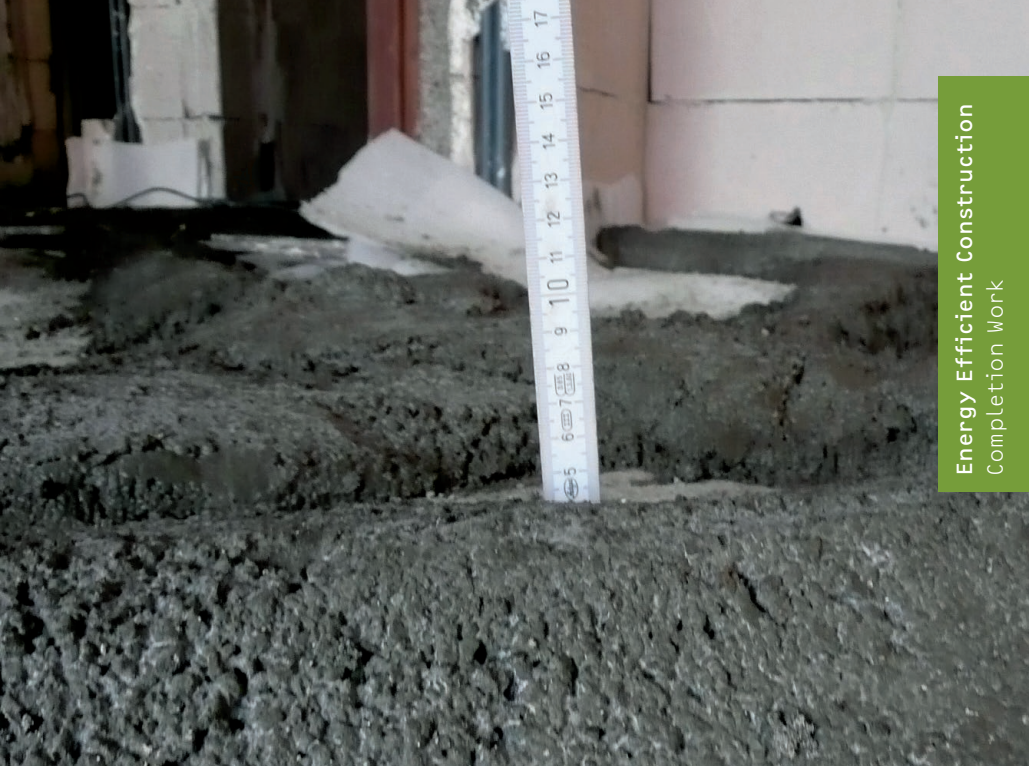
Unnecessary ceiling load due to different mineral aggregates and concrete residuals

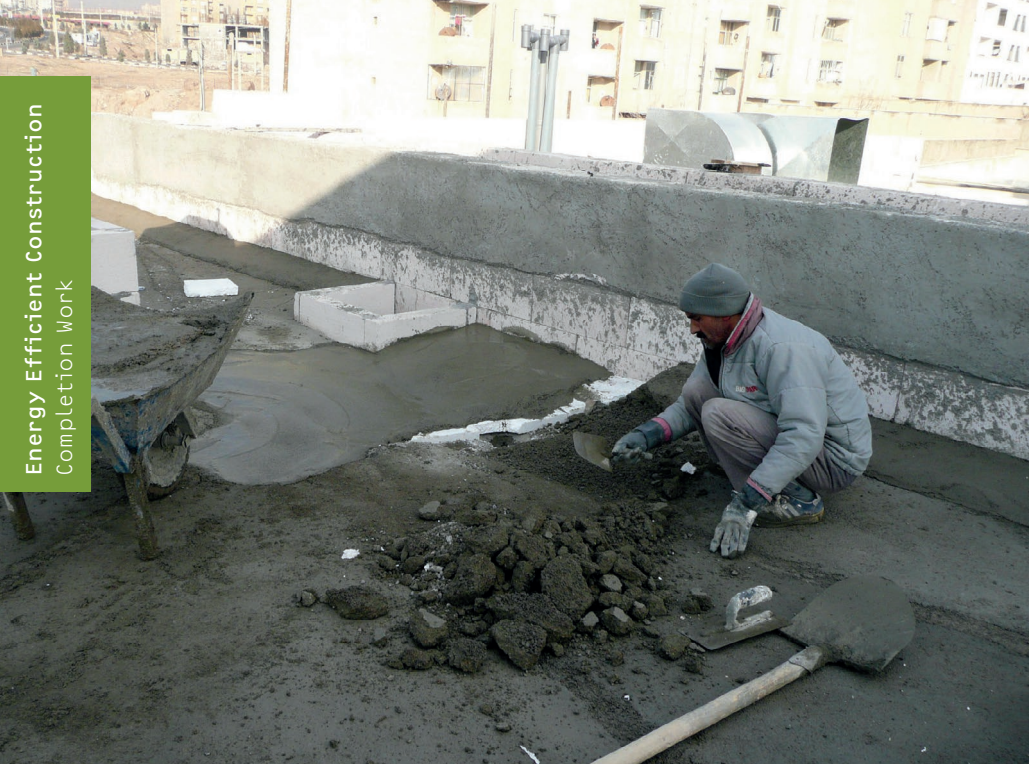
Deconstruction due to improper workmanship (happens often at Iranian construction sites)
Execution errors caused by deficient planning and/or supervision of work

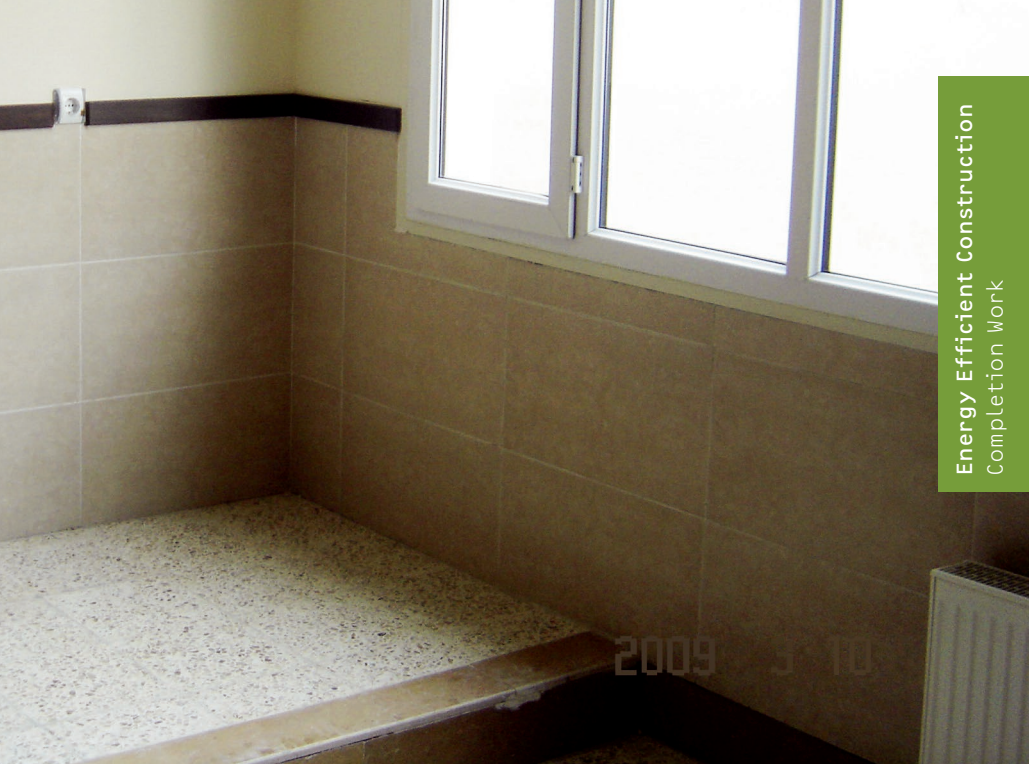
Unfavorable location of the heater

- placing the heater underneath the window

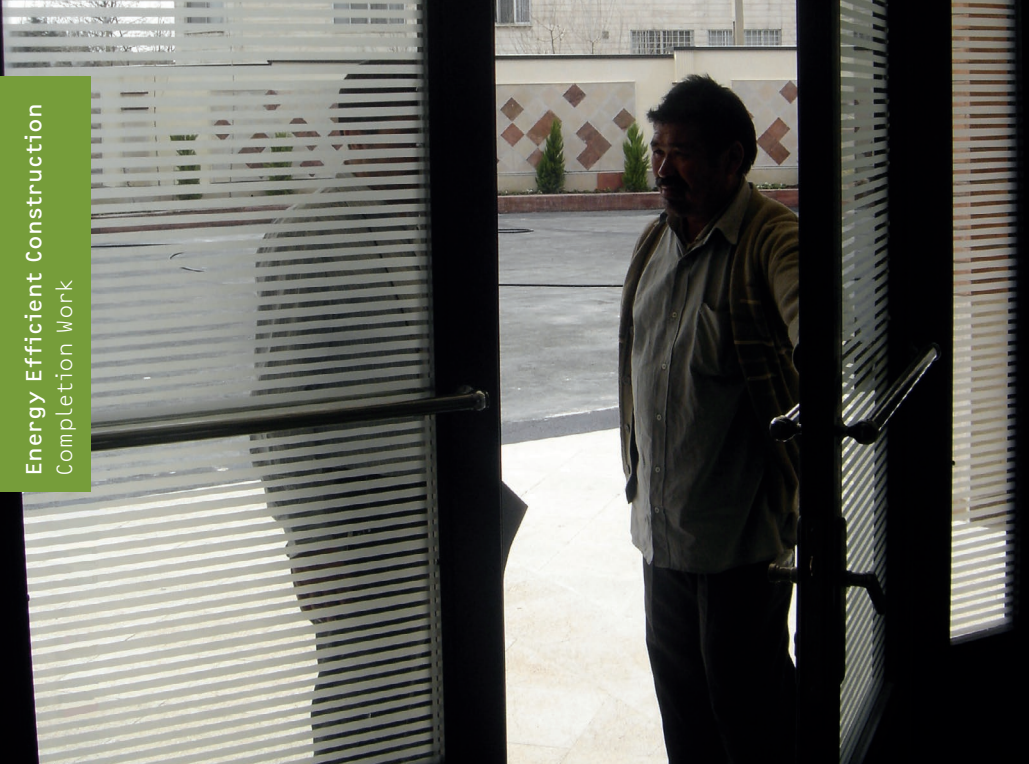
No double glazed entrance doors in windy area

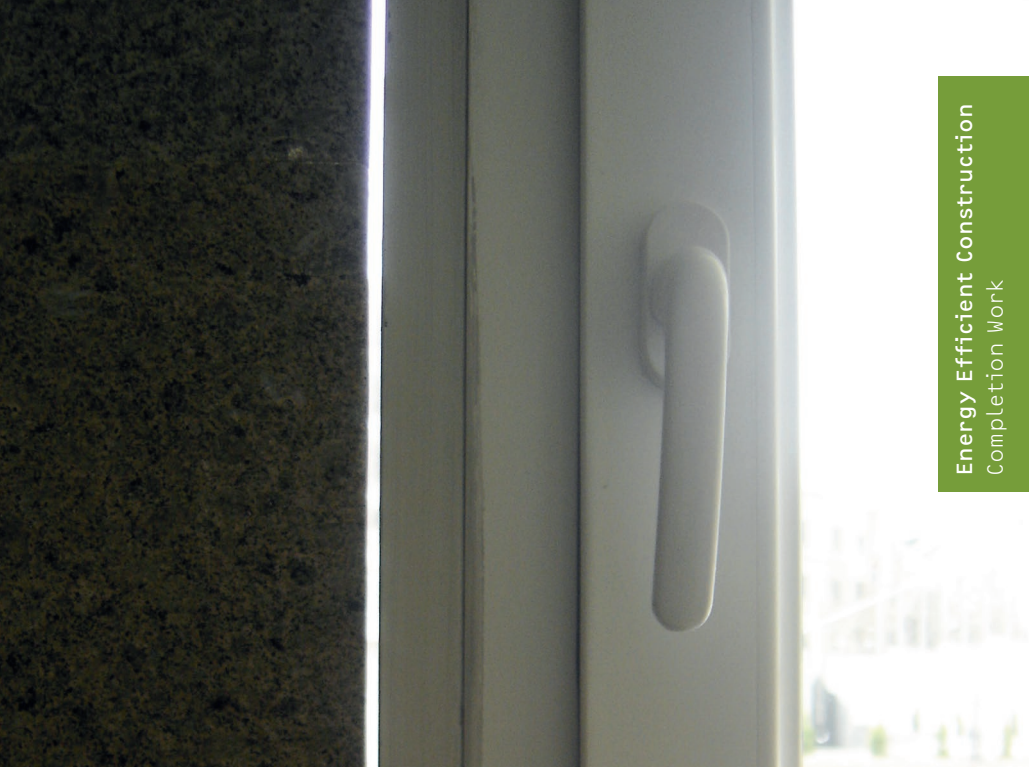
**Considerable gap between window frame and masonry
No usage of joint material**

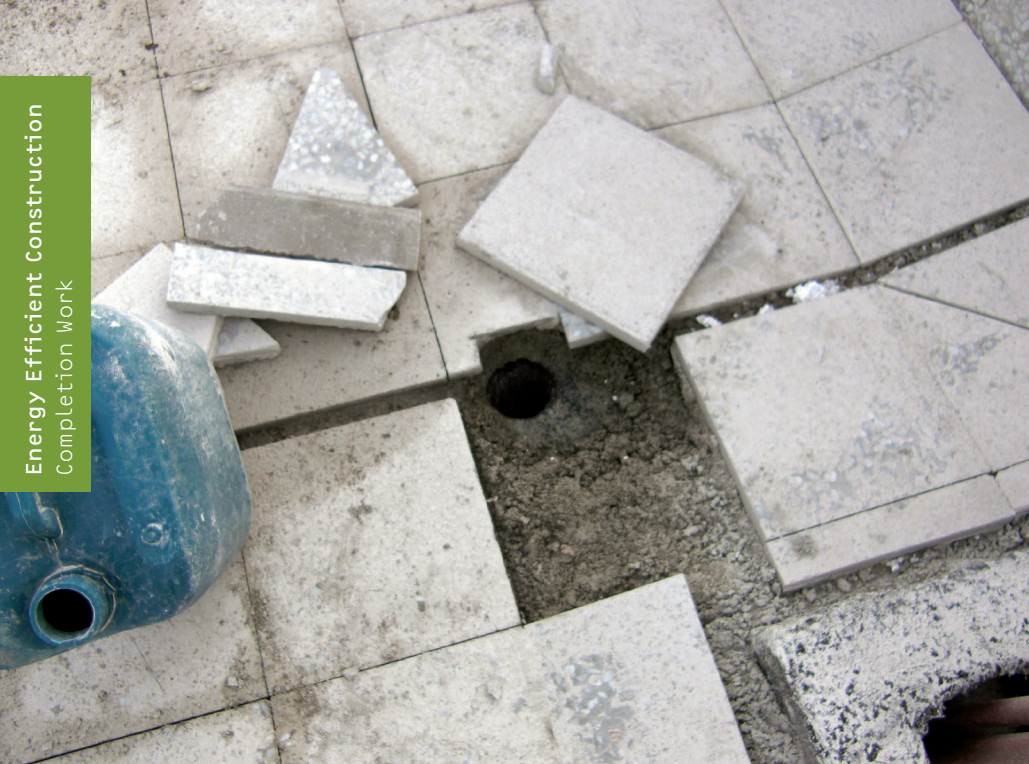
Unprotected roof drainage system during the construction phase

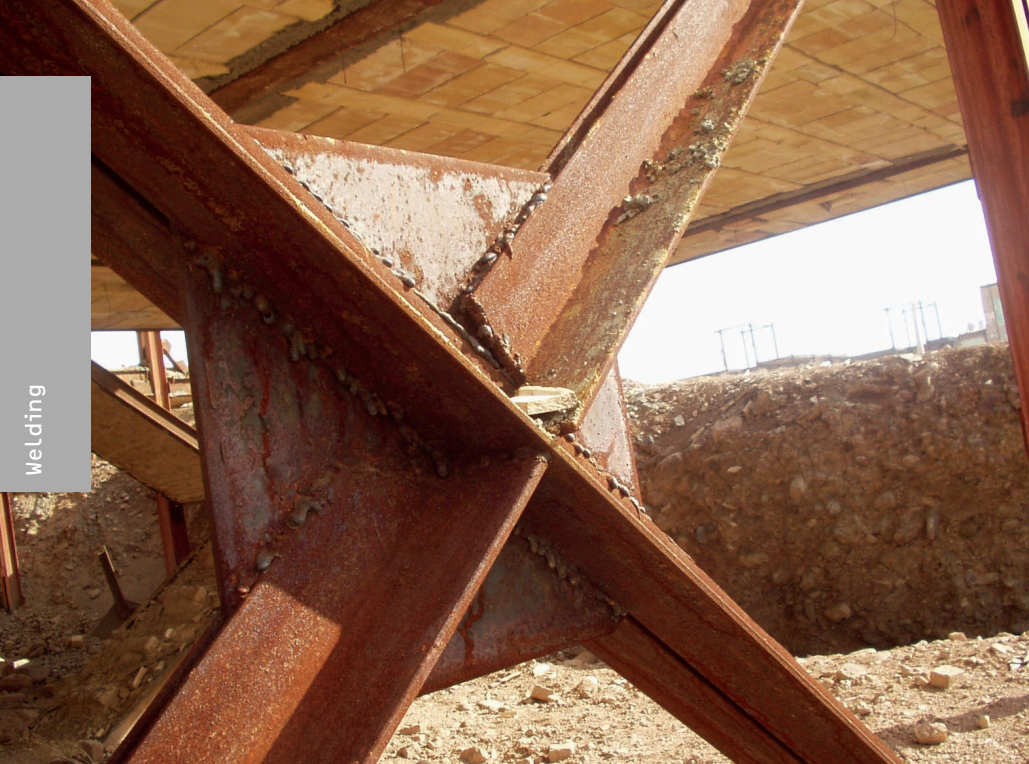
Improper execution of weld knot: poor welding seams

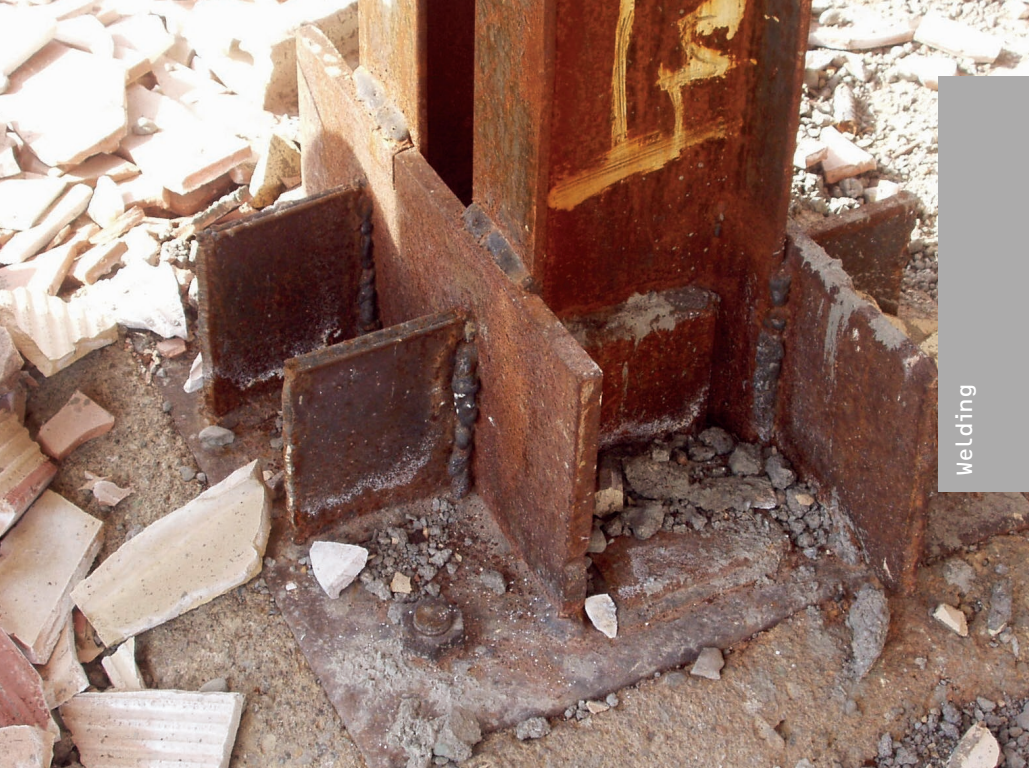
Improper execution of a bracket weld: poor welding seams, poor connections

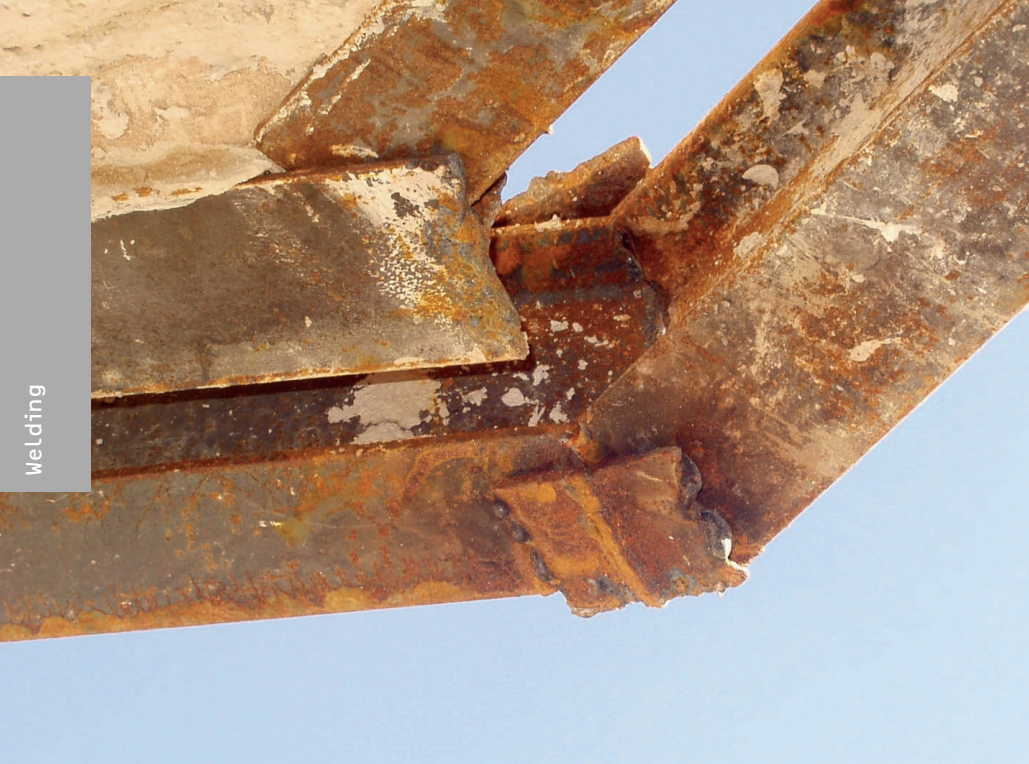
Insufficient formation of edge weld

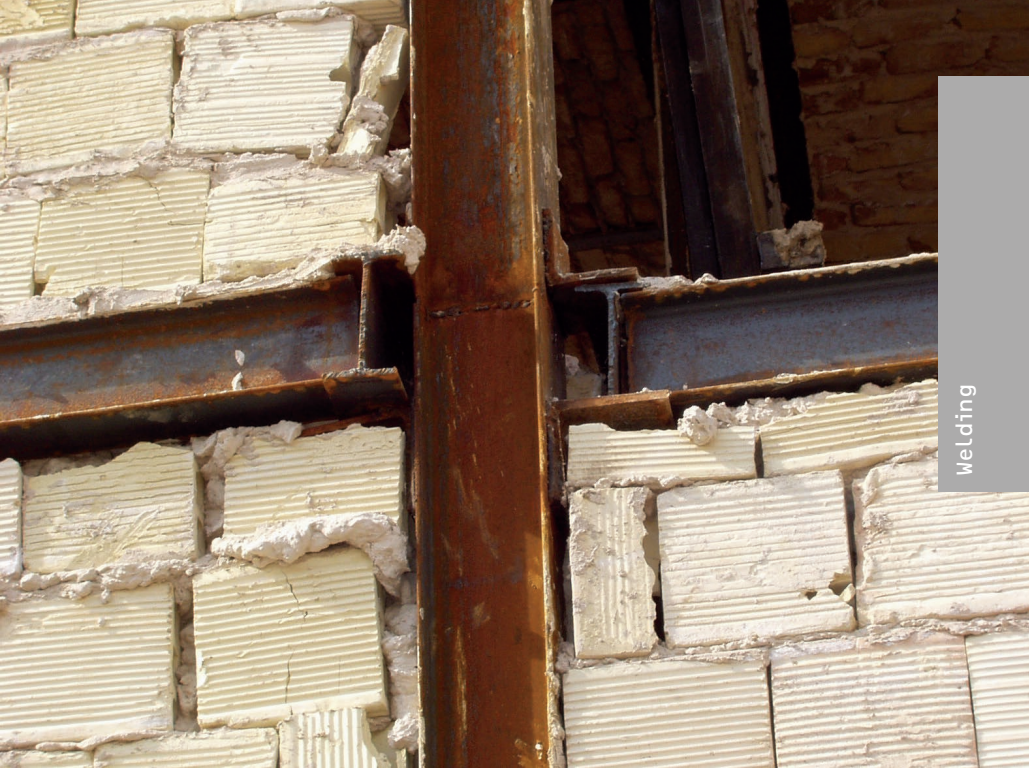
Disastrous execution of beam connection welds

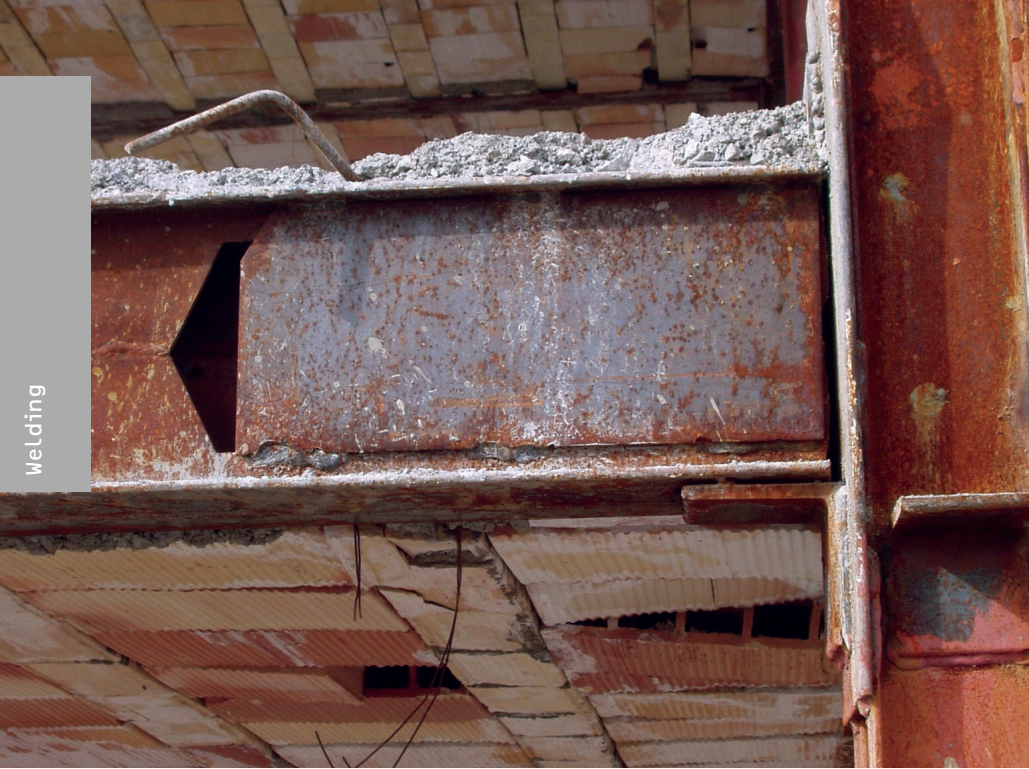
Incomplete connection of the beam Poor welding seams

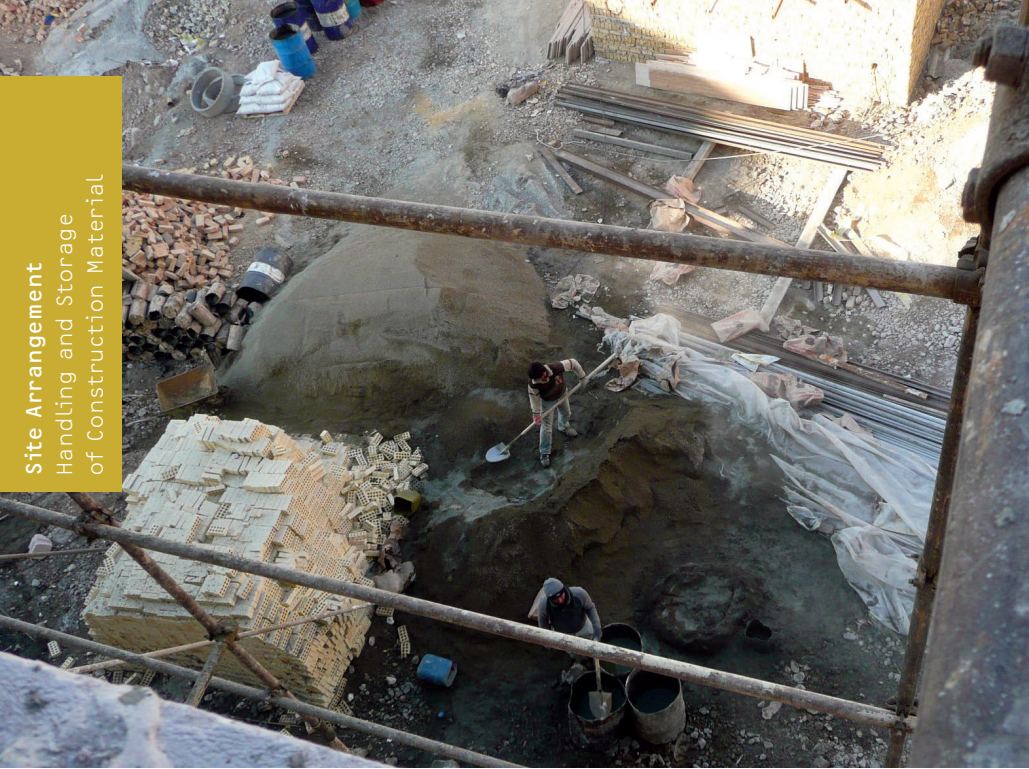
Improper storage of construction material **Orderless and unsorted material**

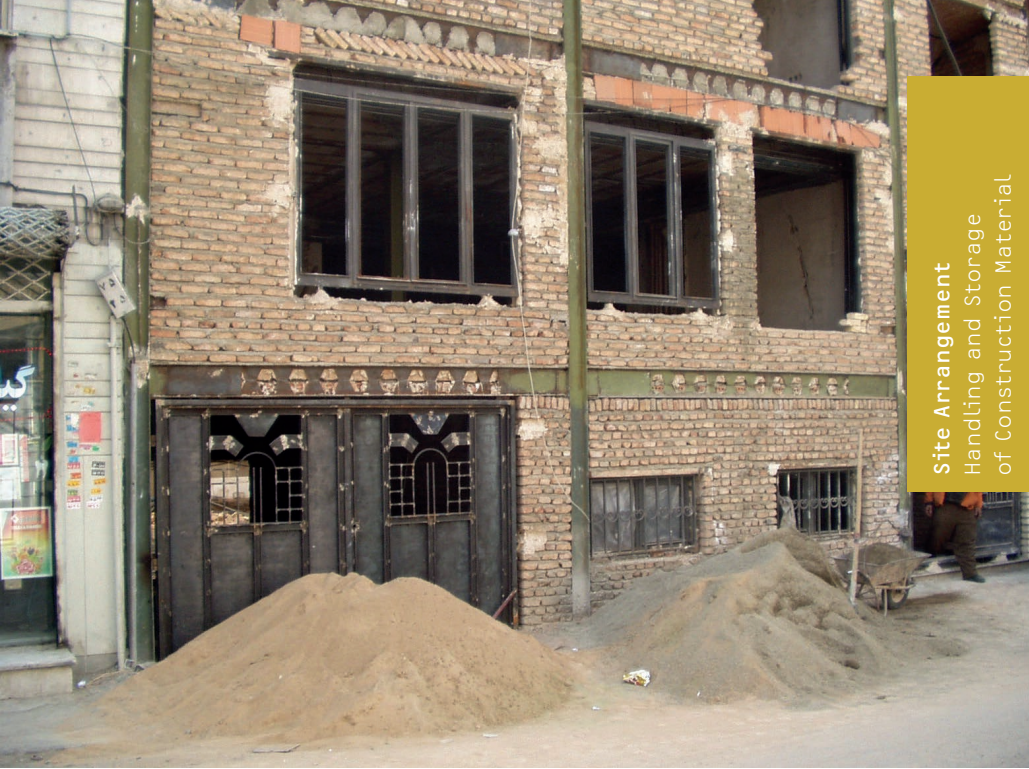
Improper storage of construction material and construction waste Construction material and construction waste become partially mixed

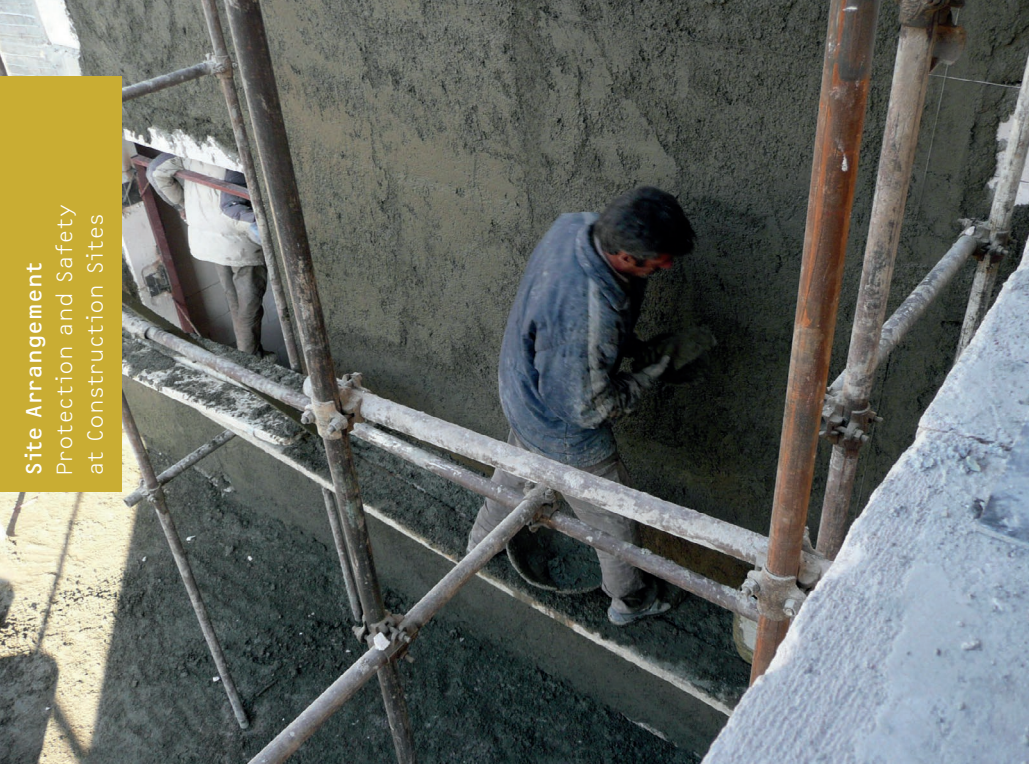
Missing or improper scaffolding
No fall protection, handrail, knee rail, or guard board
No continuous safe working deck
Missing ladders
Missing diagonal struts

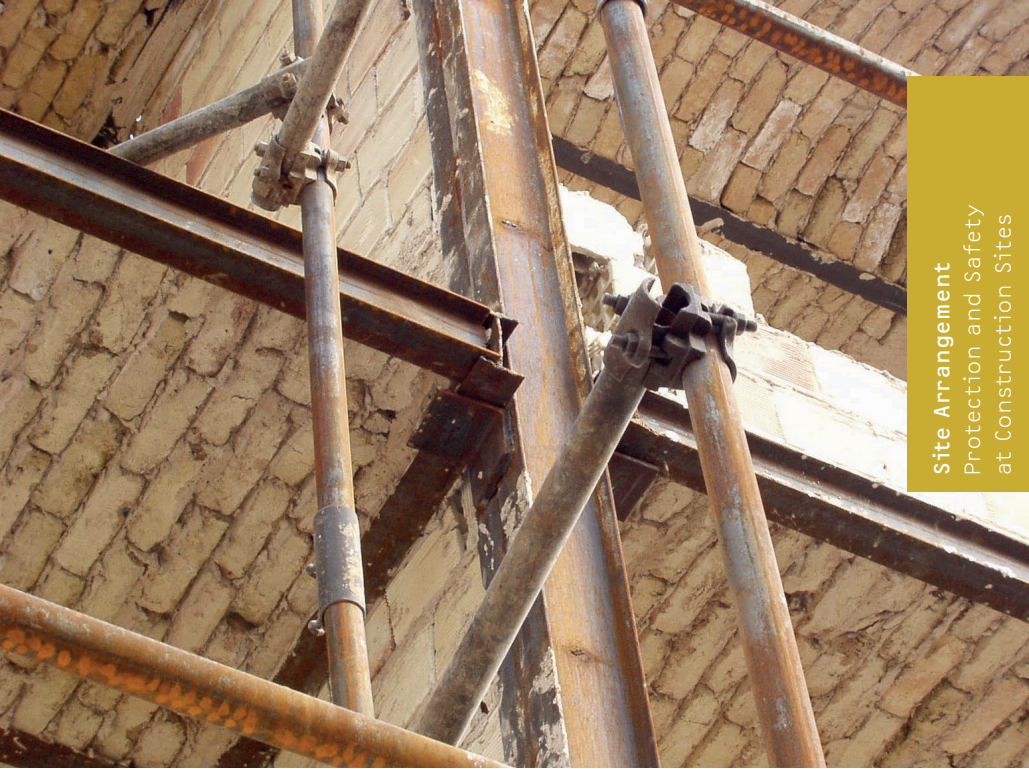
Insufficient scaffolding for welding

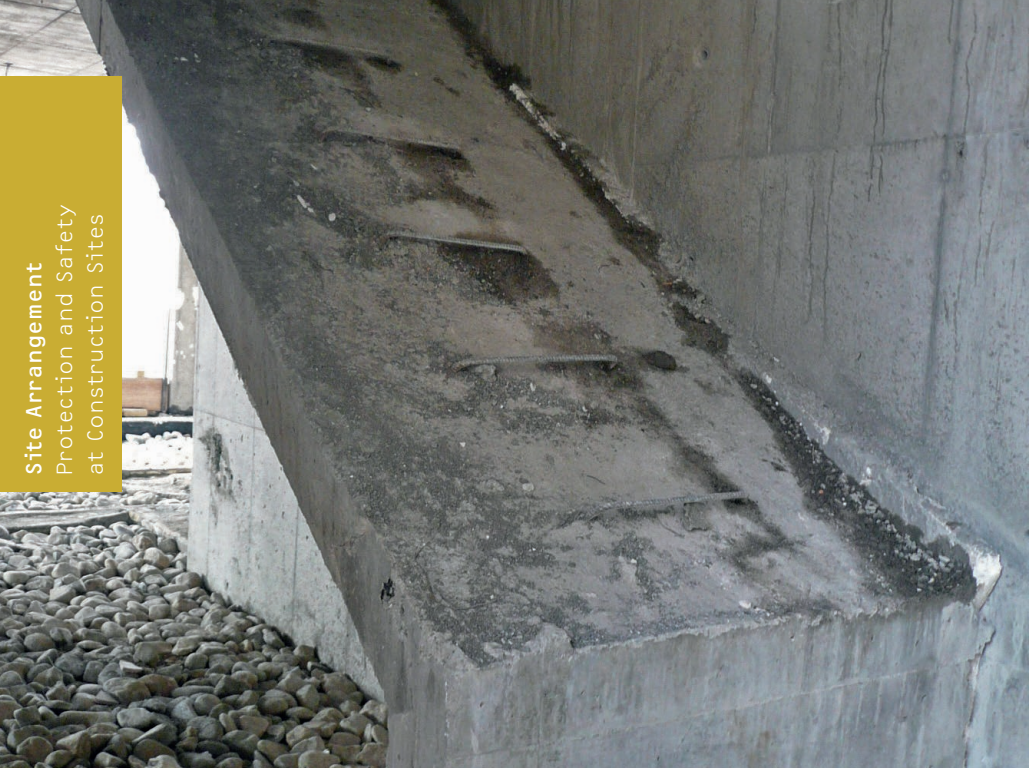
Disregarding occupational safety in shell construction of stairs
Missing stair railings as fall protection
No safe stair treads (only wire straps)

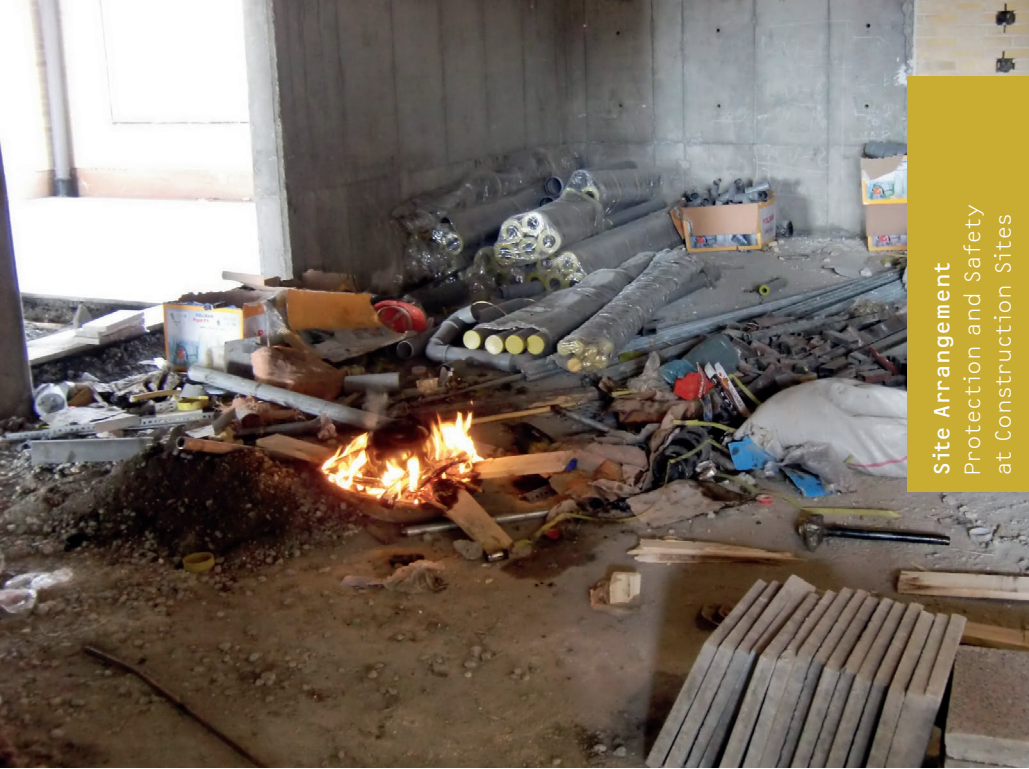
Unorderly and improper storage of construction materials Open fire at the construction site to warm up construction workers

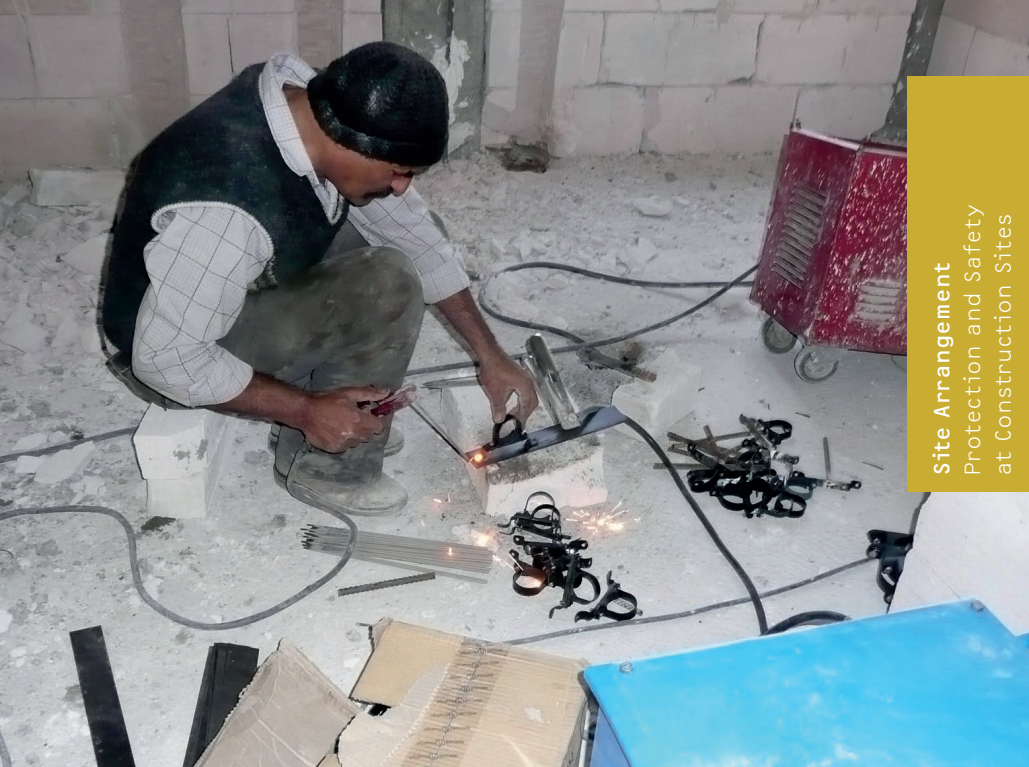
Missing welding equipment, e.g. welding table
Missing personal protection gear (eye protection, hand protection, etc.)
