Young Cities Research Paper Series, Volume 06

Construction Competencies and Building Quality Case Study Results

Bernd Mahrin, Johannes Meyser (Eds.)

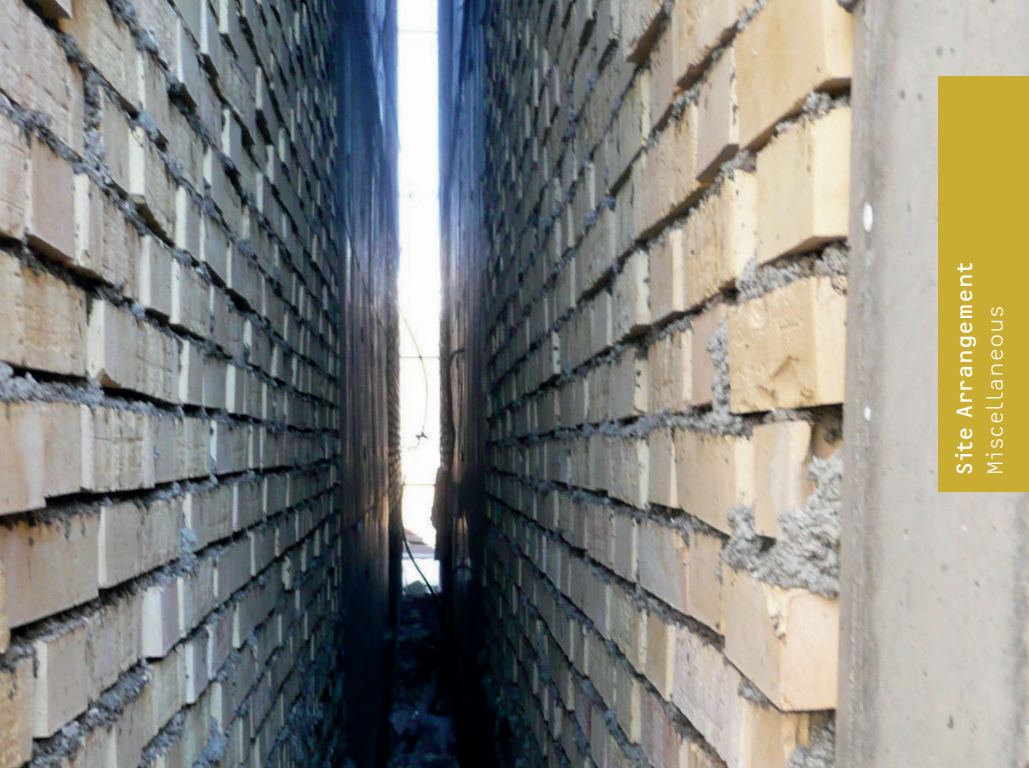
Too much distance between housing partitions

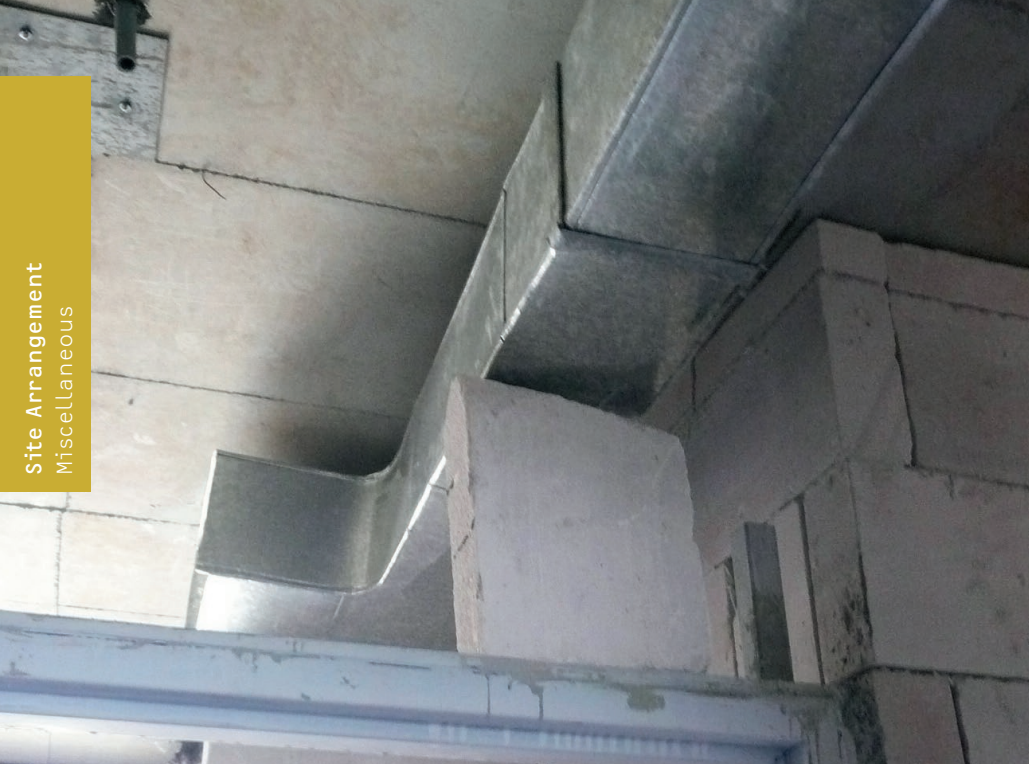
Missing mounting elements for the air conditioning canals
Mounting the canals on the wall leads to missing connection between ceiling and wall

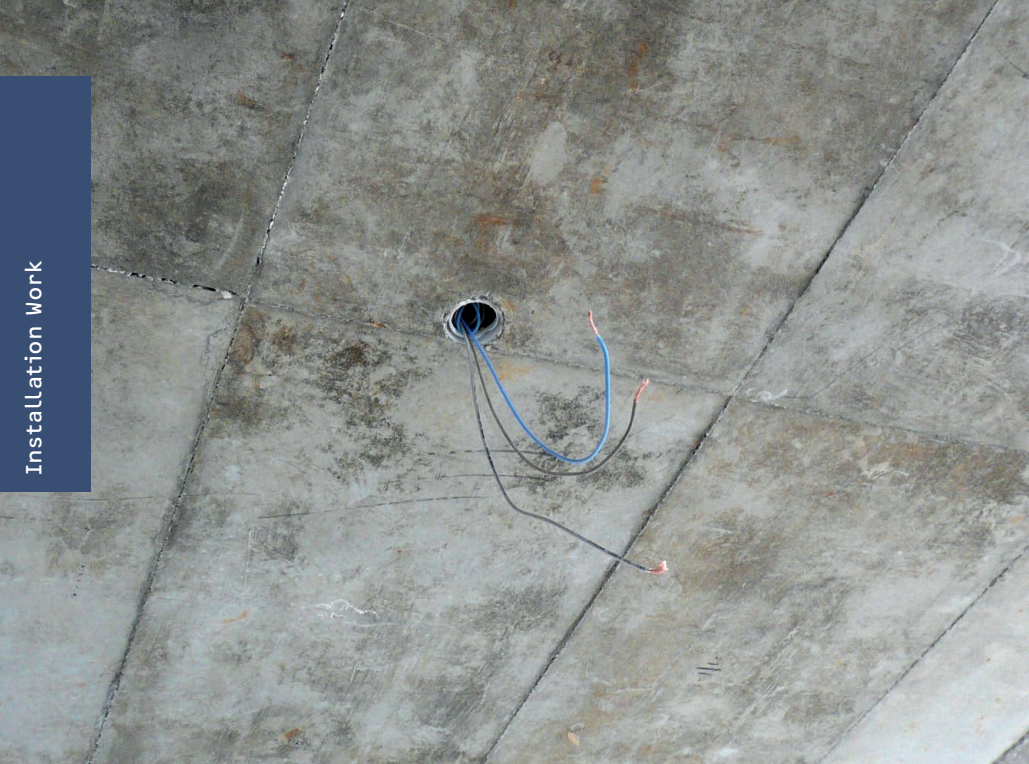
Improper laying of electrical cables Unsecured electric cable connection

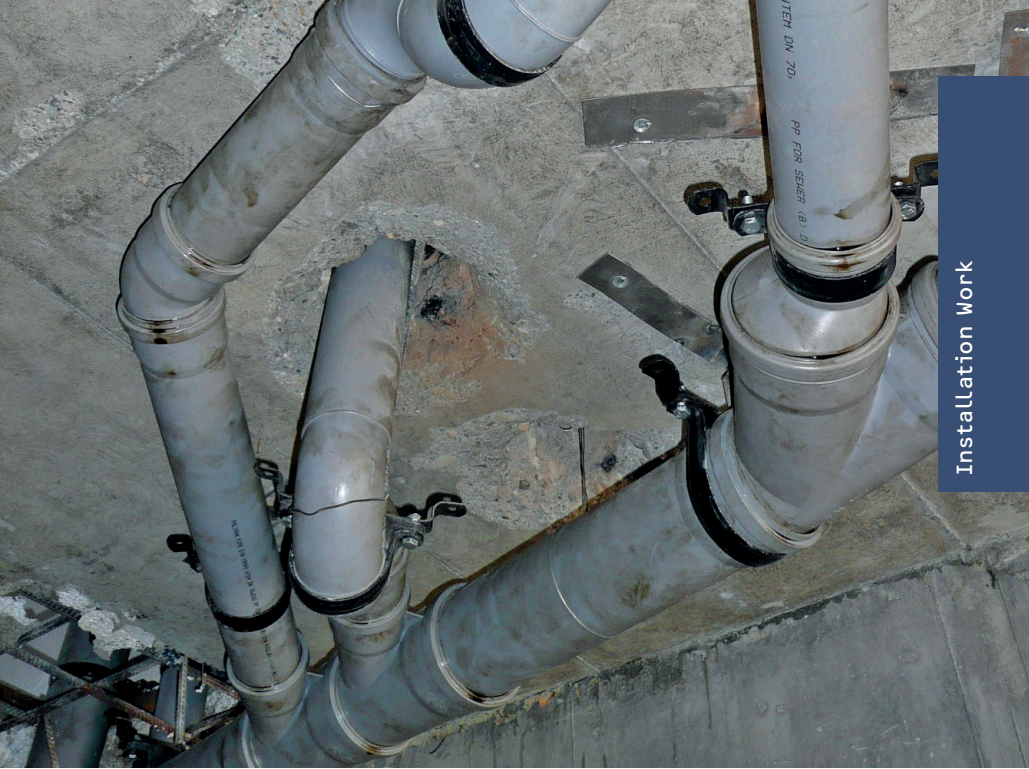
**Improper pipe installation—unnecessary bends and bypasses
Perhaps missing installation plan**

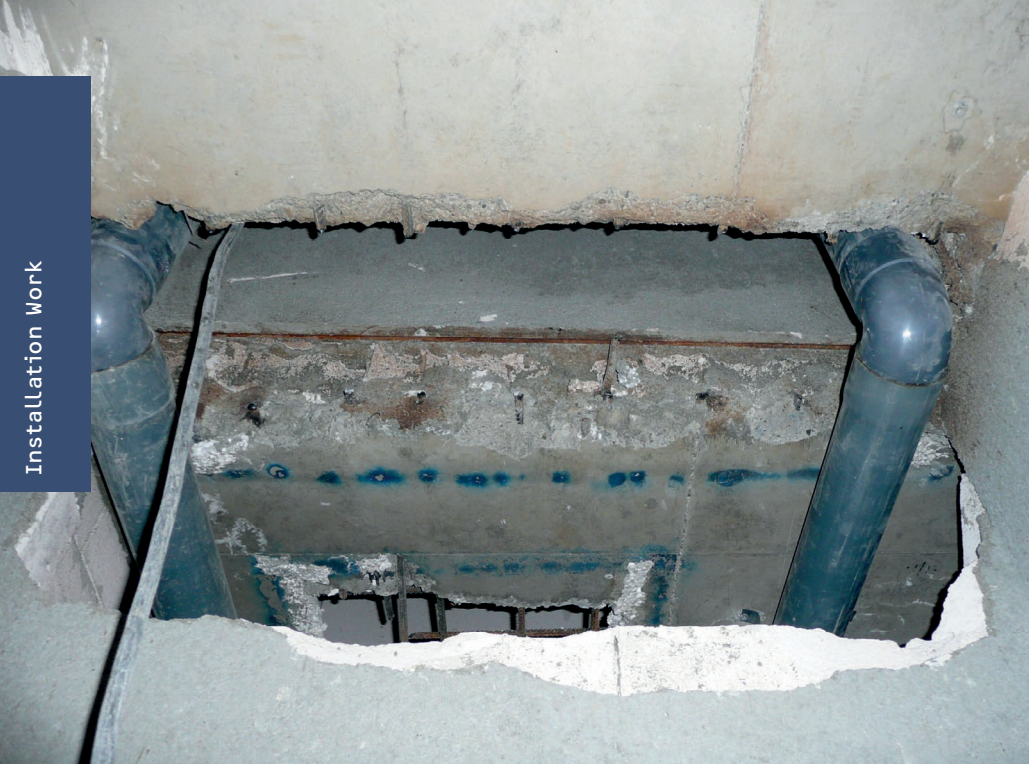
Breaking through the ceiling to lay pipes
Unacceptable severing of the ceiling reinforcement
Perhaps missing detailed installation planning

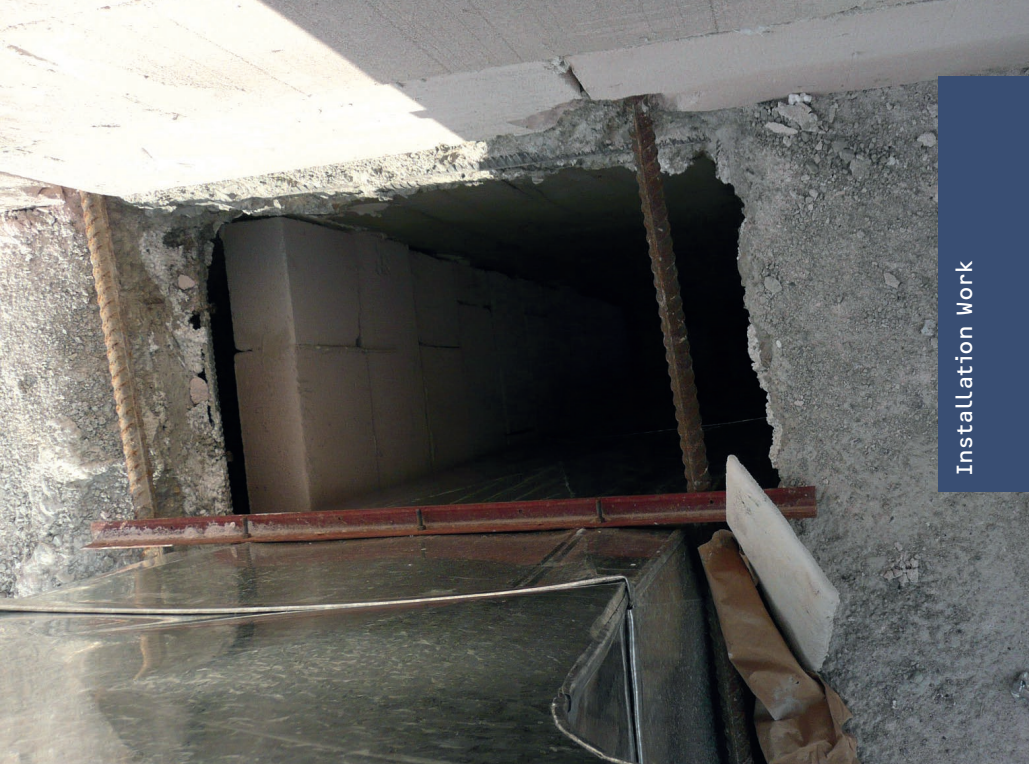
**Breaking through finished ceiling to install air conditioning channels
Welding the supporting frame to the reinforcement of the concrete
structure (strictly forbidden!)**

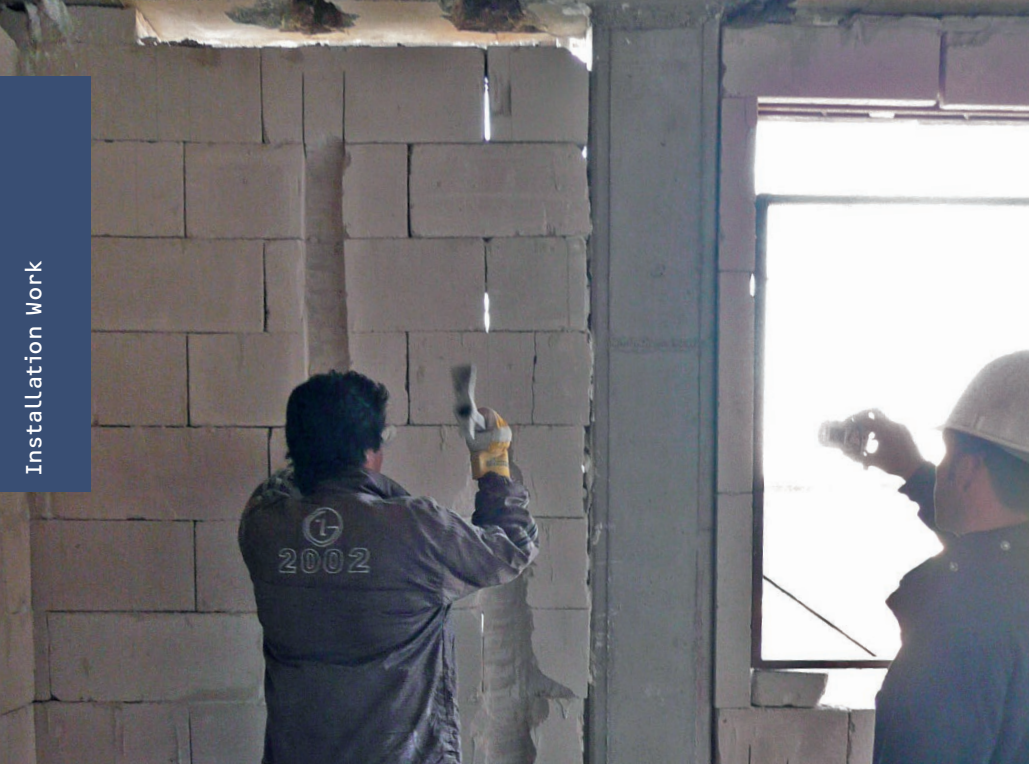
Chiseling channel slots into the new wall in order to install power supply lines/empty conduits
Improper execution of AAC masonry

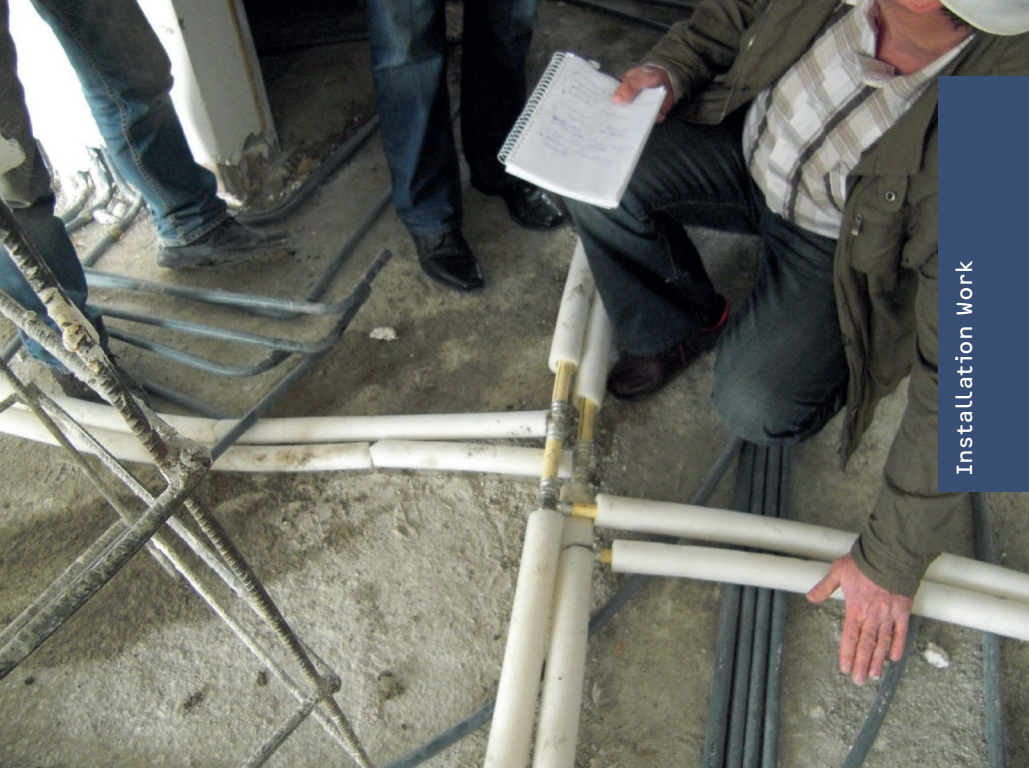
Incomplete insulation of heating pipes

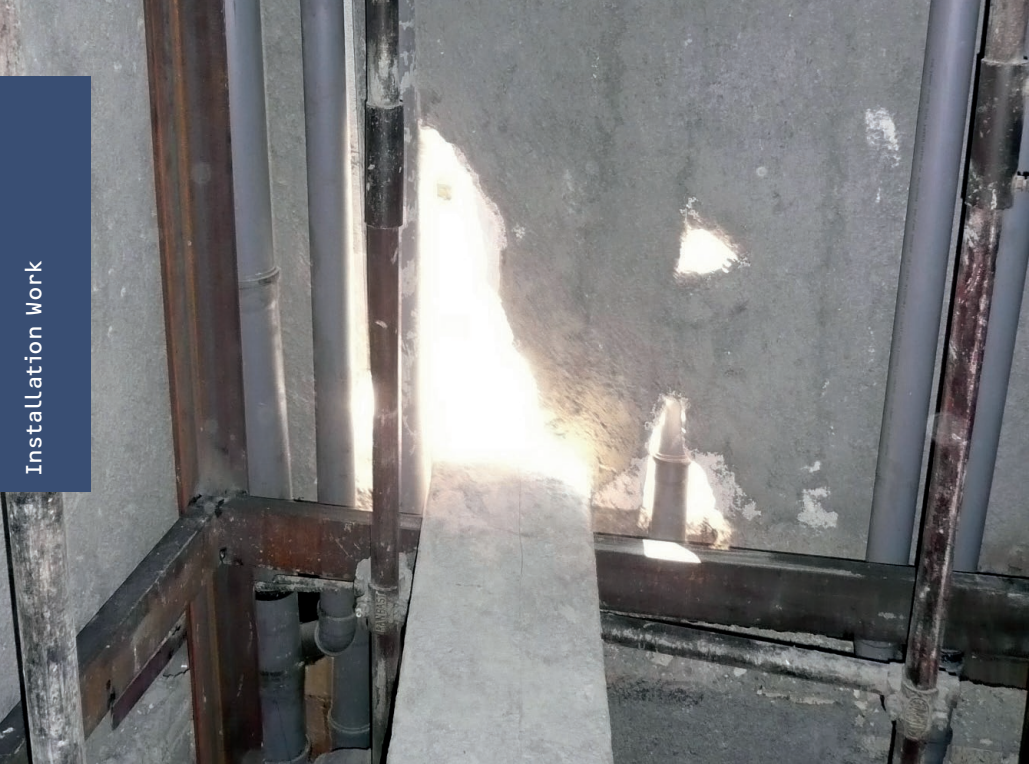
Large opening in concrete wall created post-construction
