Water hammer and column separation due to accidental simultaneous
closure of control valves in a large scale two-phase flow experimental test rig

WATER HAMMER AND COLUMN SEPARATION DUE TO ACCIDENTAL SIMULTANEOUS CLOSURE OF CONTROL VALVES IN A LARGE SCALE TWO-PHASE FLOW EXPERIMENTAL TEST RIG

A large-scale pipeline test rig at Deltares, Delft, The Netherlands has been used for filling and emptying experiments. Tests have been conducted in a horizontal 250 mm diameter PVC pipe of 258 m length with control valves at the downstream and upstream ends. This paper investigates the accidental simultaneous closure of two automatic control valves during initial testing of the test rig. The simultaneous closure of both valves has induced upsurge and downsurge at the same time. Large water hammer and column separation have caused failure of pipe supports and leakage at pipe joints. The incident was caused by a fault in an electronic conversion box due to power failure. Afterwards the downstream end automatic valve has been modified to a manually operated valve to avoid the accidental simultaneous closure of the valves. The accidental transient event has been fully recorded with pressures, flo

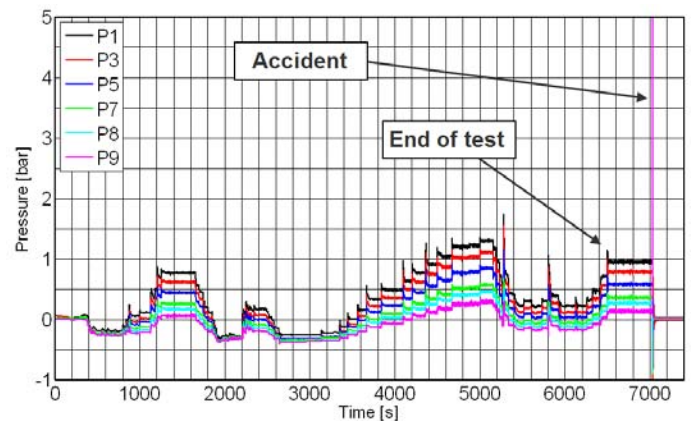
Figure 3: Pressure history at different positions along the PVC pipeline during testing and accident.

The performance of the newly installed upstream-end automatic pressure-control valve needed to be tested. For this reason the researchers started with gradually changing the pressure set-point on the control panel (up and down) thereby waiting for the initiated transient to damp out into steady state flow in the PVC pipeline (Figure 3). At all times during the testing the group focused on stability and reliability of the automatic upstream-valve performance. Because the experimental test rig was designed for two-phase flow experiments, and not for water hammer tests, the pressure jumps during all tests were moderate and there was no speak of any significant pressure surge (Fig. 3). As the pressure set-point testing was not part of the experimental programme, the

sampling rate was reduced to 20 Hz, which was sufficient for its purpose, and - as it turned out later - it was just high enough to catch the unintentional water-hammer accident. It turned out that the performance of the upstream-end automatic control-valve was reliable and stable. The testing successfully ended after 6500 seconds and then the team members were gathered in the control room to discuss new settings for the second series of experimental measurements (all authors were present except the last co-author). The second series concerned controlled emptying of the PVC pipeline; therefore, the flow rate through the piping system of about 145 litres per second was maintained and not interrupted. Figure 3 indicates that the accident happened approximately after 7000 seconds of testing.

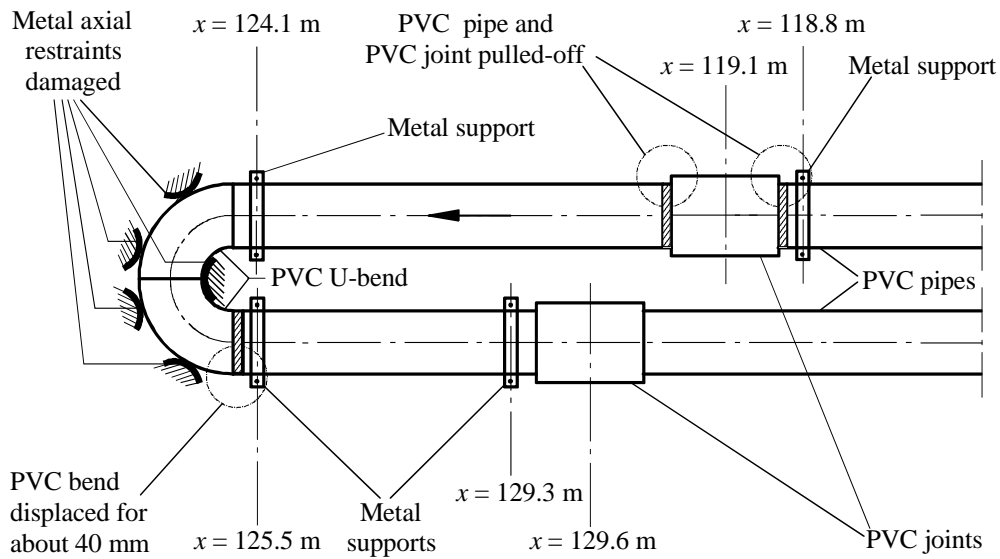
Figure 4: Overview of damages at the sharp U-bend of the PVC pipeline test section.

(1) *Description of damages at the sharp U-bend (Figs. 4 and 5):* The U-bend was clamped with two metal supports at $x = 124.1$ m and $x = 125.5$ m and five metal axial restraints (steel hollow cylinders bolted to the concrete floor) which prevented movement in horizontal direction. During the accident, the forces on the supports were so large that four metal axial restraints were pushed away while the fifth axial restraint got entirely loose and fell away from the U-bend (screws were cut-off at the floor plane). Photograph Fig. 5b shows a damaged metal axial restraint (bolting screws were partly pulled-out and the steel column was inclined). The downstream joint of the PVC U-bend at $x = 125.2$ m displaced for about 40 mm and a small leakage was observed here. The axial movement of the U-bend resulted also in the partial opening of the PVC pipe in the joint at the distance $x = 119.1$ m (Fig. 5a). This was possible because the metal support at 124.1 m enabled axial displacement of the PVC pipe for 35 mm. However, no leakage was detected at this joint. No visible damages were detected at the metal supports (brackets) at $x = 118.8$ m and upstream, and at the metal supports at $x = 125.5$ m and downstream.

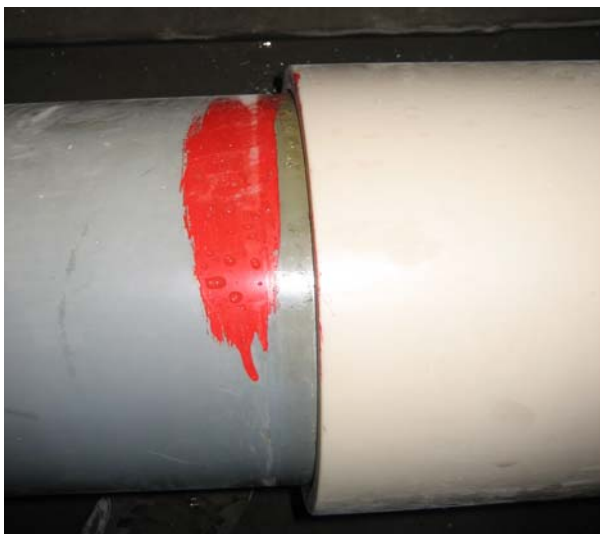
a) Damaged PVC pipe joint at distance $x = 119.1$ m.

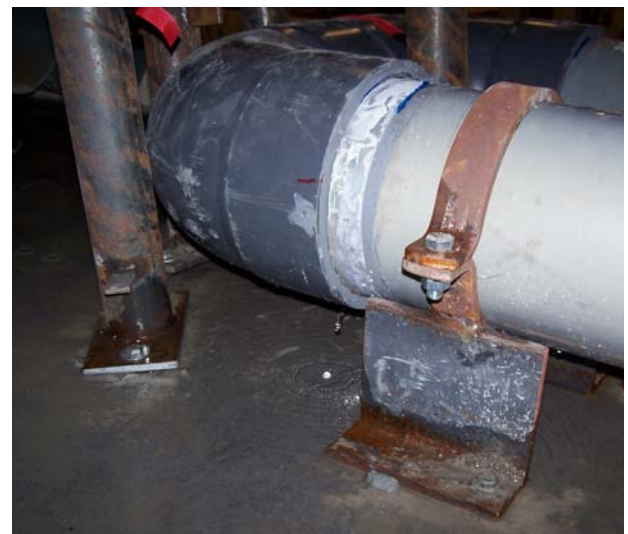
b) Damaged PVC U-bend at distance $x = 125.5$ m.

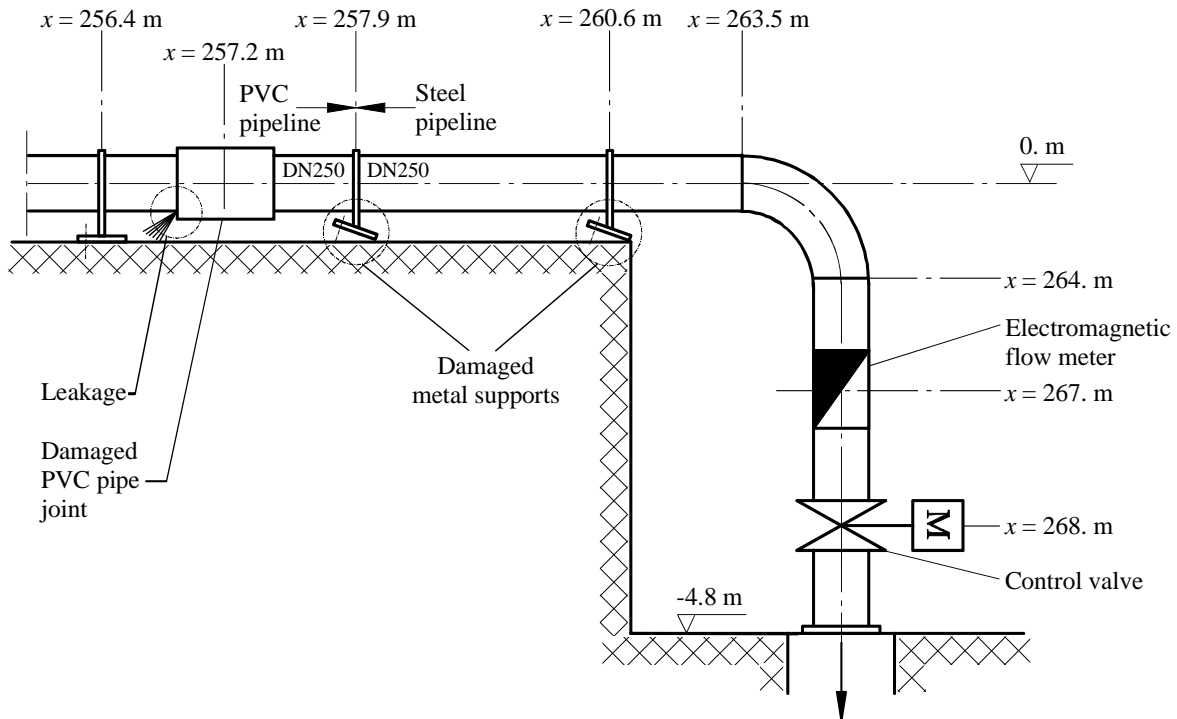
Figure 6: Overview of damages at the outlet of the horizontal PVC pipeline test section.

(2) *Description of damages at the outlet side of the horizontal PVC pipeline test section (Figs. 6 and 7):* The PVC pipeline was located on the balcony of the laboratory (first floor) and a steel pipe section with sharp downward 90° elbow was used to divert water into the sump (ground floor). The connection between PVC and steel pipeline was at $x = 257.9$ m, and the downward elbow was at position $x = 263.5$ m. The vertical part of the steel pipeline was supported by a steel structure and was free to move in the horizontal plane and in vertical direction (up). The horizontal part of the steel pipeline was clamped with two metal supports at $x = 257.9$ m and $x = 260.6$ m. When the pressure upsurge was travelling through the downward elbow, the steel pipeline was lifted-up and away from the PVC pipeline. The steel pipe itself was undamaged but the metal supports were deformed as it is evident from Figs. 6 and 7. Figure 7 shows that some of the bolts anchoring the metal supports (brackets at $x = 257.9$ m and $x = 260.6$ m) to the concrete floor were damaged. Then the PVC pipe joint at $x = 257.2$ m opened and a large water leakage occurred (Fig. 7a). The pipeline upstream of the undamaged metal support at $x = 256.4$ m was left intact up to the metal support at $x = 125.5$ m (Fig. 4). No damages were detected at the electromagnetic flow meter and the control valve.

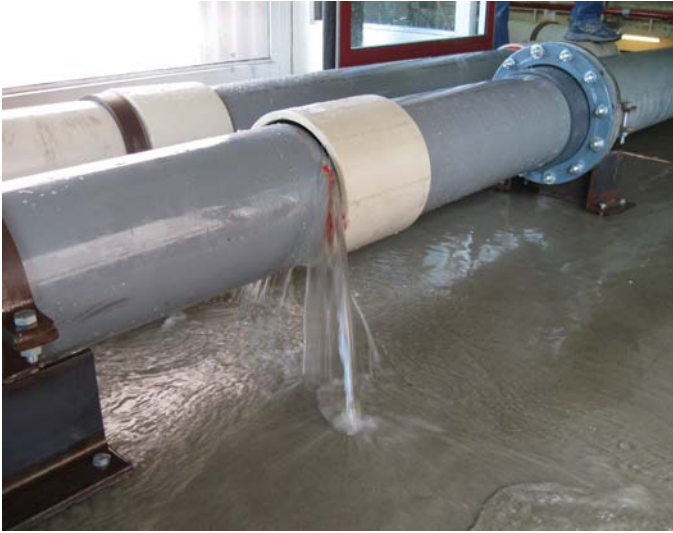
a) Leakage from damaged PVC pipe joint at distance $x = 257.2$ m.

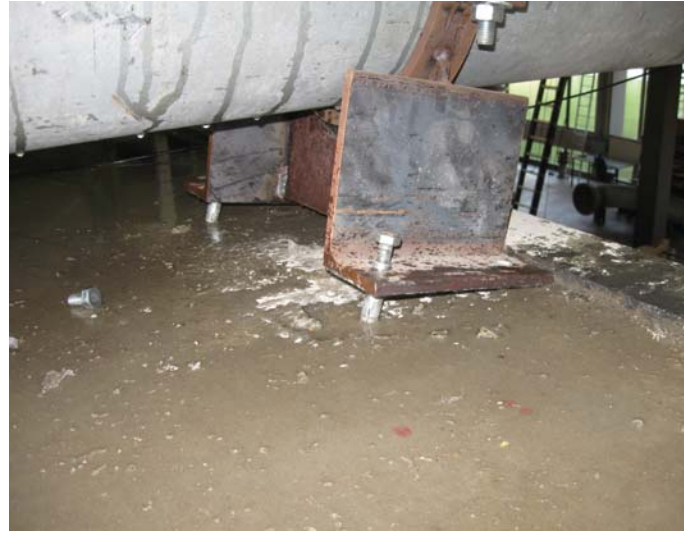
b) Damaged metal anchor at distance $x = 260.6$ m.

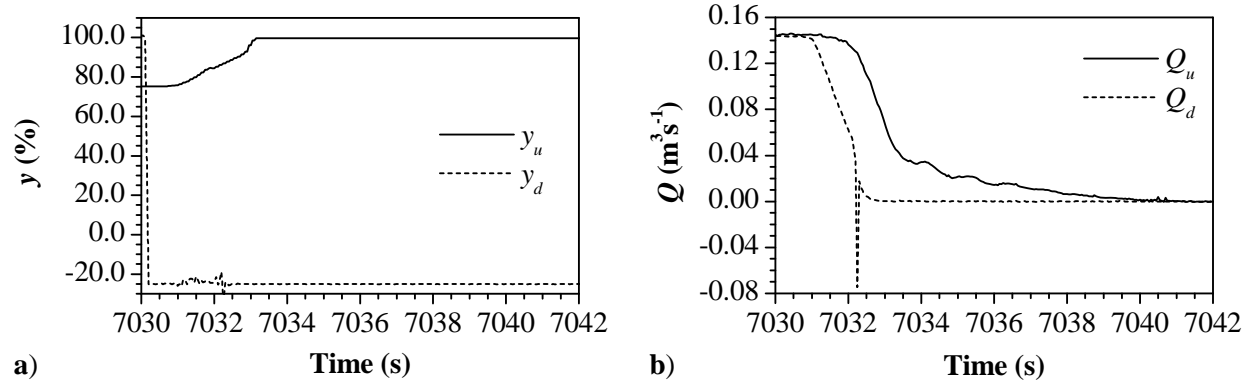
Before the accident, the DN150 upstream-end automatic valve was opened 75% and the DN150 downstream-end automatic valve was opened 100% and these settings corresponded to an initial flow rate in the piping system of $Q = 0.145$ m³/s with an upstream gauge pressure of $p_u = 1.01$ bar. Figure 8 shows the position signals y of the automatically operated control valves together with the upstream and downstream flow rates Q during the accidental event. The position signals were wired from computer via a volt-current converter to the control-valve actuators. The position signal of the downstream control valve y_d was set to a constant value (full opening) whereas the position signal of the upstream control valve y_u was controlled by computer in order to maintain a desired upstream pressure p_u set-point. The observed signals in Fig. 8a were taken as follows: (1) y_u was captured between the computer and volt-current converter and (2) y_d was captured between the volt-current converter and the valve actuator. A sudden drop of the signal y_d to -25% occurred at a test time of about 7030.2 seconds (see Fig. 8a). Because both control valves were wired to the same volt-current converter this time can be considered as the time at which the control valves started to close. However, the position signal y_u of the upstream control valve shows adjustment of the valve opening to its maximal opening at a time of about 7033 seconds (see Fig. 8a). This difference is because the position signal y_u was taken in between the computer and the volt-current converter.

Figure 8: Automatically-operated control valve position signals (y) and water flow rates (Q) during the accidental event.

The consequent change of upstream and downstream flow rates is even more peculiar (Fig. 8b). The downstream flow meter detects the first change of Q_d at time of 7030.7 seconds and the flow is stopped at time of 7033 seconds. The upstream flow meter detects the first change of Q_u at the time of 7031.5 seconds and the flow is stopped at the time of 7041 seconds. The different timing of flow changes may be attributed to different responses of the valve actuators to the accidental loss of the signal and to different flow conditions (boundary conditions). It should be noted that the distance between the upstream control valve and the upstream flow meter was about 16 metres with a pipe branch in between, whereas the distance between the downstream control valve and the downstream flow meter was only one metre (Figs. 1 and 2).

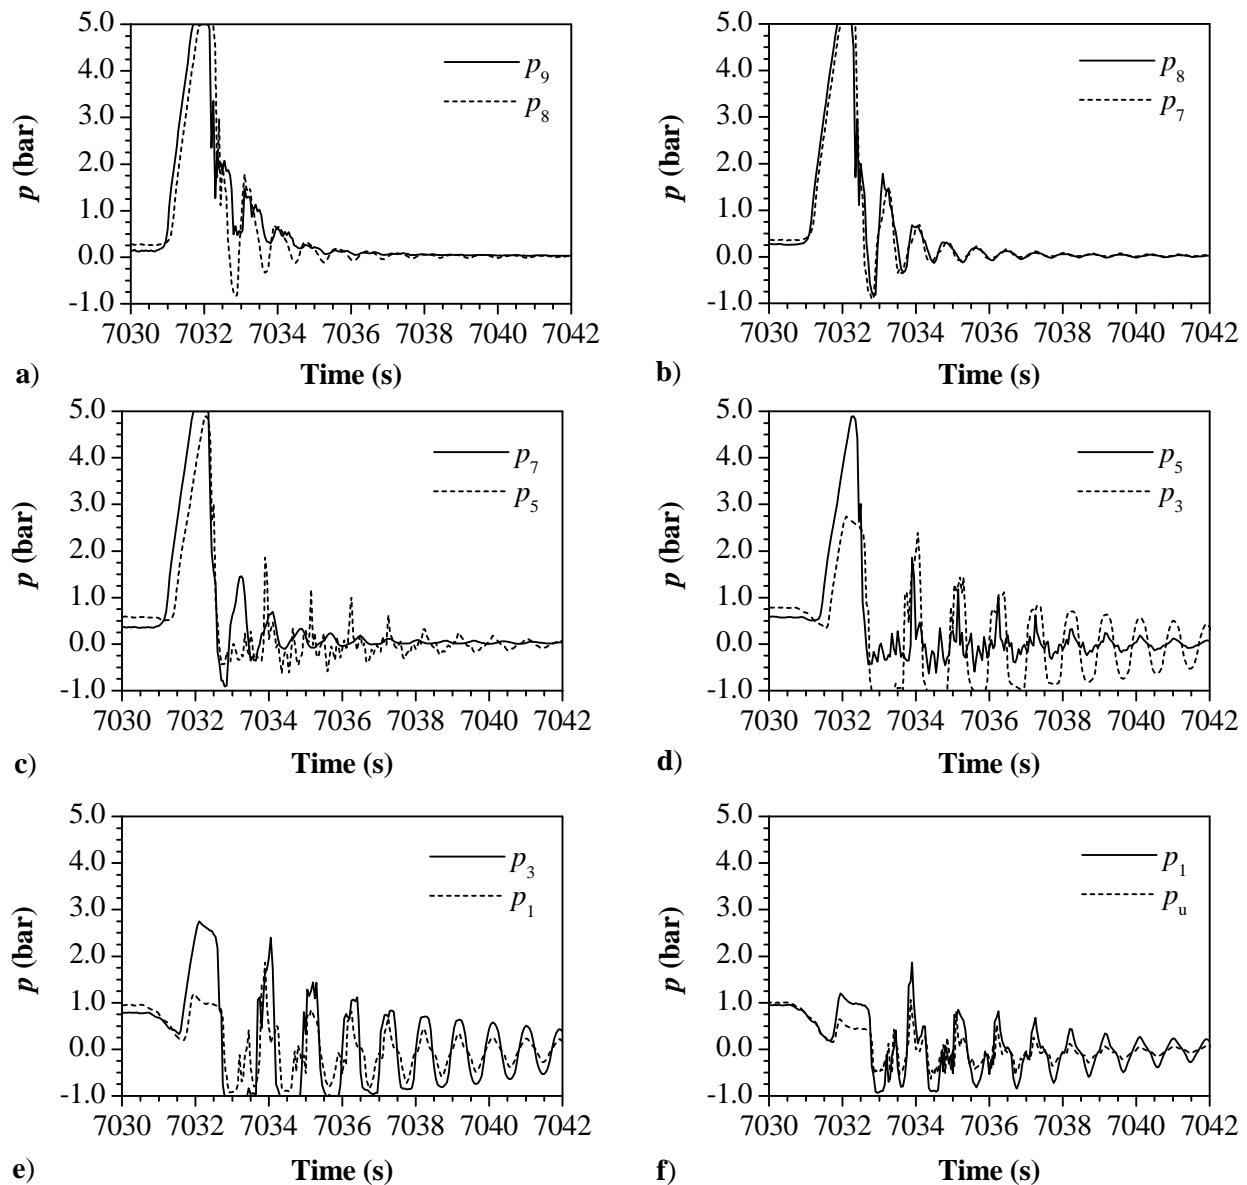
Figure 9 shows pressure histories at different positions along the PVC pipeline. From these graphs one can deduce that there were two major pressure waves in the accident: the pressure upsurge that was travelling in the upstream direction from the control valve at the outlet of the pipeline and the pressure downsurge that was travelling in the downstream direction from the control valve at the upstream end tank. Based on these recordings one may conclude that such pressures are possible only if both valves were closed almost simultaneously. The pressure upsurge travelling upstream caused damage to the piping system at various locations. Upsurge and downsurge were superimposed when they met and this is evident from the figures. Figures 9a to 9c show that pressure peak was cut off at 5 bar. This is because experiments with expected maximal pressures well below 5 bar were performed (the set maximum for the recorded pressure signal). Extrapolation of the gradient of the rising and dropping pressure gives a rough estimate of the maximal pressure p_9 close to the outlet of the PVC pipe of about 7.5 bar (Fig. 2); however, the Joukowsky pressure rise [10] in the PVC pipeline based on the initial flow rate would be approximately 10 bar. The difference between estimated actual maximal pressure and the rough theoretical estimation is attributed to the large deformations and leakages and not to viscoelastic damping. It is worth to mention here that the PVC part of the experimental

test rig was designed to withstand a maximal pressure of 7.5 bar. Figures 9d and 9e indicate intense transient vaporous cavitation zones along an extended length of the PVC pipeline.

We may conclude that the incident was caused by a fault in an electronic conversion box due to power failure and this led to the actual closure of both automatic control valves as it is clear from the flow rate (Fig. 8b) and pressure traces (Fig. 9). The short power failure damaged the volt-current converter which sent signals to the valve actuators. Both valve actuators were motorized and 1 mA converter output corresponded to closed positions of the valves (the current converter box should always supply a current in the range 1 mA to 5 mA). Immediately after the accident a technician measured an output at the converter of 0 mA, indicating that the current converter box had broken down. This confirmed that in the case of loss of signal the valves close.

Figure 9: Gauge pressures in water pipeline during the accidental event.
