# Failure Mode Analysis of an Exeter Stem Fracture Initiated at the Introducer Hole: Time for a Design Change?

## Case report

Ralph M. Jeuken, MD <sup>a, b, \*</sup>, Duncan P. Fransz, MD, MSc, PhD <sup>a</sup>, Marc G.D. Geers, PhD <sup>c</sup>,  
 Marc P.F.H.L. van Maris <sup>c</sup>, René H.M. ten Broeke, MD, PhD <sup>a</sup>

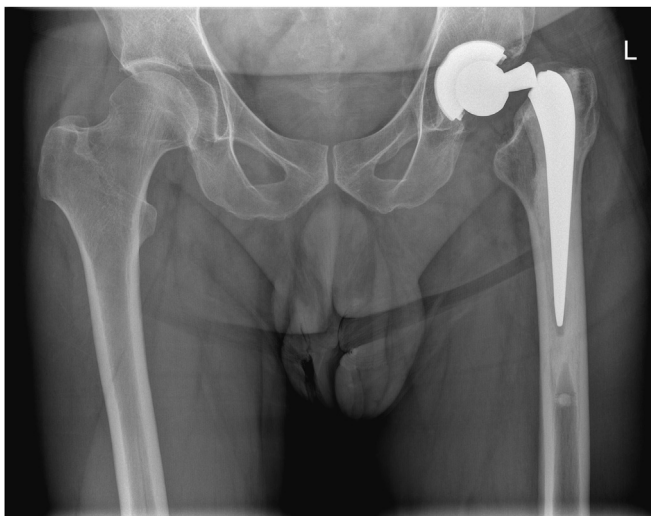
**Figure 1.** Anteroposterior pelvic plain radiograph showing the neck fracture of the cemented Exeter stem.

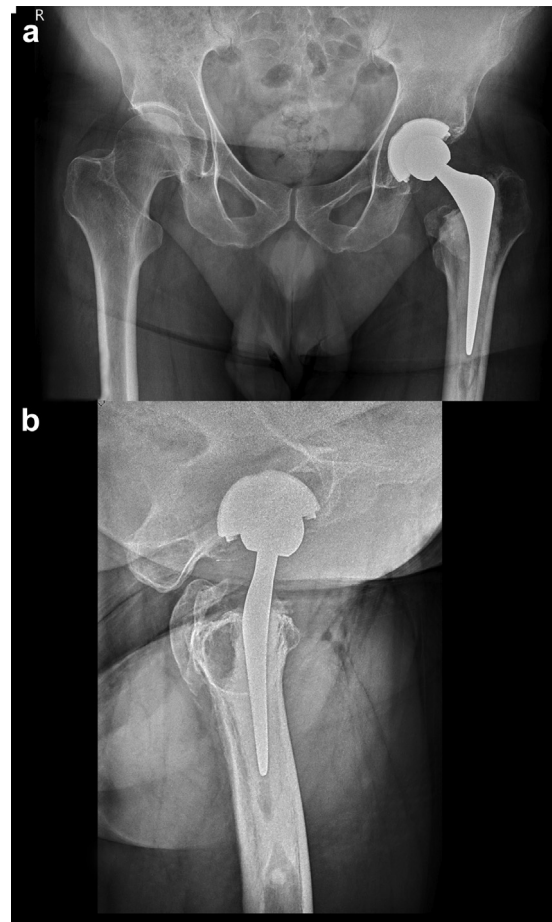
**Figure 2.** Plain anteroposterior (a) pelvic and lateral (b) hip radiographs after the revision surgery. Note the smaller implant compared to figure 3.

Intraoperatively, the *in situ* stem fragment appeared well-fixed without signs of loosening or infection. The proximal neck fragment and taper were well-engaged with the femoral head. The acetabular component had an intact rim with no signs of neck impingement, no local display of metallosis, and no evidence of eccentric wear of the polyethylene liner. The stem was removed without damaging the intact cement mantle. In brief, a hole was drilled (see the asterisk in Fig. 5) in the protruding shoulder of the Exeter stem which allowed the engagement of a clamp and linear explantation using a sliding hammer on the clamp. The femoral component was revised (cement-in-cement technique) using a smaller stem (Exeter 125-mm 44 offset, Biolox 32 + 0). No changes to the acetabular component were made (Fig. 2).

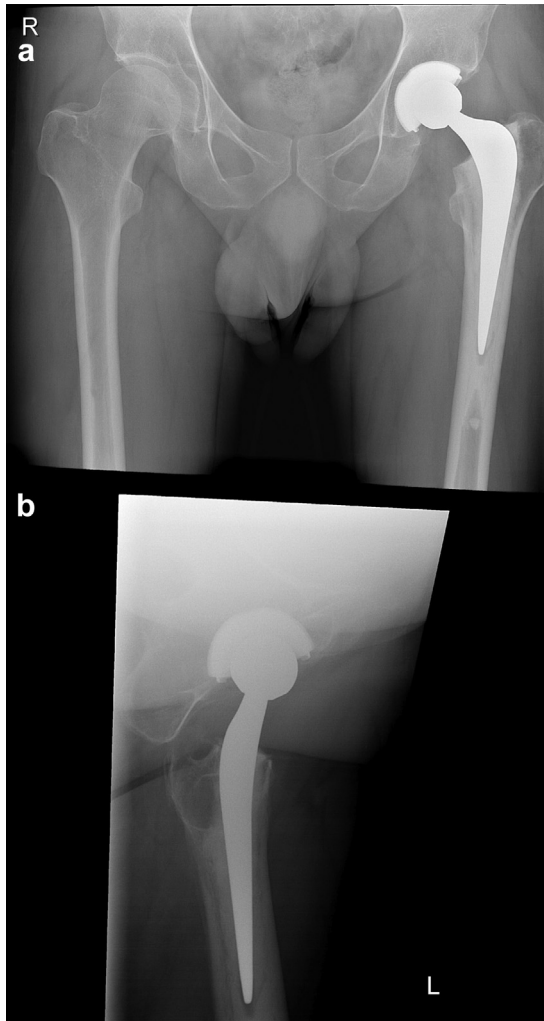
The direct postoperative radiographs of the index operation (ie, 5.5 years before the stem fracture) are shown in Figure 3. Radiological assessment showed neutral stem position, symmetric depth (no leg length discrepancy), and adequate integrity of medial support (medial cement mantle >2 mm and sufficient medial calcar bone stock). Two years after the revision surgery, the follow-up radiograph showed a Barrack type A cementing “white out” mantle with a central position of the prosthesis in both planes.

**Figure 3.** Plain anteroposterior (a) pelvic and lateral (b) hip radiographs of the index surgery showing Barack type A cementing “white out” mantle with a central position of the prosthesis in both planes.

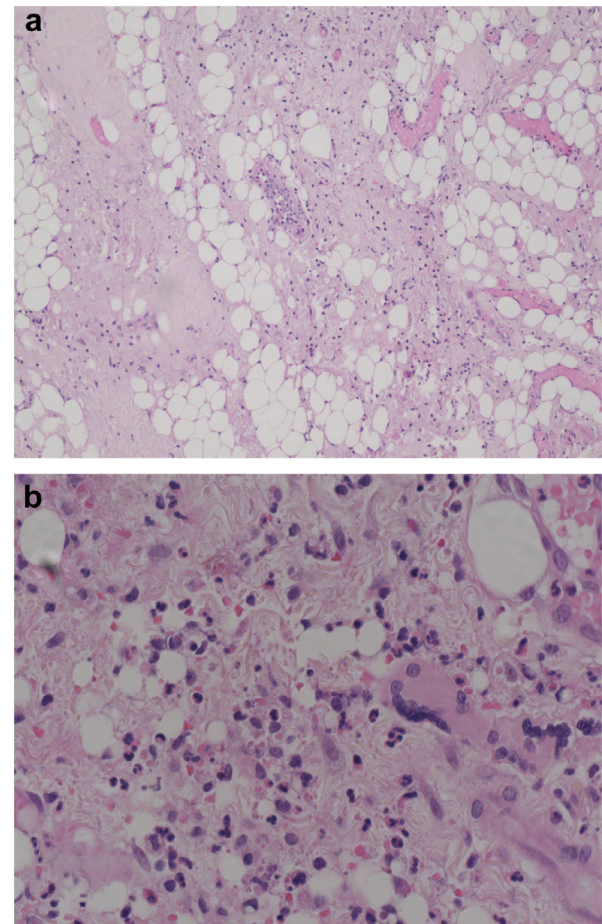
**Figure 4.** Standard hematoxylin and eosin-stained joint capsule slides at 10x (a) and 40x (b) magnification showing degenerative fibrinoid and congestive changes of the capsule and the presence of a moderate infiltrate of lymphocytes, neutrophils, and some eosinophilic granulocytes in between some nuclear debris.

Histopathology of the obtained capsule tissue (Fig. 4) shows degenerative fibrinoid and congestive changes of the capsule and the presence of a moderate infiltrate of lymphocytes, neutrophils, and some eosinophilic granulocytes in between some nuclear debris. A few giant cells are present; however, there are no metal particles.

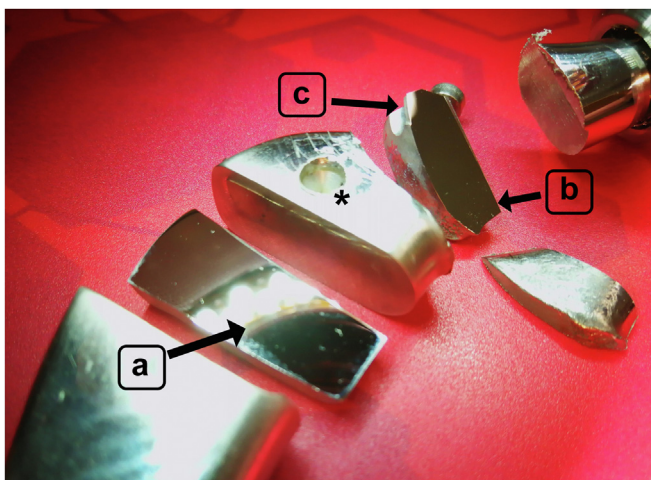
- A: at the stem away from the fractured surface;
- B: surface perpendicular to the initiated crack near the stud hole;
- C: surface perpendicular to the stud hole.

**Figure 5.** The explanted implant processed for further analysis. Samples were taken from 3 different locations: (a), at the stem away from the fractured surface; (b), surface perpendicular to the initiated crack near the stud hole; (c), surface perpendicular to the stud hole. \* Drilled hole to engage a clamp for explantation.

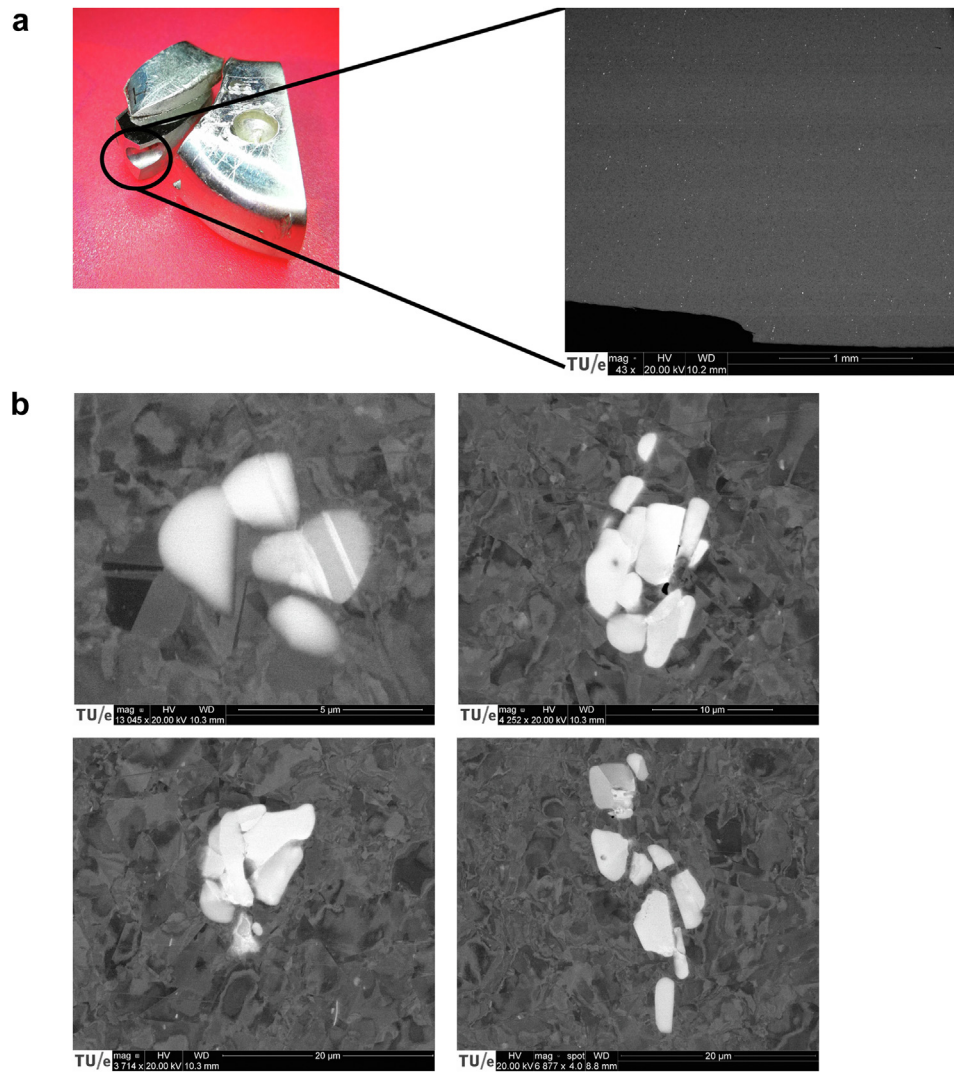
Cross-section B revealed white spots under the scanning electron microscope which appeared to be niobium (Nb)-rich phases on higher magnification (Fig. 6). Energy dispersive spectroscopy was used to identify the different elements with their compositional fraction of the metal alloy and were compared to the ISO standard. At cross-section A, most of the element fractions were in line with the expectations, except for carbon (C) and nitrogen (N), which clearly surpassed the ISO5832-9 specification (Table 2). The scanning electron micrographs and element mapping were also performed at Nb-rich locations (Fig. 7), revealing a higher concentration of N and, to some extent, also chromium (Cr). The C content in these regions is not given, as it is not accurate enough.

**Figure 6.** Scanning electron microscopy analysis of cross-section B (the surface perpendicular to the initiated crack near the stud hole) showing niobium (Nb)-rich phases (a) and on higher magnification (b).

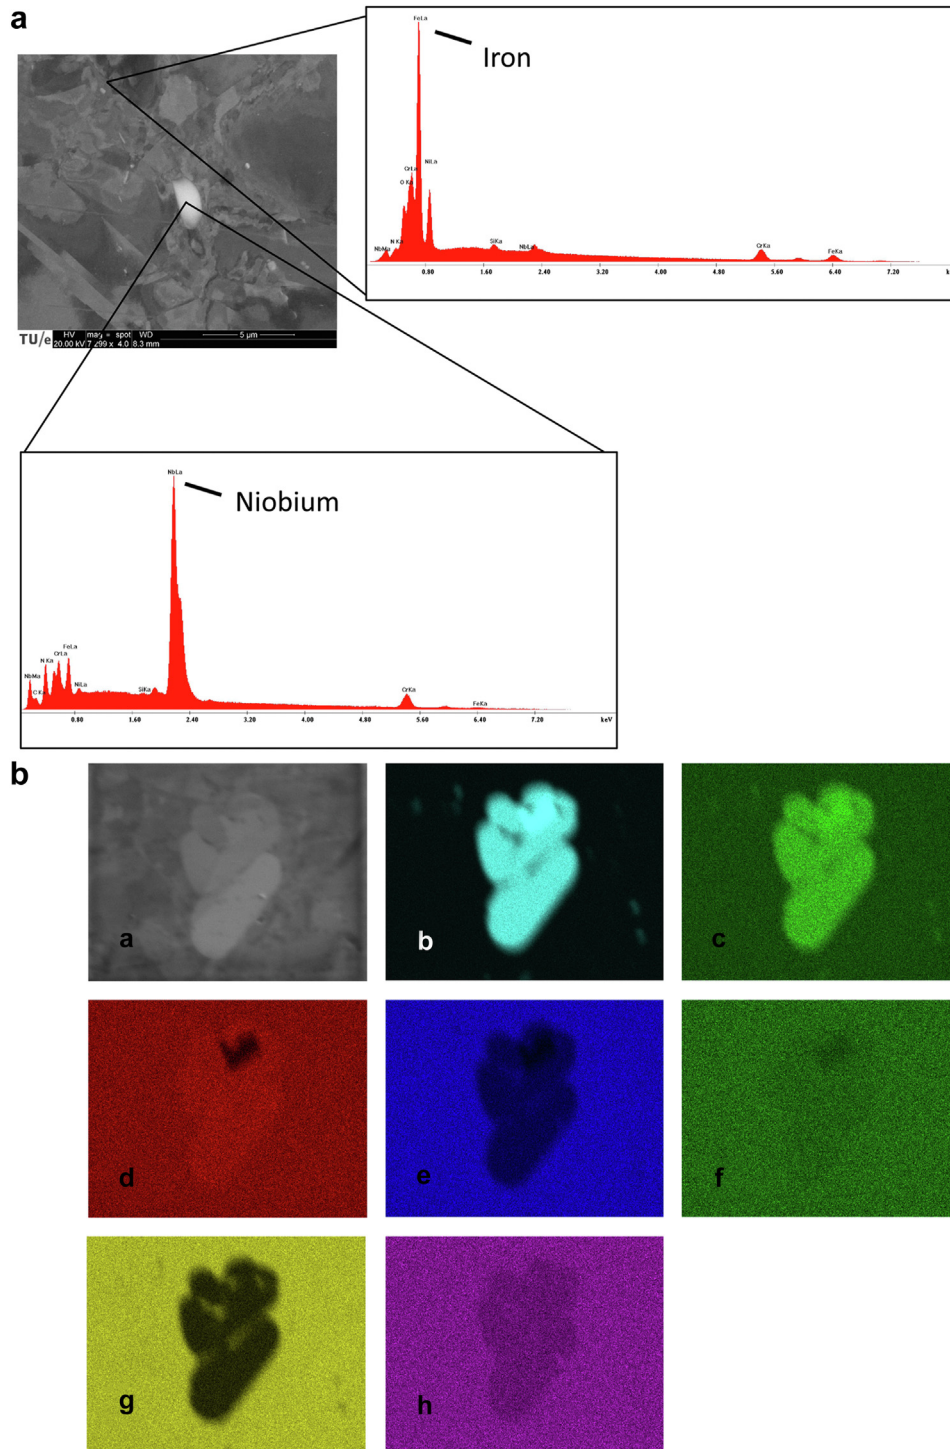
**Figure 7.** (a) Scanning electron microscopy image with elemental analysis at the indicated niobium-rich location (white particle) and at a control location outside the precipitate. The Nb-rich regions also reveal a higher concentration of nitrogen and, to some extent, chromium. (b) Element maps showing the concentration of elements in the Nb-rich phase (most likely CrNbN zeta phase) within the matrix (austenite). A, scanning electron microscopy overview; B, niobium; C, nitrogen; D, chromium; E, iron; F, manganese; G, nickel; H, silicon.

carbides. The addition of Nb to stainless steels is known to induce the precipitation of Nb carbonitrides, in different sizes and shapes [24]. The energy dispersive spectroscopy results indicate that the grain of the phase examined here was indeed Nb(C,N) precipitates. These precipitates have a high hardness.

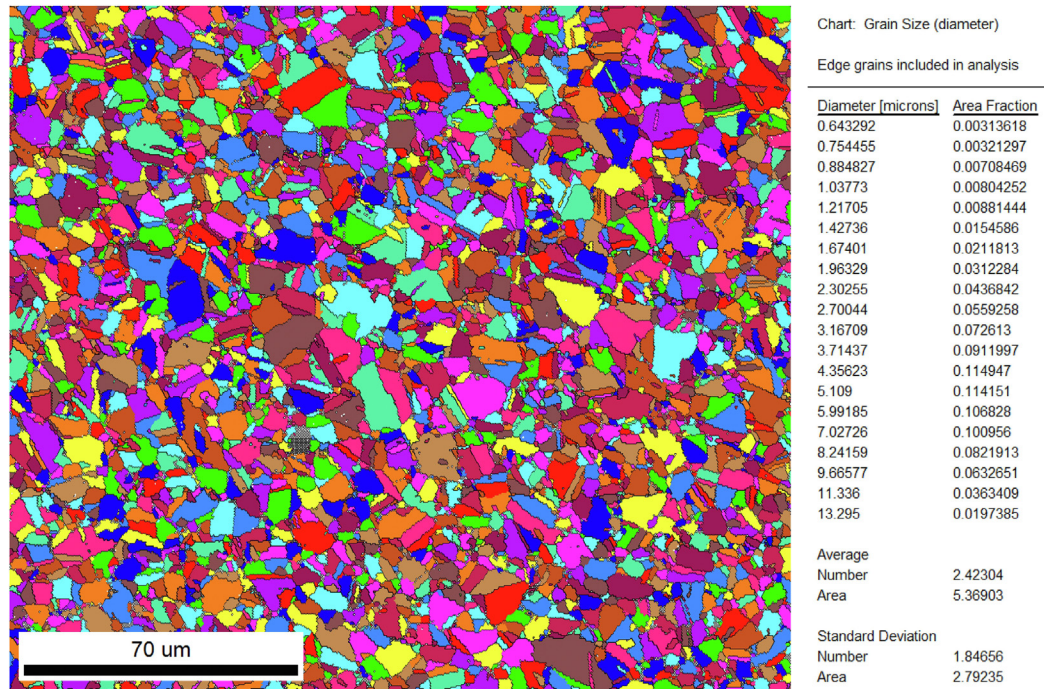
Orientation imaging microscopy was used at cross-section B to analyze the grain structure and orientation, allowing to visualize the microstructure of the base material (austenite). The average grain size was ~5 microns. The global microstructure was visualized using electron backscatter diffraction imaging (Fig. 8), whereby each grain is indicated with a separate color to distinguish it from its neighbors. The electron backscatter diffraction also revealed CrNbN Z-phases.

**Figure 8.** Grain size analysis using orientation imaging microscopy (colors only indicate the existence of the different grains).

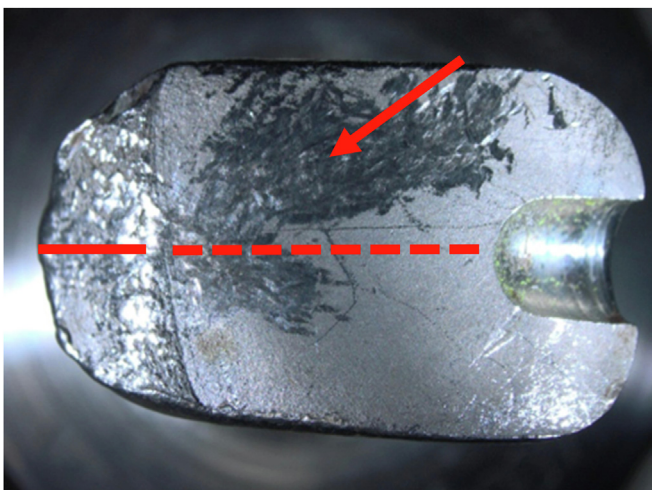
The fracture plane and the microstructure of the material in the fracture plane were initially assessed using stereomicroscopy. The fracture plane mainly consisted of a smooth surface with striations and beach marks, which are characteristic for fatigue failure. The residual crack surface was rough and dimpled, which is the surface where the prosthesis ultimately failed under loading. As the 2 stem parts were in frictional contact with each other, surface damage in the form of abrasions emerged (Fig. 9).

Beach marks and fatigue striations clearly indicate a fatigue failure mode [15]. A hole or crack in the surface of a metal results in a substantial increase of the stress level in the surrounding material. Hence, the combined presence of this microscopic fissure and the introducer hole is expected to be the prime cause of the fatigue “crack” initiation for this failure case [25,26].

**Figure 9.** View of the fracture plane. On the right is one half of the introducer stud hole. The dotted line entails the smooth fracture fraction with beach marks. The un-interrupted line is where the stem ultimately fractured. The arrow points to the abrasion marks due to the stem parts moving on to each other in vivo.

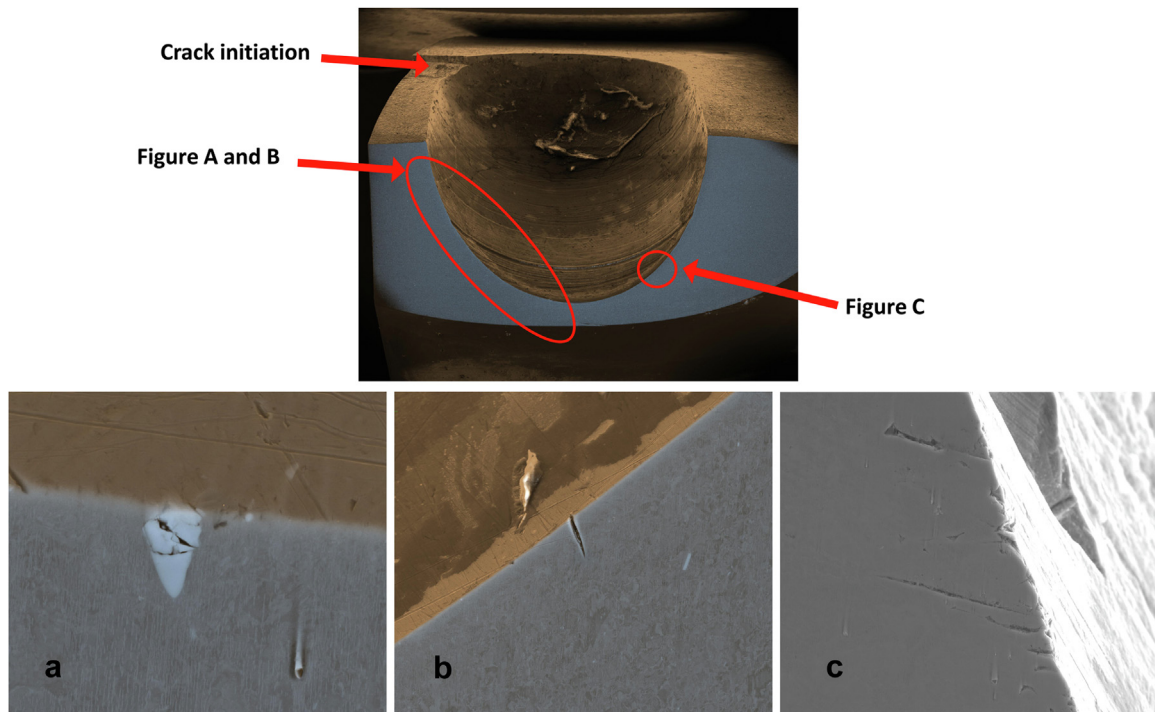
The introducer stud hole was further analyzed using secondary electron and backscattered electron analyses. The presence of multiple smaller cracks near the stud hole and near or at the Nb-rich precipitates was identified (Fig. 10).

The fractography revealed the presence of multiple smaller cracks near the stud hole and near or at the Nb-rich precipitates. The present study indicates that the manufacturing of the stud hole may well have induced these cracks, or at least initiated them. As the stem was removed by means of a separately drilled hole in the stem, the introducer hole remained untouched. We therefore postulate that cracks in the introducer stud hole were formed during the manufacturing of the prosthesis. Most likely, the Nb-rich precipitates (CrNbN zeta phase) are abrasively removed upon machining the stud hole, leaving behind regions of stress concentrations and tiny microcracks. These likely serve as initiators for fatigue cracking.

**Figure 10.** Fractography of the introducer stud hole. Colored scanning electron microscopy imaging combining secondary electron and backscattered electron imaging. (a) A clear example of a CrNbN phase — precipitate — at the edge of the stud hole with microcracks inside; (b) and (c) microcracks.

Moreover, the Exeter stem design consists of a lever-arm geometry. From a pure mechanical perspective, it is, therefore, remarkable that the relatively large introducer hole is manufactured at its current location where, provided that the stem is adequately cemented in the femur shaft, the bending moment is large. From a mechanical perspective, it would be relatively easy to propose a solution that does not entail such undesirable stress concentrations. For instance, future stem designs could reduce the normal stress due to the bending moment at the introducer hole by placing it more lateral, that is, at the wider part of the stem, such as with the small 30-mm cemented Exeter [27]. Another solution could be to reverse the engaging principle between the introducer and the hole: a protruding mounting piece on the stem instead of a hole. Although implant design changes would mandate costly and laborious amendments to regulatory bodies, they could prevent serious adverse events.
