# LONGYEARBYEN, SVALBARD - VULNERABILITY AND RISK MANAGEMENT OF AN ARCTIC SETTLEMENT UNDER CHANGING CLIMATE - A CHALLENGE TO AUTHORITIES AND EXPERTS

Erik Hestnes\*, Steinar Bakkehøi and Christian Jaedicke

Norwegian Geotechnical Institute (NGI), Oslo, Norway

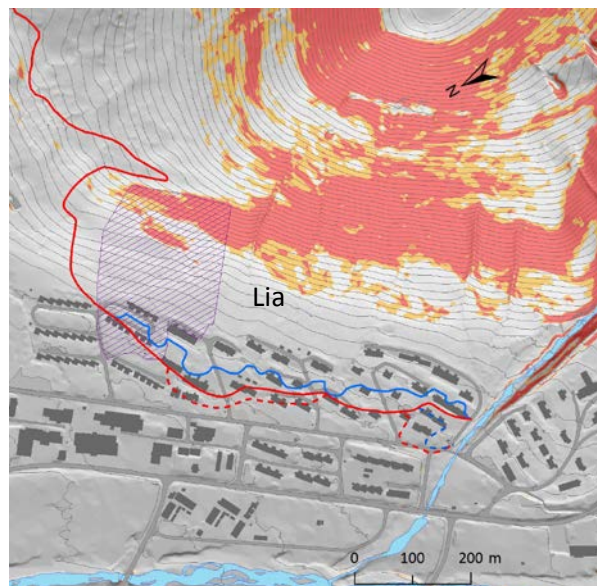
Fig. 2: Lia and Vannledningsdalen (right). The hazard zones of avalanches (red) and debris flows (red dotted). The disastrous avalanche 19 December 2015 (violet).

The catastrophic avalanche in 2015 stopped 25-60 m beyond the hazard zone based on the experience and runout models available in 1992. The registered runout coincides well with back-calculations based on today's knowledge and models (Fig. 2). The  $\alpha$ -angle was approximately 16°, not a surprising value in Arctic environments.

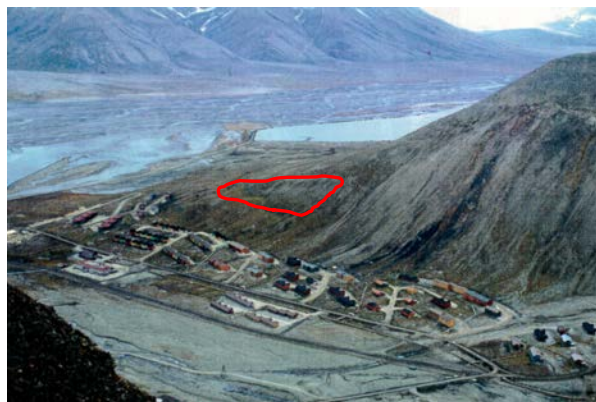
Fig. 3: Lia. The SE wind is coming from the valley in the background and is mainly depositing snow in the low hillside above the houses to the left. Photo E. Hestnes

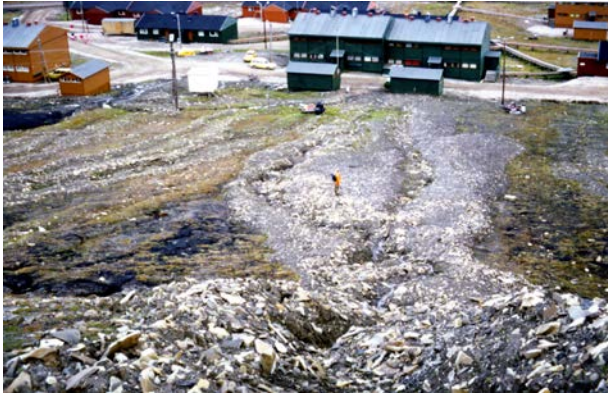
and Lied 1991, Hestnes and Bakkehøi 2003, Vogel et al. 2012). The size and frequency of debris flows depend on the weather conditions, the depth and texture of the *active layer* and the soil-water content at the time of release (Fig. 4).

Fig.4 Houses in road 226 are built on old debris and debris deposited in 1972, and hit by a debris flow in 1981. Photo E. Hestnes.

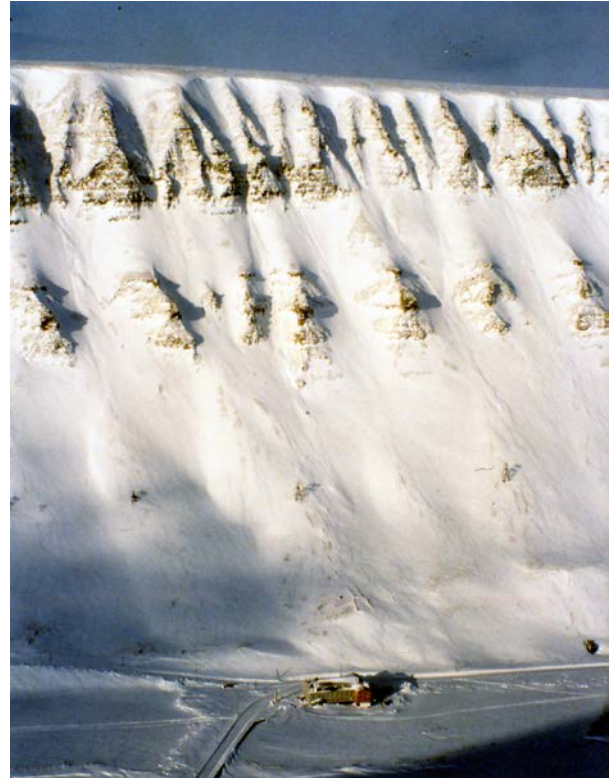
*Rockfall* from the steep cliffs is frequent. So far, it presents a problem primarily to cableways and constructions by the adits below the cliffs on both sides of the valley, the community centre and restaurant, as well as the road on the western side (Fig. 5). If the permafrost horizon shrinks as predicted, *rockslides* from these cliffs might become a critical hazard in the future.

Fig. 5 The community centre and restaurant Huset is exposed to avalanches and rockfall. Cornices are built along the rim. Rockslides might be a future problem. Photo E. Hestnes.

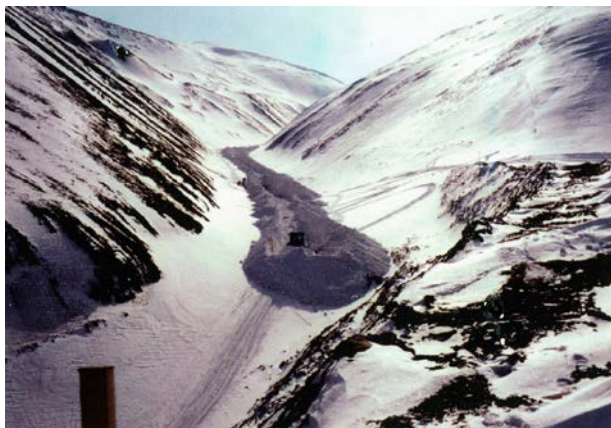
Fig. 6 Opening of the drainage channel in Vannledningsdalen by bulldozer before periods of runoff. Photo E. Hestnes

has been missing, except for the contribution by SNSK to the safety of the Haugen area against slushflows (Fig. 6). Finally, at the end of 2013, the Norwegian government decided to incorporate Svalbard in the national all-around settlement of financial support for hazard evaluation and safety measures.

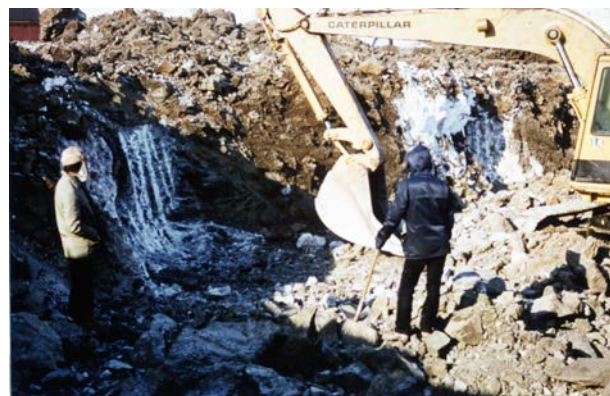
Detailed mapping of periglacial processes documented consequences to buildings and infrastructure, and ice wedges and large lenses were found to constitute a critical foundation problem (Fig. 7). Gelifluction and creep within the housing area have been monitored by inclinometers, and thermistor strings to a depth of 75-100 m in Longyearbyen and Svea have recorded changes in temperature (Lied and Hestnes 1986, Bakkehøi 2005). Problems related to periglacial processes will accelerate as the depth of the active layer increases.

Fig. 7 Large ice-wedges in a foundation cavity on road 232. Normally traceable by ground inspection. Photo O. Gregersen

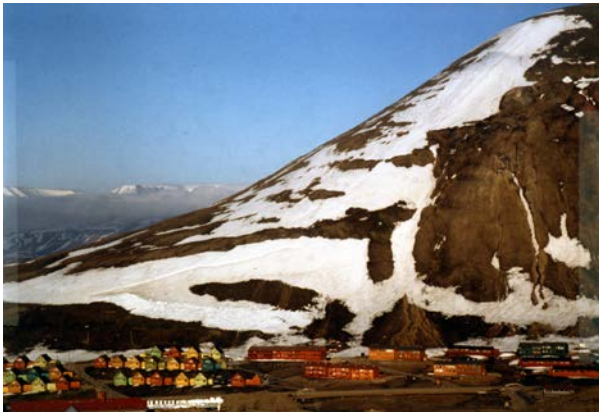
Fig. 8 Avalanches do occur almost every year in this part of Lia. This one was released 5 April 1991. Photo E. Hestnes (12 June 1991).

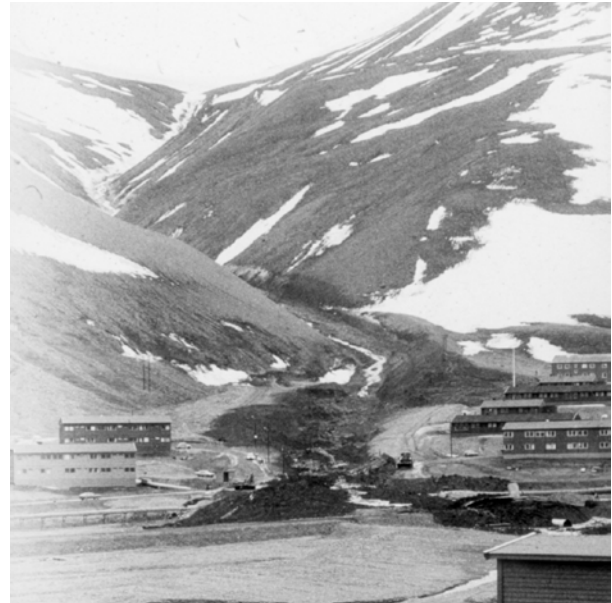
On 14 June 1989, just five months after the reorganization of the coal company (SNSK), a small slushflow from Vannledningsdalen hit the Haugen area damaging one house, and destroying the main water and heating pipes. NGI offered straight away our service to the new community administration, knowing from experience that many houses were at risk and that the existing protection measures were mismanaged (Figs. 9a-b). As a consequence, a wide variety of practical problems related to rapid mass movements and drifting snow were dealt with during the early 1990s, including establishing routines for handling acute problems and evacuations (Hestnes 1993). NGI has later on complemented and extended previous work, and private developers and enterprises have been served as well.

Fig. 9a The small slushflow 14 June 1989 climbed the old guiding dam and damaged a private home. It went on to the floodplain breaking the water and heating pipes and closing three roads. Photo K. Anthonsen

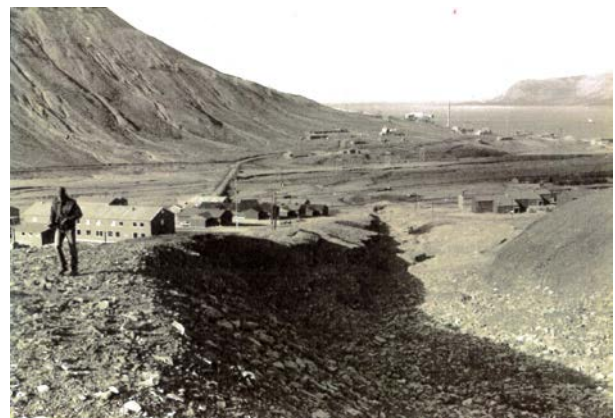
Fig. 9b The guiding dam in August 1987. The channel filled with debris and water has undercut the side. The channel and dam are maybe not maintained since construction in 1953. Photo K. Lied

Mitigative measures against slushflows from Vannledningsdalen have been a recurrent question, especially in land-use planning. In 1990, NGI recommended guiding dams in the runout zone and stabilizing the snowpack in the flat basin up-valley by strong wire-nets. Due to lack of financial resources, the community had to carry on opening the drainage channel by bulldozer before the melting season in May (Fig. 6). A review of the established routines in 1994 showed no failure vis-à-vis meteorological data over the last 38 years, but human negligence had resulted in slushflows in 1960 and 1989. NGI recommended an important supplement to those routines, expressing: *If the weather forecasts indicate potential hazard earlier in the winter season, opening of the channel will be carried out.* Already the following year, a critical rain-on-snow event occurred in December, and such events have occurred many winters after the turn of the century. The most recent destructive slushflow occurred on 30 January 2012 (Hestnes and Bakkehøi 2012). Since then, the local community has planned permanent safety measures as advised by NGI in 1990. The construction plans are now completed, but financial support is still missing.

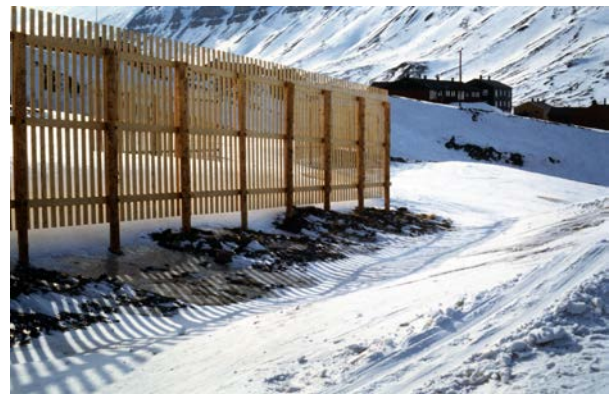
Snow fences were considered in 1990-1992 for reducing cornice formation and accumulation of snow in the most critical starting zones. In the same period, plans for using fences and redesign of roads to reduce problems with snowdrifts in doorways, on service roads and roads were drawn. The plans that have been implemented have proved successful. The established fences are with vertical boards to prevent children from using them as climbing frames. However, the builder did not take the indicated wind loads into consideration, so the constructions had to be strengthened after partial failure (Fig.11).

Fig.11 Snow fence before strengthening the construction and adjusting the ground clearance. Photo E. Hestnes

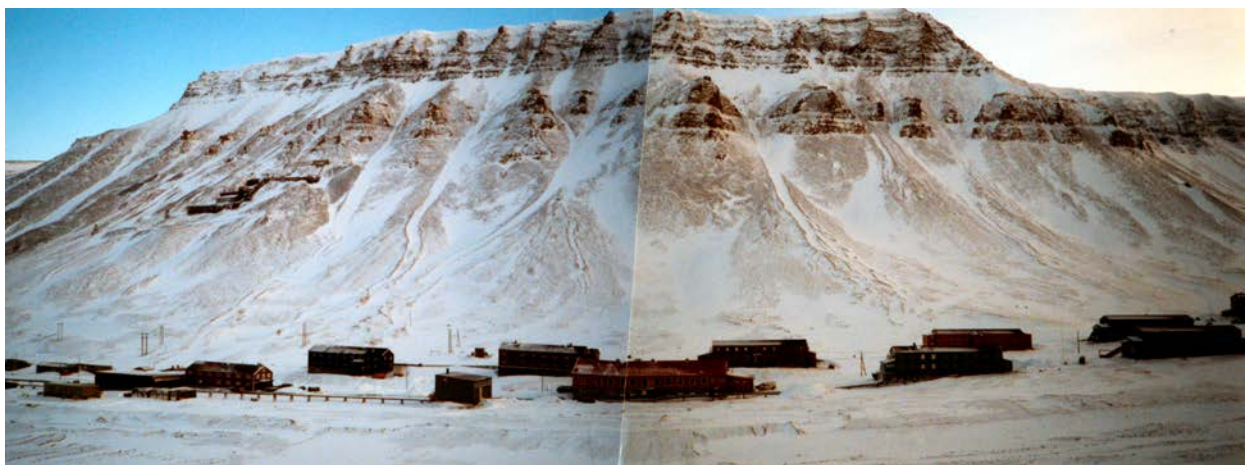
Safety measures against avalanches and debris flows have been on the agenda since 1990. A few plans are completed, others set apart. Routines for controlled release of cornices from the rim above Nybyen, as SNSK had done when the mine below was in operation, was promptly dismissed as unfit for use (Fig. 10, Hestnes and Lied 1991). The catastrophic event in December 2015 has renewed the

Fig.10 Nybyen 27 February 2003. Mid-winter and very little snow. Only small cornices along the rim above. The starting zones and paths for avalanches and debris flows below the rim are easily observed. Rockslides might be a future problem. All houses are within the hazard zone. Photo E. Hestnes
