# INVESTIGATION INTO MAGNETIC DRIVE SEALLESS PUMP FAILURE 3 FLARE GAS RECOVERY UNIT (FGRU)

## ABSTRACT

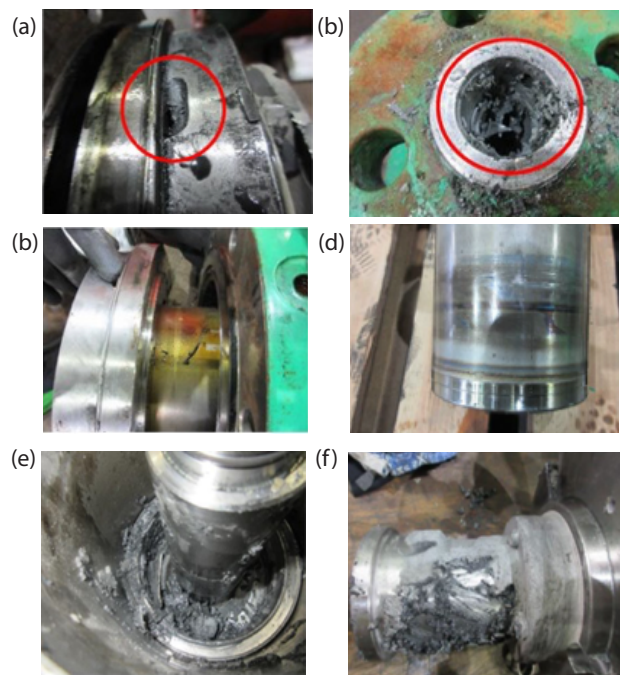
The investigation found that the internal flushing or internal lubrication flow line was clogged with process solid particles. This caused lubricant starvation and loss of cooling to the pump's internal parts. The absence of lubrication had increased friction which caused the mating surfaces to seize. The pump containment shell showed external burnt marks and rubbing, and the bushings were found damaged. In fact, it was supported by the temperature records on the containment shell, which displayed an increase of normal temperature of 60°C to a high of 103°C. Figure 2 shows the extent of damage to the pump's internal parts.

**Figure 2** (a) Clogged flushing line (b) Process particles (c),(d) Burn mark on containment shell (e),(f) bushing damages

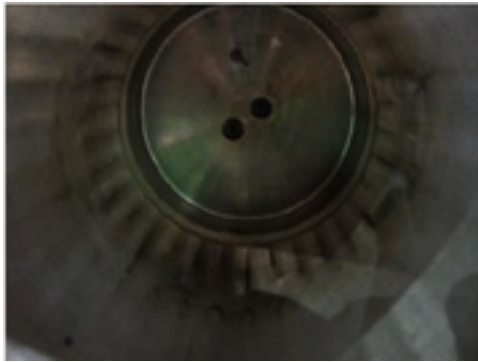
The damage was enhanced with the expanded Outer Magnetic Ring (OMR). The bearing housing could not be removed because the OMR expanded and seized with the bearing expanded & seized with bearing housing and shell containment. Figure 3 shows the expanded OMR.

**Figure 3** Expanded Outer Magnetic Ring (OMR)

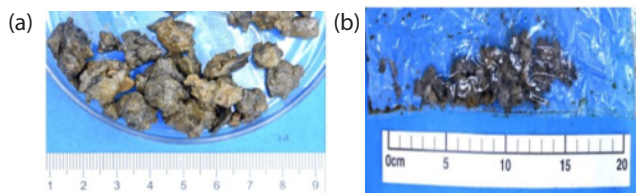
In addition, further analysis of the filtered particles found a few types of particles that caused the clogging of the flush line. Figures 4a and 4b shows images of particles collected at the pump's strainer. The debris consisted of moist dark and light brownish lumps and had an alkaline pH of 9.5. It contained mainly carbon, oxygen, sulphur and calcium, with other elements such as aluminium, manganese, iron and strontium. The compounds detected contained mainly calcium carbonate (aragonite) with a small amount of calcium carbonate (calcite), iron sulphate hydrate (rozenite) and iron oxide (maghemite).

**Figure 4** Particles collected at the pump internal and filter

Based on X-Ray Diffraction analysis, as shown in Table 1, the deposited solid particle found at the damaged sealless pump was rich in calcium carbonate. The

The origin of calcium ions could only be identified in the service water stream from the upstream process. In this case, the stream acted as a liquid ring at the upstream Liquid Ring Compressor and make-up water at 3-Phase Separator Vessel. It was found that the 3-Phase Separator Vessel level had reached a high level (100%), consequently showing high-level build-up (91%) at the downstream Amine column. This indicated a high potential for service water-carryover to the Amine Column. The liquid in the column was then pumped by the two FGRU mentioned above, Rich Amine Pumps, with one pump operating continuously and one on standby. Therefore, by examining these facts, the contamination of the water that resulted in the calcium carbonate-rich solid particle generation that clogged the magnetic drive pump's flushing and cooling line might have been the true cause of the failures.

Although sealless pumps are the way to prevent mechanical seal leaks and lower emissions of greenhouse gases (GHGs) into the environment, they have some drawbacks. The following lessons learned should be considered when selecting a sealless pump for the refinery hydrocarbon application during the project design phase to prevent similar failures in the future. The selection of a sealless pump should only be considered for clean processes and liquid services, such as exporting the final HC product and the base oil plant. During the design stages, the pump datasheet must specify the size and concentration of allowed solid particles in the pumping liquid. To ascertain the solid's size and concentration, a sample of the process liquid must be taken and analysed at a defined interval. The sealless pump should be designed to accommodate

a duplex filter for the internal flush system to reduce the risk of particle contamination further. Additionally, a differential pressure gauge or indicator must be designed and installed across the duplex filter for routine field operator monitoring. The operator will be notified when particles begin to build up inside the duplex strainer due to this increase in differential pressure. A temperature sensor must be installed in the pump isolation or containment shell for high alarm and high-high trip protection. The pump will trip whenever the temperature exceeds the normal range, preventing further damage. After the investigation and major pump repair were finished, these suggestions were incorporated and implemented in the Fuel Gas Recovery system. The pumps have normally been operating thus far, with neither a single nor any failures recorded.
