AN ANALYSIS OF CATALOGED DECEMBER 2020 LANDSLIDES NEAR HAINES, ALASKA

Geological Engineering

University of Alaska Fairbanks

May 2023

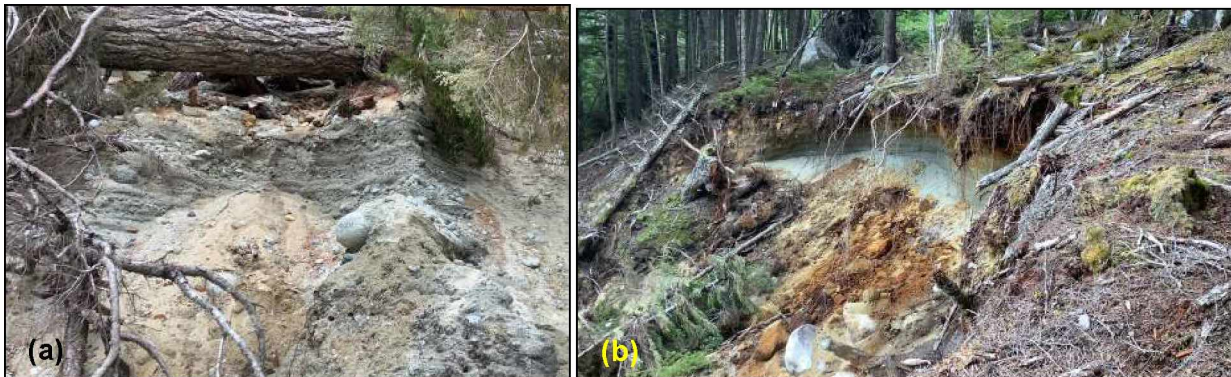
Figure 16. Photographs of the VP sand flow slide (June 2021) showing: (a) stratigraphy exposed in the left flank at the slope base, showing alternating fine and coarse sand layers with interspersed gravel and cobbles; (b) the head scarp, as seen from the left flank, with iron-cemented sand both intact beneath the organic mat and loose on the slope.

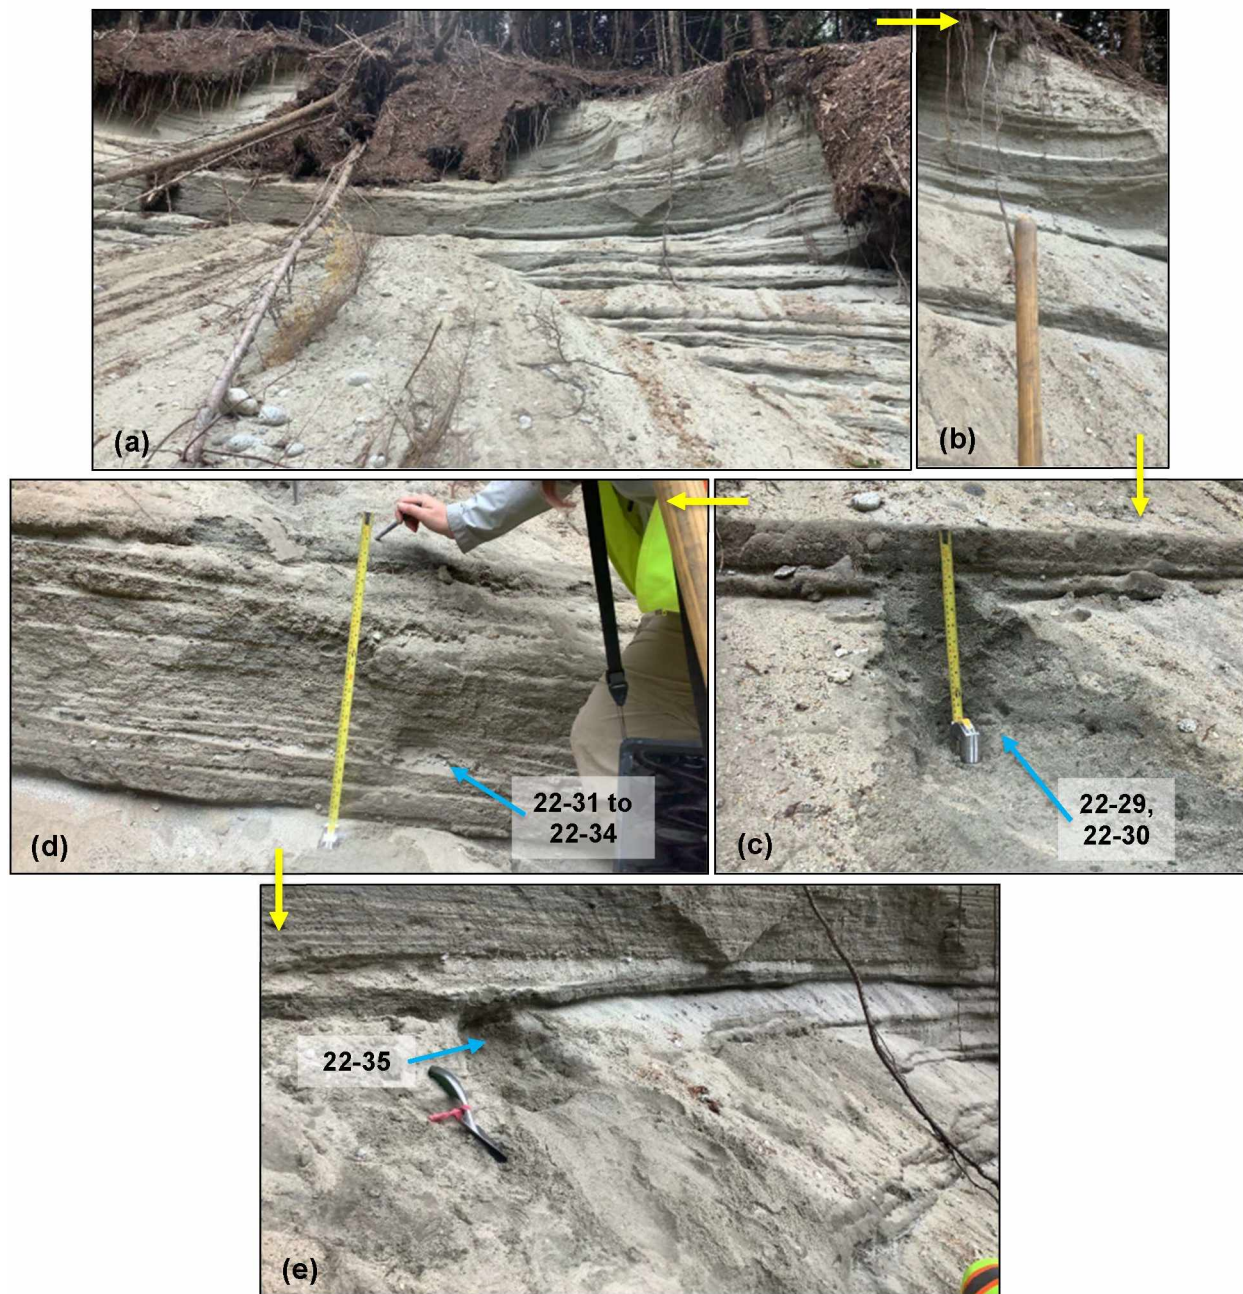
Soil Stratigraphy: Refer to figure 19 for photographs illustrating the overall stratigraphy; the average thicknesses were 5 cm for the fine-grained layers and 10 cm for the coarse observed throughout the deposit. We also observed coarse-grained layers with gravel and cobbles throughout the deposit.

Figure 19. Photographs of the FP sand flow, taken in sequential order (see yellow arrows) starting from the head scarp and moving downslope (July 2022): (a) head scarp area near the left flank, with fine-grained and coarse-grained sand; (b) continuation of stratigraphy directly below the extent of (a), illustrating the coarse-grained sand as a “slope-forming unit” and the fine-grained sand as a “cliff-forming unit;” (c) approximately 0.5 m below the extent of (b), we sampled a 6.5-cm thick fine-grained / 30-cm thick coarse-grained sequence (samples 22-29 and 22-30); (d) directly beneath (c), a 58-cm thick sequence of fine-grained (avg. thickness 3.0 cm) and coarse-grained (avg. thickness 1.5 cm) sand, from which samples 22-31 through 22-34 were taken; (e) 1.5 m to the right of (d) was a less-disturbed exposure of fine-grained sand layers (each approximately 5-cm thick), from which we sampled 22-35; sample 22-36 was collected from a coarse-grained layer just below the extent of (e).

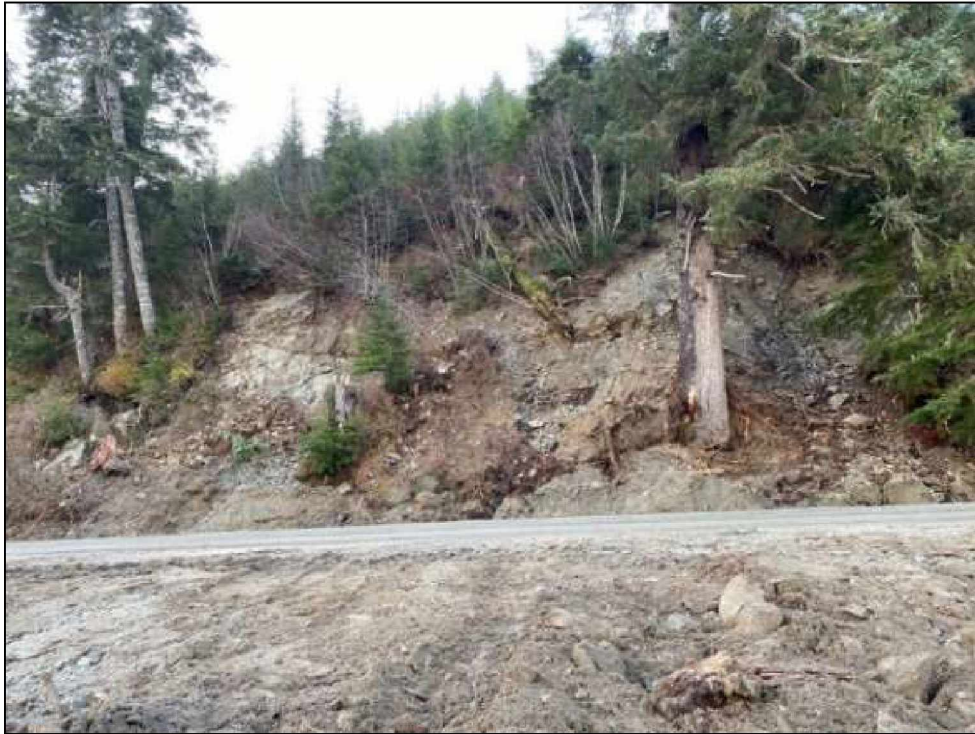
Site Description: ADOT&PF (2020) reported a full blockage of Lutak Road in December 2020 and noted that the landslide had exposed the rock face (fig. 40). Between 100 and 200 cubic yards (70–150 cubic meters) of debris moved as part of this landslide (ADOT&PF, 2020).

Figure 40. View of slope failure at FEMA DOT#24 from Lutak Road in December 2020, post clean-up (photograph courtesy of ADOT&PF).

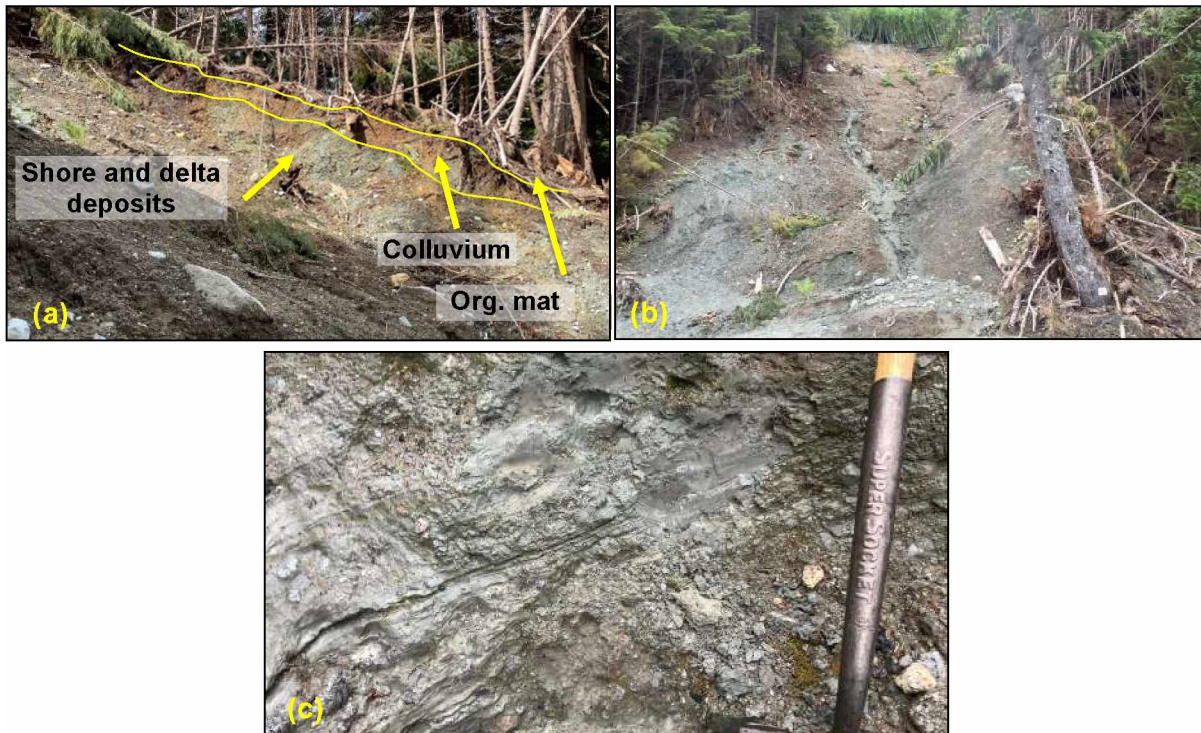
Site Description: At this site, a landslide initiated below a logging road, occurring in colluvium and elevated shore and delta deposits (Lemke and Yehle, 1972; fig. 47). This landslide blocked both lanes of Lutak Road (ADOT&PF, 2020). We observed layering in the silty soil, expressed both as alternating light and dark layers and as coarse- and fine-grained textures. This layering may represent seasonal deposition.

Figure 47. Photographs of FEMA DOT#27 slide area: (a) the left flank with annotated stratigraphy (June 2021); (b) looking up to the head scarp from Lutak Road (June 2021); (c) stratigraphy in the creek flowing down the slide path, showing light and dark layers (July 2022).

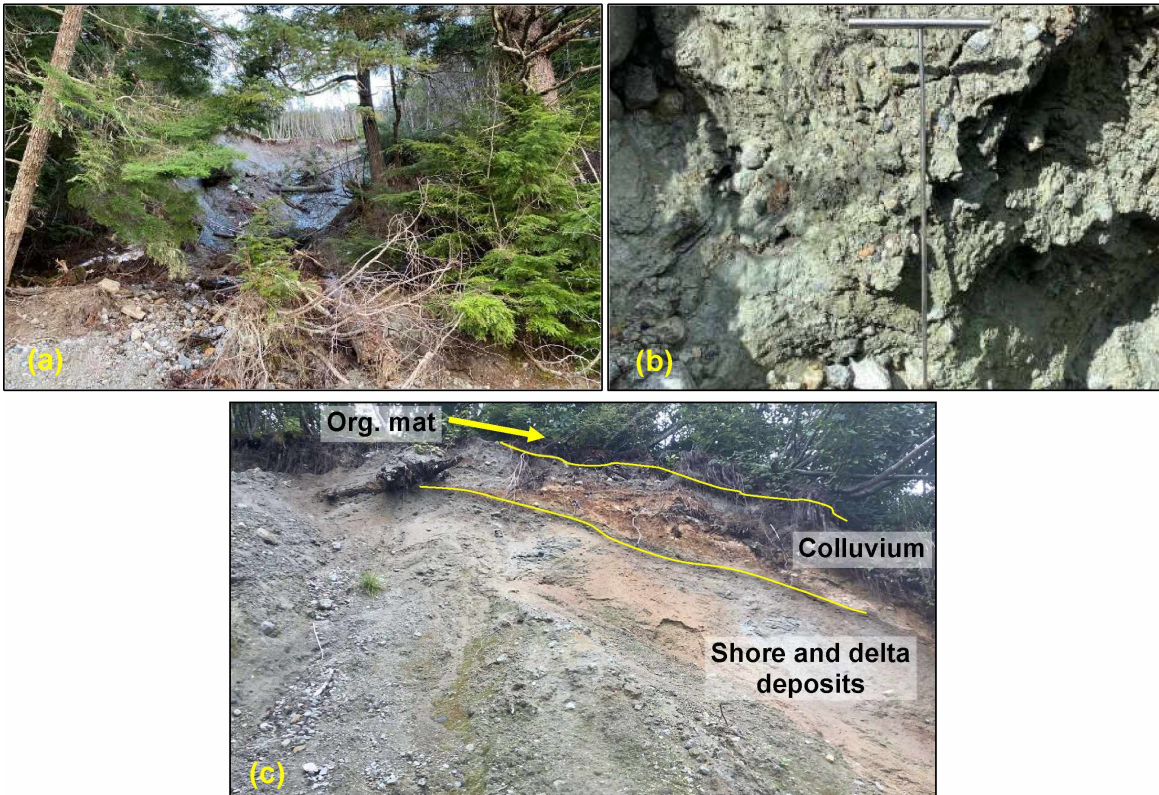
Site Description: The landslide at this site initiated below a logging road; a culvert outlet is exposed in the head scarp. The landslide occurred in colluvium and elevated beach and delta deposits (Lemke and Yehle 1972; fig. 50), and deposited several hundred cubic yards/meters of debris, blocking Lutak Road (ADOT&PF, 2020). We observed stratified silty sand with gravel in the slide area, along with cobbles and boulders up to 1 m in diameter. We also observed slabs of intrusive igneous rock (diorite, approx. 1 m by 0.1 m by 0.6 m) in the debris along the small drainage running through the landslide.

Figure 50. The FEMA DOT#28 landslide along Lutak Road: (a) view up to the head scarp in December 2020 (photograph courtesy of ADOT&PF); (b) silty sand with gravel exposed beneath the colluvium layer (June 2021); (c) sharp contact visible on left flank between colluvium and the underlying beach and delta deposits (July 2022).

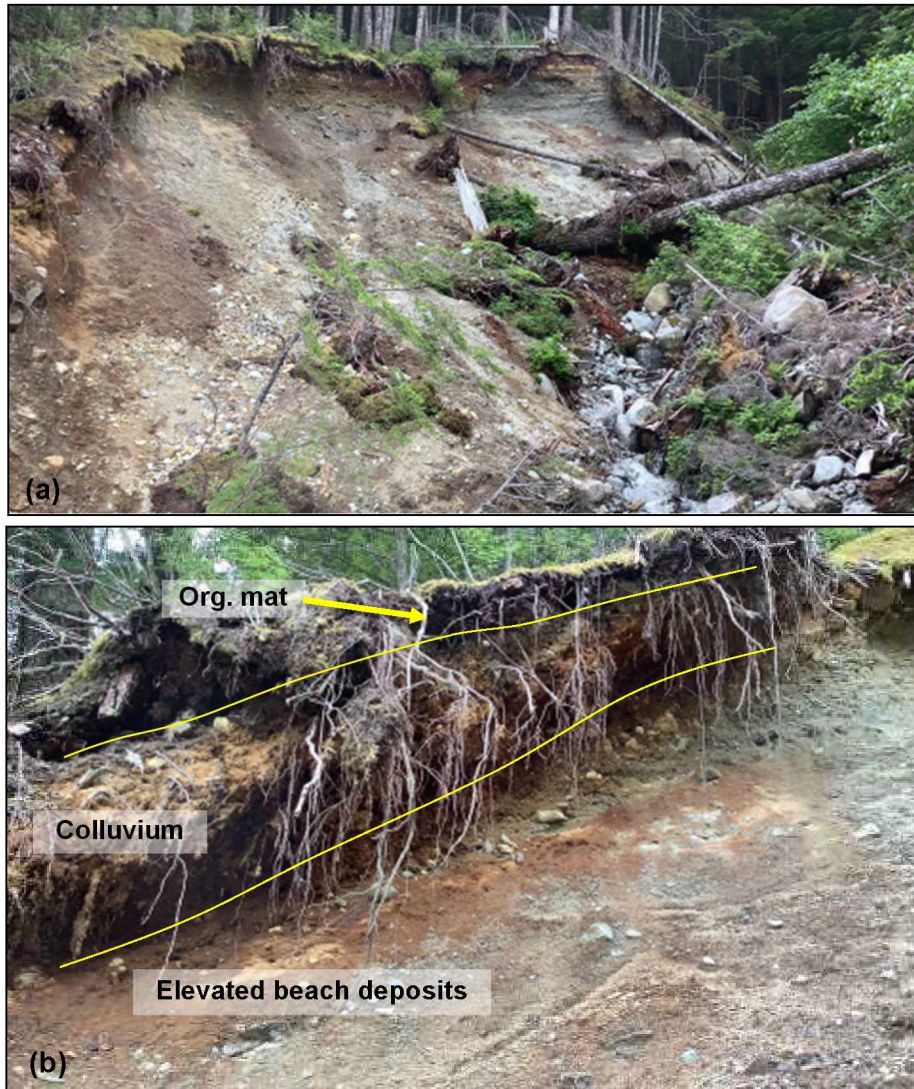
Site Description: ADOT&PF (2020) estimated removing several hundred cubic yards/meters of material from this area, and that the slope failure likely occurred on the right stream bank. Observations made during the 2022 site visit also support this conclusion (fig. 67).

Figure 67. Photographs of the FEMA DOT#36 area (in June 2021): (a) the channel and head scarp area; (b) annotated view of stratigraphy visible within the right flank.

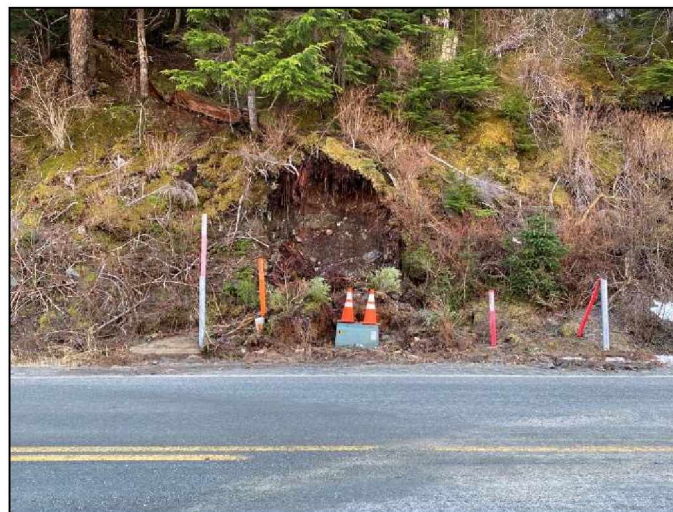
Figure 69. View of the failure at FEMA DOT#37 from Lutak Road (photograph courtesy of ADOT&PF).

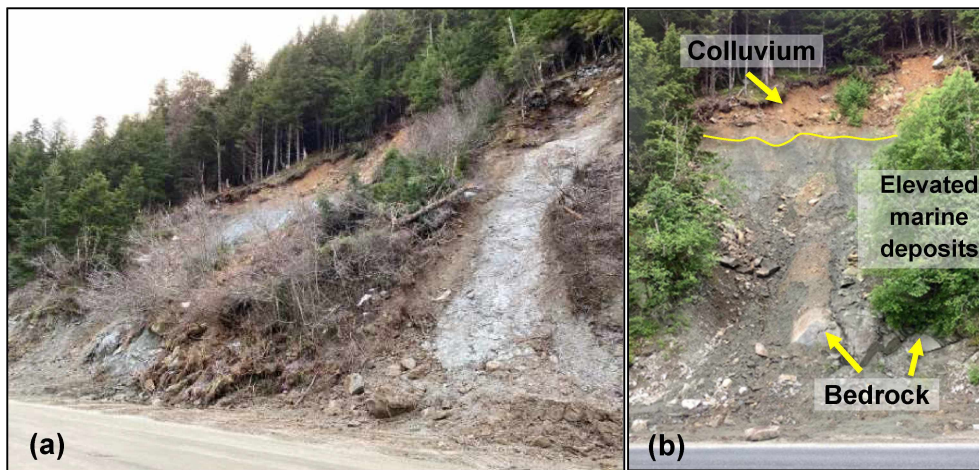
Site Description: ADOT&PF (2020) indicated approximately 50 cubic yards (38 cubic meters) of rock fall at this location, which was mostly contained within the uphill ditch. We observed that soil along the head scarp and flanks was being held in place by tree roots (fig. 77). ADOT&PF (2020) noted there was a “hazard tree” 50 ft (15 m) uphill from the road that was undercut by the failure.

Figure 80. Views of the affected area at FEMA DOT#42: (a) extent of failure in December 2020 (photograph courtesy of ADOT&PF); (b) annotated view of debris slide area with exposed bedrock, in June 2021.

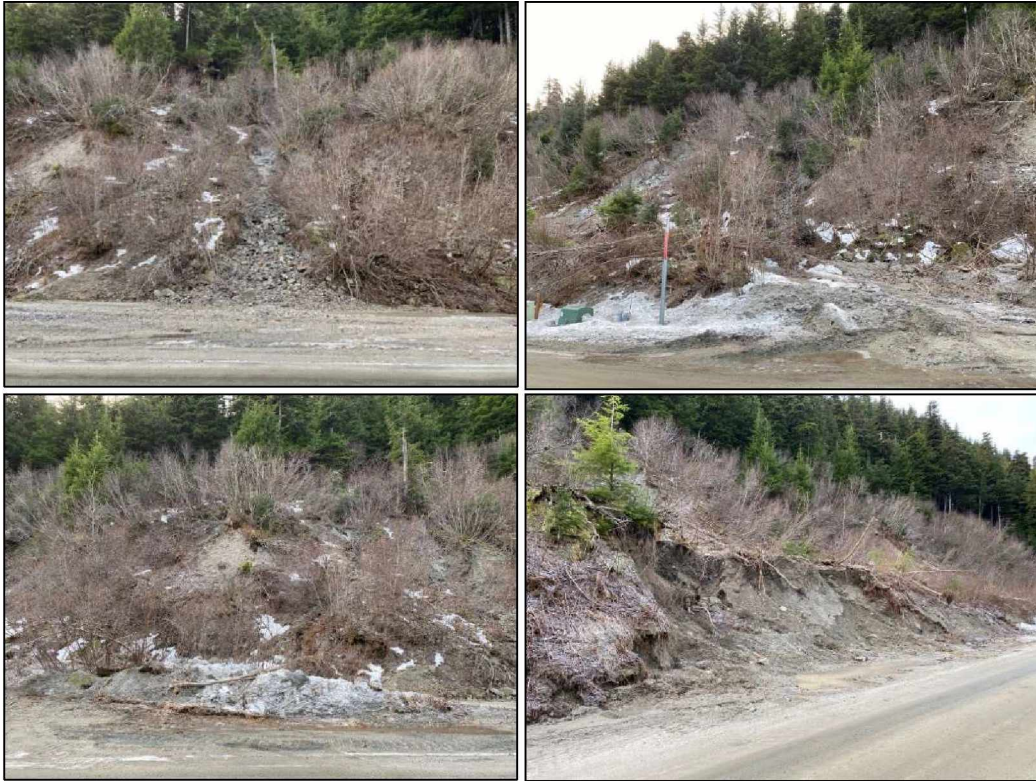
Figure 84. Collection of photographs of the FEMA DOT#44 landslide area in December 2020, showing evidence of both debris slides and debris flows (photographs courtesy of ADOT&PF).

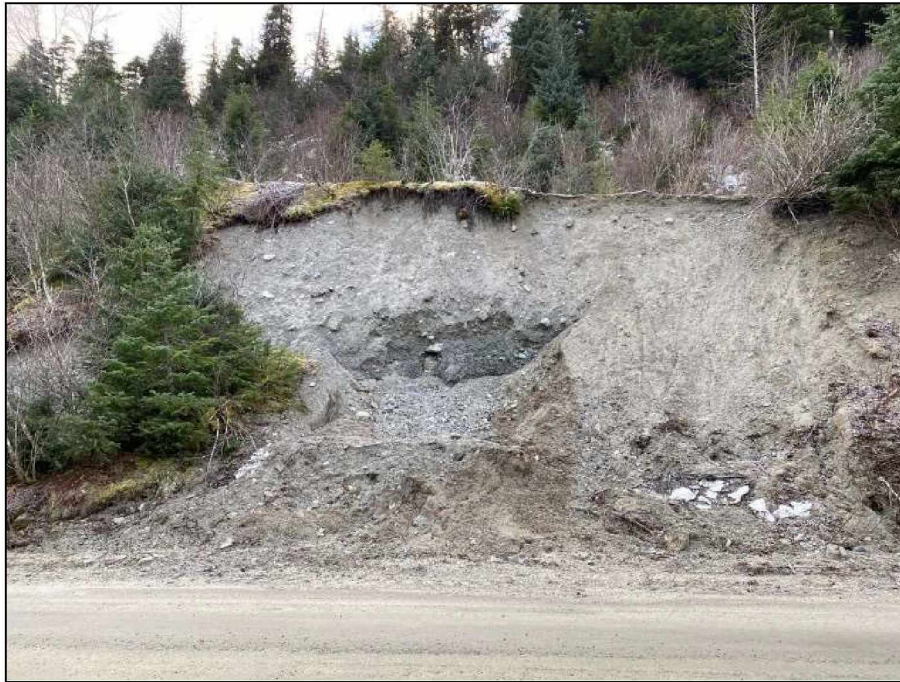
Figure 86. View of the failure at FEMA DOT#45 from Lutak Road in December 2020 (photograph courtesy of ADOT&PF).

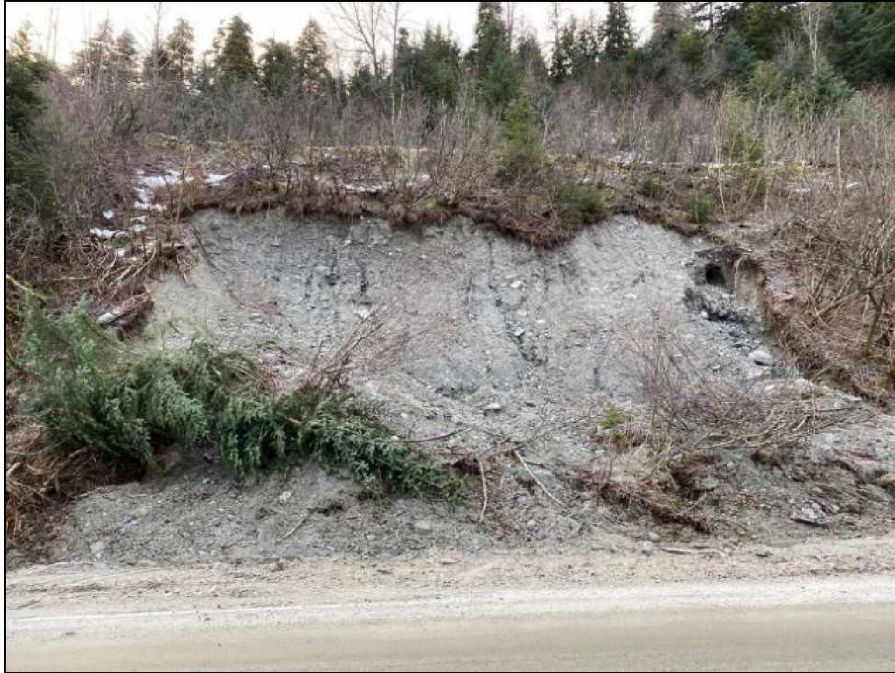
Figure 88. View of the failure at FEMA DOT#46 from Lutak Road in December 2020 (photograph courtesy of ADOT&PF).

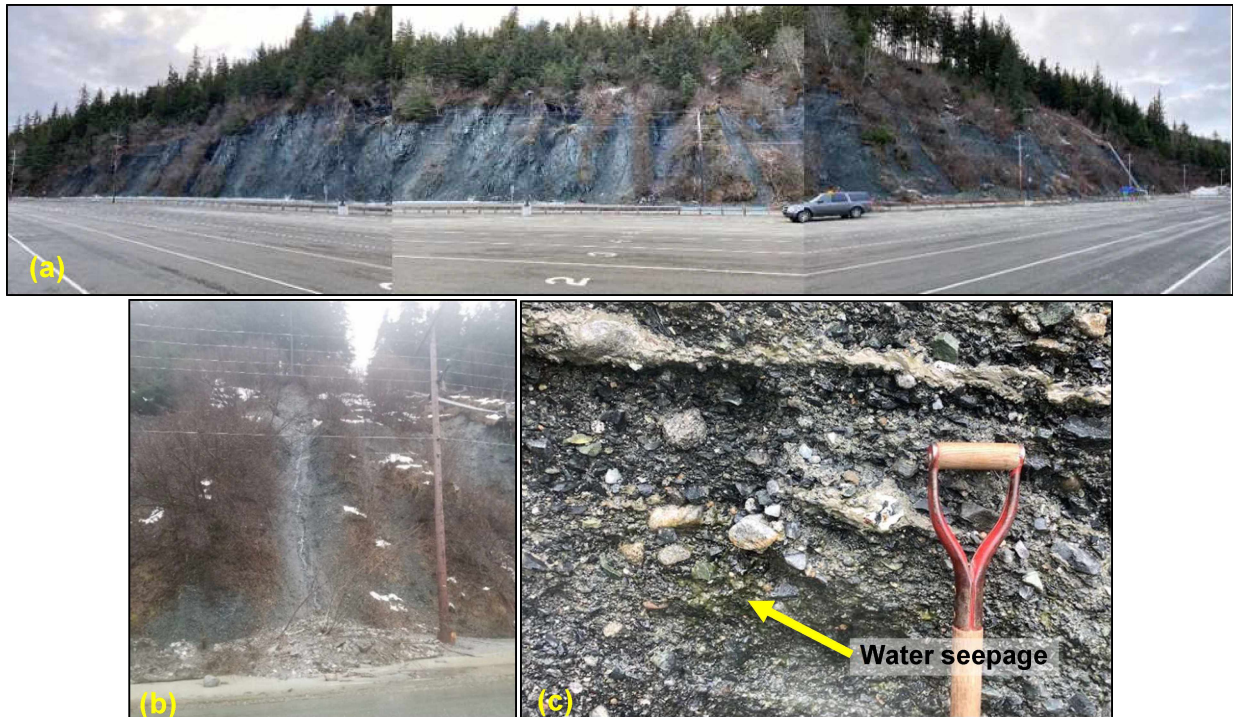
Figure 95. Photographs of the slope adjacent to the ferry terminal (FEMA DOT#49): (a) the entire extent of the slope across Lutak Road from the ferry terminal, post cleanup (December 2020; photograph courtesy of ADOT&PF); (b) an individual debris flow in December 2020 (photograph courtesy of ADOT&PF); (c) view in June 2022 of soil at sample location 22-07 and 22-08, demonstrating ongoing water seepage (note the algae growth in the left side of the image).

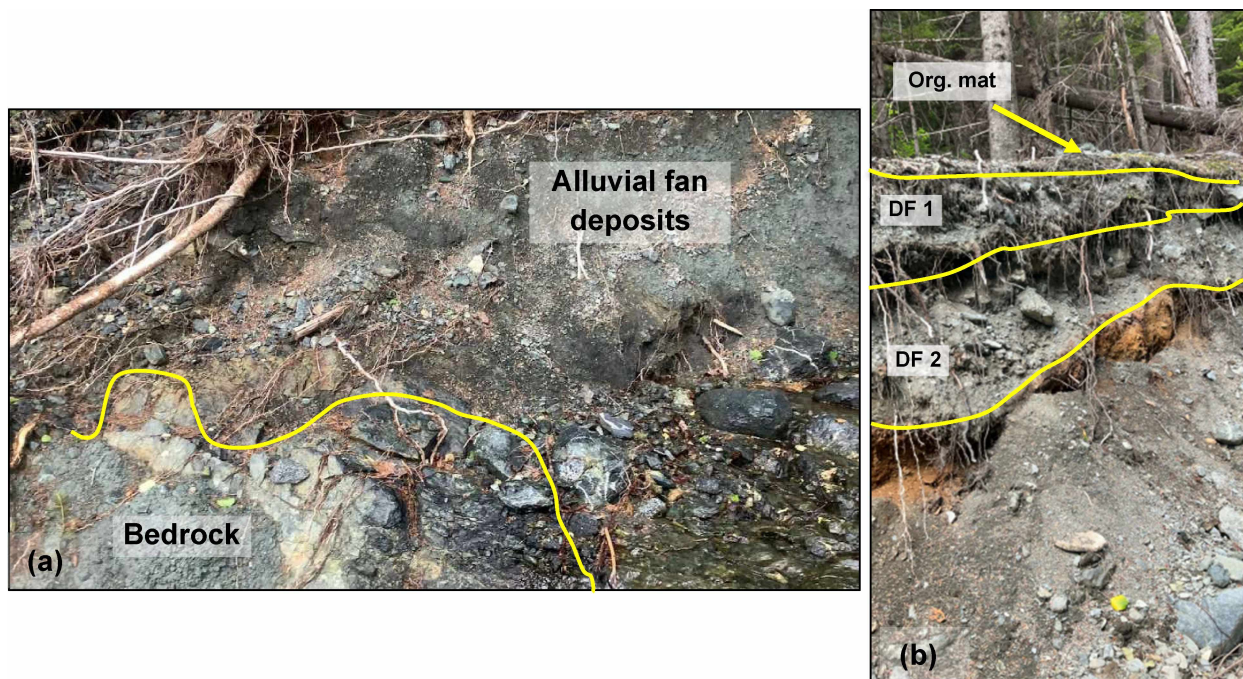
Figure 135. Annotated photographs of the stratigraphy within lower Cunningham Creek: (a) bedrock exposure within the channel, overlain by sand and gravel (June 2021); (b) two potential past debris flow (DF 1 and DF 2) burying organic mats (July 2022).
