U.S. Department  
of Transportation  
Federal Railroad  
Administration

## Locomotive Crash Energy Management Vehicle-to-Vehicle Tests 1 & 2: Analyses and Test Results

<b>1. REPORT DATE (DD-MM-YYYY)</b> 9/9/2022	<b>2. REPORT TYPE</b> Technical Report	<b>3. DATES COVERED (From - To)</b> 8/24/2018–5/10/2022
--	---	--

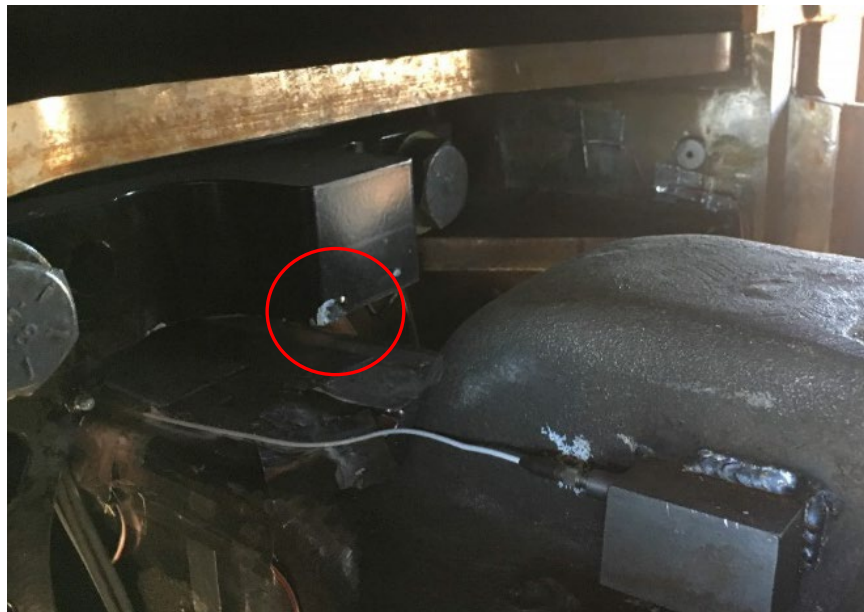
**Figure 20. Damage to the limit stop mounted to the front of the sliding lug due to contact by the back of the PBC coupler head**

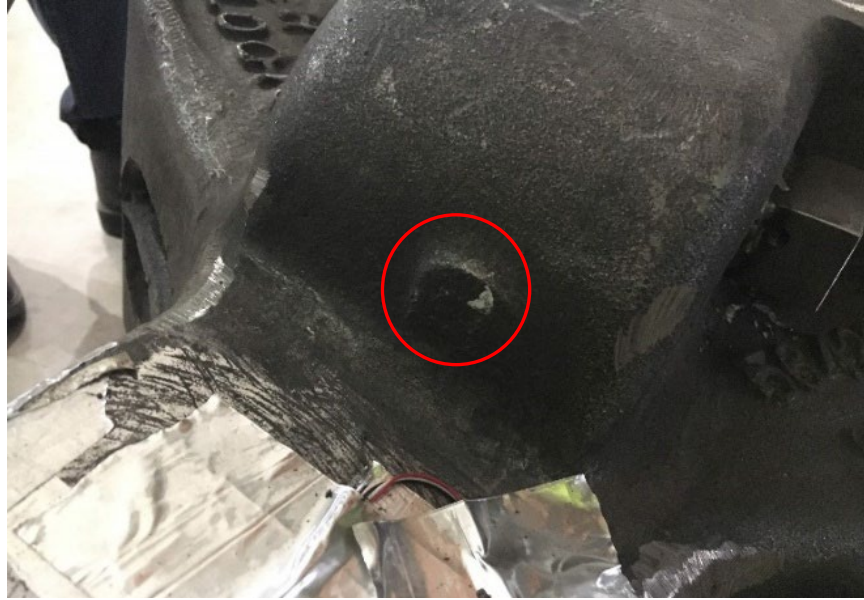
**Figure 21. Damage to rear of the PBC coupler head from limit stop contact**

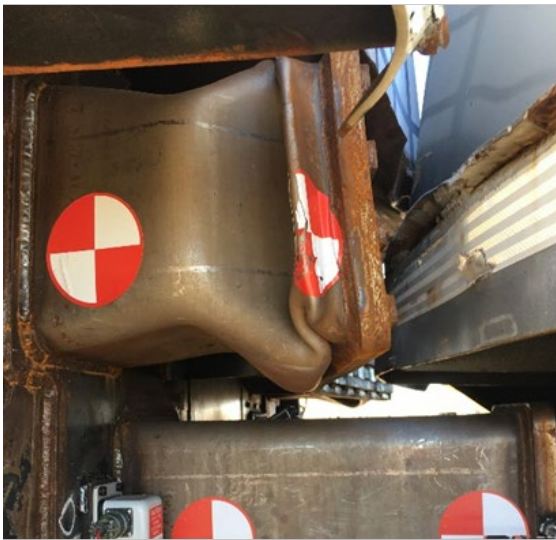
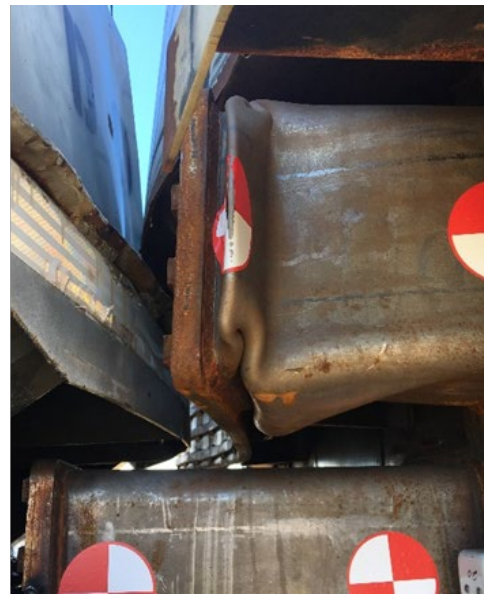
**Figure 25. Deformed upper DAC tubes, right and left sides, respectively**

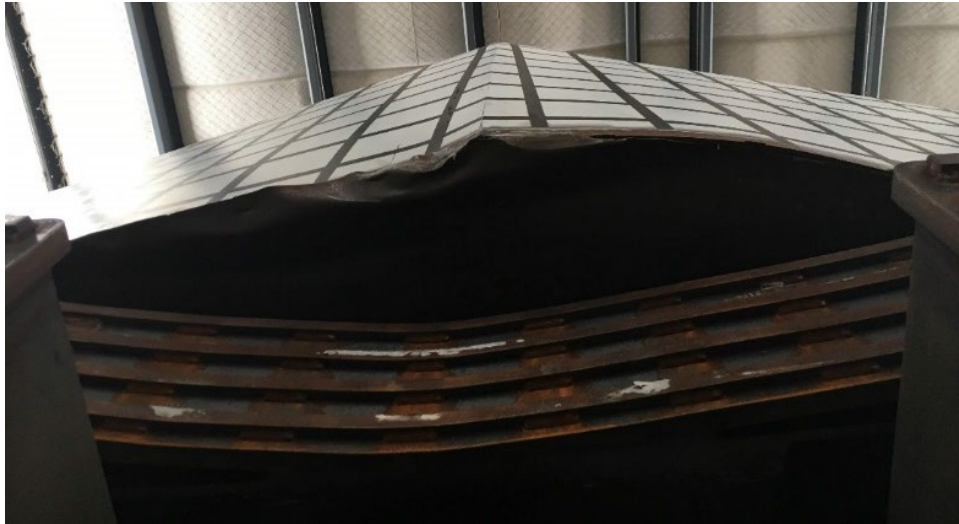
Other than the damage to the CEM components, which was designed to occur, there was minimal damage to the CEM locomotive. [Figure 26](#) shows the small amount of deformation of the bottom of the short hood. This was minor and easy to repair.

**Figure 26. CEM locomotive damage**

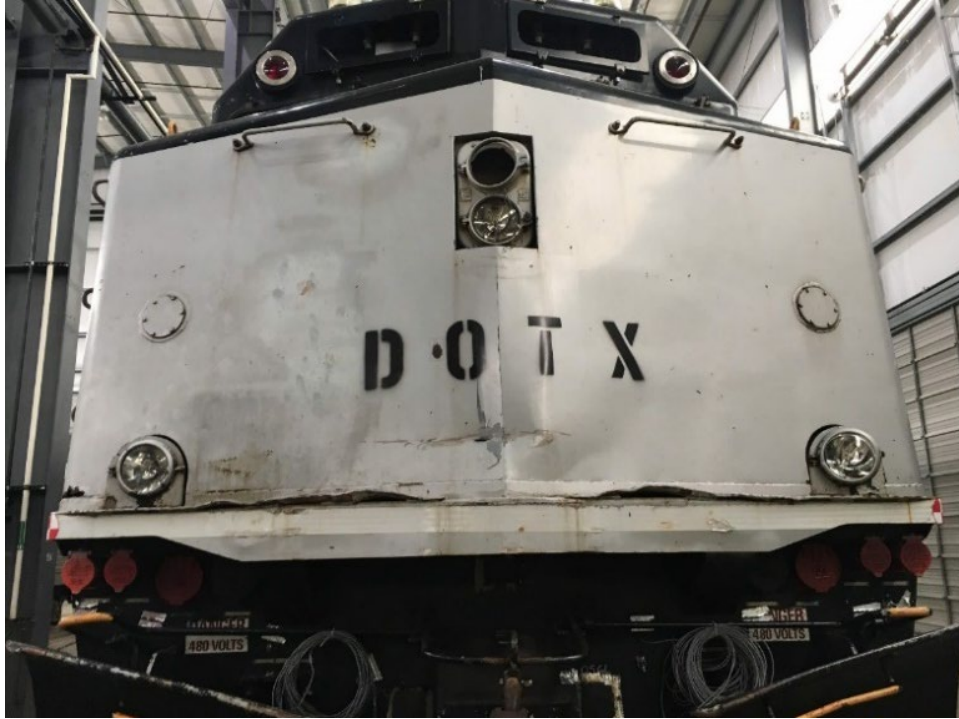
There was also minimal damage to the conventional locomotive. [Figure 27](#) and [Figure 28](#) show the dent caused by interaction with the short hood of the CEM locomotive. This was also minor and easy to repair.

**Figure 27. Conventional locomotive damage**

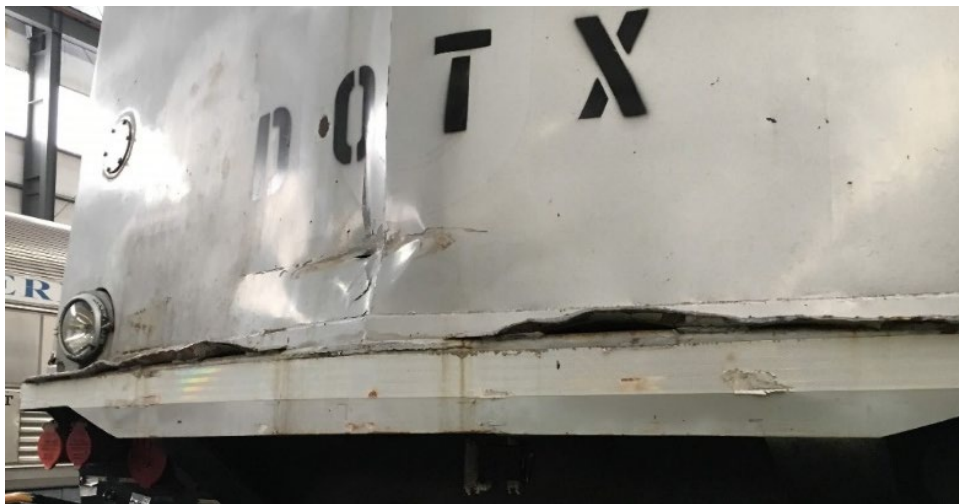
**Figure 28. Close-up of conventional locomotive damage**

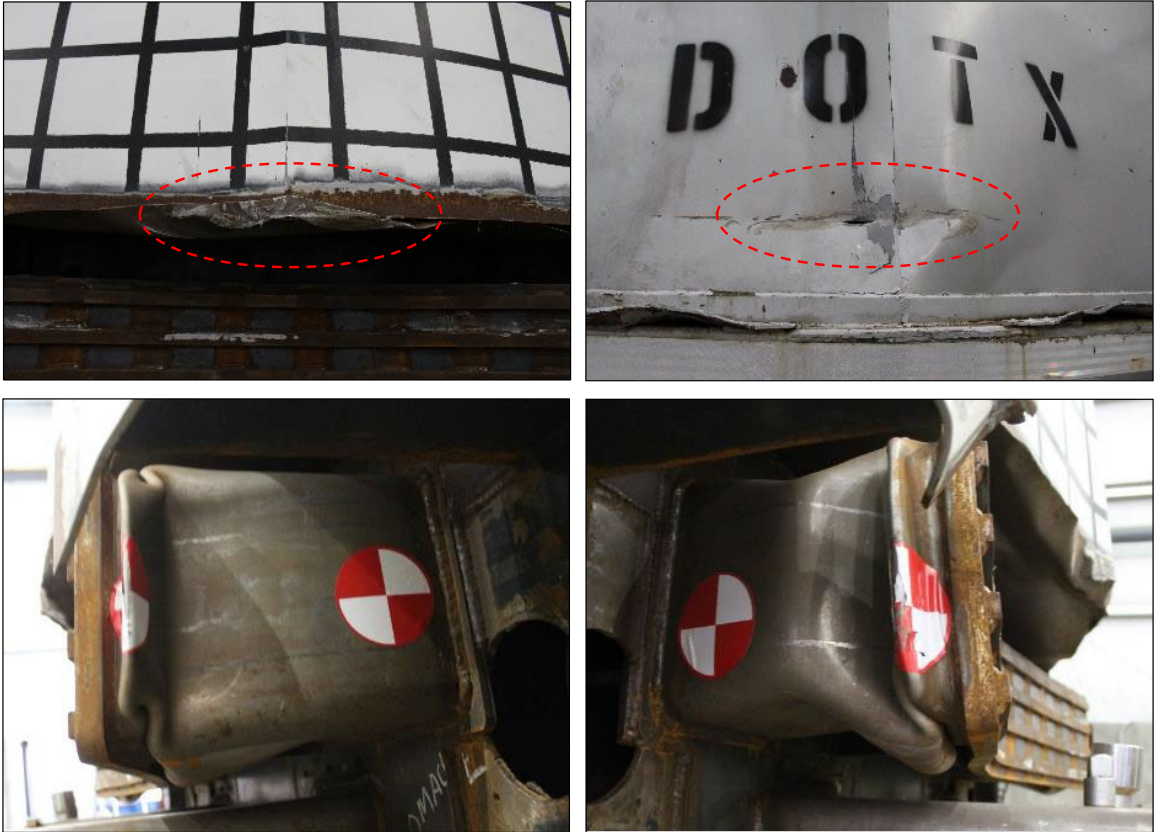
Figure 29 shows a comparison of post-test photographs that provide evidence of the lateral offset of the colliding vehicles: matching scratches on short hoods of CEM locomotive (top left) and conventional locomotive (top right) indicate a 2.5" lateral offset. This offset resulted in less extensive crush of the left upper DAC tube (bottom left) relative to crush of the right upper DAC tube (bottom right).

Figure 29. Post-test photographs indicating lateral offset of the colliding vehicles

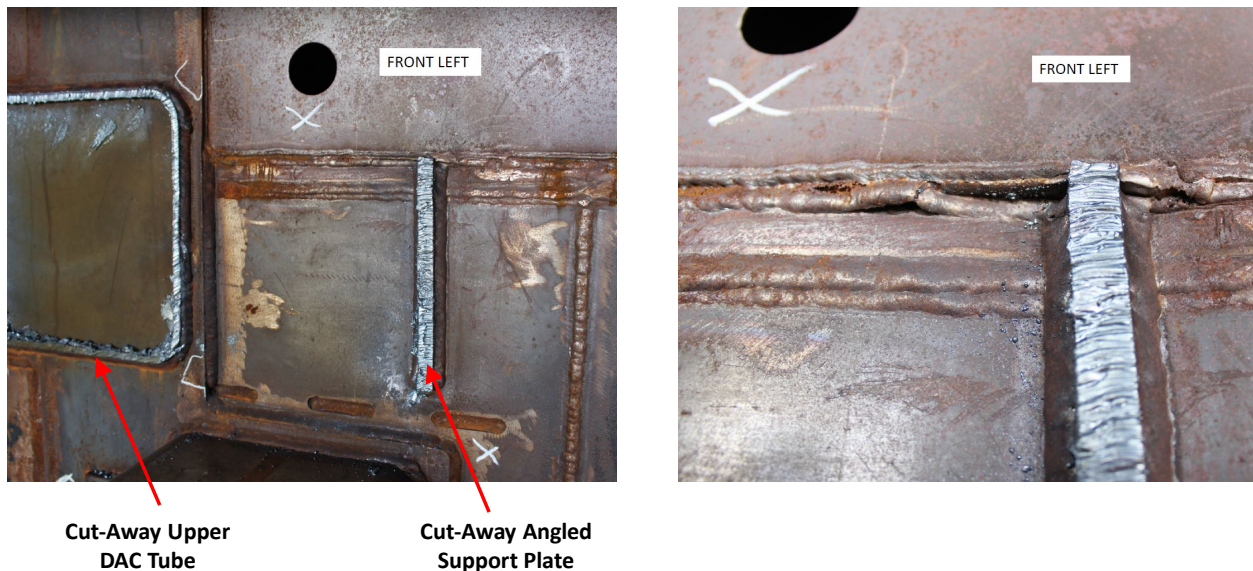
**Figure 50. Left — photograph showing cut-away left upper DAC tube and angled support plate; right — detail showing damage at top of connection between angled support plate and front plate**

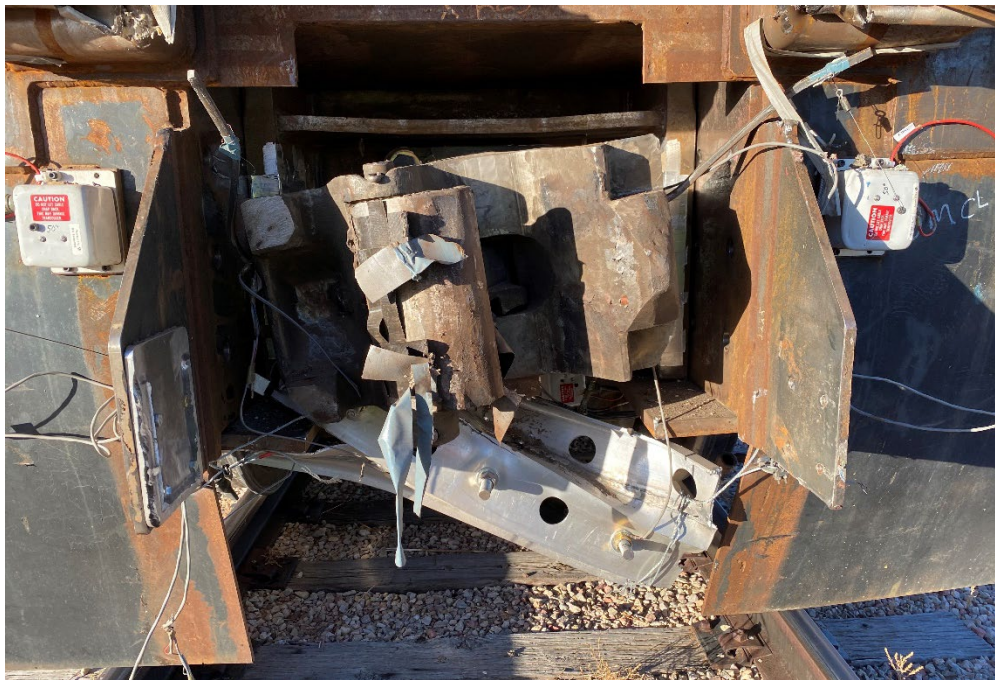
**Figure 67. The deformed coupler carrier caught between the sliding lug and a bottom plate of the draft pocket**

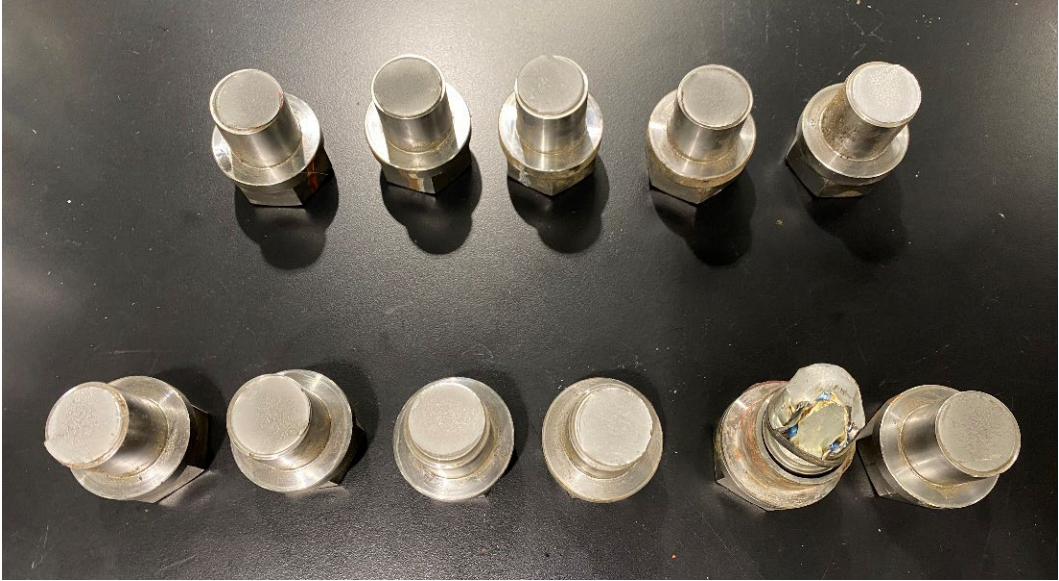
**Figure 75. All shear bolts broke cleanly, except #5 (bottom row, second from right)**

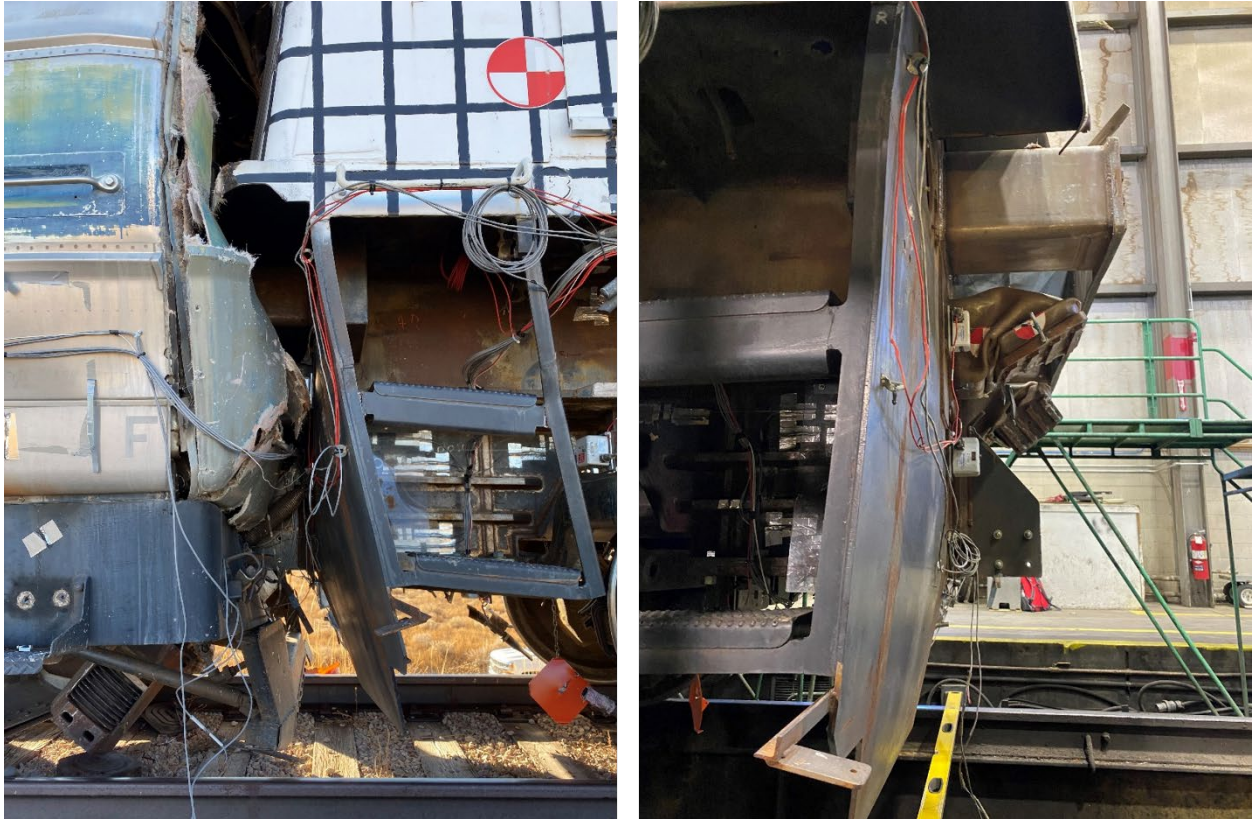
**Figure 78. CEM locomotive end plate deformation on left (left) and right (right) sides**

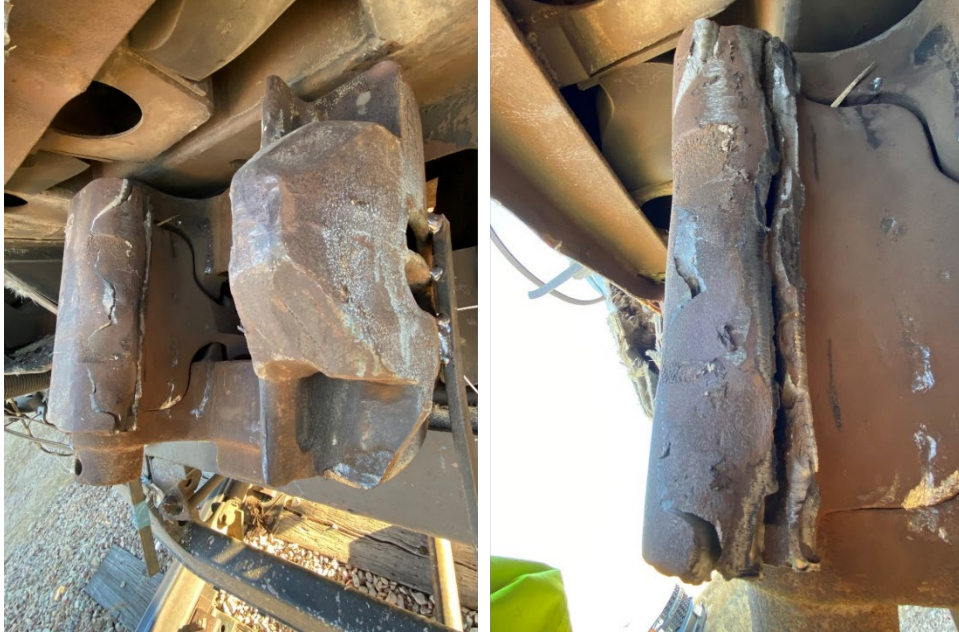
**Figure 79. M1 coupler knuckle fracture (left), and a close-up of the fracture (right)**

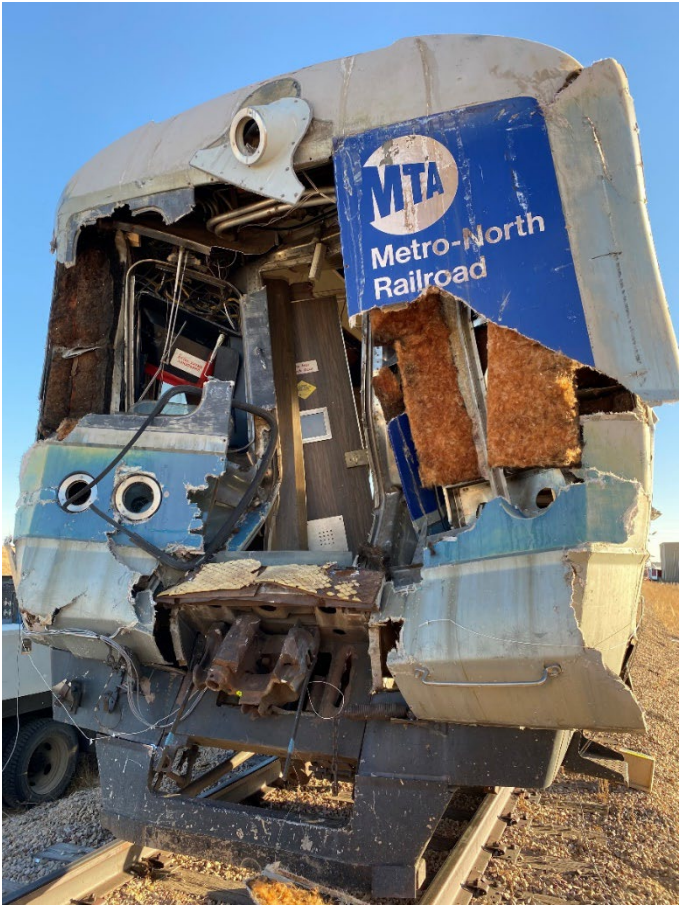
**Figure 80. Post-test damage to M1 end frame**

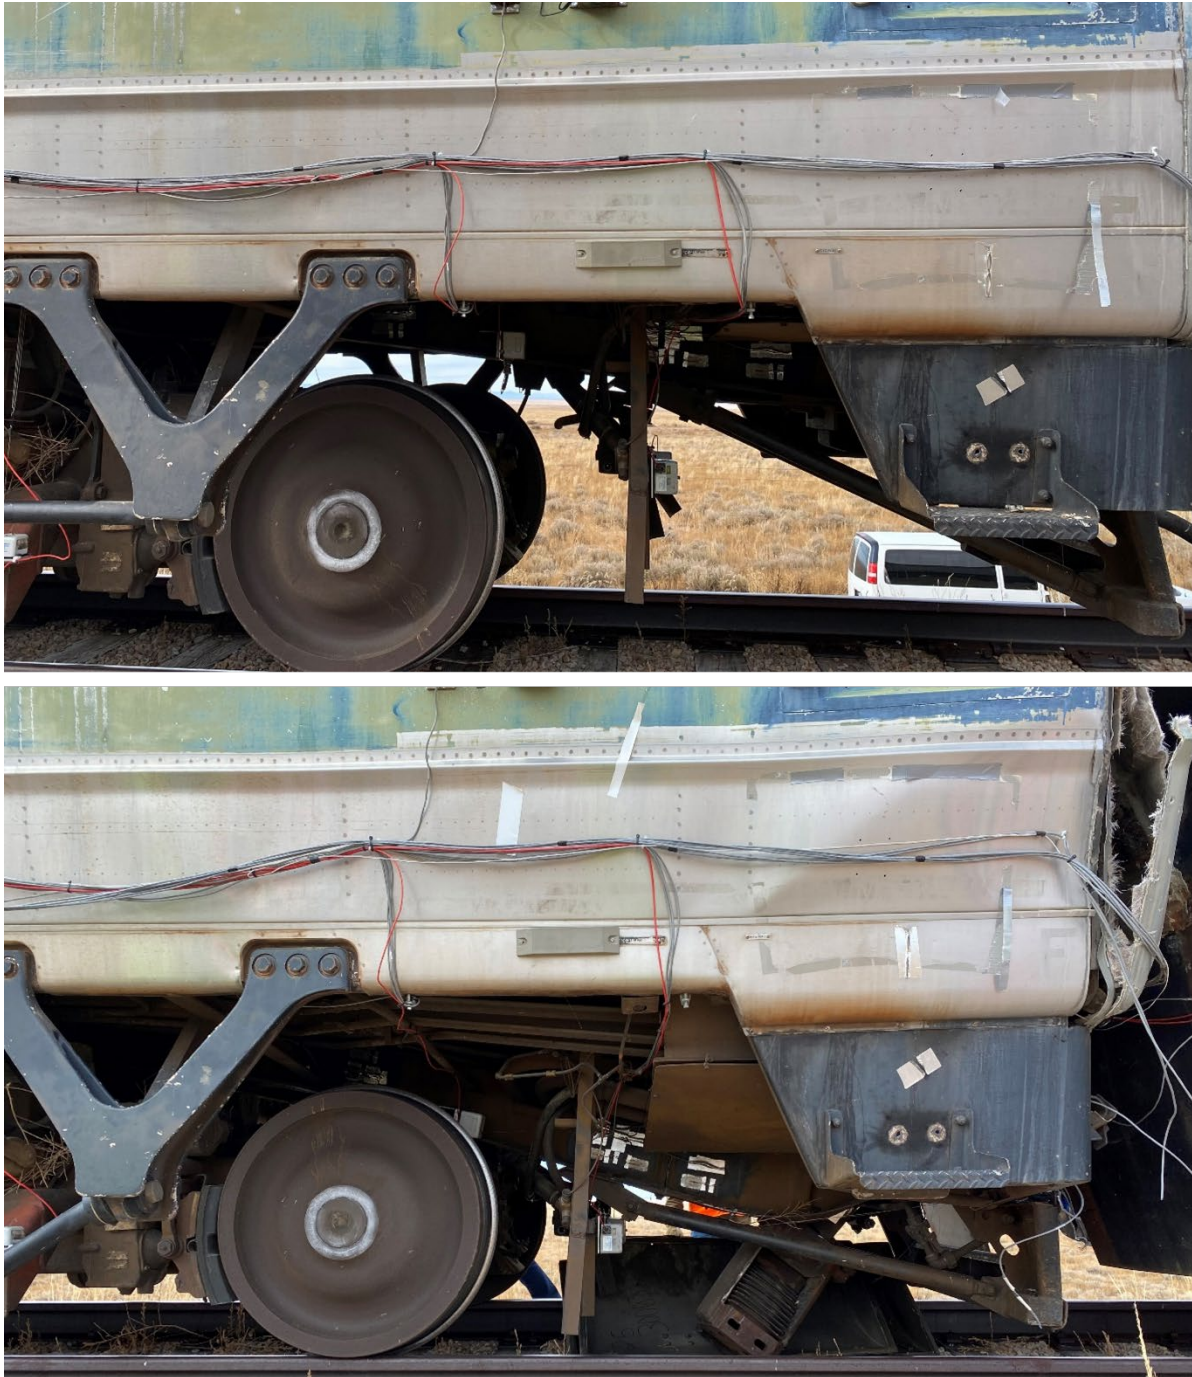
**Figure 81. M1 draft sill before impact (top) and after impact (bottom)**

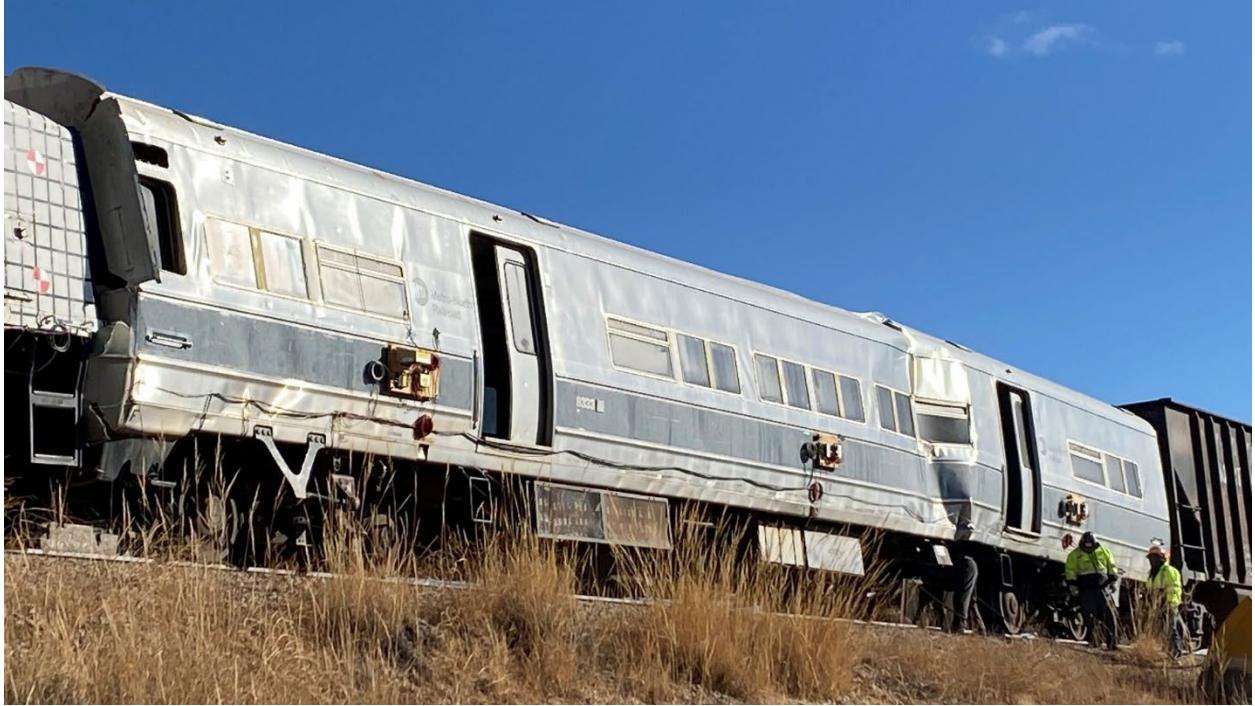
**Figure 82. M1 carbody buckled inboard of rear doors**

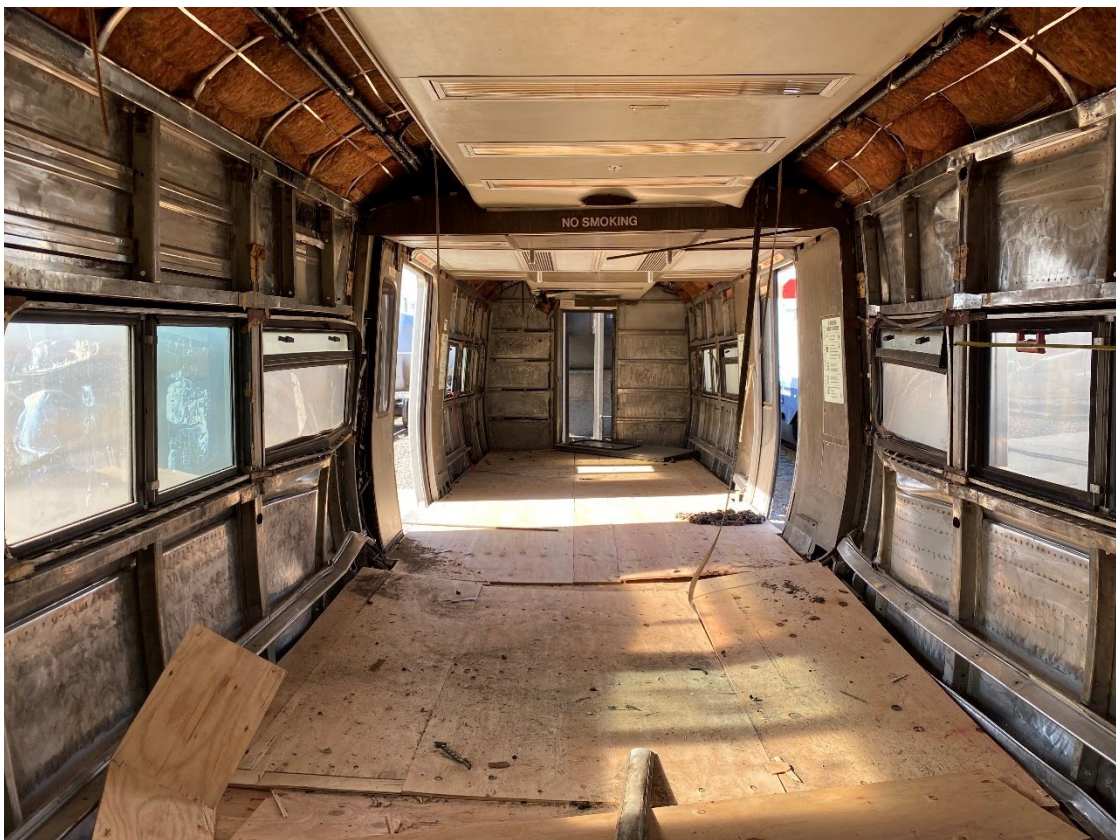
**Figure 83. M1 interior damage, buckle at rear door**
