**DOT/FAA/TC-23/24**

# **Assessment of Emerging Metallic Structures Technologies through Test and Analysis of Fuselage Structure: Panel 2**

July 2023

Final report

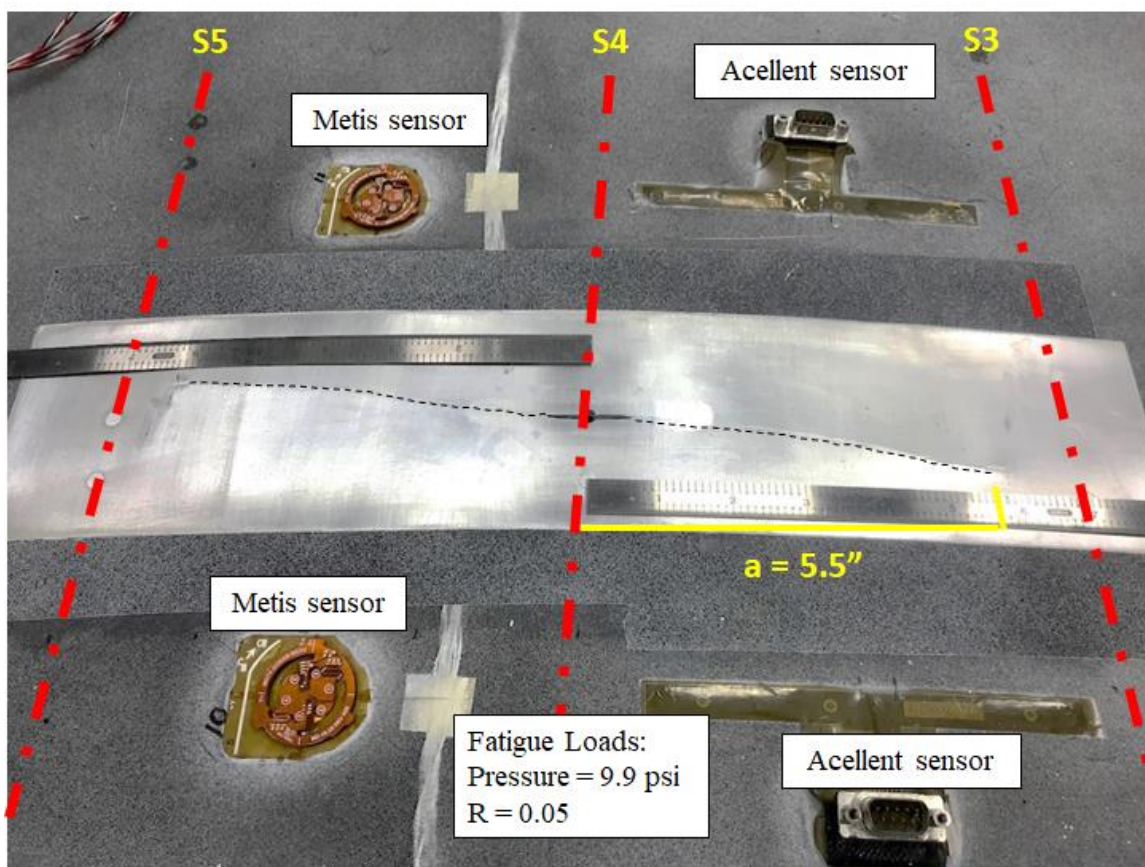
Figure 11. Picture of Phase 1 fatigue crack growth at 48,850 cycles

The panel was fatigue tested under simulated flight load conditions for 48,850 cycles, during which the skin crack extended across two stringer bays to a final length of approximately 11 in., as shown in Figure 11 and Figure 12. In general, slow and stable crack growth was observed during the fatigue test. The crack surface morphology had distinct transition points where, on both sides, the surfaces changed from V (valley) to S (slant) fracture and from a  $+45^\circ$  to a  $-45^\circ$  slant fracture. Results indicate that crack-growth rates changed at these transition points similar to those observed in panel 1 testing (Tian, Stanley, & Backuckas, 2021) and coupon tests conducted on  $M(t)$  specimens (Stonaker, et al., 2019).

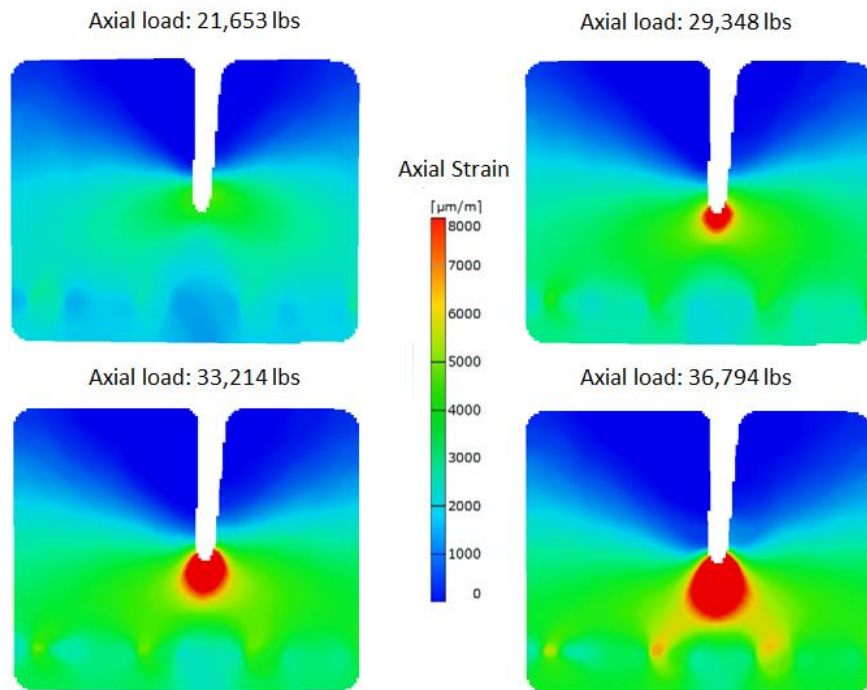
Figure 18. ARAMIS result during the circumferential direction limit load test

After fatigue testing, panel 2 was subjected to approximately 2.5 g of axial load in a limit load test holding the pressure constant at 9.9 psi. Strain gages located on the inner and outer flanges of the stringer ahead of the fatigue crack revealed that the stresses were below the yield strength of the stringer material (see Figure 17). The intact stringers ahead of the crack were effective in containing the damage. In addition, limited stable-tearing extension and crack-tip plasticity was observed from each crack tip, as shown in Figure 18 using DIC measurements.

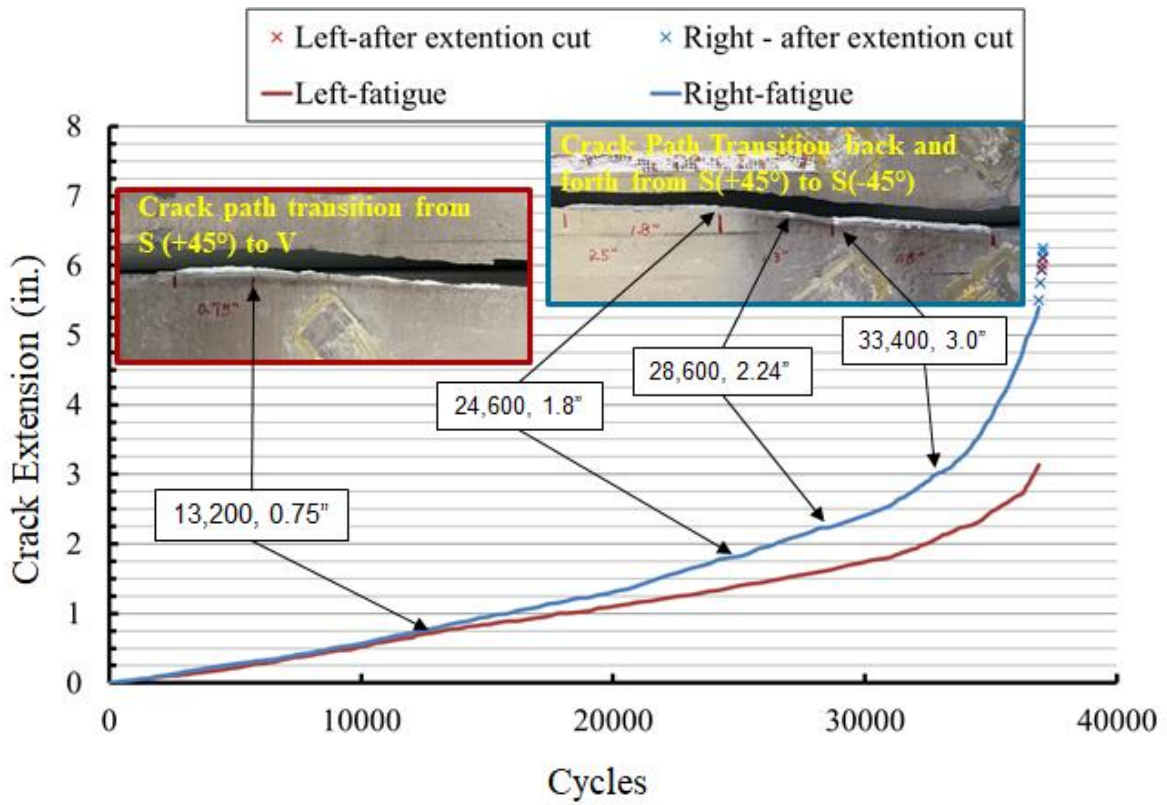
Figure 21. Slow and nonsymmetrical fatigue crack growth

For this phase, the panel was fatigue tested under pressure load conditions for 37,070 cycles, during which the skin crack extended across two frame bays to a final total length of approximately 16 in. The crack growth was non-symmetrical as shown in solid lines in Figure 21. The fatigue test phase ended at 36,700 cycles, when the right side crack was about 5.4". The left side crack was extended using a grinding wheel to the same length as the right side. Then, the panel was fatigue cycled under the same pressure load conditions for about 800 cycles so that panel 2 has the same total crack length as panel 1 for the residual strength test.

Post-residual strength test investigation revealed that the unsymmetrical crack growth was due to the transition of crack surface morphology resulting in crack growth-rate changes as observed during Phase 1 fatigue test. The right-side crack had slanted crack surface and transitioned back and forth from +45 to -45 at approximately 24,600 cycles (1.8" crack extension), 28,600 cycles (2.24" crack extension) and 33,400 cycles (3.0" crack extension) respectively. The left side crack had slant crack surface up to 0.75" and changed to V surface for the rest of the fatigue cycles, which led to the slower crack grow. However, panel 2 exhibited better average crack growth performance compared to panel 1, as shown in Figure 22. Crack extension occurred across two frame bays to a final length of about 15.25 inches after 29,000 and 37,070 fatigue cycles in panel 1 and 2, respectively.

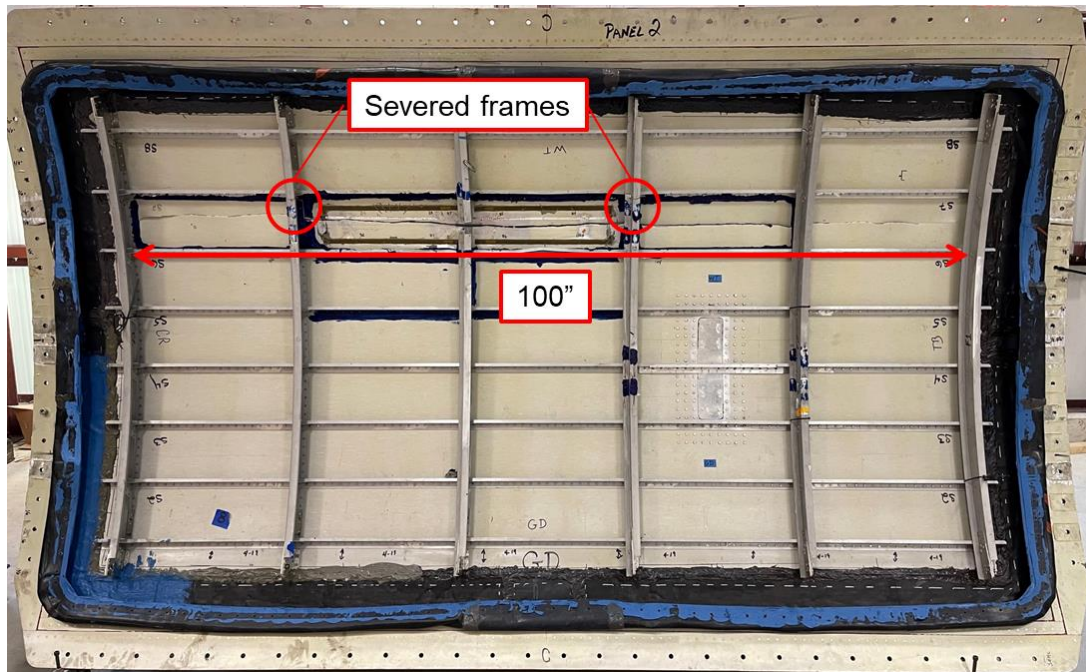
Figure 23. Picture of panel 2 after residual strength test

After fatigue testing, the final stage of testing is a residual strength test to certain limit load conditions identified in 14 CFR §25.571 (b) (Damage-tolerance... , 2023). The residual strength test was conducted under pressure loading applied quasi-statically. Unstable tearing occurred at maximum applied pressure of 14 psi, resulting in failure of the panel. Extensive damage occurred to the panel where the skin crack extended to a total length of 100 inches and severed two intact frames, as shown in Figure 23. The pressure at failure exceeded the residual strength damage-tolerance requirements in 14 CFR §25.571 (b).
