# Liquefaction Damage of Harbor Facilities during the 1995 South Hyogo Earthquake

Minoru YAMANAKA\* and Keinosuke GOTOH\*

This paper describes results of field surveys about damages of harbor facilities and liquefactions mainly in Kobe City, and discusses some about the mechanism and the countermeasure.

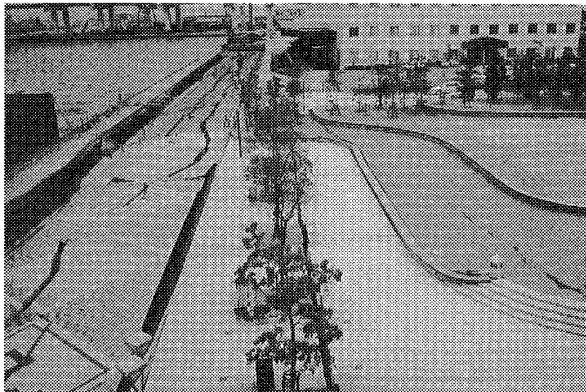
Photo 1 shows damage of the north caisson quaywall in Rokko Island. At the ground on the right side some cracks run on the surface. A lateral flow of ground is occurred due to liquefaction.

Photo 1 Lateral flow (taken on Feb. 4).

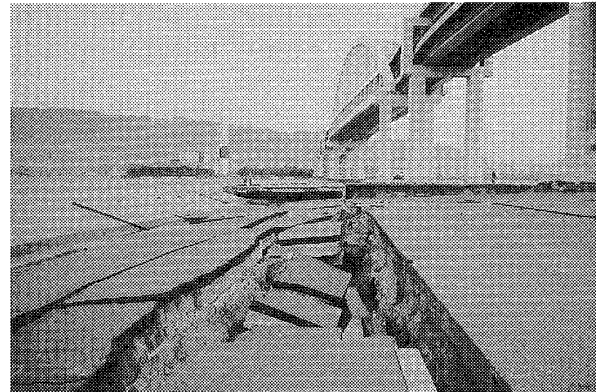
Photo 2 shows a slide of caisson quaywall to the

sea side and a scene of destruction of quay surface due to liquefaction. Under pavement a decomposed weathered granite, called "Masado", is accumulated. This soil is colored light brown color and has a large cohesion. Inside, much sand boiling is spread over the surface.

Photo 2 Destruction of quay surface (taken on Feb. 4).

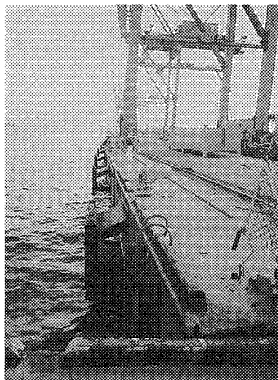
The moving to the sea side of the east caisson quaywall in Port Island is shown in Photo. 3. The front line of quaywall had moved all alike. From this moving style point of view one may say that the quaywall had been moved by the main shock of this earthquake.

Photo 3 Moving of caisson quaywall (taken on Feb. 12).

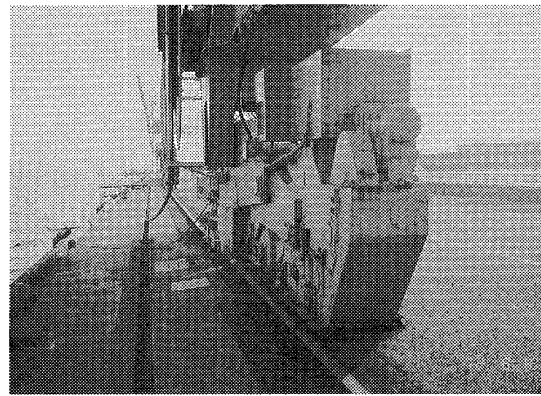
It can be seen in Photo. 4 that the leg of gantry crane is dropped from the driving rail.

Photo 4 Damage of gantry crane (taken on Feb. 12).

Many harbor facilities have got grave damages by this earthquake. Because Kobe City is a harbor town in particular, this earthquake caused many influences on a social and a economical activity. The gantry crane on caisson quaywall was almost completely destroyed as shown in Photo. 4, and this damage have made almost loading and unloading

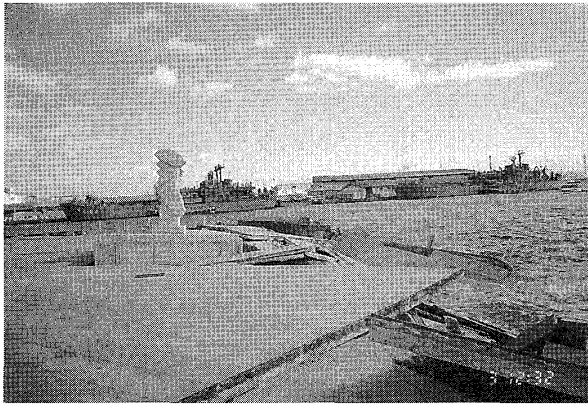
Photo 5 shows the destruction of bulkhead on the south side in Meriken Park. This place is considered as a recreation spot for citizens particularly for

Photo 5 Destruction of bulkhead (taken on Feb. 3).

visitors. The symbol of a sightseeing in Kobe had completely damaged too. The ground under concrete pavement slab has undergone a surface soil Stabilization, because the upper layer under crushed stones is white and is self-supported. it can be regarded that the lower layer had been.

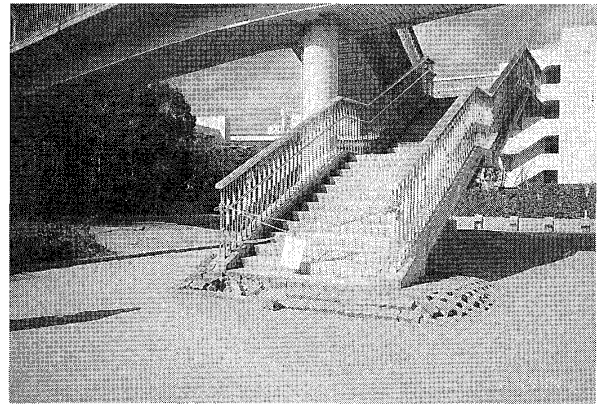
Photo 6 shows a condition on which liquefied the step of pedestrian bridge rised due to settlement. This location is about 200m from one of Photo. 5, and the ground have subsided about 20cm. From this view point one may say that the whole area have subsided.

Photo 6 Settlement and rised pile (taken on Feb. 3).

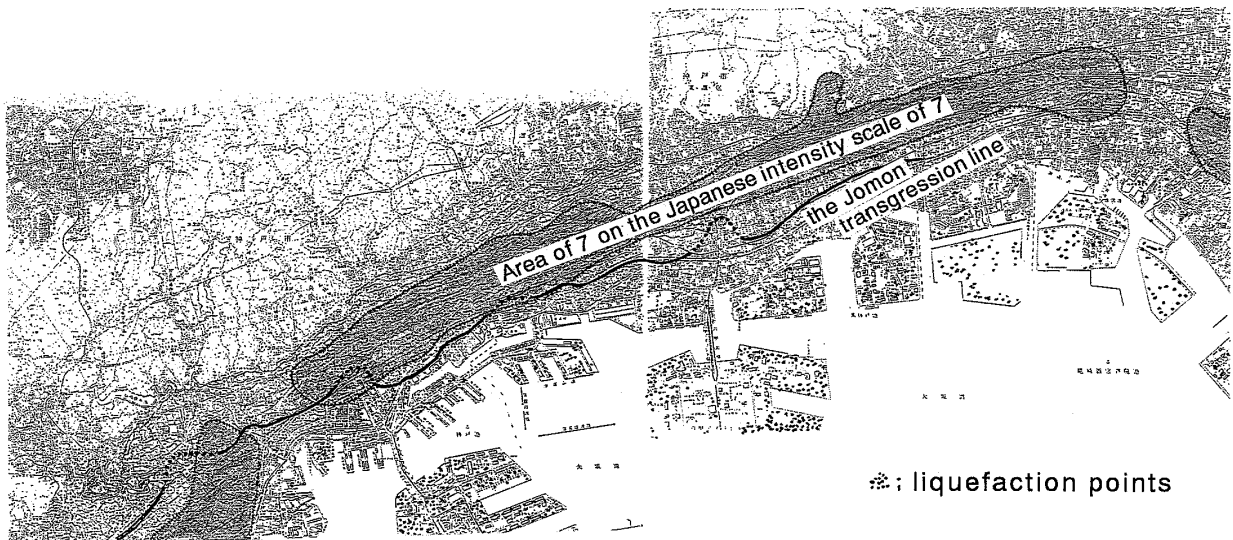
Fig. 5 Relationship the liquefaction area and the Jomon transgression line.

Figure 5 shows the points where liquefactions were occurred. the area of intensity 7 on the Japanese intensity scale and the Jomon transgression line are presented together. These liquefaction points are not included within the area of intensity 7 on the Japanese intensity scale, they are located below the Jomon transgression line, they are distributed in the alluival plain or the reclaimed land. Because these areas are considered as young sedimented areas, the loose grounds are spread.

As shown in Fig. 5, we can verify the topographical factor that make liquefaction easy to happen, 1) a loose ground, 2) a high water table.

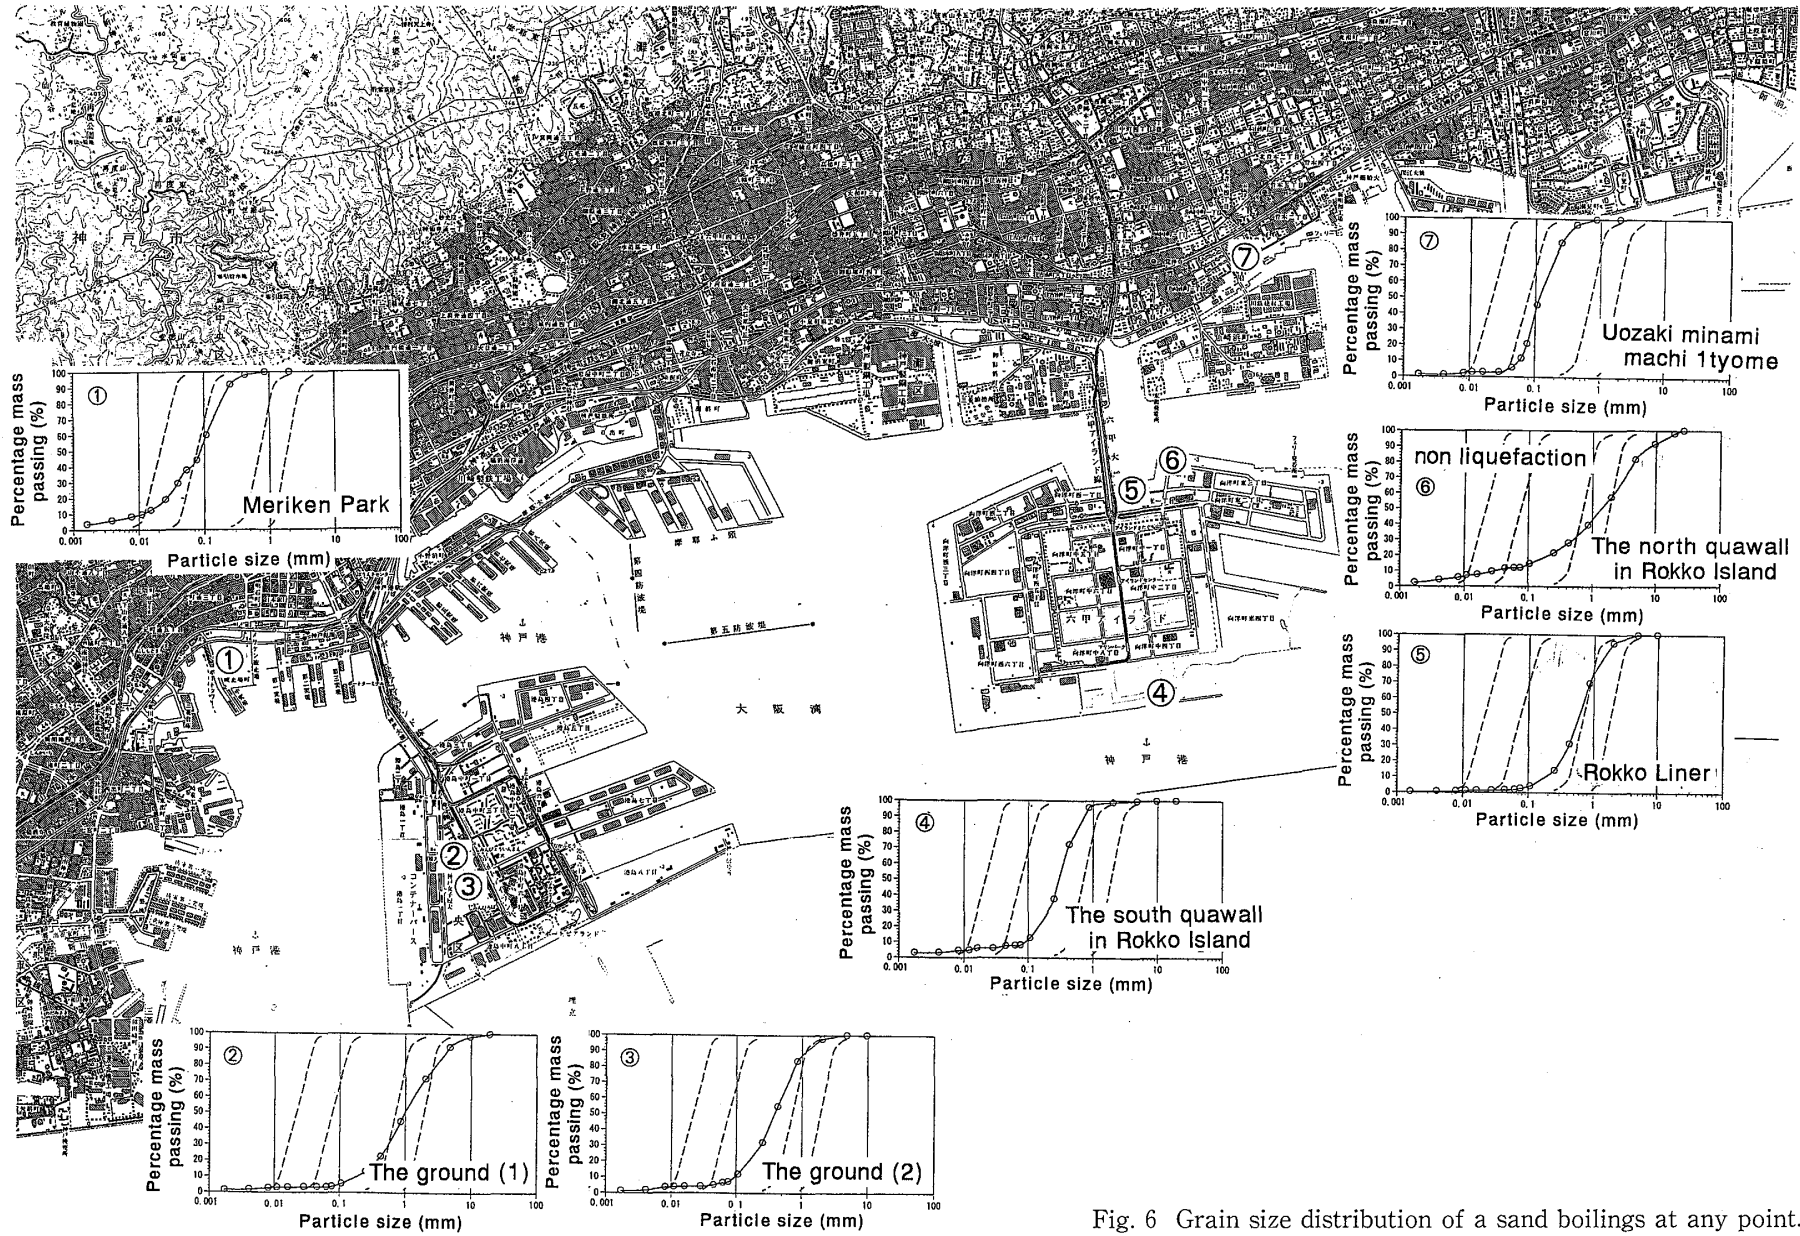
Fig. 6 Grain size distribution of a sand boilings at any point.

Results of grain size analysis of sand boiling sample obtained from in situ are shown in Fig. 6. Because sand boiling is a soil which spouted and accumulated above the ground with waters, we must be care that the grain size distribution for laboratory test is different from which in the field.

The No. 2 sand boiling that picked up at the school ground in Port Island includes some big gravels with the biggest diameter of 19mm of the particle size. This fact indicates that a very large water pressure has occurred when the earthquake was started.

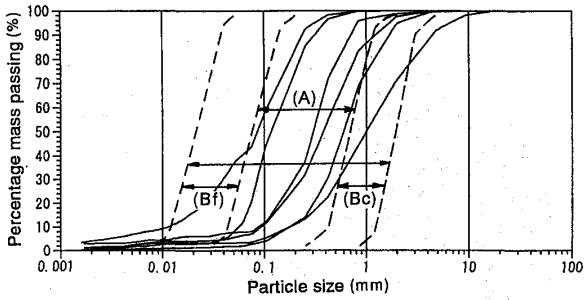
Fig. 7 Grain size distribution of a sand boiling.

The grain size accumulation curve shown in Fig. 7 includes all curves shown in Fig. 6 can be used as a judgement criterion of liquefaction<sup>3)</sup> as established by the Harbor Office, the Ministry of Transport. If a curve is included within the range A, the soil is judged as a soil with a big possibility of liquefaction occurrence. If a curve is included within the range B<sub>f</sub> or B<sub>c</sub>, the soil is judged as a soil with possibility of liquefaction occurrence.

As a result of laboratory test for the sand boiling, it can be regarded that all soils are included within the range A.

In Fig. 7, the No. 6 soil at the north quaywall in Rokko Island is not a sand boiling. The grain size accumulation curve is distributed in wide range. So far as the grain size distribution is concerned, it can be used in judging weather liquefaction may

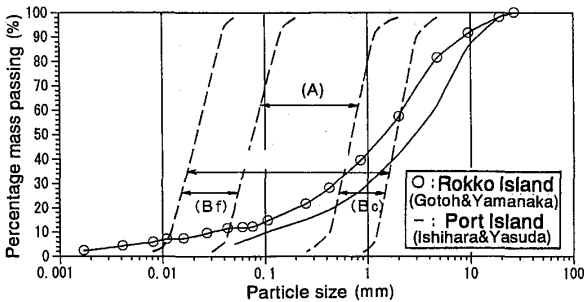
Fig. 8 Grain size distribution of a reclaimed material (comparing our data with the data of K. Ishihara & S. Yasuda<sup>4)</sup>).

A decomposed weathered granite originated at Rokko Mountains have been used in reclaiming artificial islands like Rokko Island and Port Island. As Fig. 8 indicates, this soil has a good grain size distribution and has a cohesion to some degree, and it has been said as a suitable soil for reclamation purposes material because it has a good resistance against liquefaction. Eventhough liquefaction have been ocured widespreadly in these artificial islands. We can say that some analysis are left for future.

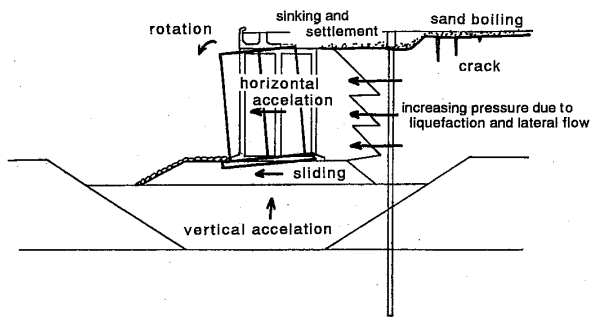
Fig. 10 Estimated diagram for the damaged condition.

An estimated diagram for the damaged conditon is shown in Fig. 10. As a result of our field surveys, we noticed that most of the caissons were bent forward the sea side, and uniformly moved forward. Because of the moving of the caissons, the behind ground had sunk about 1~2m. And sand boilings were accumulated on the subsided ground and the behind area from the ground.

- At first the caisson is lifted by the seismic acceleration which was beyond the expectations, which is in the vertical direction in this case, the friction force between the base of the caisson and the foundation riprap is lost, and the caisson is moved in forward direction due to a active earth pressure of the behind reclaimed soils.
- Because of the moving of the caisson and occurrence of the liquefaction, the behind ground

flows in lateral direction and some cracks occur in the ground.

On the other hand, it may be that the caisson was moved by the increasing pressure due to the liquefaction and the lateral flow. But the seismic acceleration of this earthquake is very large, and is a direct type earthquake which occurs in a short period of time. By considering the appearance process of liquefaction, it is difficult to think that the pore pressure rises at a short time like this shake and the liquefaction occurs later. Therefore it seems reasonable to suppose that the most important external force, which moved the caisson, is the inertia force due to the seismic acceleration.

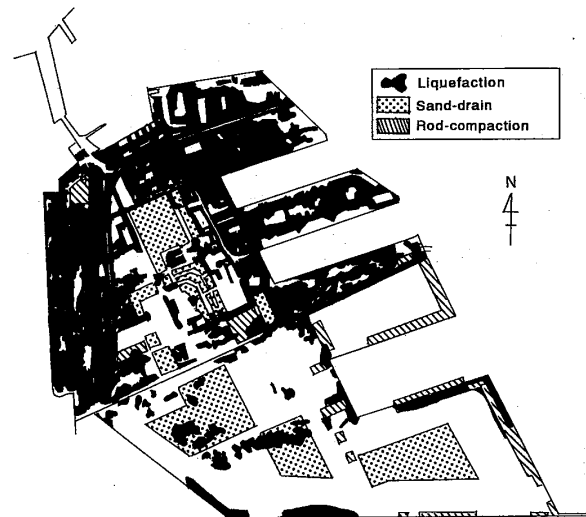
Fig. 11 Distribution of liquefaction in Port Island.

Figure 11 shows the relationship between the area of these countermeasure methods<sup>6)</sup> and the liquefaction distribution area<sup>7)</sup> based on the survey of the Geographical Survey Institute, Ministry of Construction. In areas which constructed by the rod compaction method as a liquefaction countermeasure, there is few area of liquefaction, this effect is obviously. And in the area which done by the sand-drain method as an accelerated consolidation method, it is noticed that there is some effect of liquefaction countermeasure. On the other hand, in area of no liquefaction countermeasure liquefactions widely occurred, from here we can observe the effect of these soil improvement
