# Coating Condition Detection and Assessment on the Steel Girder of a Bridge through Hyperspectral Imaging

In this study, hyperspectral imaging is proposed to inspect the coatings on the steel girder of a real bridge. Some typical coating defects under natural weathering exposures are preselected for hyperspectral scanning to demonstrate their capability. The hyperspectral results are validated with ground-truth lab characterizations, FTIR, scanning electron microscope (SEM), and energy-dispersive X-ray spectroscopy (EDS), to illustrate the applicability of hyperspectral imaging techniques in coating condition detection and assessment. It is found that the coating scratch profiles can be detected, and the scratch depth is character-

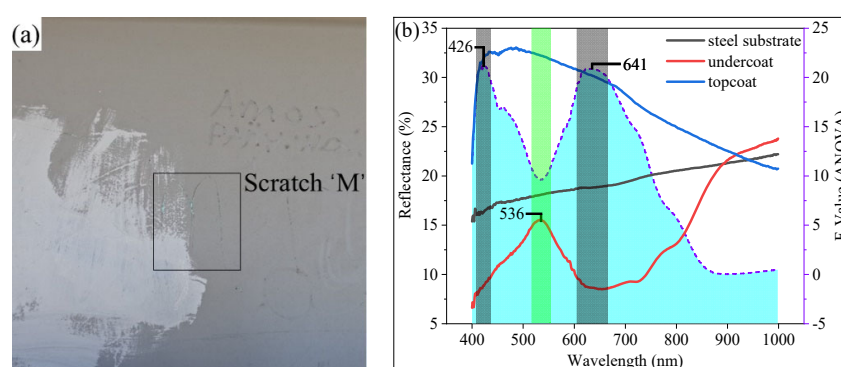
Figure 4 presents a view of the coating scratch on the bridge steel girder. It is observed that the scratch depth varies along the trace as the scratch even reaches the undercoat in

some areas. The coating thickness is reduced, though the color difference from the original view is not significant. In addition, it is not known whether the substrate steel is exposed due to scratches. A coating is used to protect the steel from corrosive media. Corrosion can initiate at a bare steel spot, and the effect gradually propagates concentrically to the local area, which progressively damages the health coatings. Figure 4b shows the comparison of the spectral signatures in the range of 400–1000 nm (visible and near-infrared, VNIR) from different objects, topcoat (pigmented alkyd), undercoat (epoxy), and girder steel, in the domain of scratches from the hyperspectral imaging. In view of hyperspectral imaging, those three objects are spectrally different, especially for the topcoat and undercoat, though both are organic polymers that are characterized by aromatic rings and side chains. As for the substrate, steel does not yield any absorption features in the range of VNIR because it is composed of metal ions, which do not absorb photons in the current wavelength domain [29].

**Figure 4.** Coating scratch on the steel girder. (a) Original view; (b) spectral signatures of different coating layers and the corresponding F-values from ANOVA analysis of spectra.

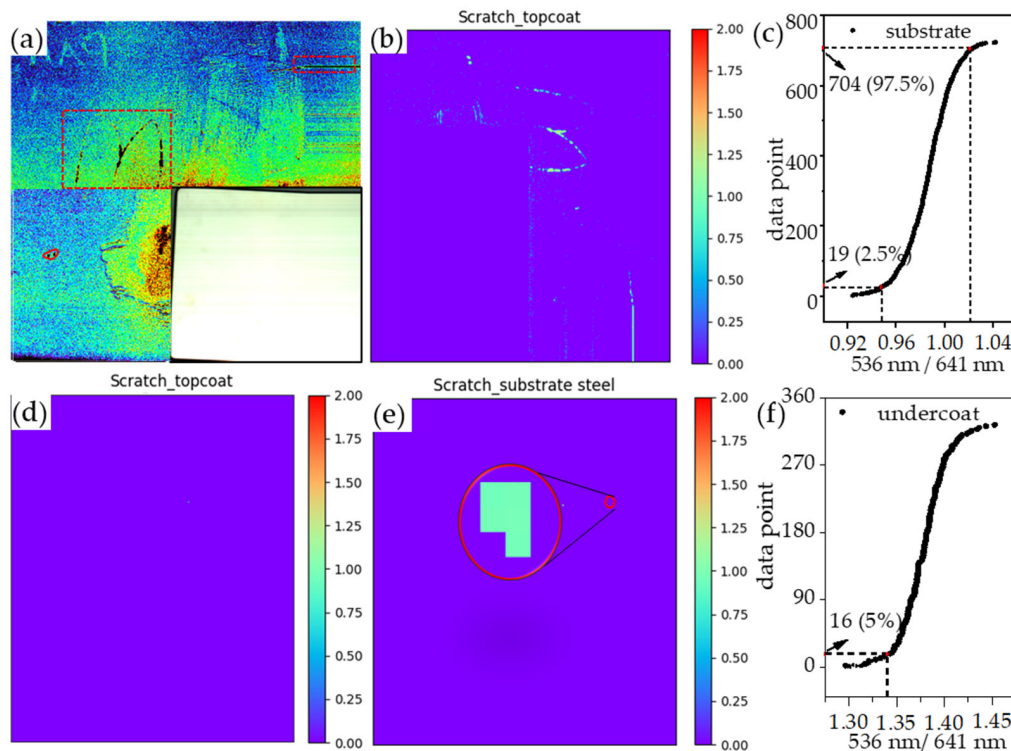
To differentiate different layers of coating, a scratch depth indicator (SDI) is developed by comparing the ratio between two bands, 536 nm and 641 nm. Figure 4b displays the F-value results derived from the one-way ANOVA analysis based on the spectra from the three objects. There are two local maxima at 426 nm and 641 nm and one local minimum at 536 nm. According to the ANOVA F-value, spectra at wavelength 536 nm yield the least variation ( $p < 0.05$ ) in the range of 400–750 nm. For comparison, 426 nm and 641 nm are more sensitive to the differences between different coating layers because higher close F-values are observed, which are around 21 ( $p < 0.05$ ). To establish a robust indicator, 641 nm is selected as the most sensitive band in this study because 426 nm is located at the beginning of the spectrum, which is usually subjected to severe mechanical noises [8]. Figure 5a demonstrates the mapping of SDI (536 nm/641 nm) in hyperspectral imaging. The scratch profile can be easily identified, and the exposed undercoat can be located by the black spots. For the RGB method, the color feature of the scratch is used to identify the scratch profile, and the result is easily subjected to false detection if objects with similar colors are present [31]. In order to assess the scratch condition, different layers of the coating are retrieved from the mapping by thresholds to demonstrate the scratch depth. The corresponding SDI threshold for undercoat and steel is obtained from the distribution of the SDI values, as illustrated in Figure 5c,f. For undercoat epoxy, the critical SDI of 1.33 isolates the exposed undercoat, though some scattered misidentifications can be observed. Most of the misclassifications of the undercoat are located in the shades of the white reference board. This is because the shade can distort the spectra and thus produce incorrect information, which can be eliminated by the additional external light source in real practice [26]. It is noted that several pixels are distinguished from the undercoat in the heart of scratch “M”, which is the substrate steel. As hyperspectral imaging also enables a high spatial resolution of 0.56 mm in this study, the exposed steel can be spotted by the critical SDI of 0.95. The selection of the critical SDI in this study is because 95% of the calculated SDI from the

pixels on the steel substrate are between 0.95 and 1.02. There are in total 5 pixels (pixel dimension:  $0.56 \times 0.56$  mm) that can be identified, which makes a  $1.57 \text{ mm}^2$  exposure. It is worth noting that hyperspectral imaging can perform a much more accurate inspection by using spectral information compared to RGB inspection because the resolution is not high enough to identify such small defects [21,22].

**Figure 5.** Different layers of the girder coating with scratches. (a) Mapping of SDI (536 nm/641 nm) in hyperspectral imaging; (b) scratch of undercoat (SDI > 1.33); (c) derivation of the critical SDI for undercoat; (d) topcoat; (e) scratch of substrate steel ( $0.95 < \text{SDI} < 1.02$ ); (f) derivation of the critical SDI for steel.

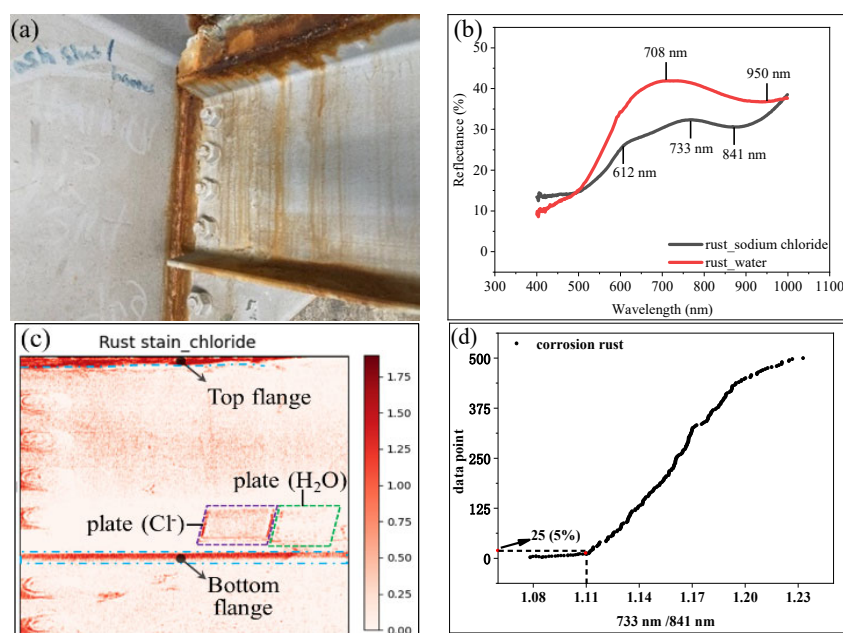
The steel rust percentage has been used as an indicator to assess the coating conditions according to ASTM D610-08 for timely remedies [23,31]. Figure 6 presents the coating surface with steel rust stains as well as the corroded steel girder top flange. Many corrosive media cause rust in the atmospheric environment, and the corrosion products may vary. Acidic exposures are prone to producing magnetite ( $\text{Fe}_3\text{O}_4$ ), ferrous chloride ( $\text{FeCl}_2$ ), and iron oxide-hydroxide ( $\text{FeOOH}$ ) [31]. For chloride salt ions attack, akageneite ( $\beta\text{-FeOOH}$ ) and goethite ( $\alpha\text{-FeOOH}$ ) are the main corrosion products [31,32]. Two steel plates treated with sodium chloride and water, respectively, are prepared and placed in the scanning view. Figure 6b shows the spectral signatures in the VNIR range derived from corrosion spots on two plates. It is noted that the rust products with different exposures differ spectrally. Rust obtained from sodium chloride solution yields three absorption features at 612 nm, 733 nm, and 841 nm, and water-based corrosion products have features at 708 nm and 950 nm, which are characterized by water [8]. The spectra for the corrosion rust from different sources are consistent with the previous study [33].

**Figure 6.** Girder coating with rust stain. (a) The view of the rust spot; (b) spectral signatures of the different rust products in VNIR; (c) rust stain demonstration by CR indicator ( $>1.11$ ); (d) critical CR for rust stain on topcoat.

As chloride corrosion is more aggressive, it is worth emphasizing its corrosion effect before the pervasive attack on both substrate and organic coatings [14]. The chloride rust (CR) indicator, 733 nm/841 nm, is constructed to demonstrate the corrosion products. Figure 6c demonstrates the mapping of CR in the domain of hyperspectral imaging with a threshold of 1.11. This critical CR is obtained from the stain pixels in the diaphragm with the same method as illustrated in SDI. The severely rusted steel flanges can be identified in CR mapping as indicated by the dark red areas. Moreover, the rust stain on the coating in the diaphragm is also detected by the CR, though the CR values are smaller compared to the rust spots. It is because rust products intermingle with the topcoat in the domain of a pixel. The hyperspectral spectrum is representative of the overall composition of the chemicals in that pixel [8]. As for the rust spot inspection, the hyperspectral imaging technique greatly reduced the false detection as opposed to the RGB method [33].

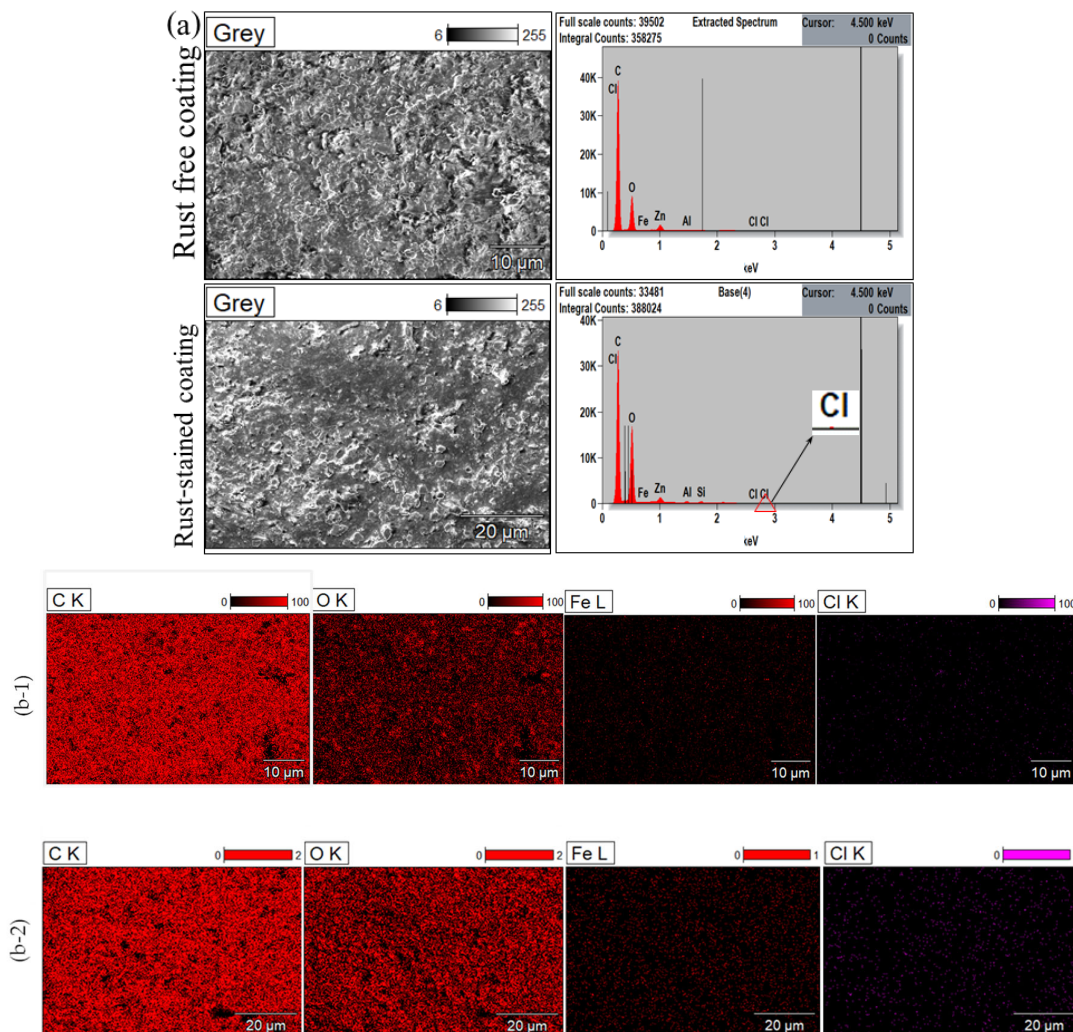
The coating samples with rust stains are analyzed by energy-dispersive X-ray spectroscopy (EDS) as opposed to the normal coating on this girder. Figure 7 shows the comparison of the element mapping results. The EDS spectrum as shown in Figure 7a demonstrates detectable peaks in terms of chloride (Cl) for the rust-stained coating, while the rust-free coating is dominated by the topcoat polymer compositional elements, carbon (C) and oxygen (O). The presence of Cl is also reflected by the element mapping result, as illustrated in Figure 7b. For elements related to steel rust, Fe and Cl show significant differences in distribution. Oxygen (O) is not considered here to distinguish rust because of its massive existence in alkyd resins and thus cannot be easily impacted [34]. As seen from Figure 7b, Fe is more visible on the coating with rust stains, though Fe is also spotted in the rust-free coating samples. For Cl, the contrast is more significant because it almost disappears in rust-free samples. Table 1 shows the element ratio of each detectable element present on the coating surface. C and O occupy, in total, about 90% of the coating topology, and nitrogen (N) is the third prevailing element that makes up around 7.5% of the coating topology. The elemental dominance agrees well with the composition of alkyd. The rust-stained coating has Fe of 1.78%, which is higher than the 0.56% in the rust-free coating. As for Cl, it occupies 0.51% of the total detectable elements for the topcoat with rust stains in comparison with 0% Cl in the stain-free topcoat. Element Cl distinguishes the rust-contaminated coatings from the rust-free sample, which shows negligible presence.

The result is consistent with the hyperspectral imaging result, which shows the rust stain distribution as well as the corrosion source as Cl-related media.

**Figure 7.** Comparison of the element distribution on the coating with and without rust stains by (a) EDS spectra, (b-1) element distribution of rust-free topcoat from EDS mapping, (b-2) element distribution of rust-stained topcoat from EDS mapping.

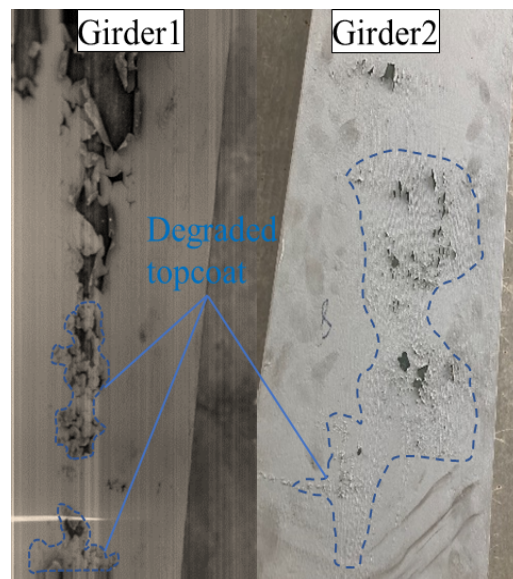
A degraded topcoat can expose the undercoat and thus increase the corrosion probability of the substrate. Early detection can potentially enhance the serviceability of steel girders. Figure 8 shows the deteriorated topcoat on the bottom flange of the steel girders in the proposed field bridge. Those deteriorated topcoats have lost their cling to the undercoat and thus cannot effectively protect the undercoat and substrate. As the degradation is generally characterized by chain breakage due to oxidation, Figure 9 displays the comparison between healthy and degraded topcoats by both FTIR and SWIR spectroscopy from hyperspectral imaging. FTIR provides complementary information for SWIR spectroscopy to interpret the topcoat degradation in view of the binder's chemical connections.

**Figure 8.** Demonstration of the degraded topcoat on the bottom flange of the steel girder.

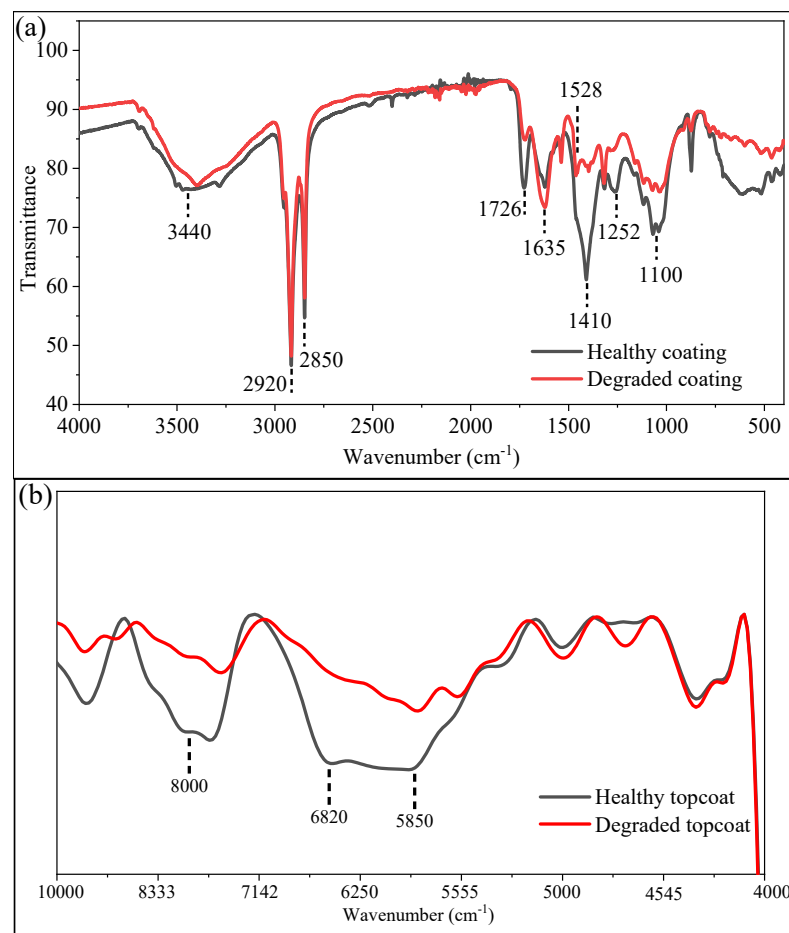
**Figure 9.** Comparison of the healthy and degraded topcoat in the range of (a) 400–4000  $\text{cm}^{-1}$  (FTIR), (b) 4000–10,000  $\text{cm}^{-1}$  (SWIR).

Considering the natural aging and atmospheric exposure effects on the topcoat, the stretching vibrations of the C=O at 1726  $\text{cm}^{-1}$  and C–O–C at 1528  $\text{cm}^{-1}$  are featured by the bond cleavage in the polyester of the girder topcoat, alkyd resin [35,36]. Table 2 sum-

marizes the band assignment of the alkyd resin. It can be seen that the narrow absorption bands at  $1726\text{ cm}^{-1}$  and  $1528\text{ cm}^{-1}$  both significantly decrease for the degraded topcoat in comparison to the healthy, which indicates the chains shortening in the polymer [36]. The chain scission in polyester is also observed by the decreasing absorption at  $2920\text{ cm}^{-1}$  and  $2850\text{ cm}^{-1}$  for degraded topcoat, which illustrates the reduced presence of the side chains [37]. In addition, the O–C–O featured band at  $1410\text{ cm}^{-1}$  almost disappears to demonstrate the reduction side chain [38]. On the contrary, it is noted that  $1635\text{ cm}^{-1}$  is boosted due to the degradation effect on the topcoat [36,39]. It is because of the autoxidation of the polymer crosslink. In this process, the degraded alkyd resin releases alcohol and carbonyl species, which thus reduces the molecular weight of the original topcoat component [37]. The decreasing weight of alkyd resin can also be implied by the diminished bands at  $1100\text{ cm}^{-1}$  and  $1252\text{ cm}^{-1}$ . The breakage of C–O–C produces volatile species, for example, phthalic acid due to the Norrish Type I reaction [39]. Figure 10 shows the microstructure of the healthy and deteriorated topcoats by SEM. In comparison, the degraded topcoat yields a messier topology, and the topcoat has been degraded into more pieces. Table 3 illustrates the presence of detectable elements on the topcoat derived from the EDS mapping results. C is significantly reduced from the healthy to the degraded topcoat due to the oxidation effect, which conforms to the FTIR results.

Figure 9b presents the spectra derived from the healthy and the degraded topcoat in the range of 4000–10,000  $\text{cm}^{-1}$  after continuum removal processing to facilitate quantitative comparison [28,39]. As illustrated in the FTIR, the main and side chains were greatly shortened due to the degradation effect. The reduction of the C=O in the degraded topcoat can also be detected in SWIR spectroscopy by the carbonyl stretching characterized bands at 5850  $\text{cm}^{-1}$  [40]. This band should be the overtones of the fundamental vibration of the carbonyl groups illustrated in 400–2000  $\text{cm}^{-1}$ . A similar decreasing trend at 5850  $\text{cm}^{-1}$  is also observed on the alkyd resins under ultra-violet exposure [41]. Another significant difference is located around 6820  $\text{cm}^{-1}$ , characterized by the second overtone of the hydroxyl group [8,41]. The absorption feature is almost gone due to the deterioration of the topcoat. The deletion of hydroxyl groups is also observed by the absorption at 3440  $\text{cm}^{-1}$  [36,37]. However, band 3440  $\text{cm}^{-1}$  remains significant, though it has decreased. It is because 3440 is characterized by not only the bending vibration of hydroxyl but also water [8]. The third recognizable spectral zone that differentiates healthy and degraded topcoats is around 8000  $\text{cm}^{-1}$ . This absorption intensity of this broadband shrinks due to the degradation of the topcoat, which is attributed to the loss of the oxygenated products, singly doubly bonded oxygen, due to photooxidation [40].

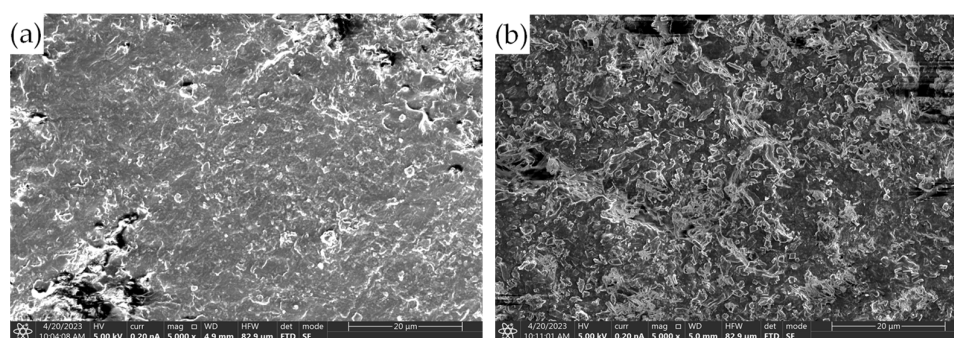
**Figure 10.** Topology by SEM of (a) healthy topcoat; (b) degraded topcoat.
