Field Reconnaissance And Observations From The February 6, 2023, Turkey Earthquake Sequence

Field reconnaissance and observations from the February 6, 2023, Turkey earthquake sequence

Gulen Ozkula¹ · Robert K. Dowell² · Tugce Baser³ · Jui-Liang Lin⁴ · Ozgun A. Numanoglu⁵ · Okan Ilhan⁶ · C. Guney Olgun⁷ · Cheng-Wei Huang⁴ · Tunc Deniz Uludag⁸

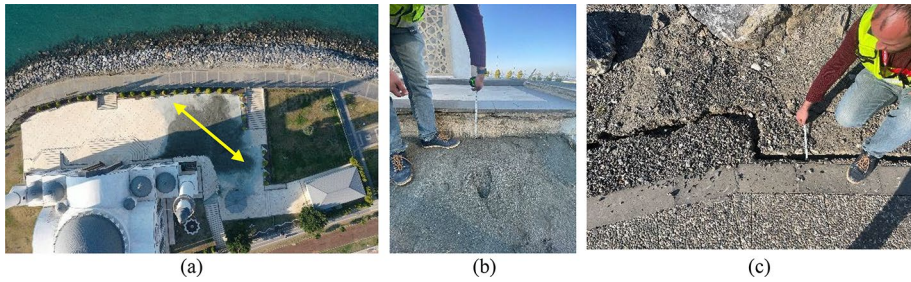
Preliminary observations indicate that Iskenderun experienced widespread liquefaction and lateral spreading. The observations regarding liquefaction, liquefaction-induced lateral spreading and ground deformations, and seismic-induced deformations in different parts of Iskenderun are presented in Fig. 6 through Fig. 8. Settlements were observed both in near-free-field conditions (Fig. 7) and under the structures, including the public dock of Iskenderun (Fig. 8). Evidence of soil ejecta and significant settlements was observed around a multi-story building and a mosque built on a reclamation area (Fig. 6). Settlements were

Fig. 6 Liquefaction manifestations in Nihal Atakas Mosque (~36°35'35.27"N/36° 9'26.74"E): **a** bird's-eye view of the sand ejecta at the corner; **b** up to 30-cm settlements of the sand near the mosque; **c** lateral spreading near the mosque towards the sea

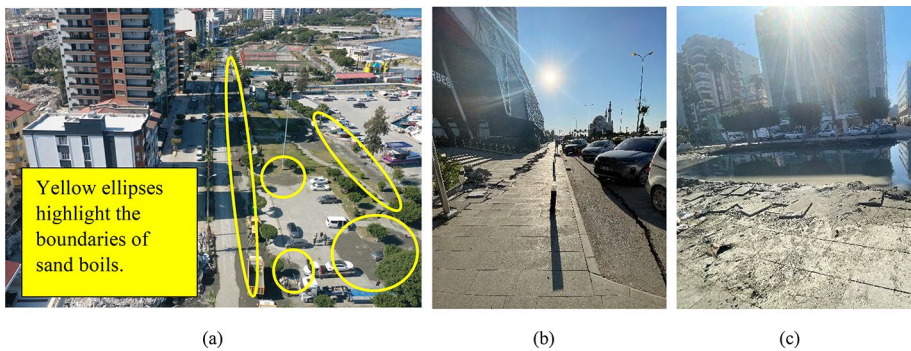
Fig. 7 Liquefaction manifestations (sand boils) **a** at Ataturk Boulevard (~36°35'26.86"N/36° 10'40.39"E); **b** cracks formed due to lateral deformation near Forbes shopping center (~36°35'36.52"N/36° 9'34.67"E); **c** near tennis courts (~36°35'26.95"N/ 36° 10'28.39"E): water accumulation and sand boils on the street

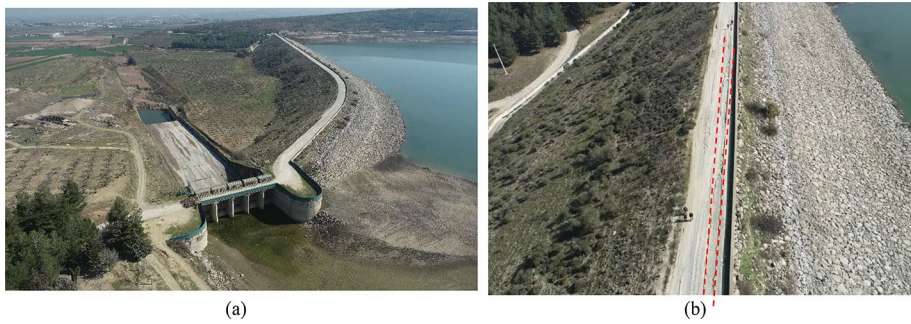
The Yarseli Dam is an earth dam constructed between 1985 and 1991 in Antakya for irrigation purposes. The crest height from the stream level is almost 37 m as seen in Fig. 11a. Crest cracking with lateral displacements varies between 0.15 and 0.25 m as shown in Fig. 11b. There were no sand boils on the earth-dam surface, so no trace of liquefaction was observed. The hydraulic structures had no obvious cracking or damage.

Fig. 11 Aerial pictures of the Yarseli dam (36.194290N, 36.329264E): **a** Overview; **b** Cracks in the crest

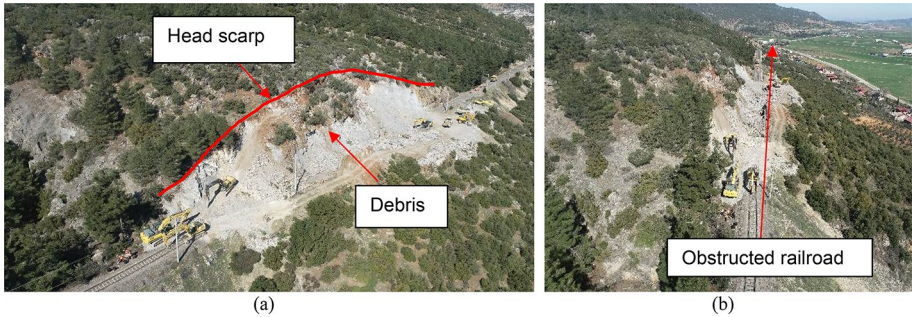
Fig. 14 Landslide near a railroad in Islahiye at $\sim 37^{\circ}06'43.41''\text{N}/36^{\circ} 39'34.91''\text{E}$ (aerial photographs taken for the same slope failure at different angles)

Another landslide was documented in the Fevzipaşa–Meydanekbez segment running N-S from the main Adana-Gaziantep rail line towards Aleppo, Syria. The approximate location of the landslide is marked in Fig. 13. As can be seen in the map, this is a critical location and is one of the segments connecting Syria with Turkey. The collected data are not enough to report if the landslide was caused by the first or second earthquake in the sequence. Aerial footage of the landslide indicates that the head scarp is approximately 100 m long (Fig. 14a). Several backhoes were immediately sent to the site for debris removal as can be seen in Fig. 14b.

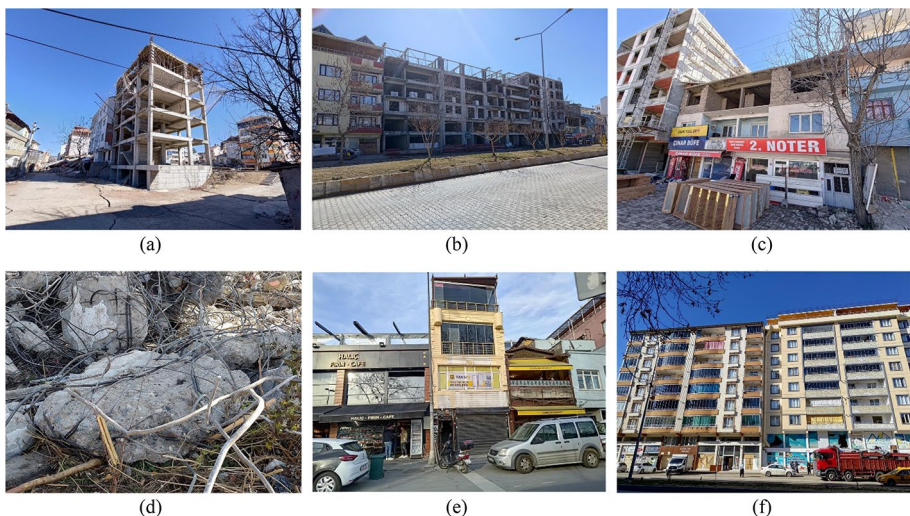
Fig. 16 a and b Two buildings with different construction practices, c a building with an added third story, d poor concrete and plain reinforcement, e and f no separation between buildings

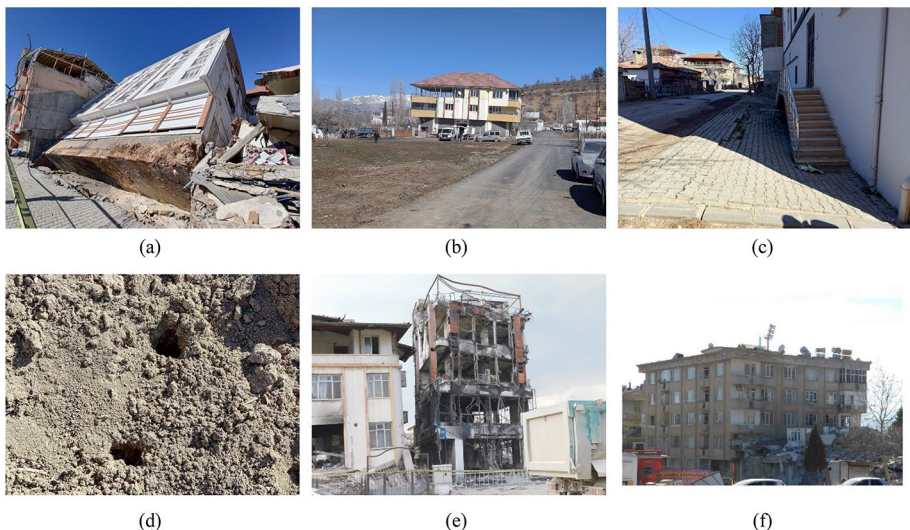
Fig. 18 **a** An overturned building, **b** unequal settlement of a building, **c** settlement of ground, **d** sand boils, **e** secondary disaster, **f** damaged facilities atop a roof

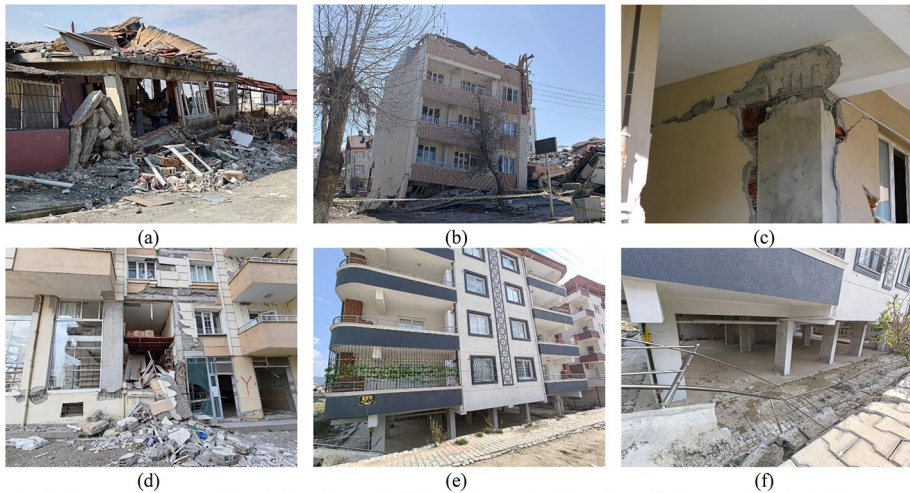
Figure 19a and b shows that two buildings collapsed along the street because the weak direction of columns was oriented along the street. The large aspect ratio of column cross sections, rather than a square, seems to be common in the region that was observed to increase indoor space. Nevertheless, once all columns are oriented in the same way, the building would be soft and weak in the weak-axis direction of the column, i.e., the vulnerable direction of the building to earthquakes. In addition, the strong beam-weak column concept likely exists in the weak direction [i.e., plastic hinges will be formed in columns rather than in the beams, such as that shown in Fig. 19c]. Figure 19d shows the

Fig. 19 Structural damages **a** and **b** collapsed buildings along a significantly weak direction; **c** plastic hinges at top and **d** plastic hinges at bottom of columns, **e** an almost intact building, and **f** a close-up photograph of **e**

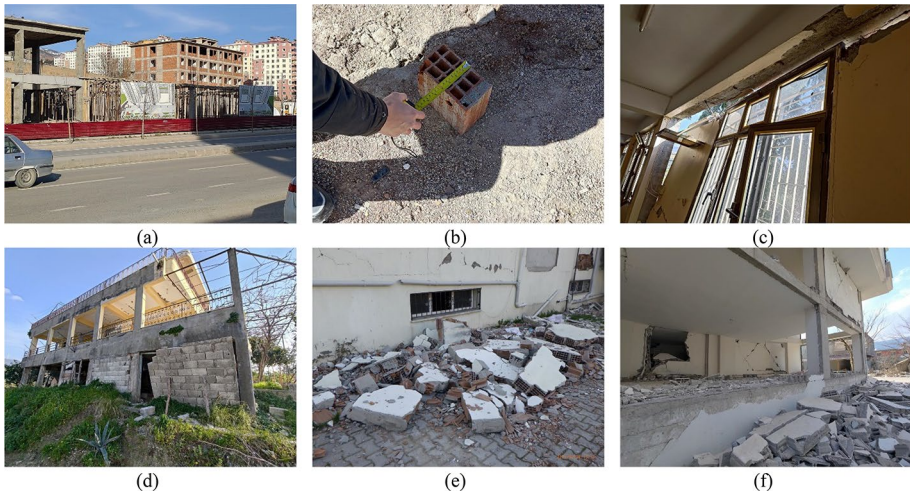
Figure 20a shows two buildings at one construction project. The progress of the right building was ahead of that of the left building. Figure 20a shows that the exterior and partition walls (often called infill walls) are usually made of bricks, which are erected after completing the beam-column frame system. The thickness of typical brick walls is 15 cm, which consists of 10 cm thickness of bricks and 2.5 cm covering on both sides of the bricks (Fig. 20b). Because there are no connectors between the brick walls and beams/columns, the brick walls fall out of the beam-column frames (Fig. 20c–e). At this point, it is not clear if the infill walls are considered in the structural analysis and design of the buildings in Turkey. Nevertheless, Fig. 20f shows that the infill walls indeed share the seismic force and partially support the building weight. Beams and columns were thus protected from damage to a certain extent (Fig. 20f). However, the participation of infill walls in the lateral force resistance significantly increases the lateral stiffness of beam-column frames. Therefore, the actual vibration periods of buildings with infill walls are substantially less than those obtained from numerical models without considering infill walls. In other words, the actual sustained seismic force of buildings is probably greater than the design base shear obtained from the numerical models without considering infill walls. Also infill walls falling to the streets represent a severe hazard to people. Turkey should decide to either consider infill walls in the seismic performance or not. These walls should be connected properly to the RC frame members and bricks or blocks properly connected to each other. If the

Fig. 20 **a** Two buildings of one construction project, **b** a typical brick, **c** and **d** brick walls popped out of frames, **e** brick walls fallen down, **f** beams and columns were almost intact but brick walls seriously cracked

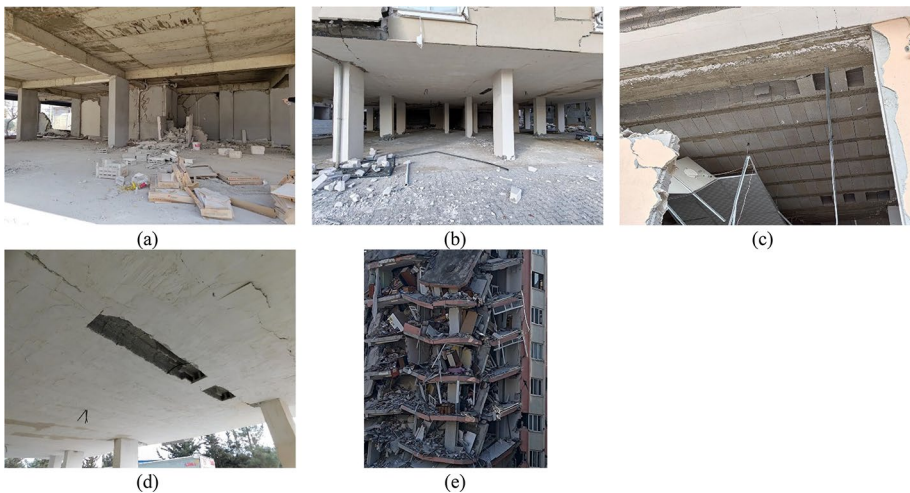
The floor slab systems used in Turkey seem to be categorized into two types: one type is supported by beams and columns (Fig. 21a) and the other type is supported by only columns which can be called hidden beam slabs [i.e., no beams, as shown in Fig. 21b]. The hidden beam slab usually consists of a flat slab that is reinforced with steel bars and has a shallow beam integrated into it. The beam is usually placed at the perimeter of the slab and

Fig. 21 A floor slab system **a** supported by beams and columns, **b** directly supported by columns, **c** and **d** bricks of the no-beam slab system fallen down, **e** a building with the no-beam slab system was under demolition

is surrounded by the concrete slab. The beam and slab work together to transfer loads from the structure above to the supporting columns or walls. However, it was observed that these slabs are made of bricks, whereas the bricks are possibly fallen down from earthquakes, as shown in Fig. 21c, d. In light of some collapsed or seriously damaged buildings consisting of that floor slab system [e.g., Figs. 17b and 21e, which is a close-up photograph of the left building shown in Fig. 15c], the seismic performance of the no-beam slab system is certainly in doubt.

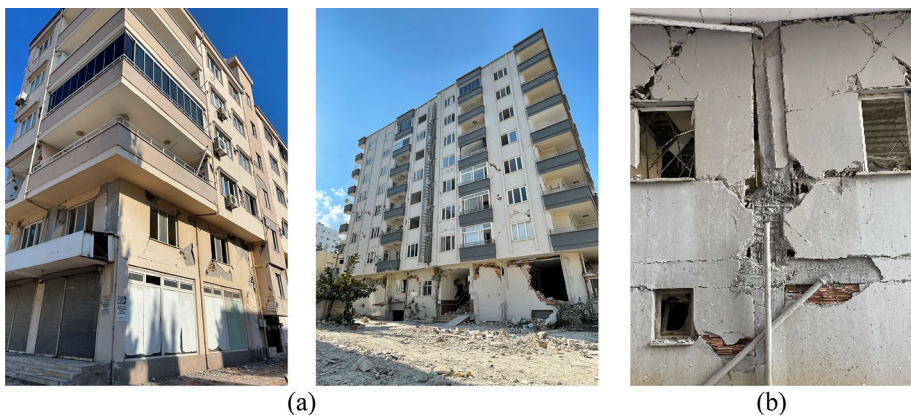
In Turkey, close and open overhangs are commonly used in building design, such as balconies, semi-balconies, and extended rooms. However, previous earthquakes have shown that buildings with overhangs tend to sustain more damage compared to those without. Despite that the Turkish seismic design code allows for overhangs and requires them to be designed to withstand seismic loads, numerous issues have been reported during construction in post-earthquake assessments (GEER 2020, DAUM 2020, METU-EERC, 2011). Damage examples caused by overhanging structures are shown in Fig. 22a. High stress is placed on the columns at cantilever beam connections that intersect with overhangs, leading to significant structural damage at these critical locations. To increase rigidity at these junctions, it may be advisable to use reinforced concrete walls instead of columns if overhangs are unavoidable. A common type of column damage occurs when the columns are partially restricted from lateral movement by strong infill walls or nonstructural partitions of partial heights. These captive columns are prevalent in many buildings, often found in areas such as staircases, toilets, and rooms with windows, primarily because structural engineers do not typically consider them in their earthquake-resistant designs. As shown in Fig. 22b, these captive columns can sustain significant damage during earthquakes. Additionally, it has been demonstrated that equations provided in the main design codes, such as ACI 318 (2005), cannot accurately predict their shear capacity, with the difference sometimes exceeding 150%. Consequently, their existence in buildings should be avoided.

Fig. 22 Residential building damages **a** due to overhangs, **b** captive/short column due to strong infill walls

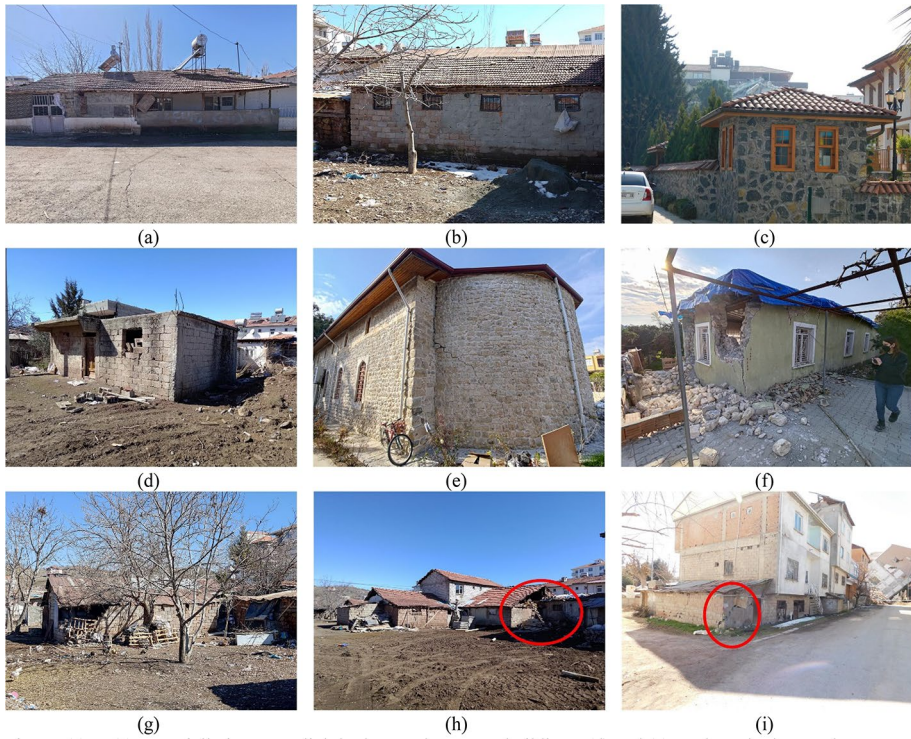
Masonry buildings were generally located in rural areas of the seismic disaster regions. Figure 23a, b shows that two old masonry buildings made of clay bricks were essentially intact, or slightly damaged, despite the two buildings seeming to be not engineered

Fig. 23 **a–c** Essentially intact or slightly damaged masonry buildings, **d** and **e** moderately damaged masonry buildings, **f–h** severely damaged masonry buildings, **i** a pure sliding mode of failure mechanism of a brick wall

structures. The masonry walls and tiled roof stayed with structural integrity from the earthquake. Note that the water tanks atop the roofs still remained, i.e., no damage to the supports of the water tanks. Because one-story masonry buildings are very stiff, ground accelerations are not amplified much at the roof line. In contrast, some similar water tanks on top of mid-rise and low-rise buildings in urban areas were toppled down (Fig. 18f). This observation means that whether the supports of water tanks are strong enough depends on the roof acceleration demands, which are usually greater as the number of stories increases. Figure 23c shows a relatively new stone masonry structure, which also seemed to be intact following the earthquake. Figure 23d, e shows moderately damaged masonry buildings with a few fallen bricks and diagonal shear cracks on the walls. Figure 23f, g illustrates severely damaged masonry buildings with crushed or toppled brick walls at the corners. This observation indicates that the brick walls subjected to bi-directional forces are a specific vulnerability of masonry buildings. Lack of connection between orthogonal walls in masonry structures may cause damage if these walls do not share some bricks to act together as shown in Fig. 23f, which was made of two-leaf brick walls. In light of the different damaged heights between the two leaves of brick walls, the mortar between the multi-leaf brick walls seemed to be insufficient. Figure 23h shows that the entire gable wall of a masonry building almost disappeared, which probably had been cleared away after the gable wall toppled. In addition, the

roofs adopted in the buildings shown in Fig. 23f–h seemed to be simply rested on top of perimeter walls. Therefore, the roofs had no capacity of constraining out-of-plan collapse of the walls. Figure 23i illustrates that a pure sliding mode failure mechanism of a brick wall occurred at a one-story masonry building, which probably resulted from the thrust of the adjacent three-story building.

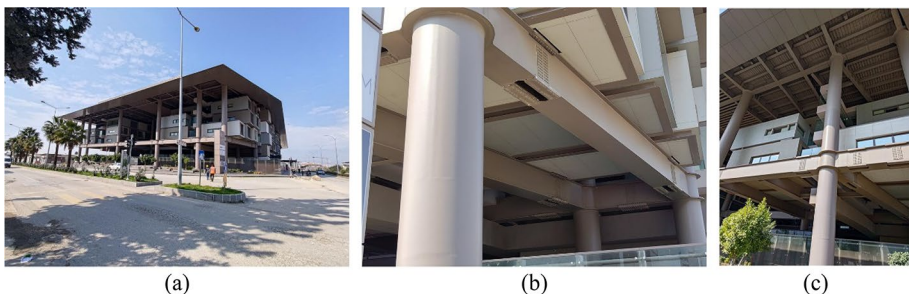
Only one steel building was observed during the six-day structural seismic reconnaissance (Fig. 24a). Entry into that steel building, which is a new museum hotel with exterior circular columns and box girders (Fig. 24b, c), was not permitted. Therefore, the state of the interior structure is unknown. Once the spectral value of the experienced ground motion at the fundamental vibration period of the building surpassed the corresponding design spectral value, some damage (even minor yielding) would be expected. Nevertheless, the building seemed almost perfect (elastic) in terms of its appearance from the outside, as shown in Fig. 24a. It is thus reasonable to infer that either the spectral value did not surpass the design spectral value or some energy dissipation devices (or base isolators) were deployed in the building.

Moreover, Fig. 24 shows that the building seems to have prefabricated modules, which look like containers stacked up to three layers. Those modules are rested upon the second-floor girders. The stacked modules are covered with a roof system, which seems to consist of general metal decks, beams, and girders. Figure 24 also indicates that the long central segments of the second-floor girders are bolted to their short side segments. The short side segments of girders are then welded to columns through top and bottom circular rings. This type of beam-to-circular column connections is likely to have bolting on site and welding in factories. In addition to the better-quality control of welding in factories, the circular rings, which probably more uniformly distribute stress to the whole circumference of cross sections of columns, should be one of the factors contributing to the remarkable seismic performance of the building from the earthquake.

Fig. 24 **a** A steel building, **b** splices of beam segments, **c** a beam-column joint

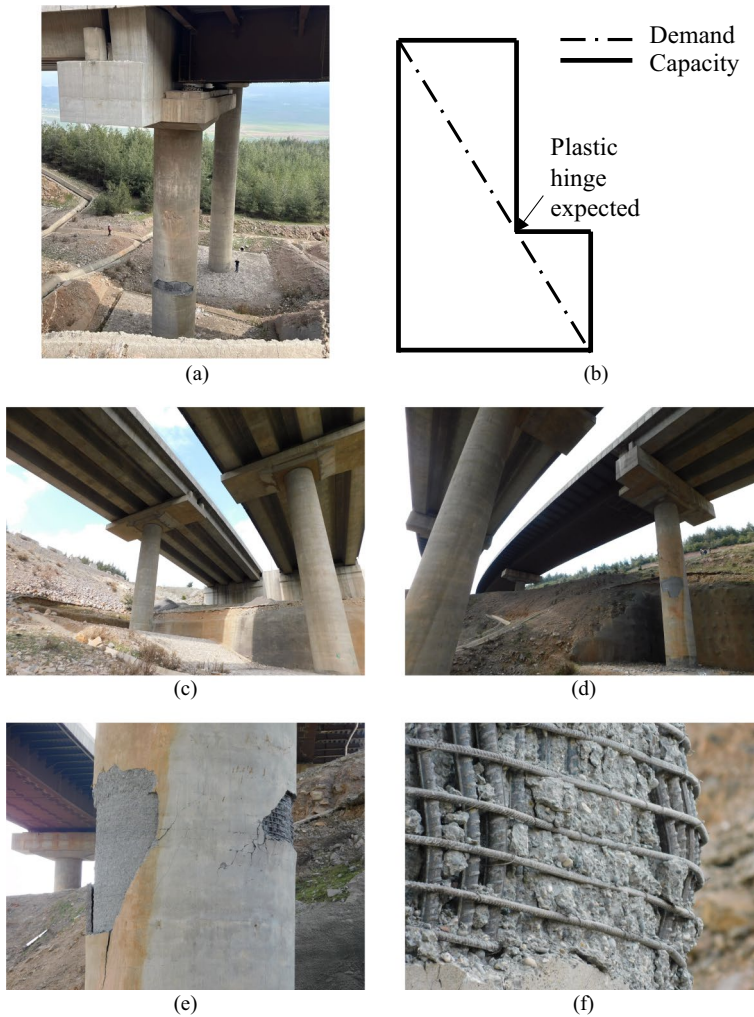
A single column plastic hinge formed at these two adjacent bridge structures of Bridge 1, but not at the bottom of the column where the moment is largest for a cantilever column. The plastic hinge developed in the transverse bridge direction at about 1/4 up the height of the column length (Fig. 27a). A side view of the plastic hinge region is given in Fig. 27e. On the one side of the plastic hinge, the vertical column steel buckled and the transverse

Fig. 27 Bridge 1. **a** overall view of column with plastic hinge, **b** moment demand and moment capacity of column, **c** under bridge, looking toward one abutment, **d** under bridge, looking toward other abutment, **e** Side view of column and plastic hinge, **f** plastic hinge with buckling of vertical rebar and yielding of transverse rebar

steel yielded over several rebar (Fig. 27f), while on the opposite side a large portion of cover concrete spalled off, but with no signs of transverse steel yielding or vertical rebar buckling (Fig. 27e). The most reasonable explanation for why a plastic hinge occurred 25% up the column height, instead of at the column/footing interface, as expected, is that there were vertical bar cutoffs at this location, reducing the moment capacity to the point that the moment demand/capacity ratio was larger here than at the column base (Fig. 27b). Spalling of unconfined cover concrete on both sides of this plastic hinge clearly indicates cyclic behavior in the transverse direction of the bent, with compressive concrete strains of at least 0.005 (and probably beyond 0.01) in both loading directions (Caltrans 2019, Priestley,

Vertical rebar buckling in a column plastic hinge indicates it was close to failure, suggesting that the structure was on the verge of collapse. Note that the spacing of the transverse steel looks good, but the bar size appears to be too small for a ductile plastic hinge to develop. This is probably because the plastic hinge was not expected at this location with, perhaps, larger transverse rebar provided towards the bottom of the column. While bar cut-offs is the most likely reason a plastic hinge formed part way up the column height, it is possible that this location had a larger moment demand than at the base of the column due to the combined effects of the transverse mass and rotational mass inertia from the large bridge structure, which is especially important for single-column-bent bridges (Dowell 2004) since the bridge is free to rotate at the top in the transverse direction as it displaces.

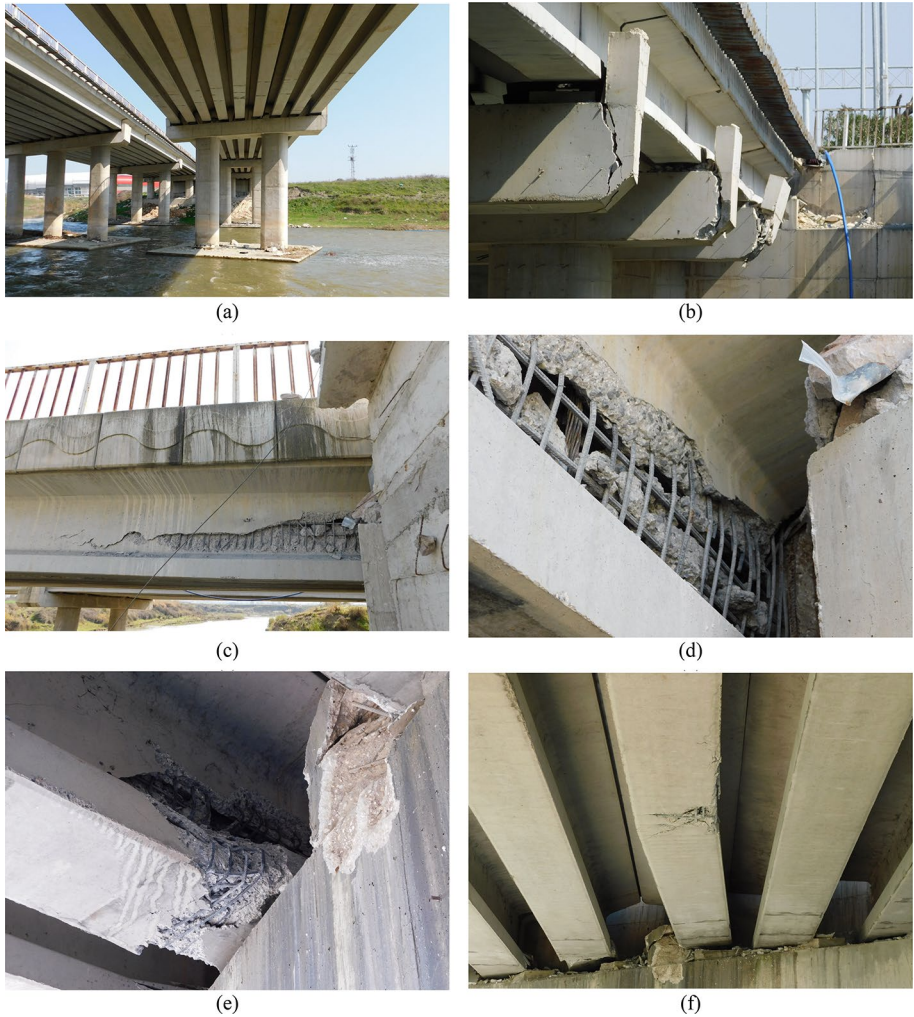
These two parallel and straight bridges (Asi Bridge) are over water (Asi River) and located at GPS coordinates N 36.25505° E 36.20430° and elevation of 315 feet (96.0 m). They consist of precast, prestressed, I-girders with RC topping slab and CIP columns (Fig. 28a). Lateral motion of the bridge caused severe damage and failure of external shear keys (Fig. 28b). The ends of all of the precast concrete girders were extensively damaged at the abutments from large vertical accelerations and forces, including impact, resulting in shear cracks and extensive spalling of the concrete, as shown in Fig. 28c, d. The spalling extended a long distance out into the girder (Fig. 28c), far beyond the supports. In many cases, there was no concrete left, with just the rebar cage remaining toward the girder end (Fig. 28d).

With no concrete left at the girder ends, there is nothing to hold the prestressing steel to the girder end region, with the transfer length moving to where there is still concrete, causing added damage to the already-cracked girder end region, with more spalling and slip, until a much longer distance of damage has developed than from just diagonal shear cracking. As seen in Fig. 28c, the spalled region at the girder ends is very long. Severe twisting and bending of one precast girder occurred, as seen in Fig. 28e, f. Also, plastic hinges developed at the base of the columns in the longitudinal direction, as expected. Settlement occurred at both approaches to the bridge, requiring vehicles to slow down to enter and exit the structure.

Fig. 28 Bridge 2. **a** overall view from underneath the bridge, **b** failed exterior shear keys, **c** damage at girder ends, **d** concrete damage and spalling at girder ends, **e** damaged and twisted girder end, **f** bent girder

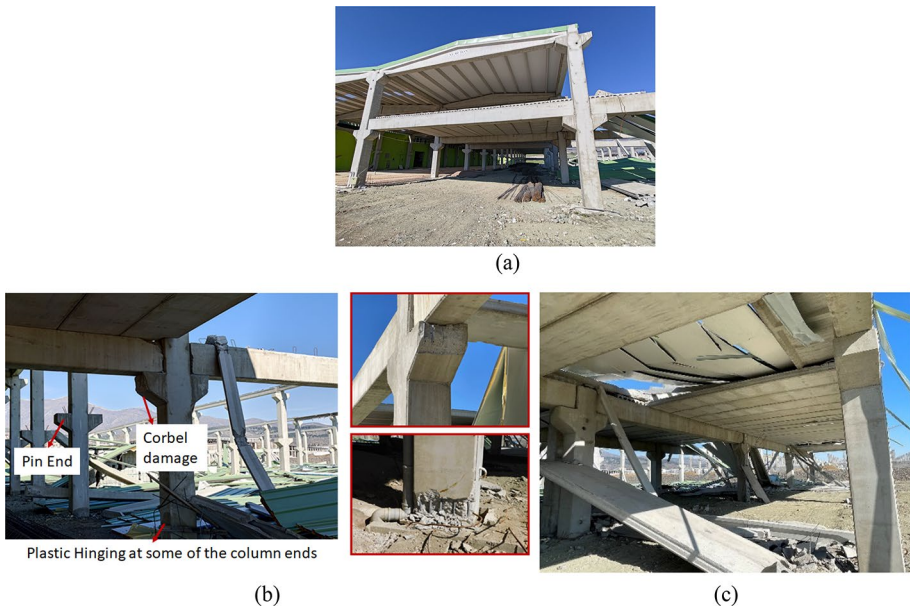
The typical major direction of the structures investigated in the Turkoglu OIZ in Kahramanmaraş had spans of roughly 15 m to 25 m, and the other direction had spans of approximately 8 m. Their story heights ranged from 7 to 10 m (Figs. 29a, 30a). As illustrated in Fig. 29a, the base of each precast column was grouted into a precast pocket foundation to make a fixed connection, and some of the column ends formed plastic hinges, as shown in Fig. 29b. The long-span roof girders were positioned along the building's transverse axis and were simply supported by column corbels. The depth of these girders frequently changes over their length, resulting in a triangle configuration (double-slope girders). Beams are directed along the building's longitudinal axis. Purlins span at regular intervals between the roof girders. The prefabricated roof girders, gutter beams, and purlins were simply held together at both ends (Fig. 29b, c). The horizontal beam–column connection is

Fig. 29 Damage of precast building: **a** undamaged portion of the precast building, **b** corbel damage and plastic hinging of column, **c** precast slab failure

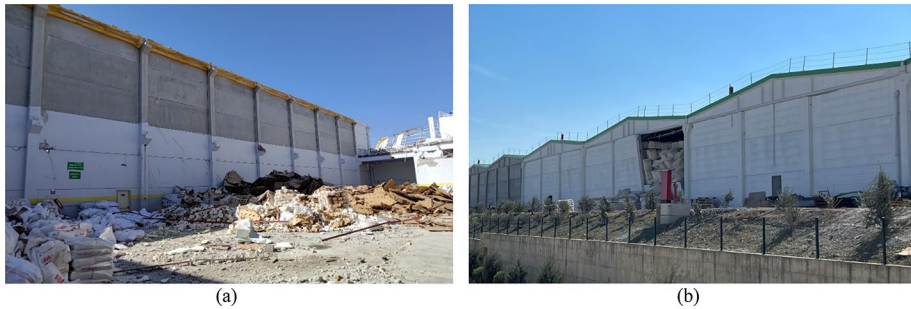
Fig. 30 Damage of precast buildings in Turkoglu OIZ **a** precast tapered beam failure owing to the loss of support, **b** cladding panels due to panel-to-structure failure

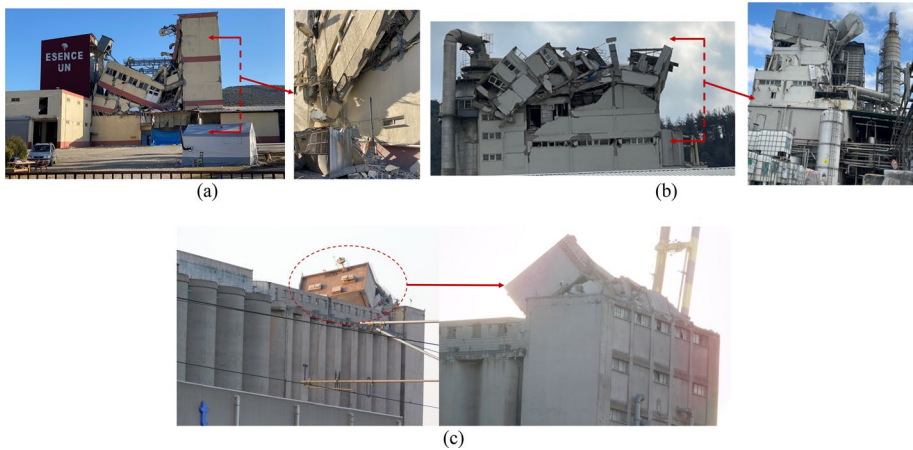
Fig. 31 Damage of RC buildings **a–b** Essence Un, **c** and **d** ABC Deterjan, **e** Toprak Mahsulleri Ofisi (TMO)

at the lower stories. High lateral acceleration demand at the top might have caused shear connection failure.

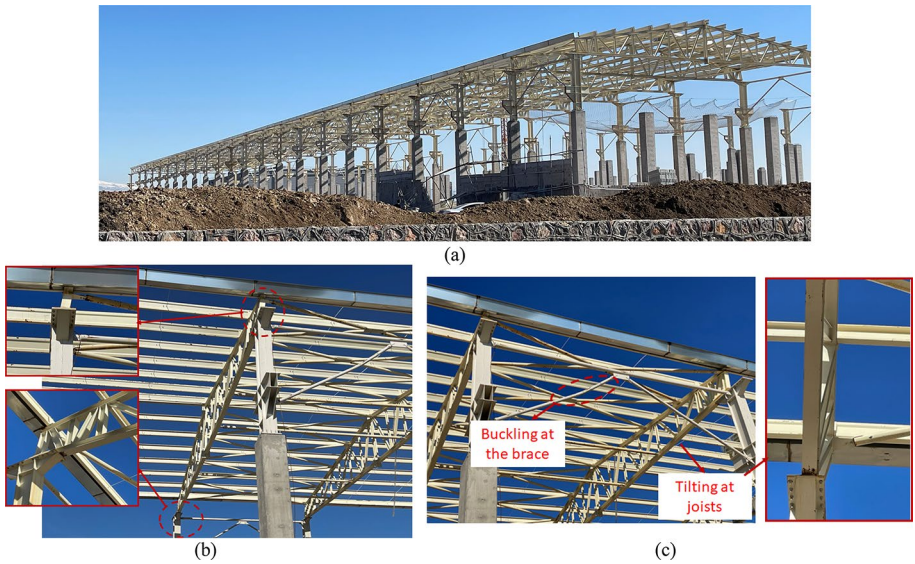
Fig. 32 Damage of steel roof system including reinforced concrete columns **a** overall view of structure, **b** steel truss tilting, **c** buckling at the brace due to collapsing of light roof covers

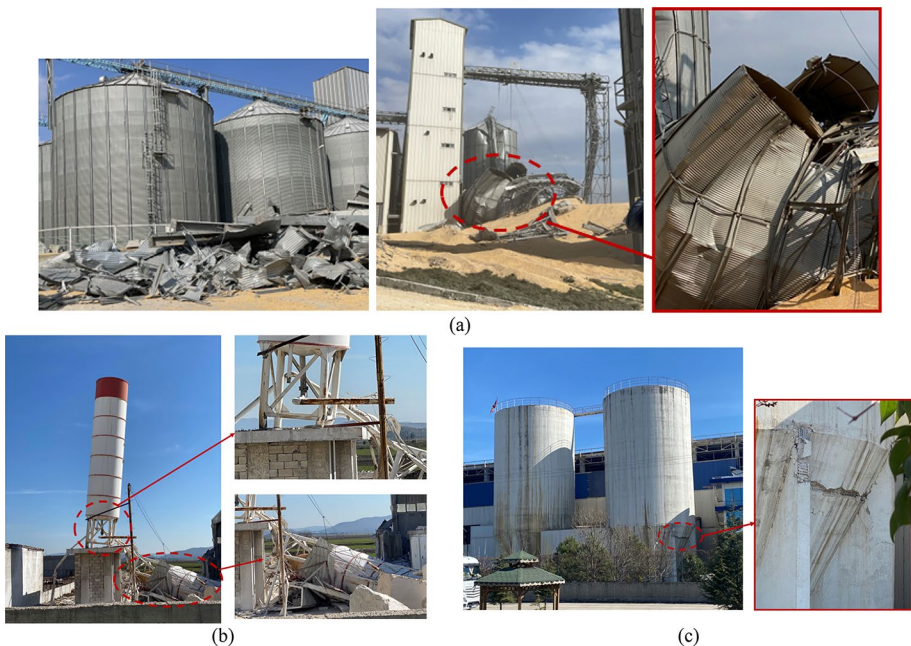
Fig. 34 Damage of silos **a** corn silos, **b** total collapse of a slender metal silo due to brittle welded connection, **c** concrete spalling on silos

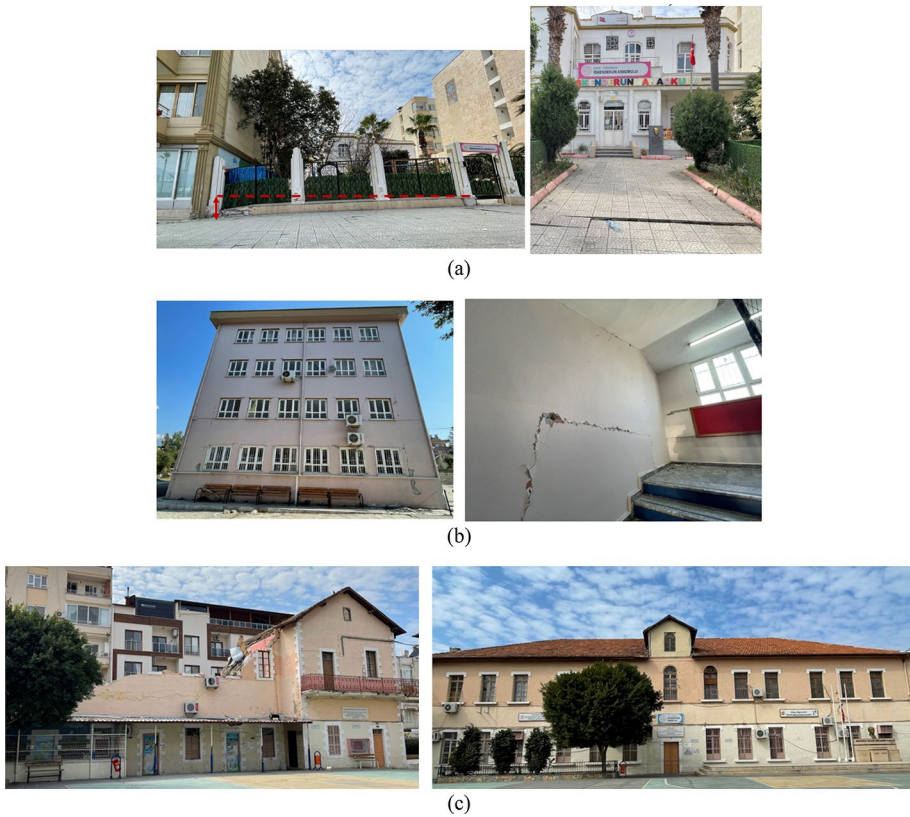
Fig. 35 Performance of schools in Iskenderun **a** Pre-school, **b** Retrofitted elementary school, **c** Unretrofitted elementary school

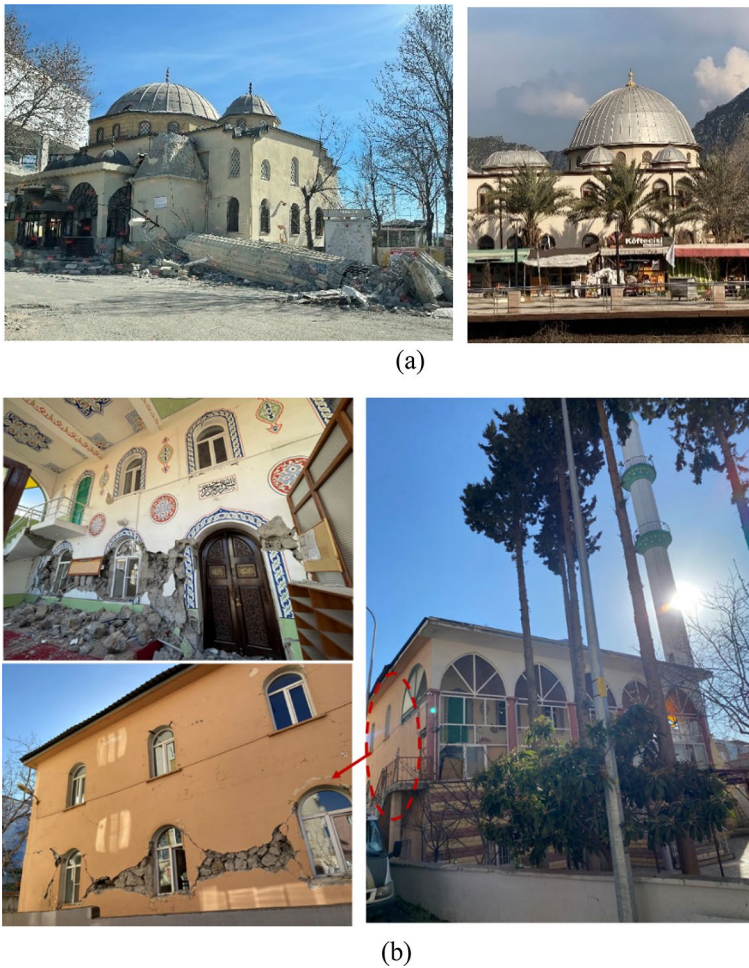
Fig. 36 Damage of mosques **a** Haci Murat Mosque in Kahramanmaraş, **b** Merkez Cumhuriyet Mosque in Pazarcik

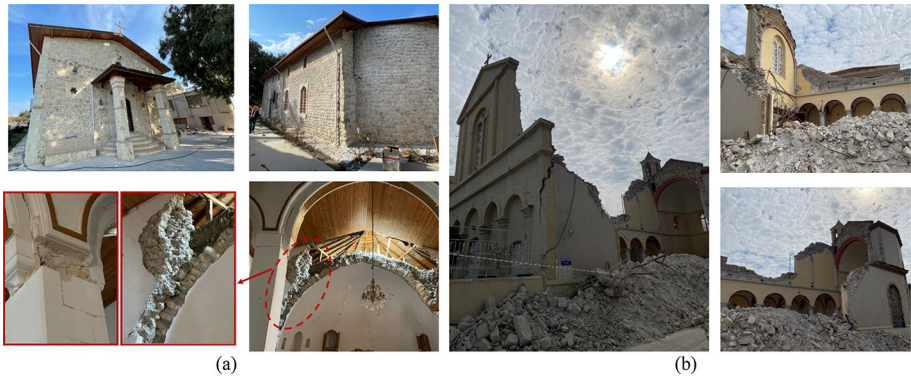
Fig. 37 Damage of churches **a** St. Ilyas church in Samandagi, Antakya, **b** Roman Catholic Church in Iskenderun
