Engineering Geology

Q1 Learning from hydrological and hydrogeological problems in civil engineering. Study of 2 reservoirs in Andalusia, Spain

This study presents a novel review of seven case histories of Andalusian reservoirs (Southern Spain) affected by 15 different hydrological and hydrogeological problems that have led to severe malfunctions. The failures reported 16 are related to (i) water quality degradation due to salinization and acid mine drainage, (ii) leakage in karstified 17 terrains, (iii) environmental and hydrogeological impacts associated with an inadequate water planning and (iv) 18 large evaporative losses from the reservoir. Detailed information on the geological context, hydrological/ 19 hydrogeological origin of the problem, repercussions on infrastructure functioning and remedial measures ap- 20 plied or proposed has been gathered for each case. Results of on-site research carried out by the authors in 21 some of the locations studied and a comparative analysis of similar case histories at international level are also 22 included. The purpose of this work is to emphasize the need of learning from past mistakes and provide guidance 23 for future dam construc

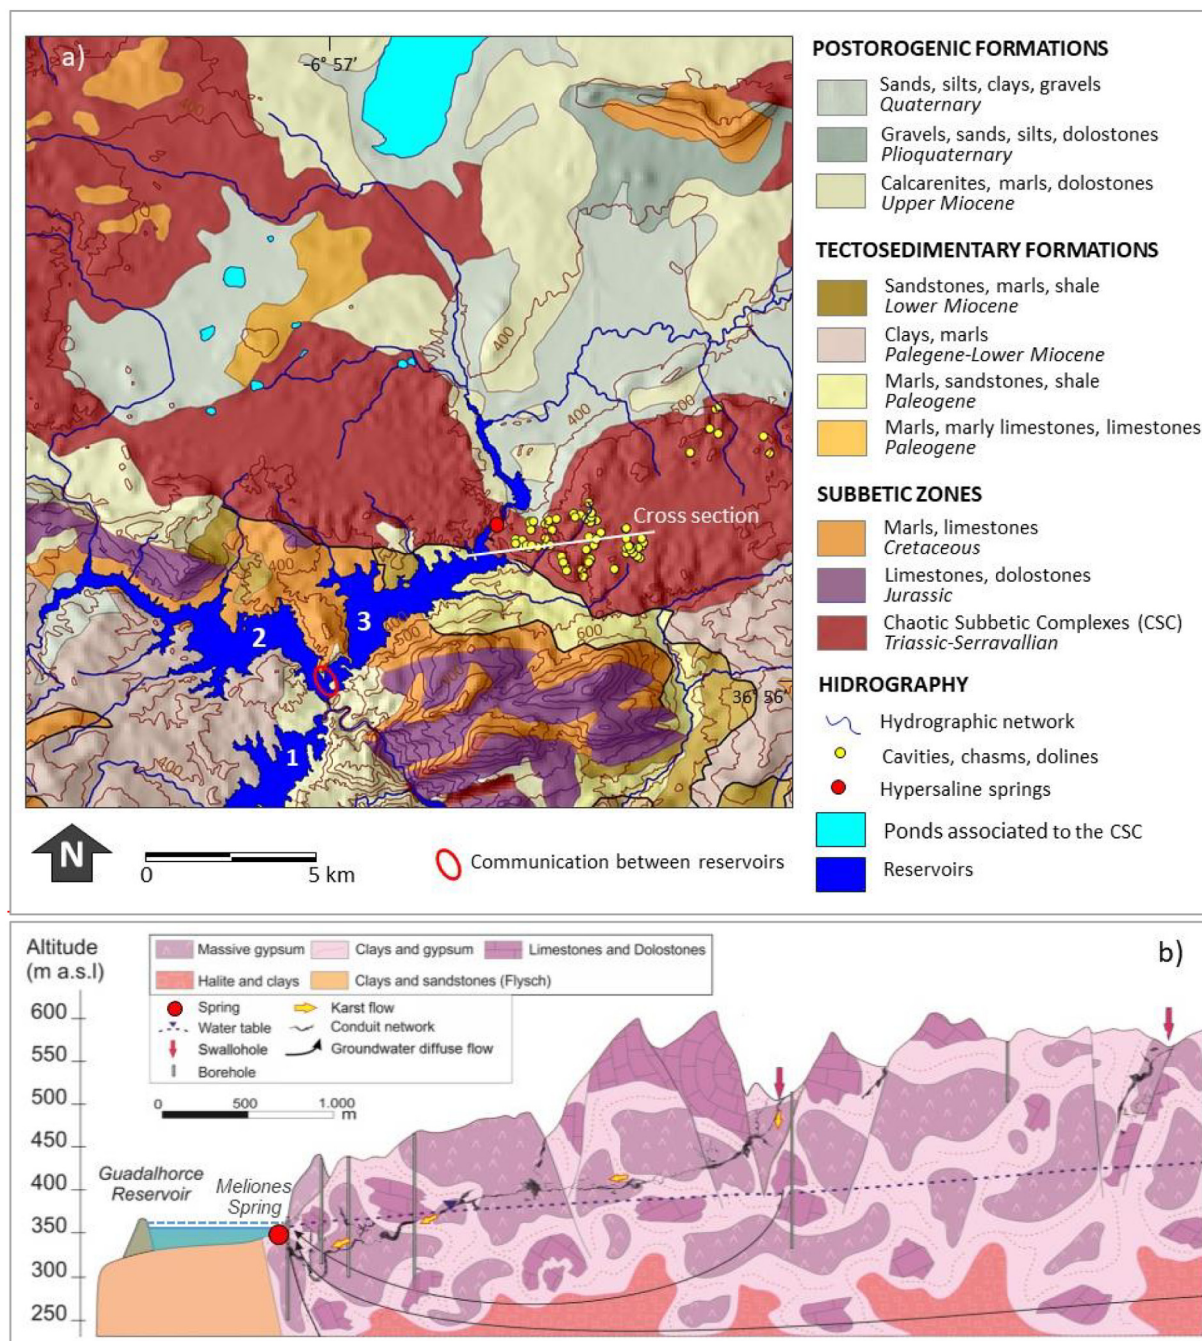
tail-end of the Guadalhorce reservoir. In this context, the above- 271
 mentioned set of hypersaline springs constitute the discharge pathways 272
 of the hydrogeological system. The conceptual model of the functioning 273
 of this sector considers distinct underground flows with different char- 274
 acteristics (Fig. 2b). Local flows are characterised by short pathways and 275
 are originated by infiltration of recent rainwater through the permeable 276
 materials around the springs. Intermediate flows are preferably devel- 277
 oped along the karst network, are fed mainly through dolines and sink- 278
 holes and produce medium-mineralized water and sulfated calcium 279
 facies. These flows respond quickly to large recharge events. Finally, 280
 the deepest flows, have longer residence times and are originated in 281
 the areas most distant from the springs, producing water of higher min- 282
 eralization and temperature with sodium chloride facies. These flows 283

Fig. 2. a) Geological map of the multi-reservoir system that supply water to Malaga. The position of the interpretative cross section shown in b) is indicated (1: Conde de Guadalhorce reservoir, 2: Guadalteba reservoir, 3: Guadalhorce reservoir) (own elaboration using information from <http://www.juntadeandalucia.es/medioambiente/site/rediam>). b) Cross section and conceptual model of the hydrogeological functioning of the Trias de Antequera for the Meliones sector (modified from Andreo et al., 2016).

310 In fact, a major design fault was committed: the vessels of the
 311 Guadalteba and Guadalhorce dams, both adjacent and simultaneously
 312 built in the decade of the 60's, were communicated. Above certain
 313 level, due to topographic reasons, the saline waters of Guadalhorce
 314 overtopped the reliefs that separate both vessels and entered in
 315 Guadalteba. This situation worsened the problem, causing an impover-
 316 ishment of the water quality in Guadalteba and compelling to the subse-
 317 quent construction of a separation dyke (see Fig. 2a). Besides, this
 318 circumstance hindered the operation of the reservoirs and the obtention
 319 of water of adequate quality to supply the urban areas (Contreras et al.,
 320 2016). In fact, while the water level in the Guadalteba tended to decrease
 321 due to urban consumption (especially during drought periods), the level

334 Numerous attempts were made to solve the problem of salinization
 335 in the Guadalhorce reservoir. Troyano and Díaz (2006) and Carrasco
 336 Cantos (2018) give a detailed description of the measures adopted,
 337 which comprised the following: (i) 1985–1987: Pumping the water of
 338 Meliones to evaporation ponds located at a higher site, in the
 339 Cañavalejo area. This initiative failed because the evaporation ponds
 340 had infiltration problems and part of the water returned to the reser-
 341 voir. (ii) 1993: Collect the brine prior to its entry into the reservoir by
 342 isolating the discharge area with a sheet pile screen and pumping it to
 343 the sea through a pipeline (approximately 50 km long and 300 m eleva-
 344 tion). The system could pump up to 75 l/s and came to reduce the salt
 345 inputs to 1/3 during dry periods, however, this measure was insufficient
 346 during very rainy periods when the discharge from the evaporitic karst

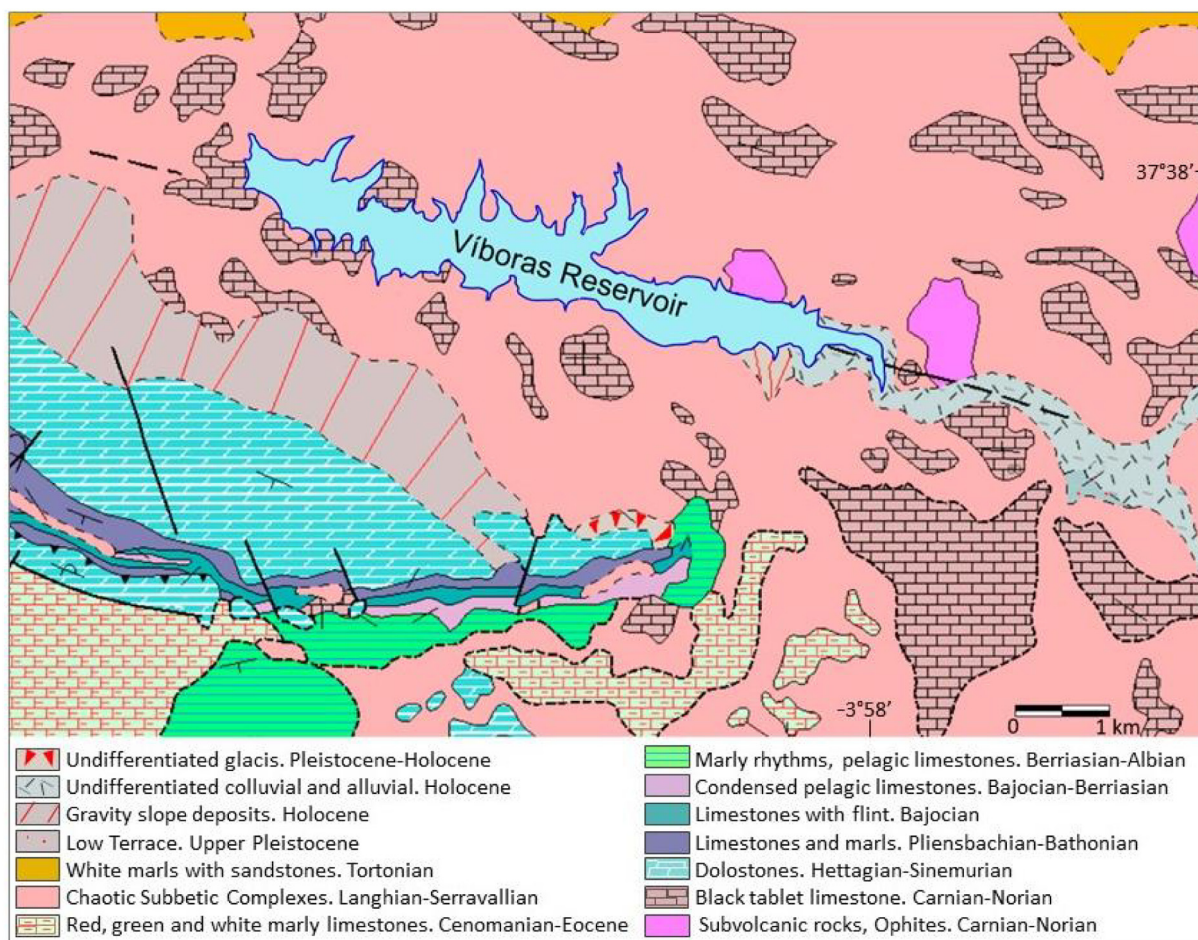
376 Part of the reservoir vessel and most of its catchment area are lo-
 377 cated in the outcrops of the SCC, described above (see section 2),
 378 where the geological materials are mostly Triassic, contain mainly
 379 clays with gypsum (locally halite), and olistolites of limestones,
 380 subvolcanic rocks, marls and sandstones (Fig. 3). These evaporitic min-
 381 erals (gypsum and halite) undergo dissolution processes when mete-
 382 oric water and runoff leach the soil and infiltrate through the
 383 permeable layers of this formation, leading to an impoverishment in
 384 the quality of its water.

Fig. 3. Geological map of the Vitoras reservoir (modified from: Continuous Digital Geological Map of Spain (GEODE, 2004).

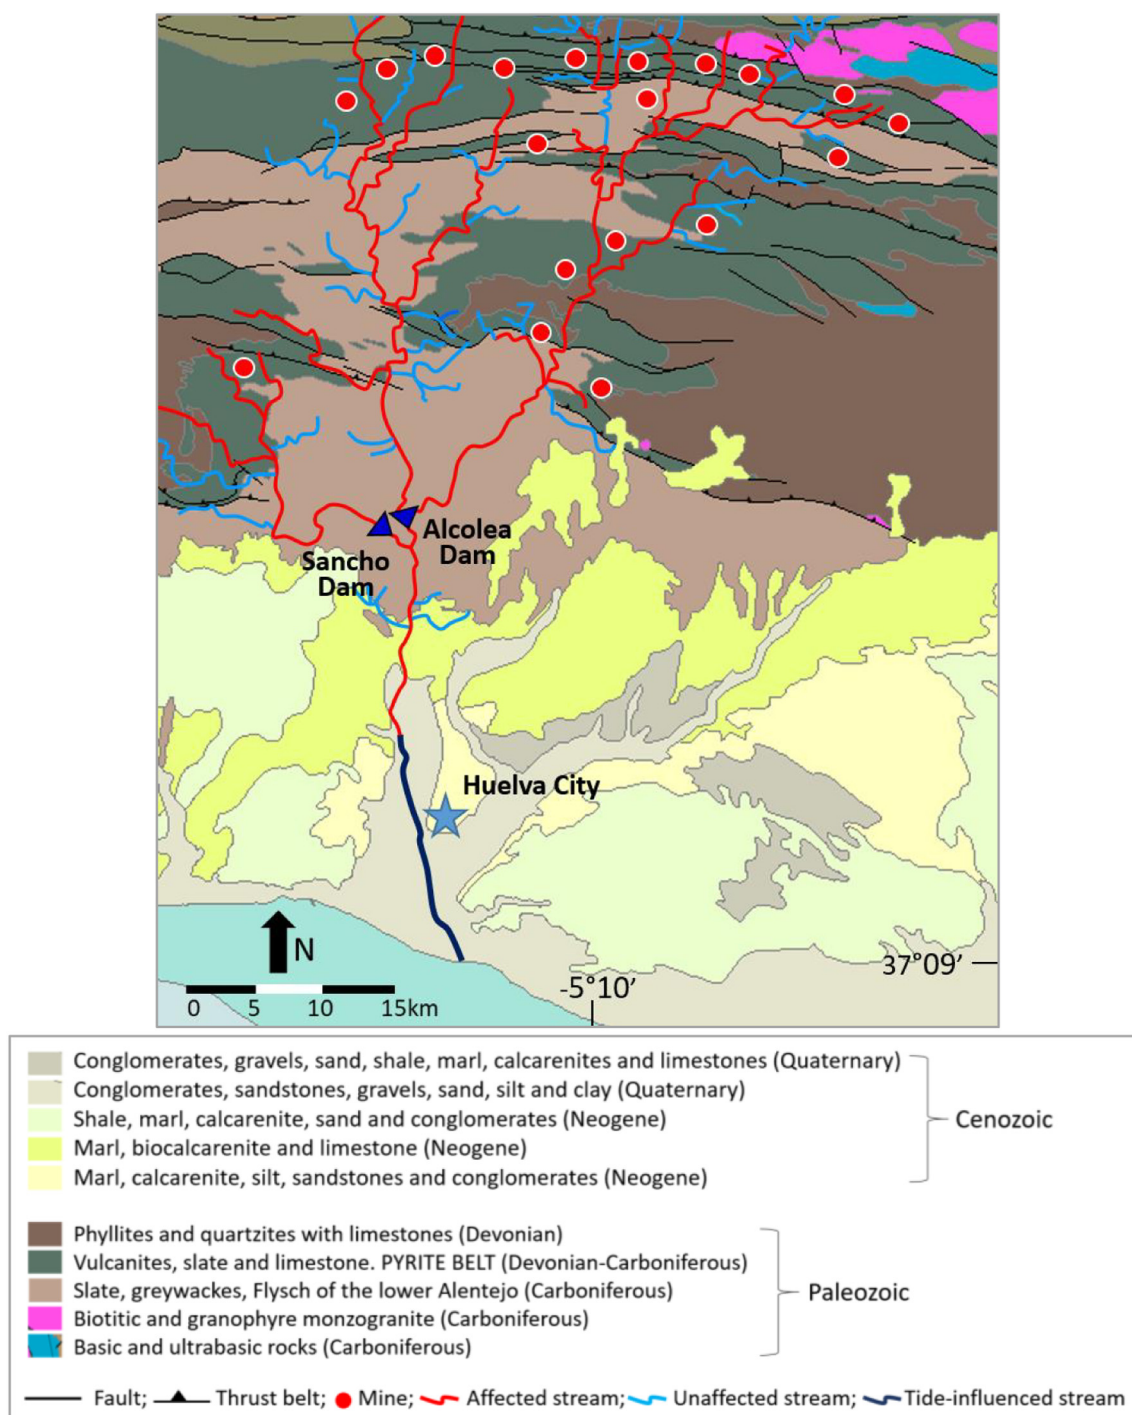
The problem of the future reservoir is that the water inputs from the 422
 local rivers have an extremely poor quality. The water resources from 423
 the River Odiel are acidic (pH = 3.4), with detected concentrations of 424
 toxic elements of 74.5 mg/L of Al, 19.6 mg/L of Zn, 12.8 mg/L of Fe, 3.2 425
 µg/L of As, 195 µg/L of Cd, 33 µg/L of Cr, 662 µg/L of Ni and 493 µg/L of 426
 Pb (Olías et al., 2011). These metal concentrations were even higher 427
 during the hydrological year 2017/2018 (Olías et al., 2020). These ex- 428
 treme conditions derive from the intense mining activity historically 429
 carried out within the IPB area, especially in the 19th and 20th century 430
 . There are currently about 30 abandoned mines within the Odiel basin 431
 containing large quantities of waste with pyrite and other sulphides 432
 (Grande et al., 2018). Combined with the atmospheric oxygen, these 433
 sulphides produce acid leachates with large amounts of toxic metals 434

Fig. 4. Geological map of the Odiel river basin with the location of rivers affected by AMD, mines and dams (own elaboration using information from the Spanish Mining Geological Institute (<http://info.igme.es/visorweb/>) and Ollas et al., 2011).

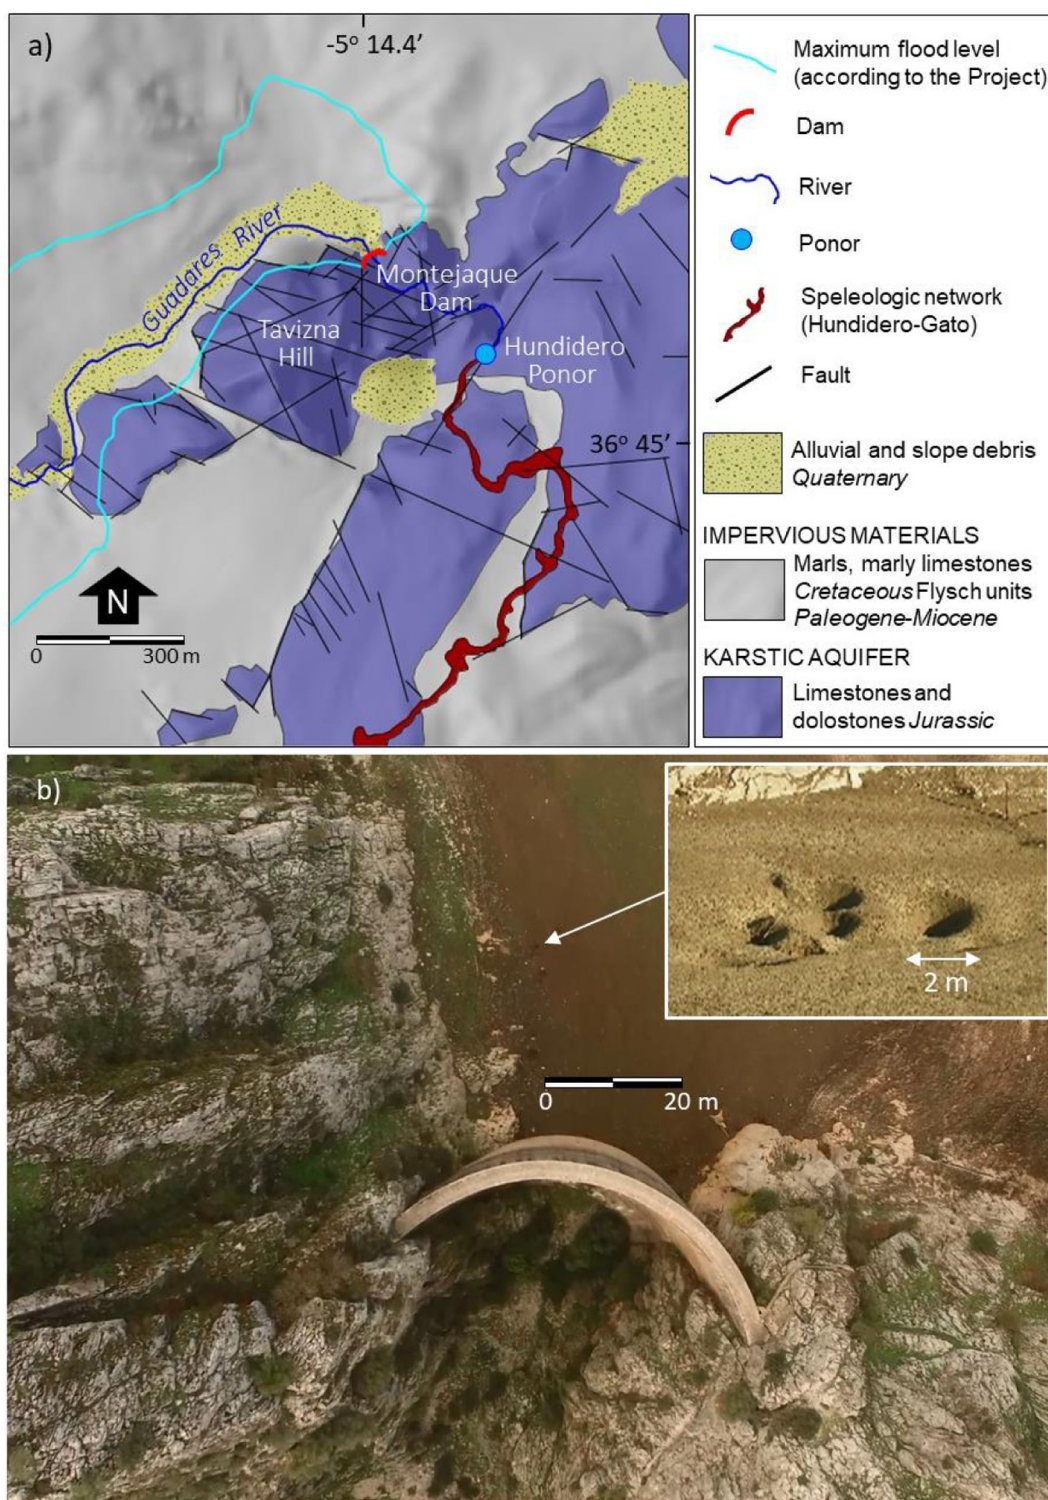
518 Albeit at that time the previous experiences with similar cases were
 519 very scarce and knowledge about karst was poorly developed, before
 520 the construction of the dam, the judgement of renowned geologists
 521 and engineers about the construction of the infrastructure in this area
 522 was very negative (Sánchez and Herreros, 2002). Finally, the energy
 523 company that promoted the project assumed the risk and the works
 524 began, finishing in record time (less than 2 years). It was expected
 525 that an adequate treatment of the rock massif would correct its deficiencies,
 526 so waterproofing treatments were applied prior to the construction
 527 of the dyke. The treatments consisted of cement injections through

perforations and sinkhole sealing. Once the dam was built, reservoir
 tests were conducted yielding very negative results. Sánchez and
 Herreros (2002) and Naranjo (2008) provide an interesting narrative
 about the subsequent operations undertaken over more than 15 years
 aimed at correcting the leakage problem. As the authors describe, tracer
 tests were conducted to define preferential flow paths and waterproof-
 ing works were carried out both from the surface and inner parts of the
 karst massif, taking advantage of the Hundidero-Gato speleologic net-
 work. The latter required the construction of an interior pathway ap-
 proximately 5 km long whose completion was not exempt from risks

Fig. 5. a) Hydrogeological map of the Montejaque reservoir (own elaboration) b) Aerial vertical view of the Montejaque dam and detail of the suffusion dolines of the bottom of the reservoir (own elaboration).

538 and difficulties. Diverse materials were used to seal the conduits and
 539 cavities; concrete, asphalt and clay, giving similar results. When the reser-
 540 voir was filled, water flowed through alternative flowpaths in a highly
 541 permeable medium, with a dense network of fractures and conduits
 542 widely distributed within the rock. It was also proposed to encase the
 543 bottom of the reservoir with an impervious layer, with gunite and
 544 even with an iron sheet cover to remediate the leakage problem.

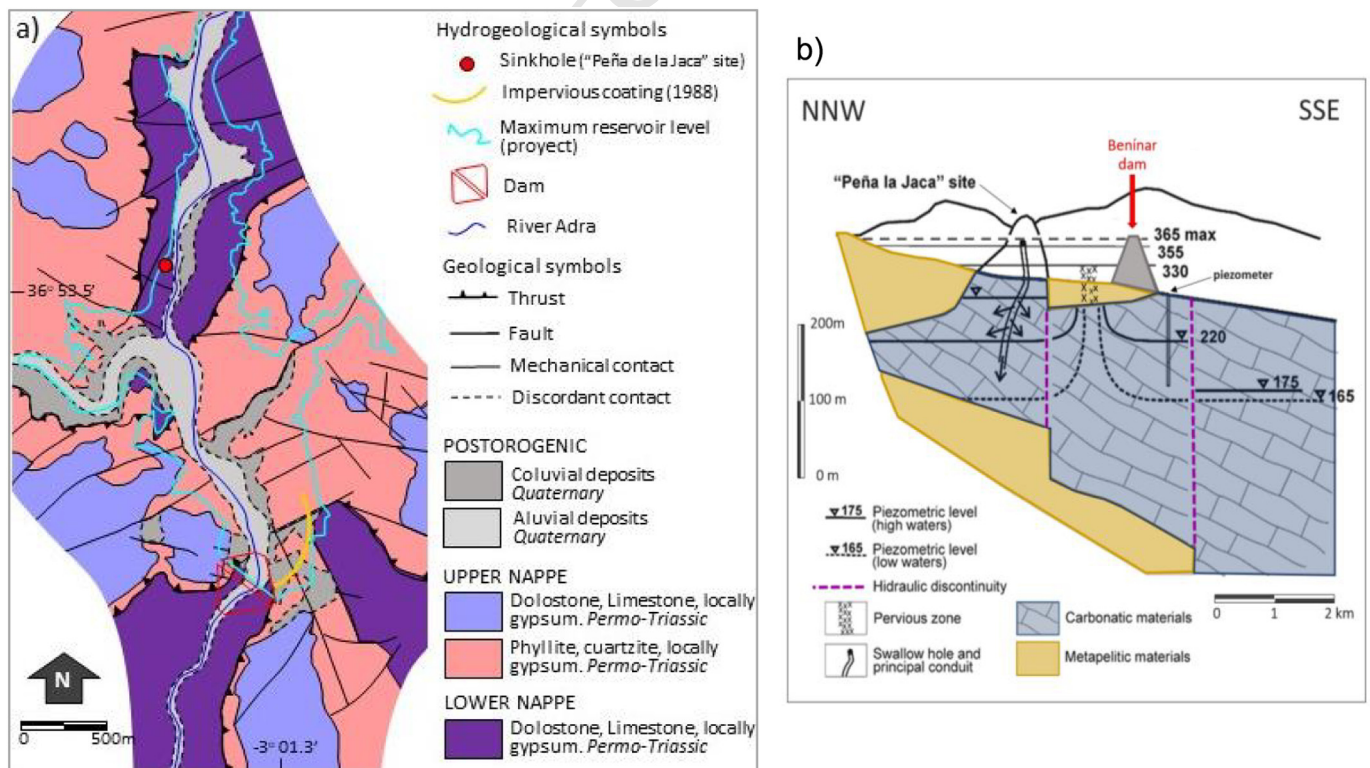
Fig. 6. a) Geological map of the Benívar reservoir (own elaboration); b) Conceptual model of compartmentalization of the recharge zone associated with the Benívar Dam (modified from García-López et al. (2009)).

Shortly after, during a wet period (hydrological year 1989/90), it was possible to check the response of the reservoir to a large flood event. During the 12 months following that rainy period, the reservoir lost about 67 hm³ owing to leakage towards the underlying aquifer. This volume lost exceeds the useful reservoir capacity (60 hm³) and its four times greater than the volume of water supplied to users during that period. The comparison between the leakage flow and the reservoir level during that event allowed to identify three situations or scenarios: (i) When the reservoir level is below 330 m and the leakage flows range between 0.1 and 1.2 m³/s, the relationship between both variables is quadratic. This can be interpreted as the progressive increase of the permeable flooded surface of the vessel as the reservoir level rise. (ii) Between 330 and 355 m and leakage flows of 1.2–2.3 m³/s, there is a linear relationship between both variables. This suggests that the permeable surface remains constant while the reservoir level rises. The increase in the leakage flow is attributable to the rise of the hydraulic head. Therefore, in this range of levels, the impoundment would show a good watertightness. (iii) Finally, when the reservoir level reached 355 m, the flow peaked to 3.4 m³/s and gradually decreased over the following 10 weeks until its stabilization at 2.3 m³/s. During that period the reservoir level remained practically constant. This sharp increase in the leakage flow is related to the action of a karstic conduit associated with the gypsum formations at Peña la Jaca site. The flow decrease is

interpreted as the gradual saturation of an underlying hydrogeological compartment. This compartment is partially connected with the rest of the aquifer through a hydraulic barrier of lower permeability and acts as storage blocks for large volumes of water (5–6 hm³). During that period of extraordinary recharge, rises in the piezometric level of the aquifer that received the leakages were detected downstream from the dam. This evidenced the existence of at least another low-permeability hydraulic barrier and consequently, the presence of another compartment. Fig. 6b illustrates the interpretative conceptual model of the system's functioning deduced from reservoir leakage. With a delay of 4–6 months, the spring located downstream from the dam (Fuentes de Marbella) reached a flow of 2000 l/s that remained stable for months. A detailed study on the evolution of the reservoir, seepage and response of the underlying aquifer can be found in García-López et al. (2009).

Owing to the unsuccessful attempts to regulate the contributions of River Adra, the Public Administration conducted a set of surveys on the calcareous aquifer. The excellent response displayed by the aquifer led to the decision of beginning its exploitation. Finally, it should be noted that, whereas the objective of defense against floods was achieved satisfactorily, the regulation purpose was not accomplished. This resulted in major modifications in the original water planning and the incorporation of groundwater bodies management (García-López et al., 2009).

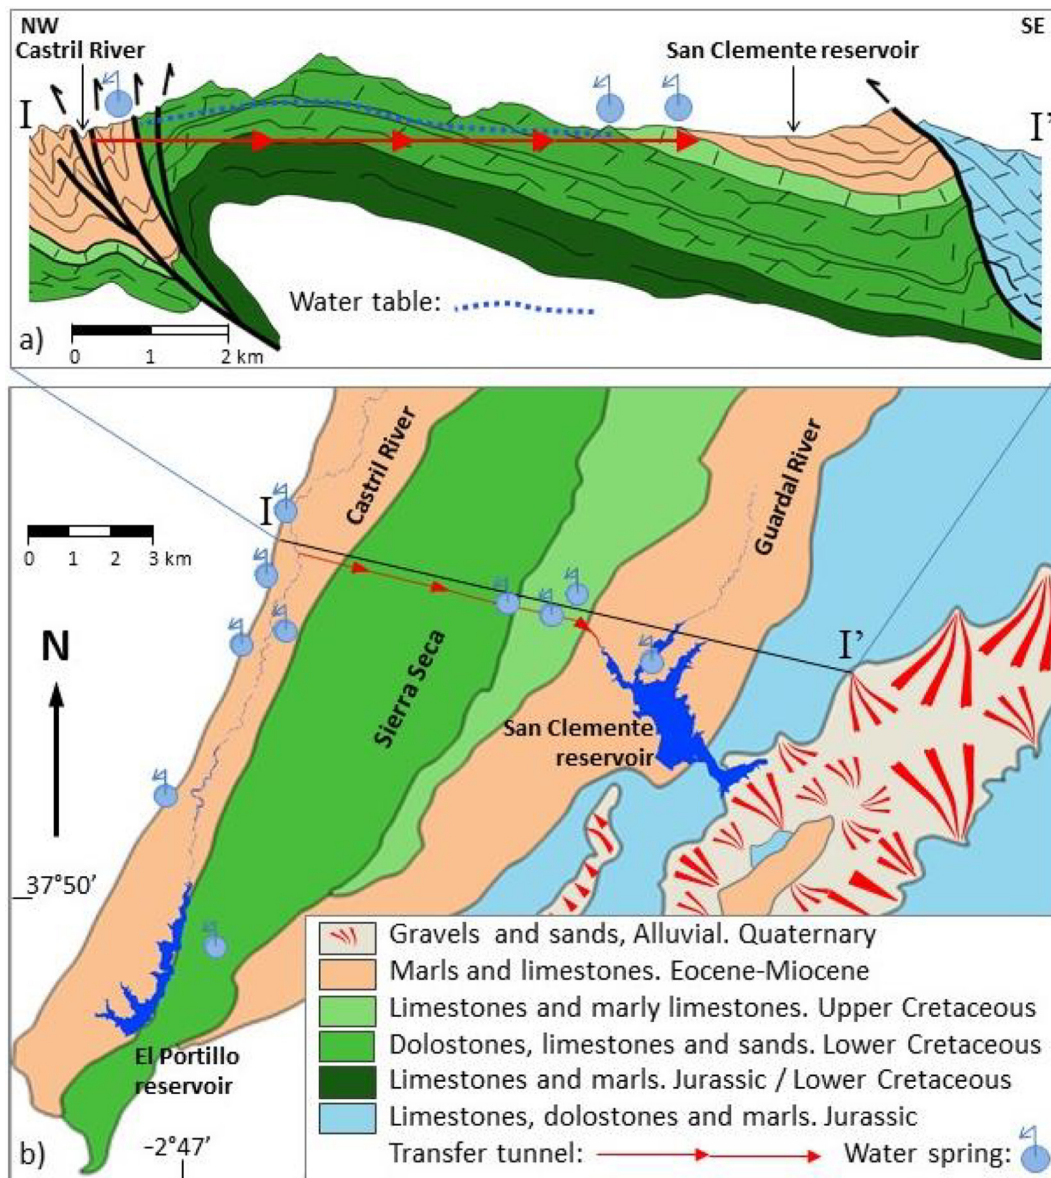
Fig. 7. a) Cross section of the area where the transfer between El Portillo and San Clemente was projected and b) geological map (own elaboration using information from: Continuous Digital Geological Map of Spain (GEODE, 2004)).

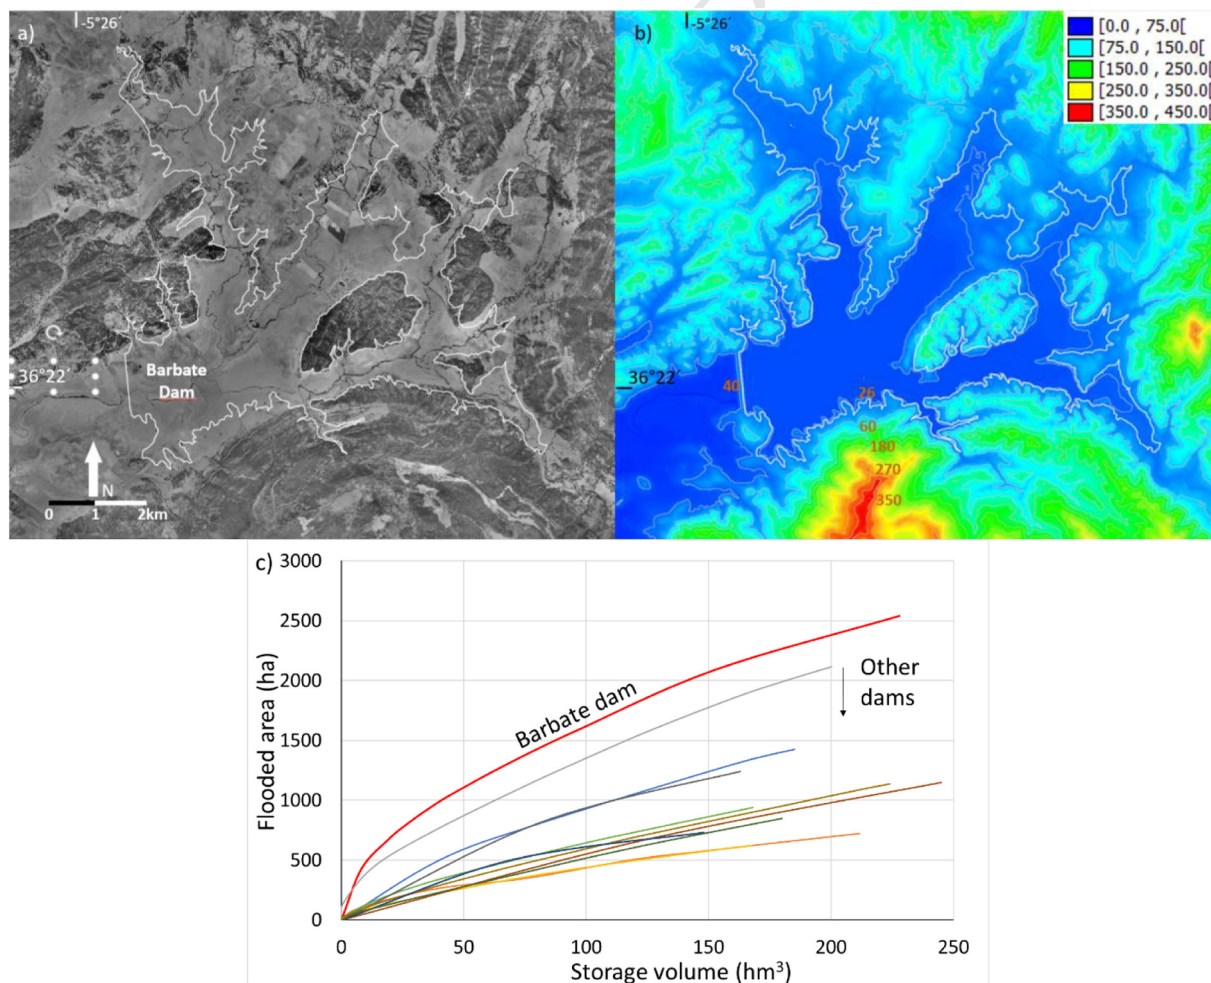
processes (the evaporated volume/supplied volume ratio is greater than 0.5) (Ruiz-Ortiz, 2019). These evaporated volumes are outputs from the system that could otherwise be exploited for human consumption and environmental uses. In this regard, it is noteworthy that the average annual evaporation reported in the Barbate reservoir (30 hm³/year for the period 1999–2016) exceeds the volume pumped from all the aquifers in the basin (18.5 hm³/year) (Junta de Andalucía, 2016). The cause of this phenomenon lies in the location of the dam itself. The infrastructure was built in 1992 in a smooth relief area (Fig. 8a) with less than 3% average slopes and terrain elevations between 20 and 80 m.a.s.l (Fig. 8b). The constructive singularities that this location conferred to the dam (dyke length 1360 m, dam height 25 m above the terrain, surface flooded of 2540 ha at maximum storage capacity) made it the most unfavourable case in Andalusia from the point of view of evaporation losses (Fig. 8c). Besides, the existence of strong and persistent winds (particularly easterly winds known as “Levante”) can substantially increase the daily evaporation, even doubling it.

Fig. 8. a) Official aerial orthophotography from the 1980's decade, prior to dam construction. The limits of the projected reservoir are indicated (modified from: <http://centrodedescargas.cnig.es/CentroDescargas/catalogo.do?Serie=FPNOA>). b) Topographic map of the Barbate reservoir area (own elaboration). c) Graph showing area/volume curves for reservoirs between 150 and 250 hm³ of Andalusia. (own elaboration).

Recently, Ruiz-Ortiz et al. (2019) analyzed in detail this hydrological problem and evaluated other water management alternatives in order to reduce the large evaporated volumes. This would also lead to the improvement of the current status of the basin's aquifers (Vélez-Nicolás et al., 2020), which are classified as in poor quantitative and chemical condition by the Administration. In their study, Ruiz-Ortiz et al. (2019) carried out analysis and modelling tasks based on Decision Support Systems (AQUATOOL-SIMGES) considering 5 potential strategies or scenarios: i) combined management of the reservoirs, ii) conjunctive
