Strategy Based on Two Stages for IR Thermographic Inspections of Photovoltaic Plants

García-López, C. Strategy Based on Two Stages for IR Thermographic Inspections of Photovoltaic Plants. *Appl. Sci.* **2022**, *12*, 6331. <https://doi.org/10.3390/app12136331>

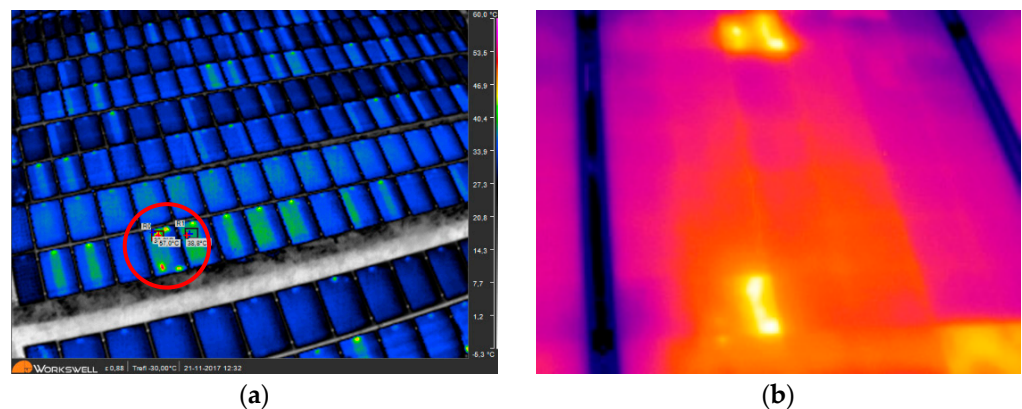
Figure 5a depicts the aerial thermographic analysis of the PV module with a broken front cover (array 5, position E10), which reaches a temperature of 57.0 °C. The temperature difference with respect to the adjacent PV module is around 19 °C. Figure 5b shows the ground-level thermographic analysis for the same module. In this case, the maximum temperature of the PV module at position E10 is 86.6 °C. This abnormality is one-time and is obtained in the cell indicated in the analysis chart. The average temperature of this cell is 63.7 °C. The difference in the results obtained for maximum values is nearly 30 °C between both thermographs. This difference is due to the fact that the abnormality is a one-off with a size smaller than the cell, and thus, the aerial inspection distance provides a spatial resolution that is insufficient for this type of fault.

Figure 5. Thermographic analysis for an incident of broken glass: (a) aerial IR inspection, and (b) ground-level IR inspection. The red circle in (a) identifies the affected PV module.

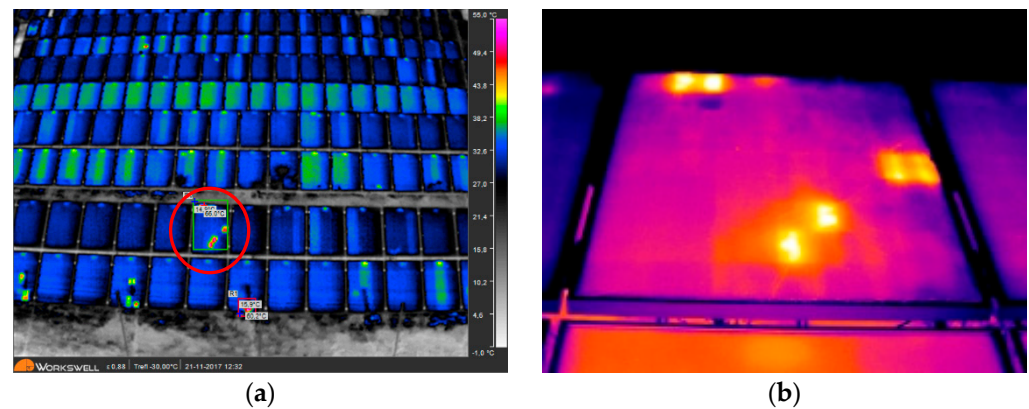
Figure 6a depicts another PV module with a broken front cover (array 6, position AK11), which reaches a temperature of 66.0 °C. Figure 6b shows the ground-level thermographic analysis for the same PV module. The top temperature in the PV module with position AK11 is 89.6 °C and is reached in the indicated cell via an analysis chart as a one-off abnormality. The difference in the results obtained for maximum values is nearly 33 °C between both thermographs. Like in the previous case, this difference is due to the

fact that the abnormality is a one-off with a size smaller than the cell, and thus, the aerial inspection distance provides a spatial resolution that is insufficient for this type of fault.

Figure 6. Thermographic analysis for an incident of broken glass: (a) aerial IR inspection, and (b) ground-level IR inspection. The red circle in (a) identifies the affected PV module.

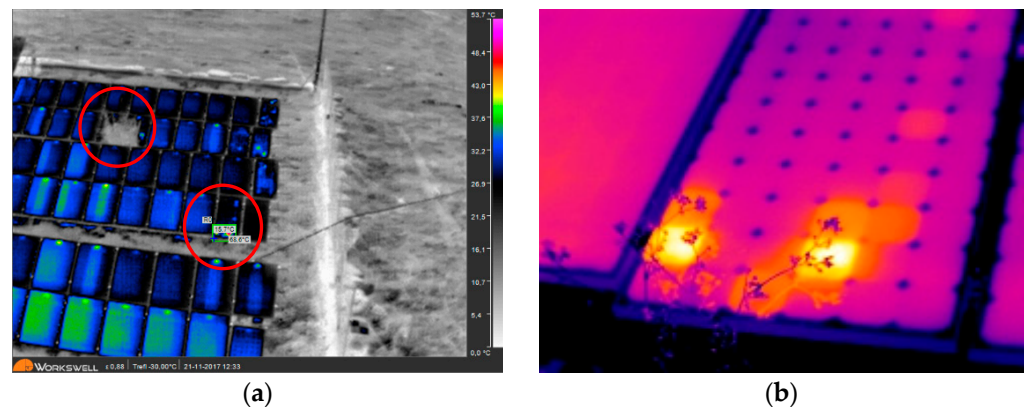
Figure 7a shows the thermographic analysis with incidents due to partial shading in cell AV6 in array 3. A maximum temperature of 68.6 °C was reached in this PV module. Figure 7b shows the ground-level thermographic analysis for the same PV module. The temperature in this PV module (location AV6) for the cell to the right attained values up to 111.8 °C and an average temperature of 88.6 °C. The cell on the left reached values of 108.4 °C and an average temperature of 85.9 °C. The temperature was not homogenous in either shaded cell. The high temperature value may be due to the fact that the vegetation has no appreciable separation over the module, so that the shading effect on the cells is fixed, without influence from the sun's position.

Figure 7. Thermographic analysis for an incident of partial shading: (a) aerial IR inspection, and (b) ground-level IR inspection. The red circles in (a) identify the affected PV modules.

The PV modules at cell positions AQ4 and AR4 (in array 2) in Figure 7a are hidden behind the vegetation, so that no overtemperature of these PV modules is observed due to obstruction by the object. Figure 8 depicts the visual image and ground-level thermographic analysis with incidents in PV modules at positions AQ4 and AR4 (in array 2). The highest temperature in these modules at AQ4 and AR4, which are shaded by vegetation, is 49.6 °C. The top area with the diode case was not considered. The temperature difference compared to the previous case (module AV6) may be due to the separation from the vegetation that caused a moving shadow depending on the sun's position.

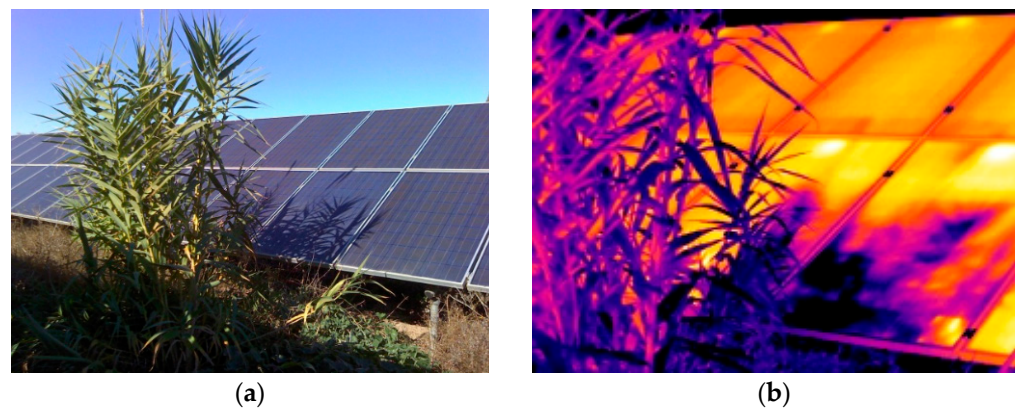
Figure 8. Ground-level thermographic analysis with an incident involving partial shading: (a) visual image, and (b) ground-level IR inspection.

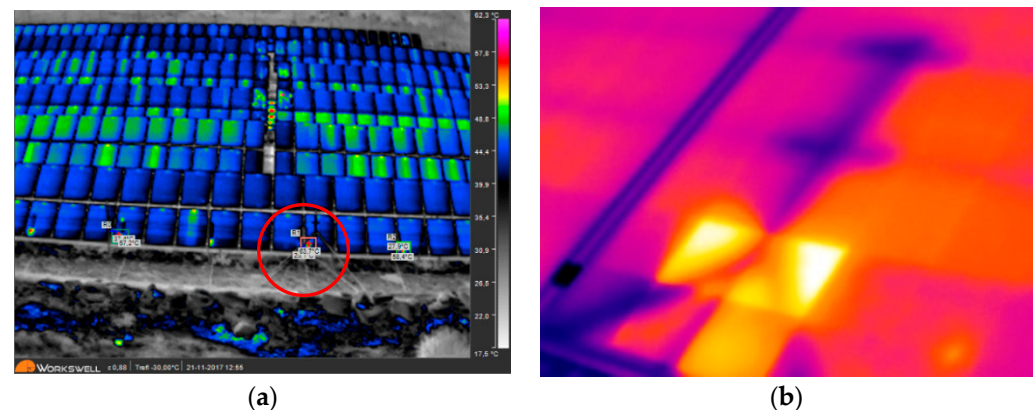
Figure 9a depicts the aerial thermographic analysis of the PV module at position AC12 (array 6), which reached a temperature of 63.7 °C. This overtemperature, or hotspot, was caused by the partial shading from metal fence posts on the perimeter and occurred in other PV modules in the bottom row of array 6 for the same reason. Figure 9b depicts the ground-level thermographic analysis with incidents in the PV module at position AC12 (array 6) that reaches a maximum temperature of 77.5 °C, where the average temperature of the hot cell is 56.2 °C. The difference in the maximum values obtained of nearly 15 °C between both thermographs may be due to the effect of concealment by the post. It could also be due to the fact that the shade moves with the movement of the sun so that the value changes over time.

Figure 9. Thermographic analysis with an incident of partial shading: (a) aerial IR inspection, and (b) ground-level IR inspection. The red circle in (a) identifies the affected PV module.

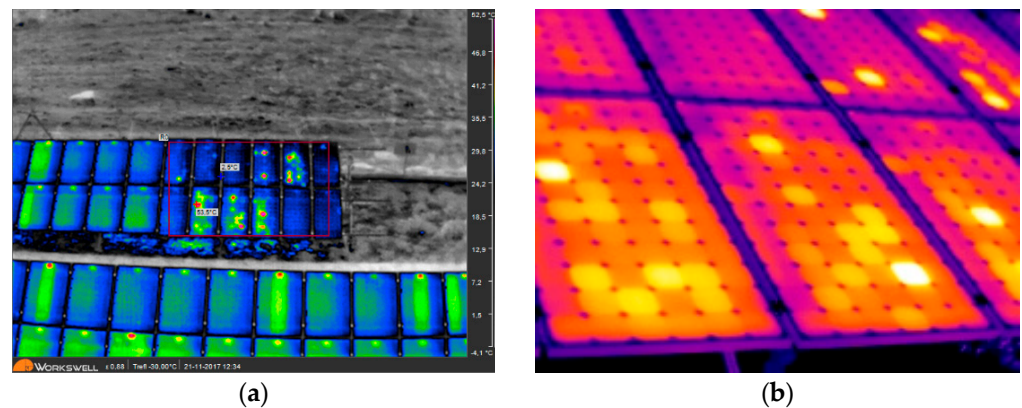
PV modules of type m-Si in array 1 reveal an irregular temperature pattern, reaching values of 53.5 °C, as shown in Figure 10a. This pattern is characteristic of a module in a short circuit according to IEC-62446-3. Remember that for the m-Si type module its $I_{sc} = 5.22$ A is less than $I_{mp} = 7.57$ A for the p-Si type module, so the series connection of both modules causes this situation. The heat pattern observed is characterised by a short circuit. The maximum temperature reached is 63.5 °C according to Figure 10b. In this case, the ground-level thermograph lets us see the irregular temperature pattern with higher resolution.

Figure 10. Thermographic analysis for an incident involving PV module technology: (a) aerial IR inspection, and (b) ground-level IR inspection.

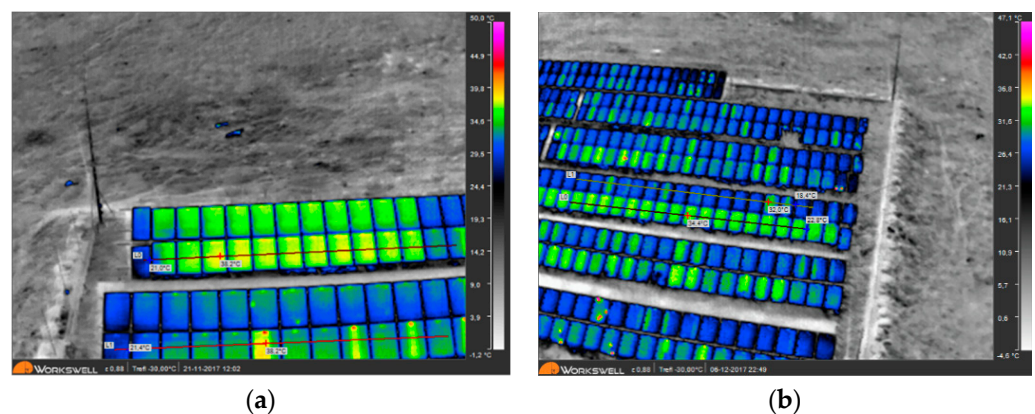
The modules with open circuits do not produce energy. All PV modules in the string that are observed in array 1 are in an open circuit with an overtemperature of some $5\text{ }^{\circ}\text{C}$ with regard to operational PV modules, as depicted in the analysis lines in Figure 11a. All PV modules in the string that are observed in array 4 (bottom part) are also in an open circuit with an overtemperature of some $5\text{ }^{\circ}\text{C}$ with regard to operational PV modules, as depicted in the analysis lines in Figure 10b. In this case, the ground-level thermograph is not necessary, as it does not provide any additional information.

Figure 11. Aerial IR thermographic analysis with an incident of open-circuit PV modules: (a) in array 1, and (b) in array 4.

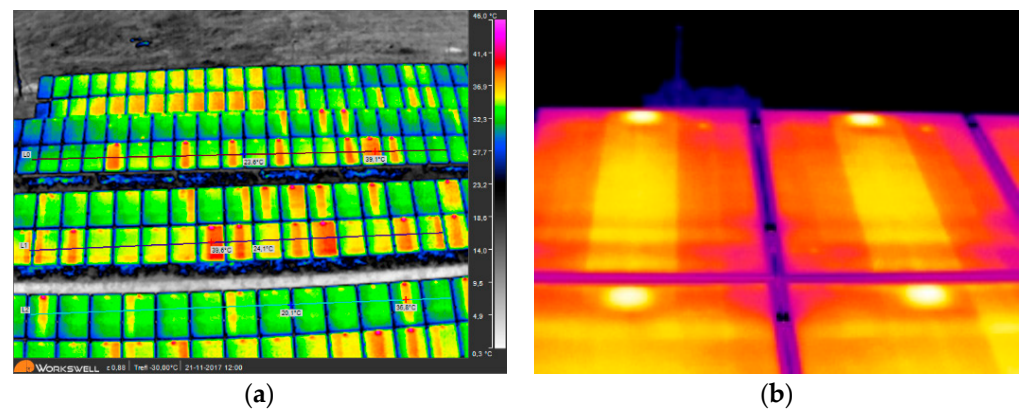
The modules can present open substrings, which limits their power generation. Figure 11a shows the aerial thermographic analysis in which some PV modules have substrings with temperature gradients of up to $5\text{ }^{\circ}\text{C}$ with respect to adjacent substrings in the same module. This is seen in arrays 2, 3 and 4, as indicated by the analysis lines. Figure 12b shows the temperature gradient corresponding to open-circuit substrings from testing with ground-level thermography.

Figure 12. Thermographic analysis with an incident of PV modules with open-circuit substrings: (a) aerial IR inspection, and (b) ground-level IR inspection.

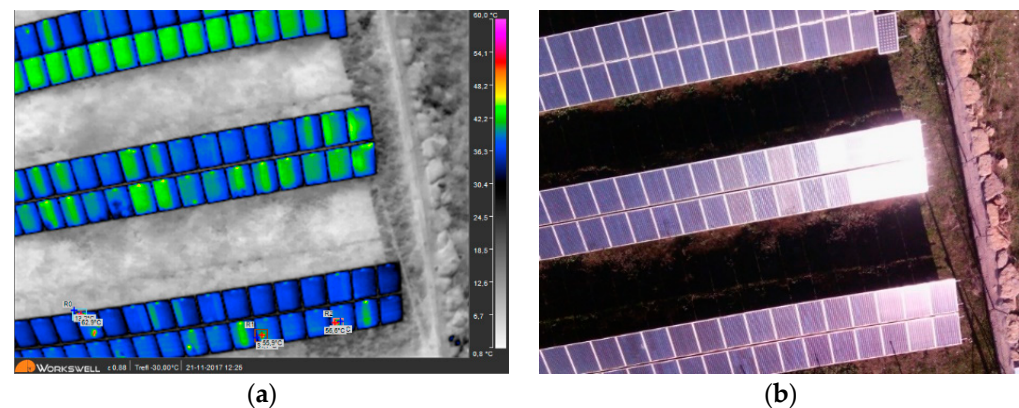
Sunlight reflections due to an improper inspection angle can cause significant reflected glare on the inspection equipment. In Figure 13a, the maximum temperature values reached in the PV modules located at AK11, AR12 and AU12 (array 6) are influenced by solar reflection, as verified in Figure 13b, meaning that they are not real values. The existence of solar reflections is more likely with aerial thermography, as the flight path may lead to some areas being inspected at an unsuitable angle with regard to the sun's position.

Figure 13. Thermographic analysis (a) and image (b) with an incident of PV modules with solar reflection.

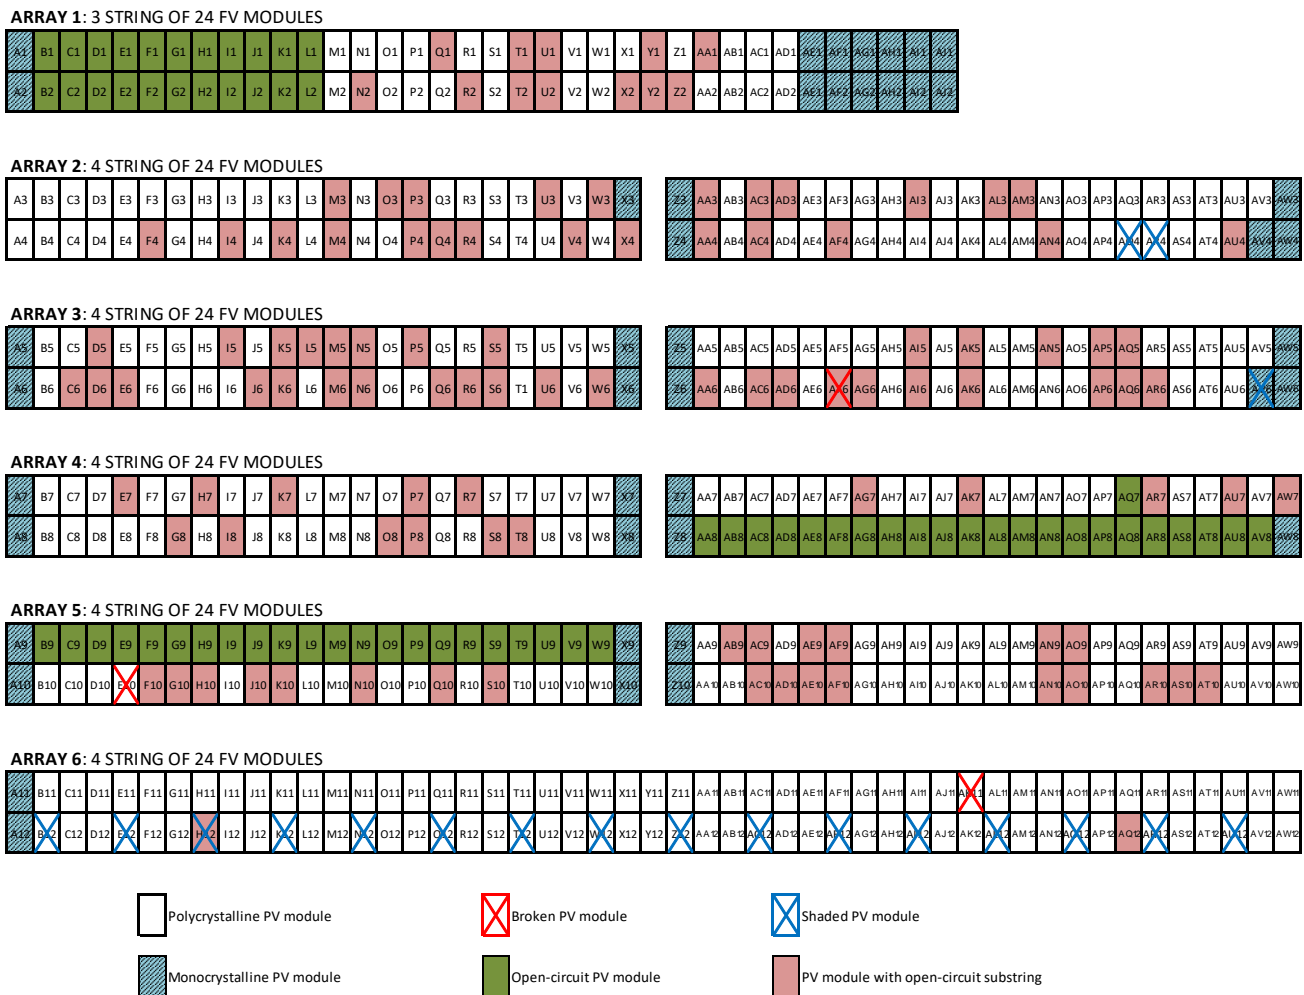
Figure 14 summarises the incidents detected after a two-stage thermographic inspection and their locations for the PV plant inspected, considering the identification matrix by module.

Figure 14. Location and types of incidents in the PV plant after thermographic inspection, considering the identification matrix of Figure 4a.
